Report Introduction

Report Summary

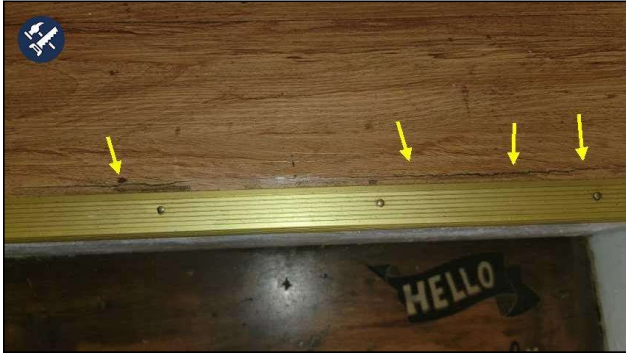
Interior Areas		
Page 19 Item: 8	Stairs & Handrail	<ul style="list-style-type: none"> • Worn Paint Noted. • Cracking Observed.

<p>Cracking Observed.</p>		
Page 19 Item: 9	Window/Wall/Floor AC/Heat Condition	<ul style="list-style-type: none"> • Could not Test, Gas Shutoff to Home at Time of Inspection.

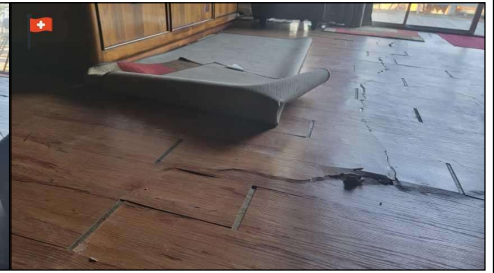
Dining Area--Numerous Heavy Foundation Cracks Noted.

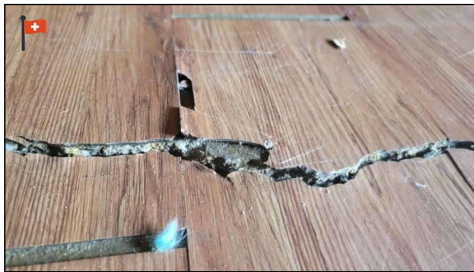
Living Room--Numerous Heavy Foundation Cracks Noted.

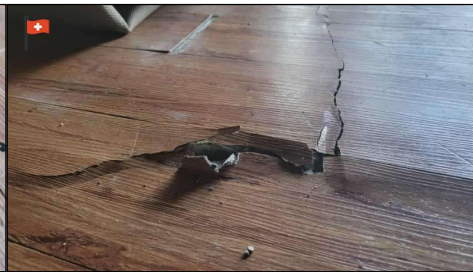
Living Room--Numerous Heavy Foundation Cracks Noted.

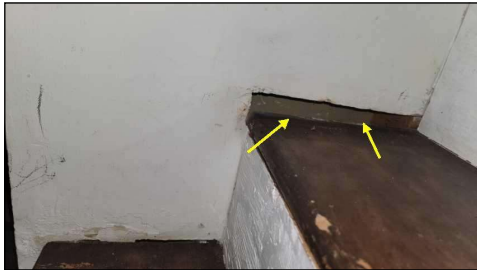
Holes Noted by Stairs.

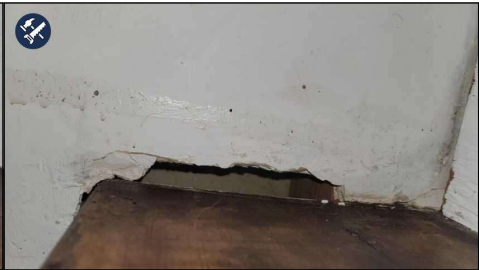
Holes Noted by Stairs.

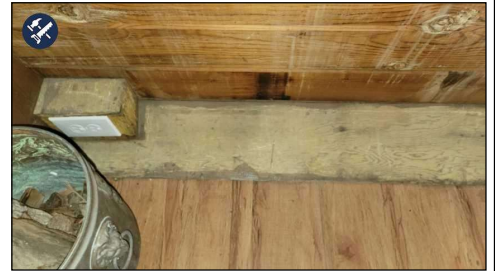
Living Room--There is evidence of moisture entering structure. We recommend contacting a contractor experienced in exterior systems to evaluate the area and suggest repair options.

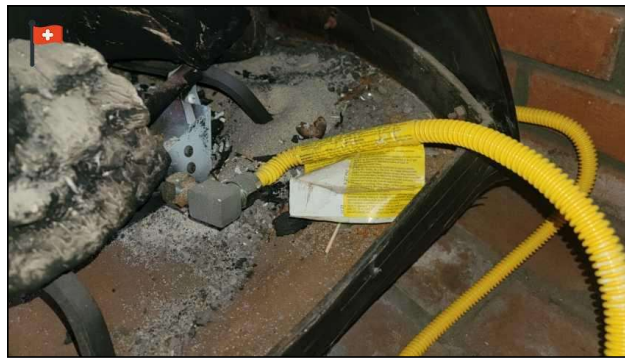
Page 26 Item: 8	Fireplace	• Cracks Observed in Brick Hearth. • A flex line was observed in firebox.
-----------------	-----------	--

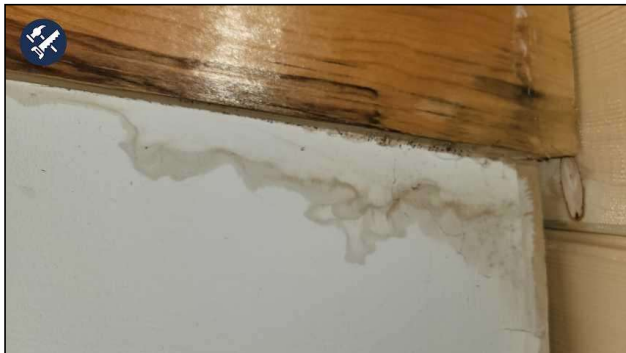
Bedroom#1, Inside Closet--There is evidence of moisture entering structure. We recommend contacting a contractor experienced in exterior systems to evaluate the area and suggest repair options.

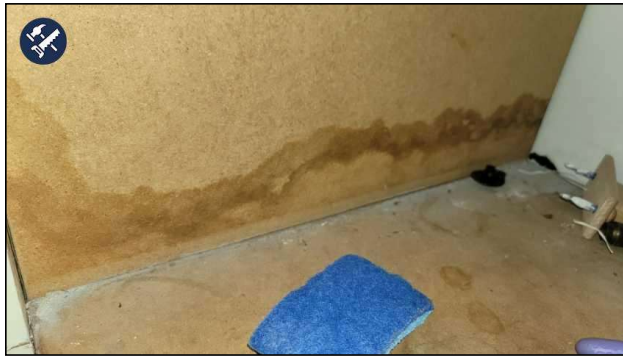
Upstairs Bathroom#2--There appears to be water damage under sink. This tested dry at the time of the inspection, but monitor for any further intrusion.

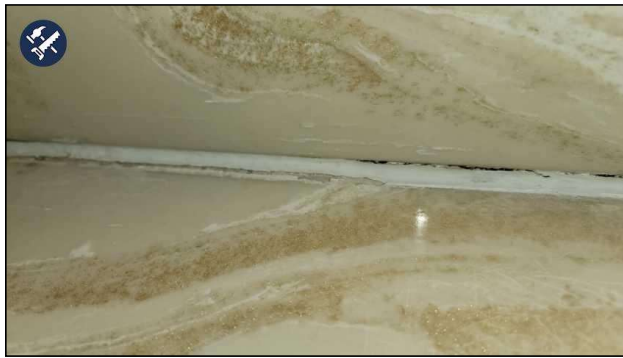
Upstairs Bathroom#2--Caulking Observed to be Cracking.

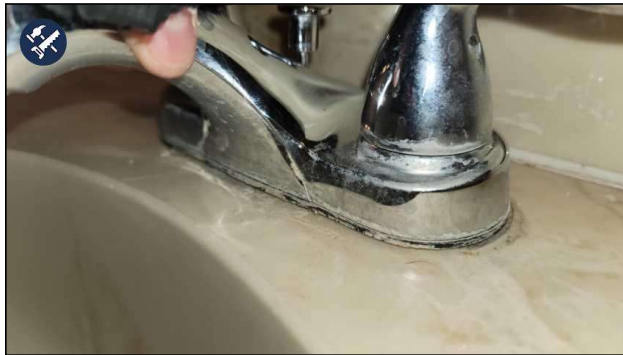
Bathroom#1--Faucet Observed Loose.

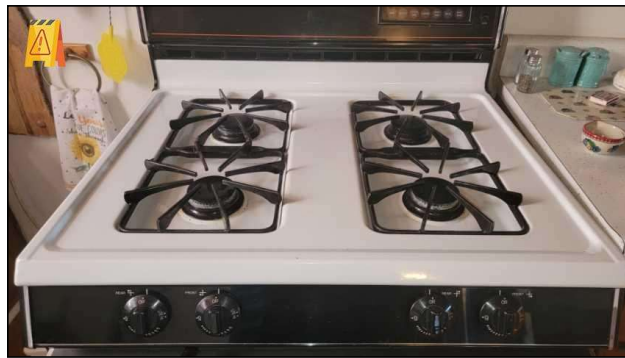
Could not Test, Gas Shutoff to Home at Time of Inspection.

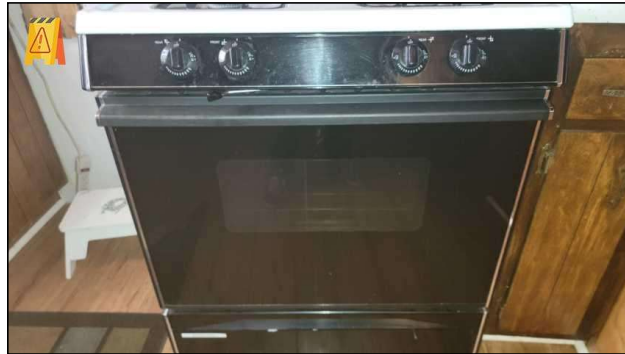
Could not Test, Gas Shutoff to Home at Time of Inspection.

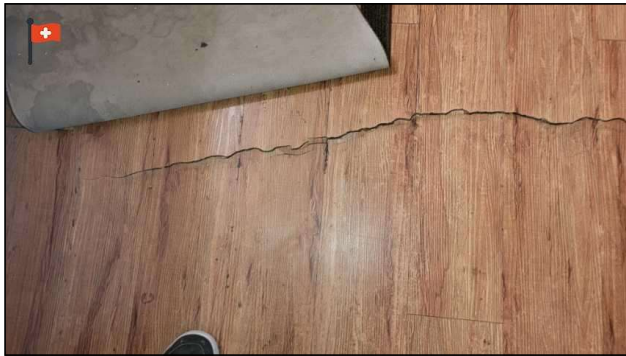
Numerous Heavy Foundation Cracks Noted.

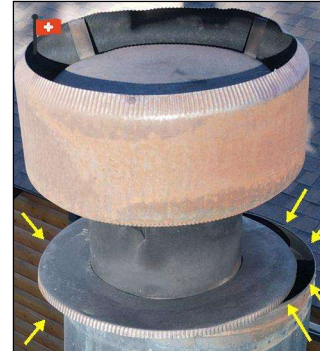
Slightly tilted to the Right

Not Secured to Chimney Pipe as seen in the Picture. This can let out hot embers into the Air and could ignite something. Recommend not using this until it has been gone over by a Fireplace specialist.

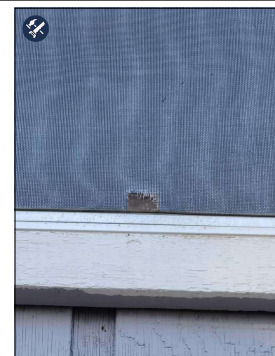
South Side--Upstairs hole in the Screen.

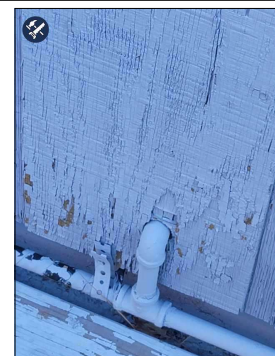
East Side--Peeling Paint Observed.

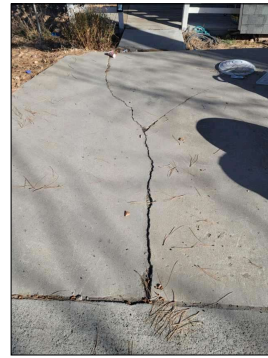
Crack in the Concrete

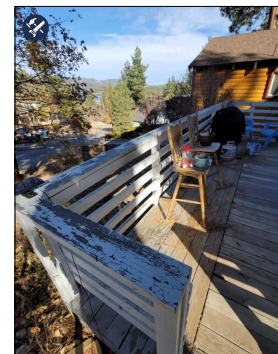
Railing is Loose

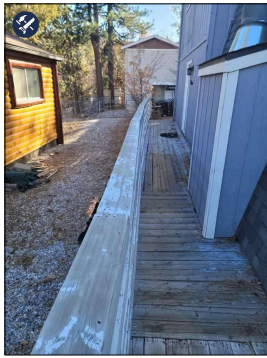
East Side--Loose Railing

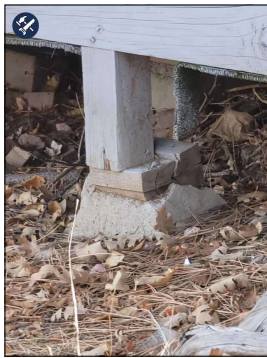
North Side--Instead of doing it right some just stacked block of Wood on top of the Failing footing to make do.

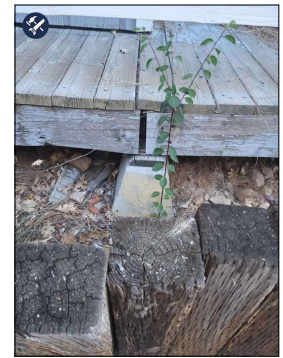
East Side--The Deck is Sagging at this point. May have to do with the Footing that are Cracked, crumbling, tilted and so on.

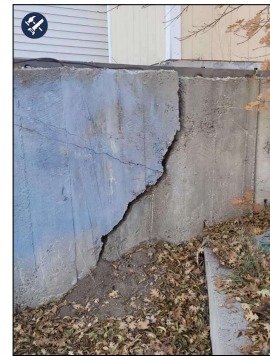
Retaining Wall is Cracked clean through and separating with a shift. On the the far west edge of th Property.

Page 56 Item: 15	Fence Condition	<ul style="list-style-type: none"> • RETAINING/GARDEN WALL • Damaged/Severely Cracked Recommend further Evaluation by a General Contractor for Answers & Options to this issue.
------------------	-----------------	---

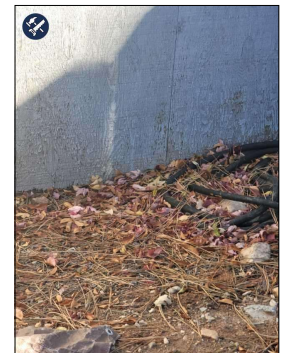
Siding is Material to Soil

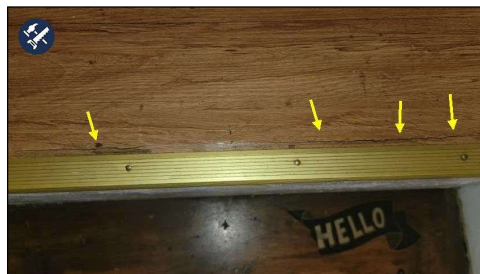
Cracking Observed.

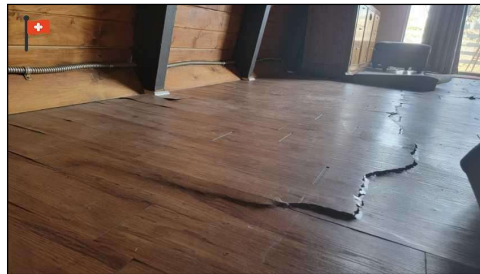
Dining Area--Numerous Heavy Foundation Cracks Noted.

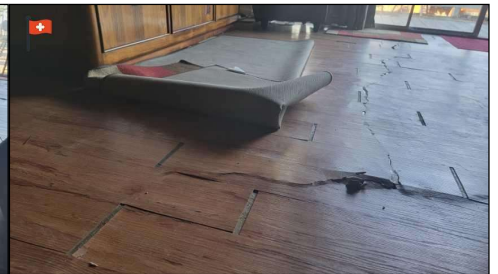
Living Room--Numerous Heavy Foundation Cracks Noted.

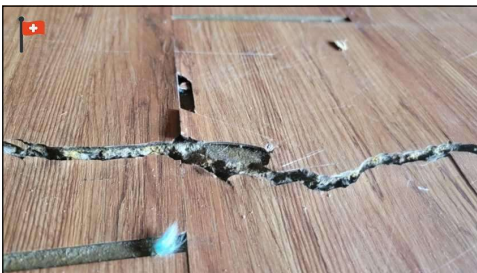
Living Room--Numerous Heavy Foundation Cracks Noted.

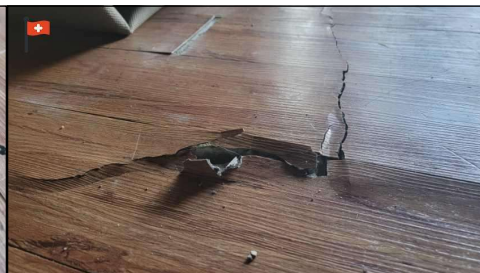
Living Room--Numerous Heavy Foundation Cracks Noted.

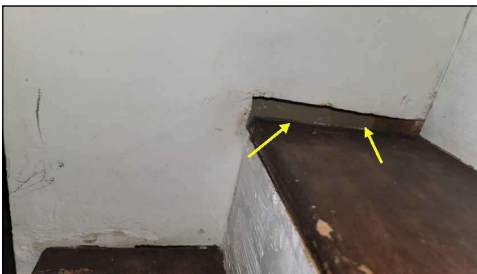
Holes Noted by Stairs.

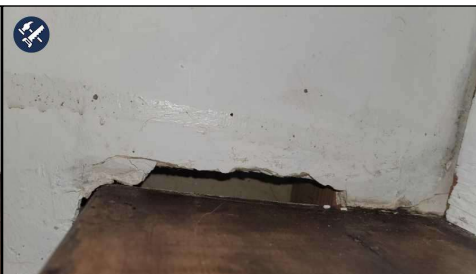
Holes Noted by Stairs.

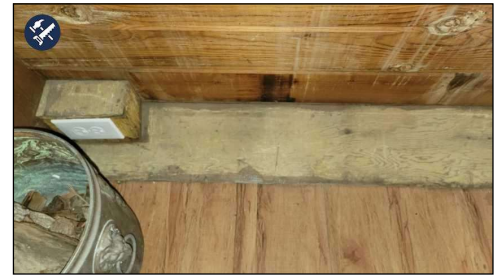
Living Room--There is evidence of moisture entering structure. We recommend contacting a contractor experienced in exterior systems to evaluate the area and suggest repair options.

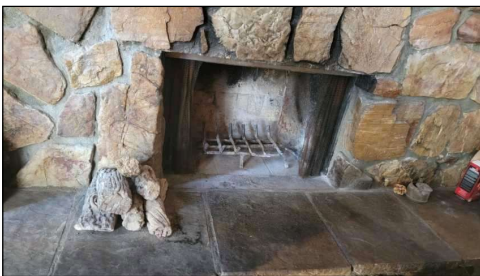
Materials: Living Room
Materials: Masonry fireplace noted.
Observations:
• ****Wood Fireplaces****
• Functional.
• **Moderate Cracks Noted.**

Living Room--Moderate Cracks Noted. Recommend Further Evaluation by a Fireplace Specialist for Answers & Options to this issue.

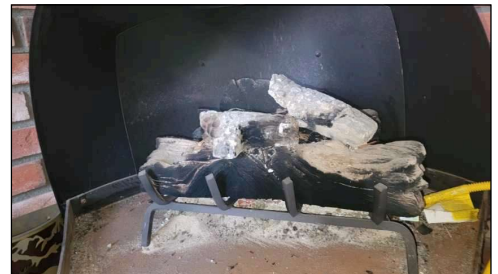
Bedroom#1

Bedroom#1--Cracks Observed in Brick Hearth.

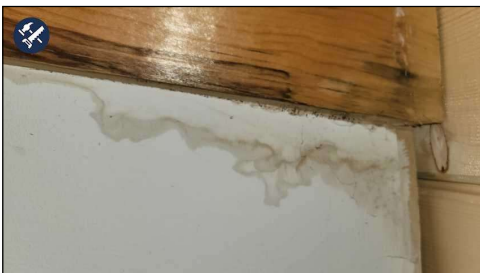
Bedroom#1, Inside Closet--There is evidence of moisture entering structure. We recommend contacting a contractor experienced in exterior systems to evaluate the area and suggest repair options.

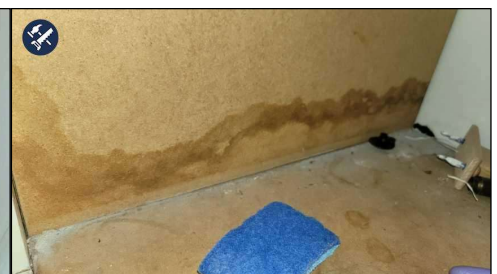
Upstairs Bathroom#2--There appears to be water damage under sink. This tested dry at the time of the inspection, but monitor for any further intrusion.

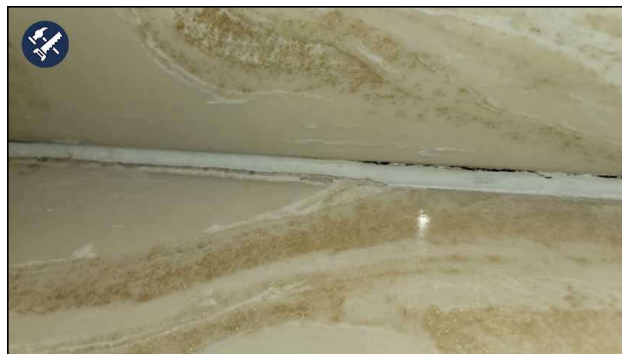
Upstairs Bathroom#2--Caulking Observed to be Cracking.

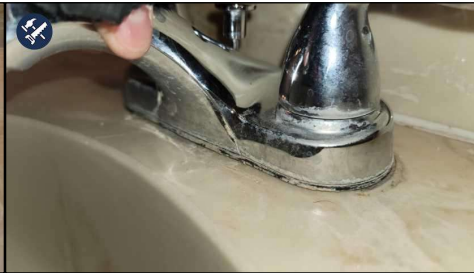
Bathroom#1--Faucet Observed Loose.

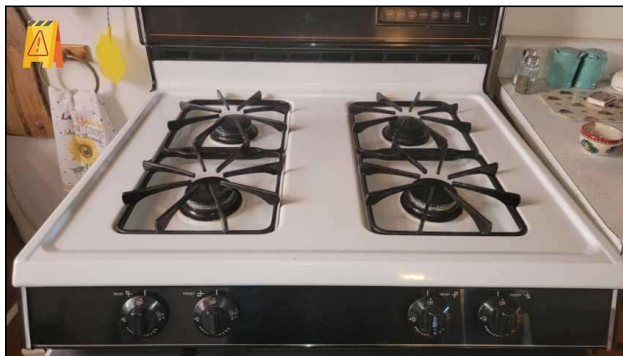
Could not Test, Gas Shutoff to Home at Time of Inspection.

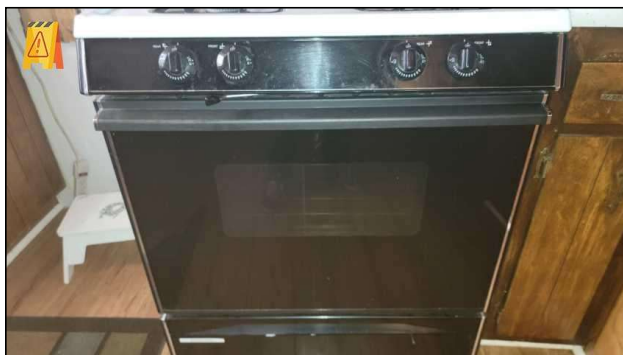
Could not Test, Gas Shutoff to Home at Time of Inspection.

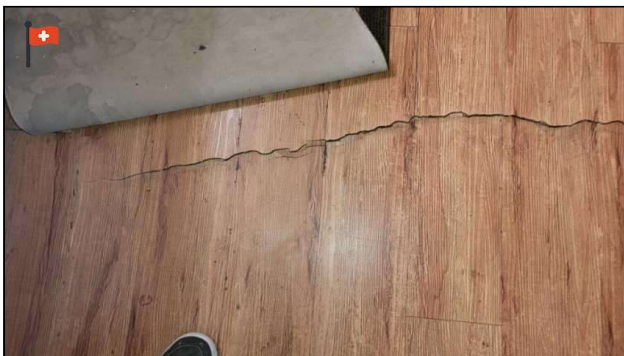
Numerous Heavy Foundation Cracks Noted.

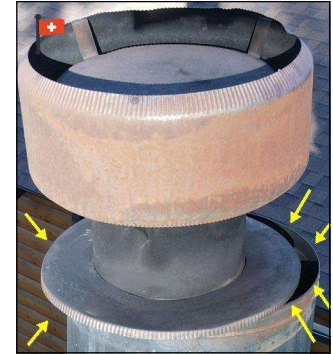
Not Secured to Chimney Pipe as seen in the Picture. This can let out hot embers into the Air and could ignite something. Recommend not using this until it has been gone over by a Fireplace specialist.

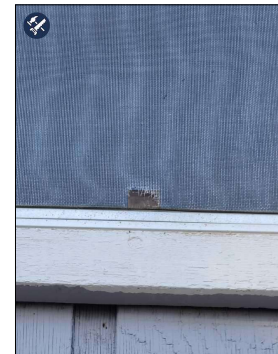
South Side--Upstairs hole in the Screen.

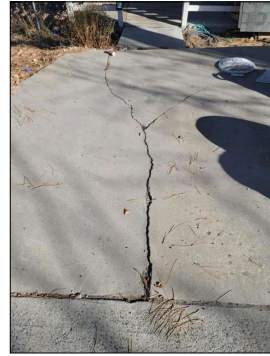
Crack in the Concrete

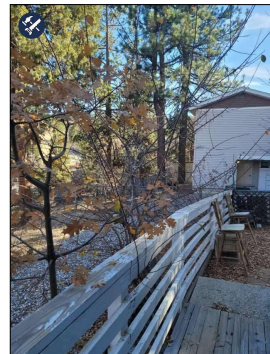
East Side--Railing is Loose

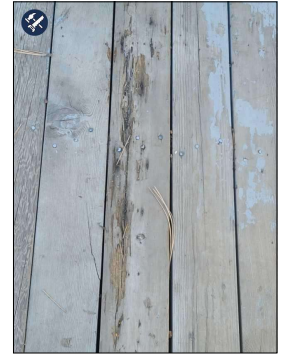
North Side Deck--Floor Boards are Showing Peeling Paint & Bare Wood Observed.

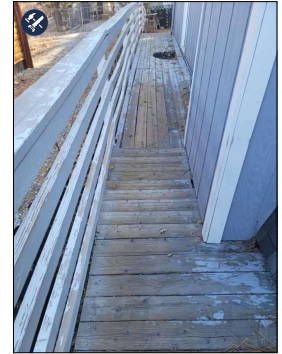
East Side--Floor Boards are almost without finish

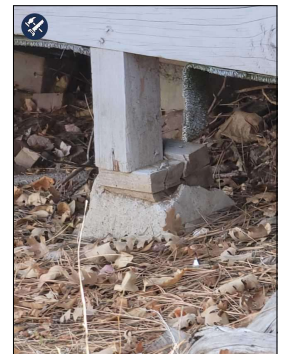
North Side--Instead of doing it right some just stacked block of Wood on top of the Failing footing to make do.

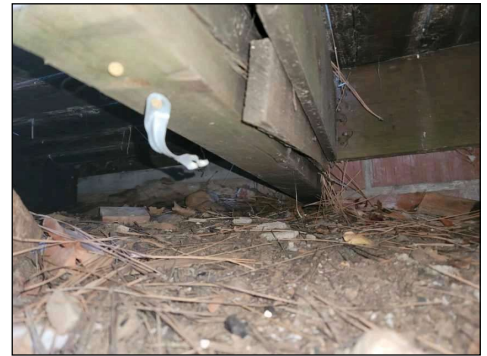
East Side--Almost Material to Soil
