# PROPERTY INSPECTION REPORT

**Donald D'Angelo  
Big Bear Home Inspectors**

**828 Angeles Blvd.  
Inspection Prepared For: Jaiden Ng  
Agent: Lila Mova -**

**Date of Inspection: 10/25/2021  
Age of House: Built in 1930--91 Yrs..old Size: 695 SqFt.  
Weather: Raining & Cold**

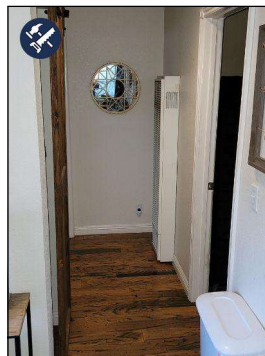
Hallway--In this Area there was a Smell in the hallway that actually smelled like a Dead rodent. Could not find and even when opened closet on the Left and the Crawlspace hatch was opened smell was not under there just in the Hallway.

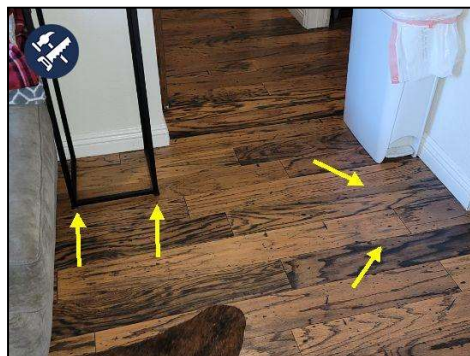
Page 12 Item: 9	Flooring Condition	<ul style="list-style-type: none"> <li>Section of the Flooring in the Living Room on the Way to the Hallway has a spot where if you bounce on the floor you can make the stand 3 feet away rock where it sits. This is probably the combination of Diagonal Plank Sub-Flooring(90 Yrs.Old) and Laminate Flooring over it. Aged sub-Floor with flexible above Flooring found a bouncy spot.</li> </ul>
-----------------	--------------------	---

Living Room Entering Hallway

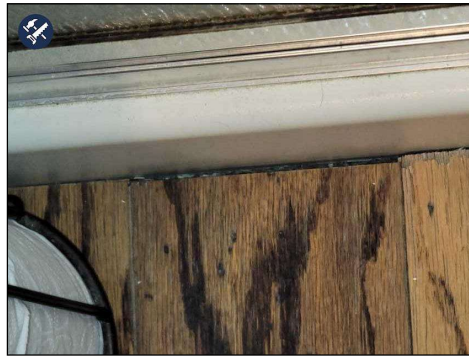
Bathroom

Page 19 Item: 7	Floor Condition	<ul style="list-style-type: none"> <li>Recommend sealing cracks/voids.</li> <li>Recommend caulking at the tub and shower areas</li> </ul>
-----------------	-----------------	---

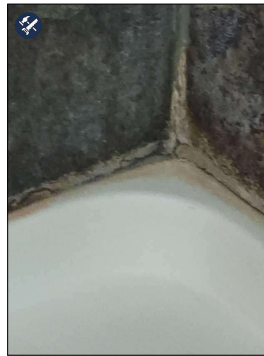
Bathroom

- **\*\*OBSERVATIONS\*\***
- Recommend sealing holes & gaps to stop water infiltration into walls.
- Missing/damaged grout observed, suggest re-grouting as necessary.

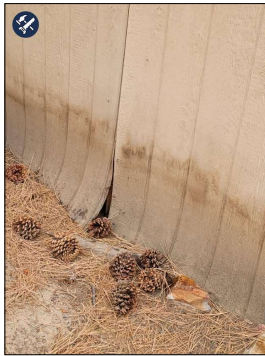
- Caulk and seal all gaps, cracks and openings.
- Some siding deterioration noted. Have repaired as necessary.

Shed Siding in the Rear Of The Property

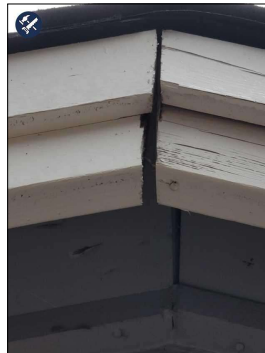
- Fill & Seal All Gaps & Cracks in the Eaves & Fascia Boards
- Broken Board Observed

Fill & Seal All Gaps & Crack in the Eaves.

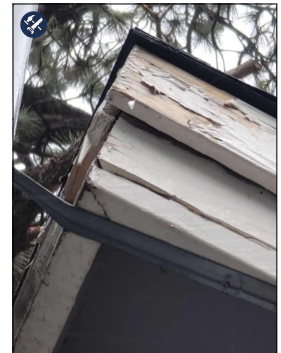
Cracked Board

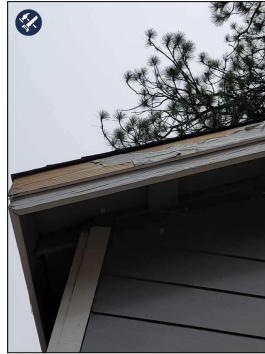
South Side

Page 39 Item: 5	Exterior Paint	<ul style="list-style-type: none"> <li>• Peeling paint observed, suggest scraping and painting as necessary.</li> </ul>
-----------------	----------------	---

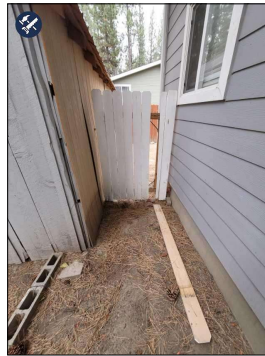
Page 45 Item: 6	Gate Condition	<ul style="list-style-type: none"> <li>• Damaged gate observed.</li> </ul>
-----------------	----------------	--

East Side--Board has come off the Gate

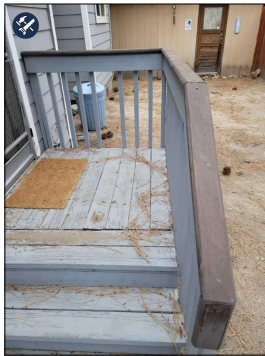
- Deck Railing is Loose
- Deck Railing has Peeling Paint & Bare Wood Observed
- Floor Boards are Showing Peeling Finish & Bare Wood

Deck Off of Bedroom#1--Handrail is Loose

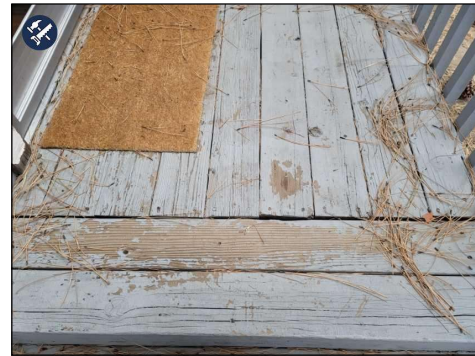
Deck Off of Bedroom#1--Floor Boards have Peeling Paint & Bare Wood Observed

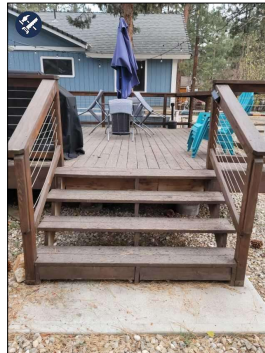
- Handrails are loose

North Side--Loose Handrails

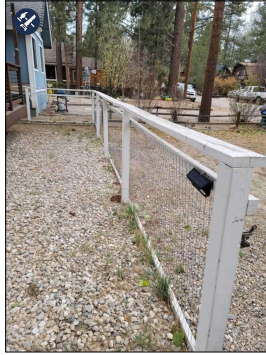
- **\*\*FENCING\*\***
- Fencing Shakes easily.

North Side is Shakey

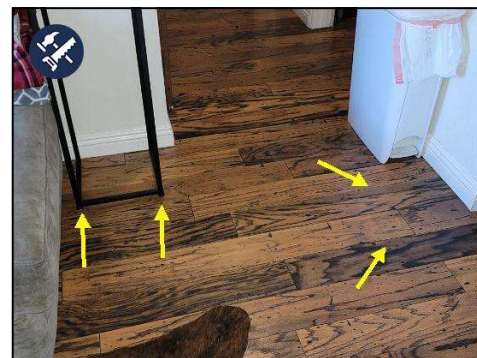
- No Apparent Issues with the Interior Flooring
- Section of the Flooring in the Living Room on the Way to the Hallway has a spot where if you bounce on the floor you can make the stand 3 feet away rock where it sits. This is probably the combination of Diagonal Plank Sub-Flooring(90 Yrs.Old) and Laminate Flooring over it. Aged sub-Floor with flexible above Flooring found a bouncy spot.

Living Room Entering Hallway

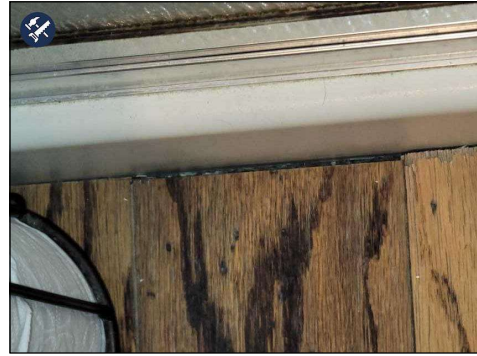
Bathroom

- Materials: Floating laminate type flooring noted.  
Observations:
- No Apparent Issues with the Flooring
  - Recommend sealing cracks/voids.
  - Recommend caulking at the tub and shower areas

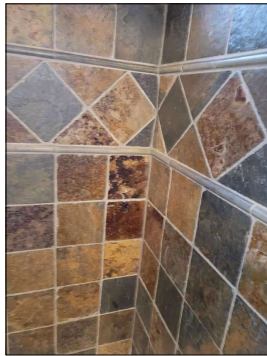
Bathroom

- **\*\*MATERIALS\*\***
- Solid surface material noted.
- **\*\*OBSERVATIONS\*\***
- Recommend sealing holes & gaps to stop water infiltration into walls.
- Missing/damaged grout observed, suggest re-grouting as necessary.

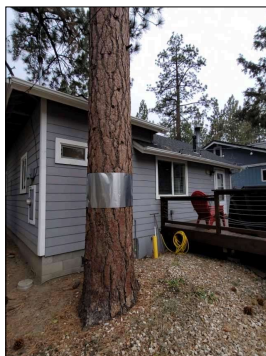
North or Front Side

- No Apparent Issues with the Siding.
- **Caulk and seal all gaps, cracks and openings.**
- **Some siding deterioration noted. Have repaired as necessary.**

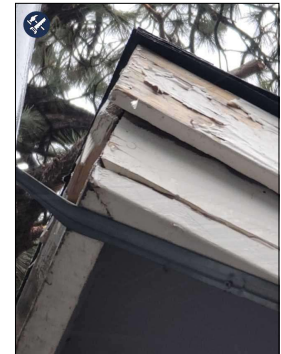
- No Apparent Issues with the Eaves
- Fill & Seal All Gaps & Cracks in the Eaves & Fascia Boards
- Broken Board Observed

Cracked Board

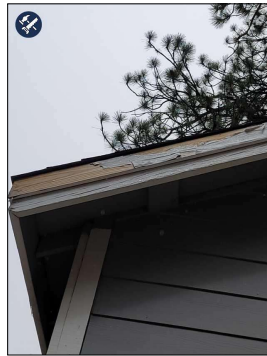
South Side

- No Apparent Issues with the Paint
- Peeling paint observed, suggest scraping and painting as necessary.

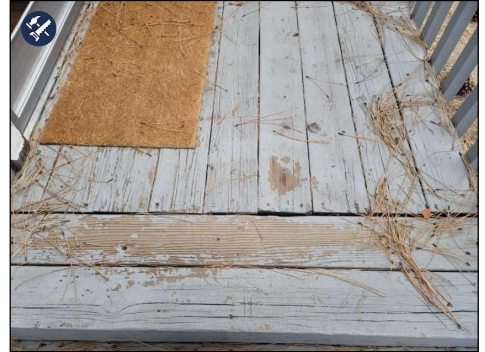
- Appeared functional at time of inspection.
- Deck Railing is Loose
- Deck Railing has Peeling Paint & Bare Wood Observed
- Floor Boards are Showing Peeling Finish & Bare Wood

Deck Off of Bedroom#1--Floor Boards have Peeling Paint & Bare Wood Observed

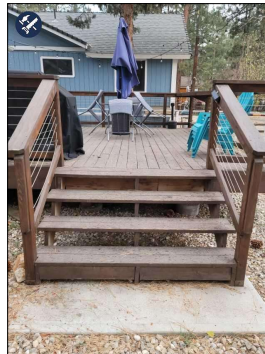
Observations:  
• Handrails are loose

North Side--Loose Handrails
