# OTCO Annual Class III & IV Workshop *for Water and Wastewater Operators*

## **Large Diameter Sewer Rehabilitation, a New Approach**

July 31, 2019

Matthew Kiefer, P.E.

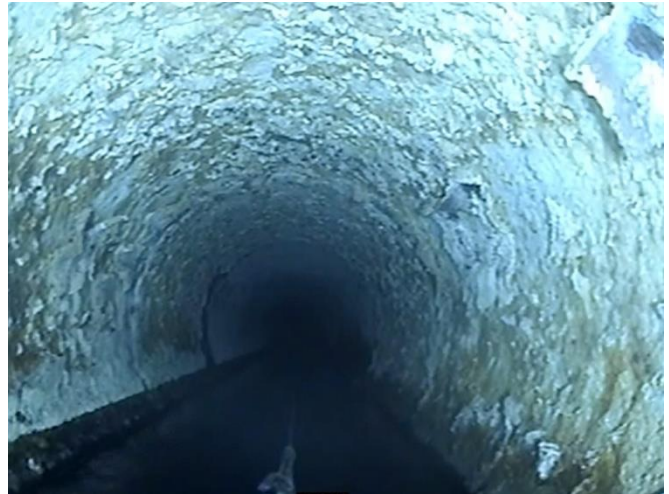
- Inspected with HD CCTV
- Contractor was concerned about pipe collapse
- Concrete falling off walls

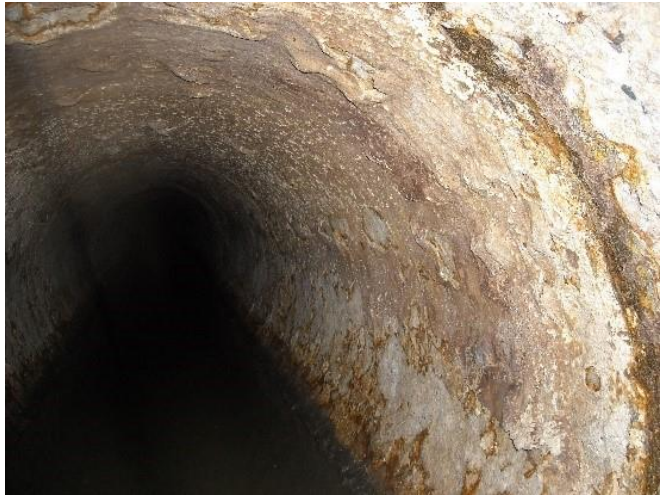
- Hire sewer cleaning contractor to power wash
- Man Entry Inspection at Manholes
- Concrete Sounding
- pH Measurement

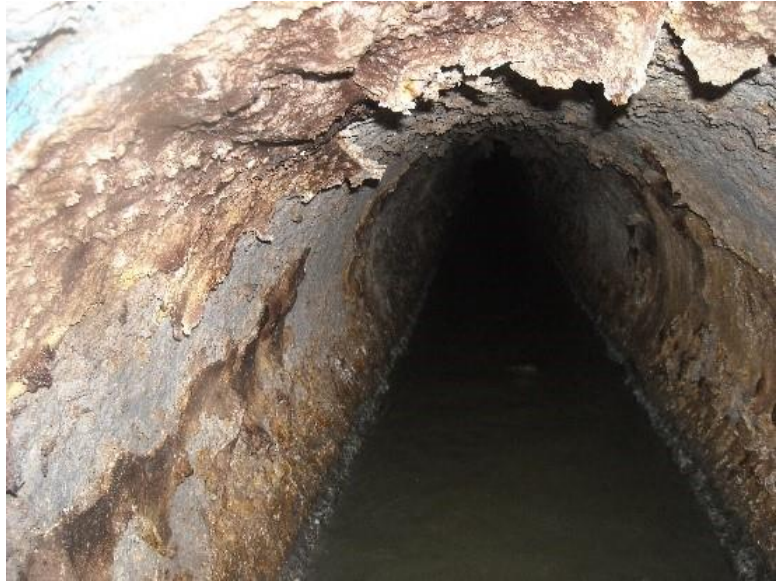
- Condition was much better than appeared on CCTV
  - Many times can't see the actual concrete (but you think you do)
- Softened concrete paste and exposed aggregates
- Poor durability properties (high permeability)

- Deferred \$6M in repair costs
- Allowed higher priority repairs to move forward

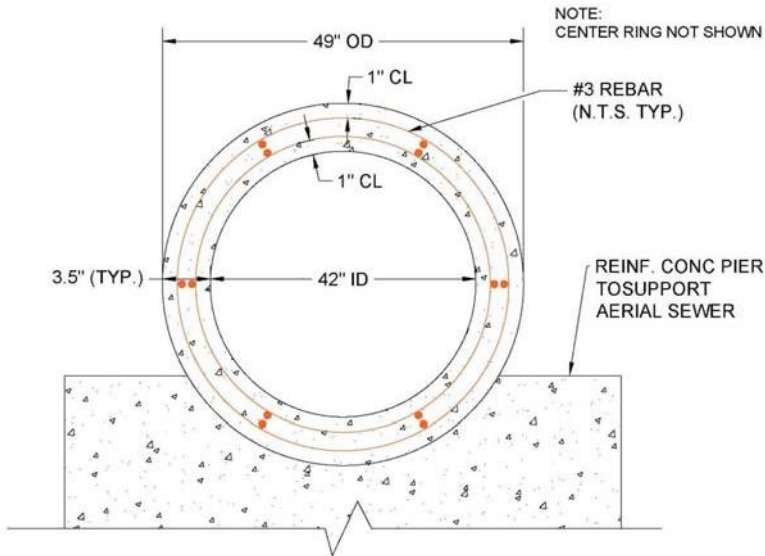
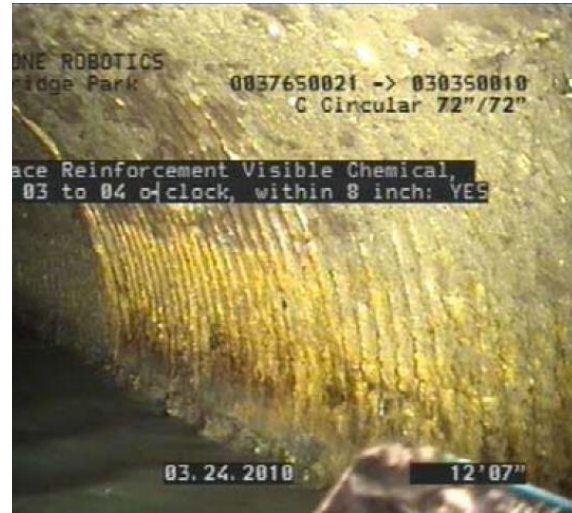
- Minimal rebar cover
- Only 1/2" concrete loss

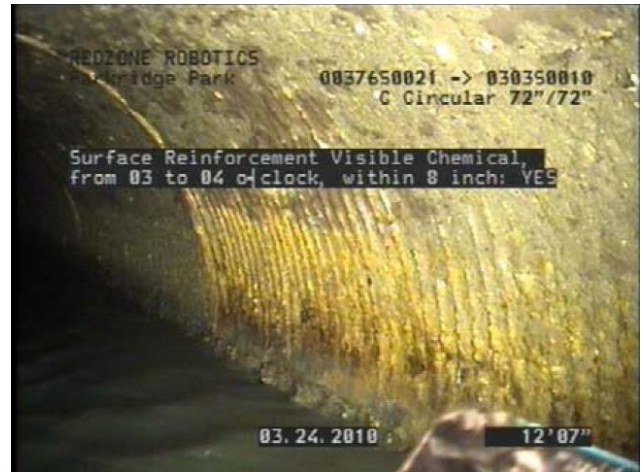
- Sound concrete between the spot defects
- Full lining is unnecessary
  - CIPP, etc.
- Condition looks worse on CCTV than it really is

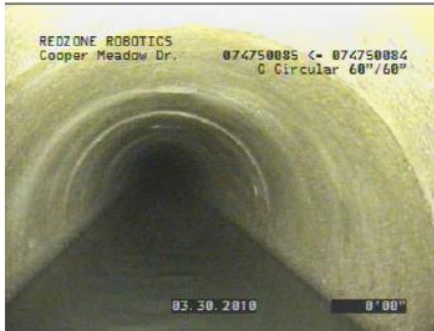
**Good Condition**  
6 Segments (9%)

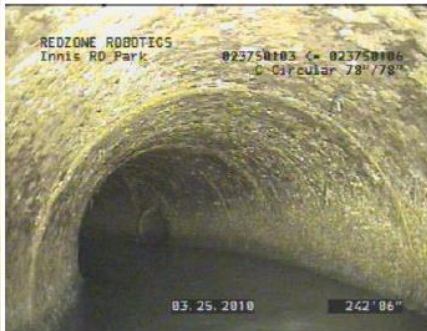
**Fair Condition**  
29 Segments (43%)

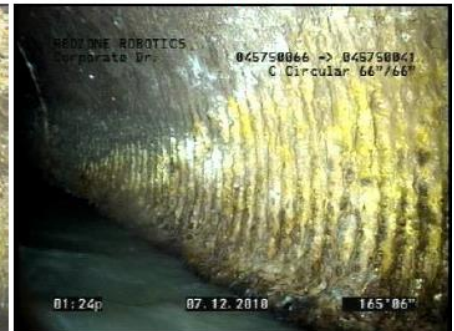
**Poor Condition**  
32 Segments (48%)

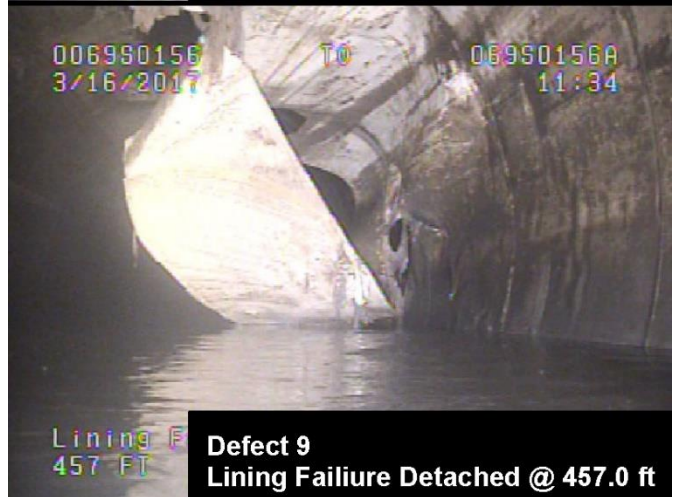
- Linabond can't be repaired
- Must be removed if another coating is installed
  - Grinding?
  - Abrasive Blasting?
- Plastic liners can be hard to maintain when they fail

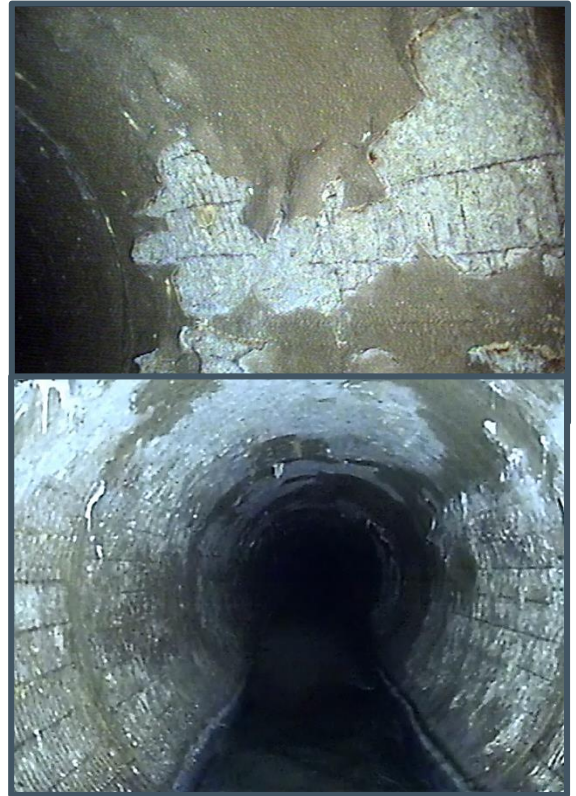
- 20 segments with surface reinforcement visible at random locations (spot defects)
- 3,650 feet of 96-inch RCP showing continuous severe concrete corrosion with visible reinforcement
