Inspected Property

Inspector: De Chen
Westpoint GDNS SW
Calgary, AB, T3H4M4
(587)437-8014
6/19/2020

DCU Home Inspection Ltd

Address
xxxxx Crescent SW
Calgary AB T3H 4Z5

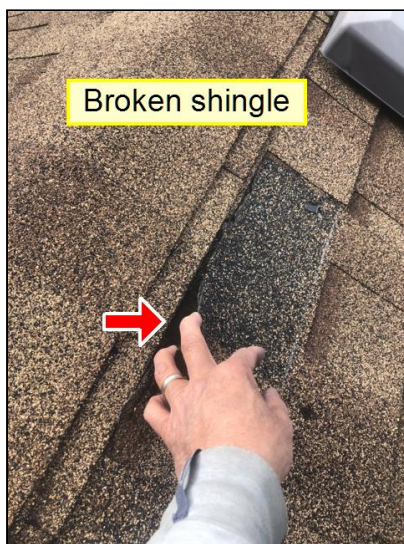
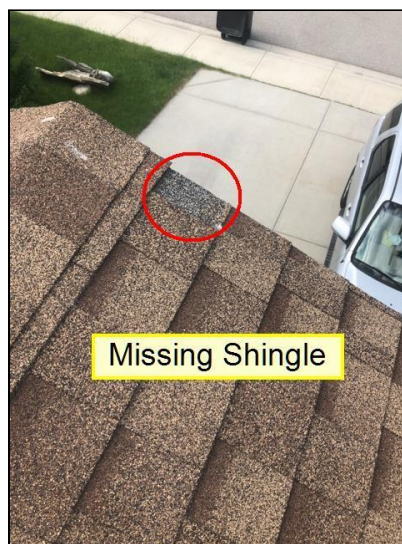
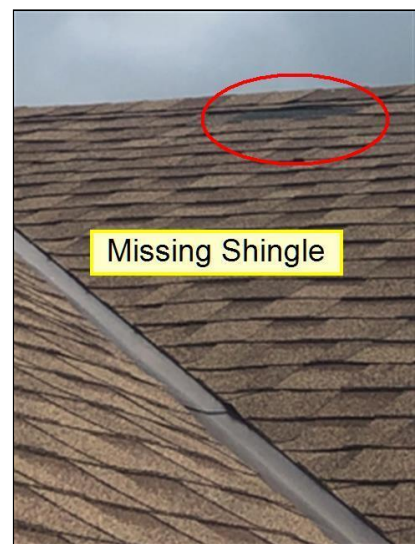
(1) An evidence of singles that has missed and damage. Upper roofs have few damaged shingles were missed. over the years and properly repair by licensed contractor is inquired to avoid the future leaks.

In the inspector's opinion, the roof covering was near the end of their useful life due to wearing. Life expectation of shingle type roof is generally the last 20 years with proper maintenance and care.

1.0 (1) An evidence of shingles that has missed and damage. Upper roofs have few damaged shingles were missed. over the years and properly repair by licensed contractor is inquired to avoid the future leaks.

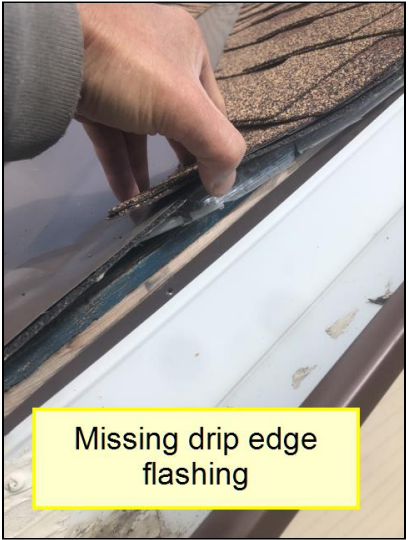
1.0 (2) It's a good practice but it's not every contractor that will install the drip edge flashing. Missing drip edge flashing could have water damage to contents under the covering. I recommend installing a drip edge flashing while replacing the new roof shingles. it's an option when roof update.

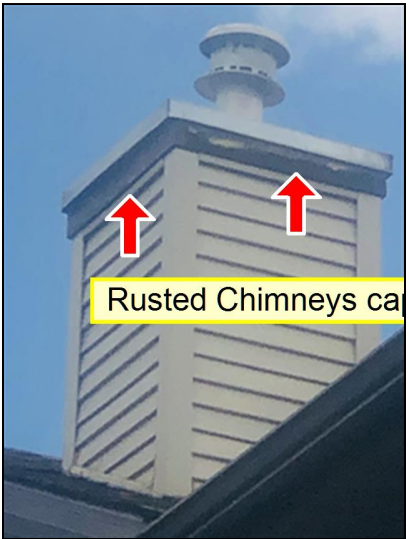
Rusted chimney cap, rust cap is prone to water penetration. I recommend to repair it by licensed contractor.

1.2 Rusted chimney cap, rust cap is prone to water penetration. I recommend to repair it by licensed contractor.

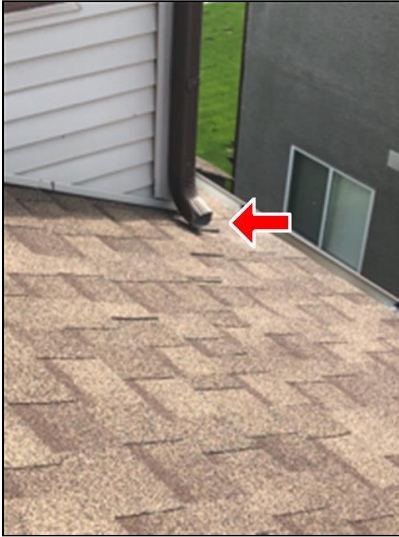
1.3 (1) One or more downspouts terminate above lower roof surfaces rather than being routed to gutters or to the ground level. This is very common, but it can reduce the life of roof surface materials below due to large amounts of water frequently flowing over the roof surface. Granules typically are washed off of composition shingles as a result, and leaks may occur. Recommend considering having a qualified contractor install extensions as necessary so downspouts don't terminate above roof surfaces.

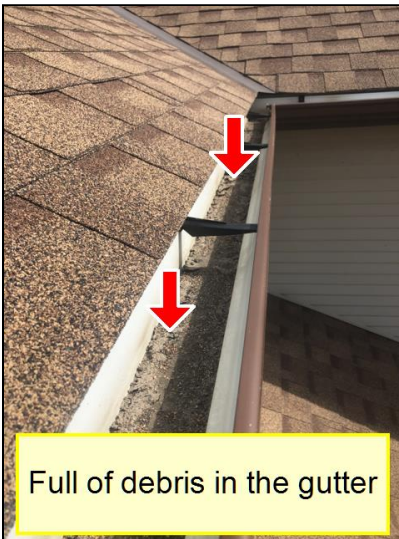
(2) The gutters are full of debris in areas and needs to be cleaned. The debris in gutters can also conceal rust, deterioration or leaks that are not visible until cleaned, and I am unable to determine if such conditions exist.

1.3 (2) The gutters are full of debris in areas and needs to be cleaned. The debris in gutters can also conceal rust, deterioration or leaks that are not visible until cleaned, and I am unable to determine if such conditions exist.

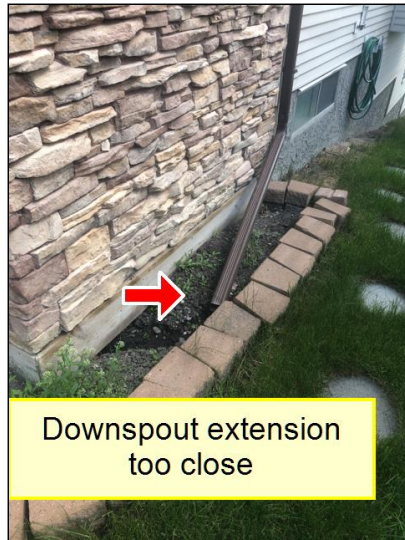
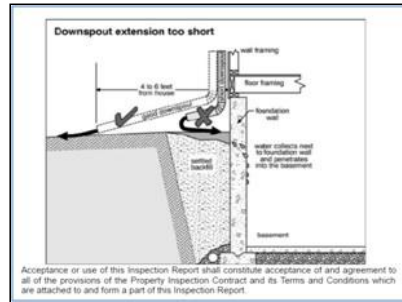
(3) The downspout pipe at right side (facing front) was short to direct roof water run-off straight down into the foundation of the home. The downspout(s) should always be extended on a good slope with discharge water at least 5 feet from the house. I recommend that longer downspout extensions should be installed

1.3 (3) The downspout pipe at right side (facing front) was short to direct roof water run-off straight down into the foundation of the home. The downspout(s) should always be extended on a good slope with discharge water at least 5 feet from the house. I recommend that longer downspout extensions should be installed

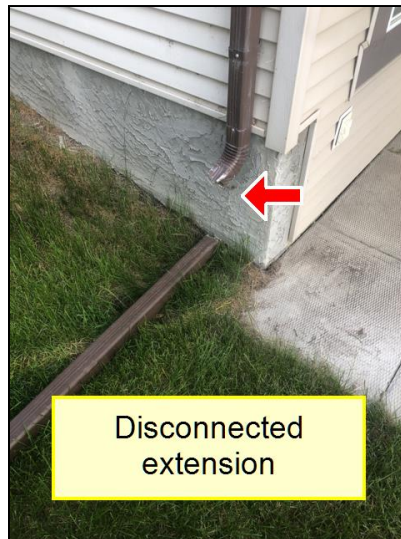
1.3 (4) The downspouts disconnected at the right side of the house (facing front).

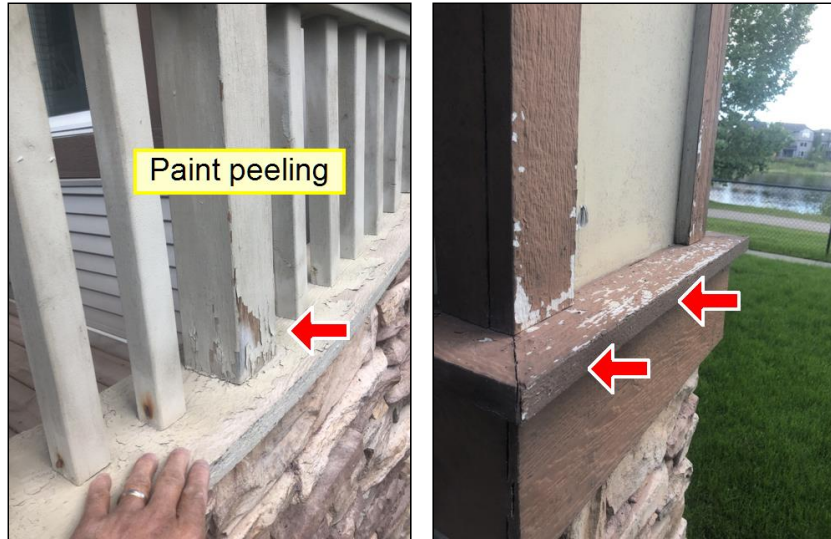
2.1 (1) The wood trim needs primer and paint at right side (facing front).

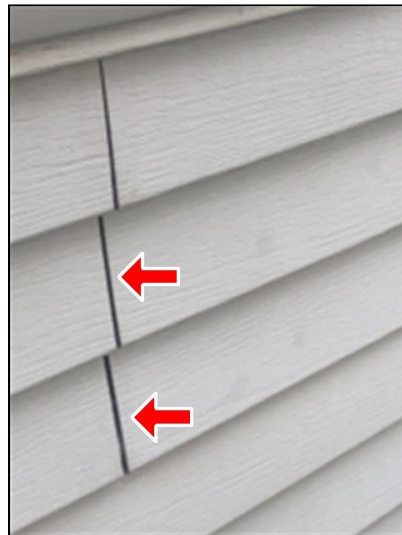
(2) The Vinyl siding at the right side of home installed improperly or not according to standard workmanship practices. deterioration can eventually occur if not corrected. A qualified person should repair or replace as needed.

2.1 (2) The Vinyl siding at the right side of home installed improperly or not according to standard workmanship practices. deterioration can eventually occur if not corrected. A qualified person should repair or replace as needed.

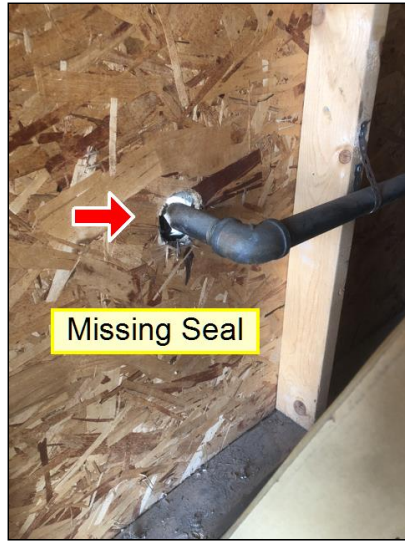
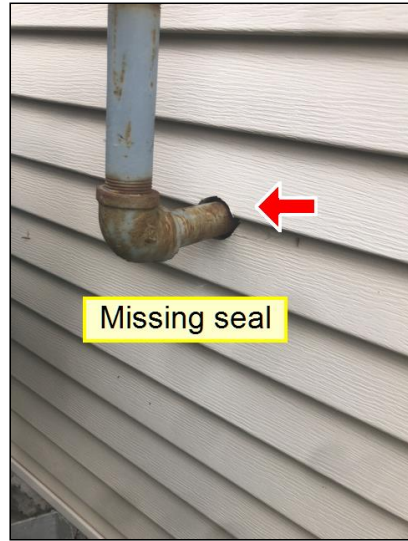
Gas pipes need to sealed to avoid water and moisture into garage.

3.1 Gas pipes need to be sealed to avoid water and moisture into garage.

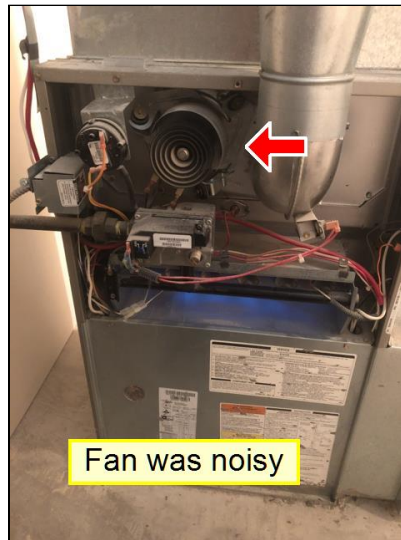
(1) The fan was a little noisy during this time of the inspection. This is a maintenance issue and should be repaired. I recommend service or repair as needed.

6.0 (1) The fan was a little noisy during this time of the inspection. This is a maintenance issue and should be repaired. I recommend service or repair as needed.

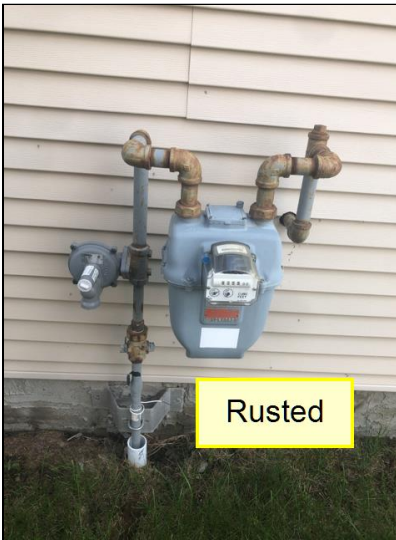
6.0 (2) Rusted meter. I recommend to paint it to avoid further deterioration as the part of maintenance program.

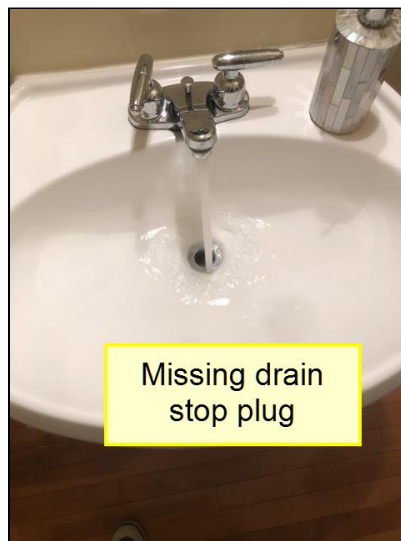
Missing sink drain stop plug at the guest bathroom.

8.1 Missing sink drain stop plug at the guest bathroom.

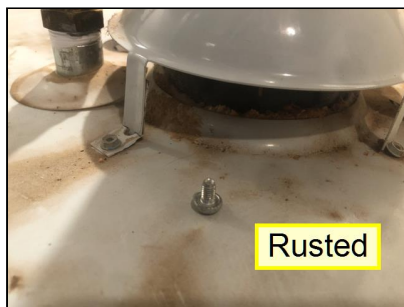
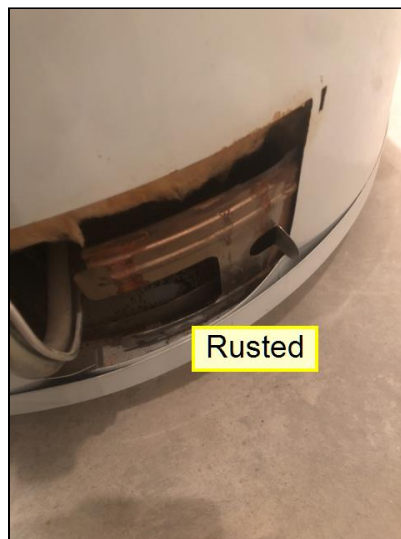
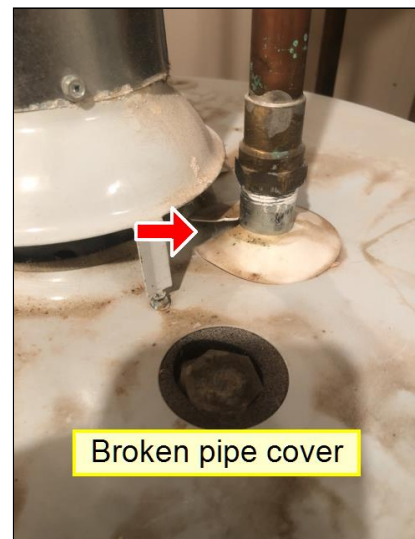
(1) Monitor: Most water heaters have a general life expectancy of 7 to 15 years. The existing water heater is approximately of this age. Some units will fail sooner and some will last much longer. I recommend to replace it.

8.2 (1) Monitor: Most water heaters have a general life expectancy of 7 to 15 years. The existing water heater is approximately of this age. Some units will fail sooner and some will last much longer. I recommend to replace it.

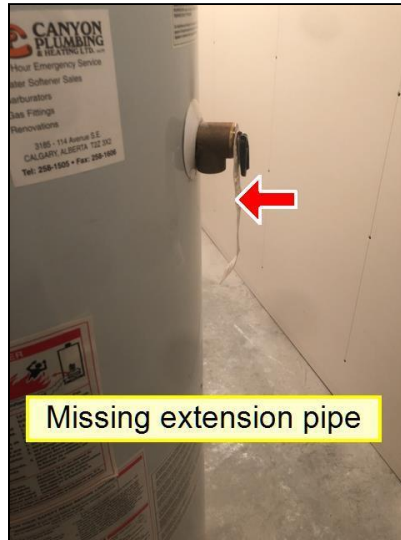
(2) The T&P (Test and Pressure) valve on water heater needs a 3/4 threaded pipe to extend within 6 inches of floor for safety. (PVC is not approved for hot water use). I recommend repair by a qualified person.

8.2 (2) The T&P (Test and Pressure) valve on water heater needs a 3/4 threaded pipe to extend within 6 inches of floor for safety. (PVC is not approved for hot water use). I recommend repair by a qualified person.

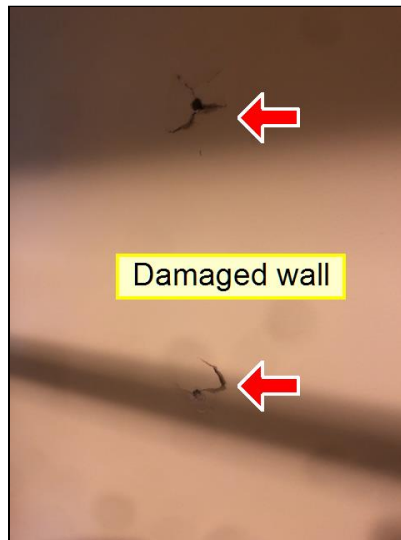
Damaged wall inside the closets at guest bedroom .

9.1.A Damaged wall inside the closets at guest bedroom .

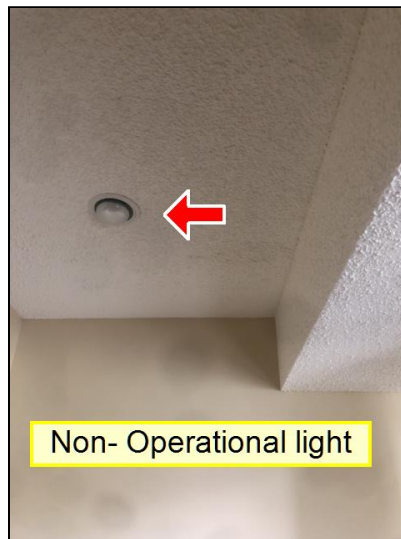
9.2.A Non-operational light.

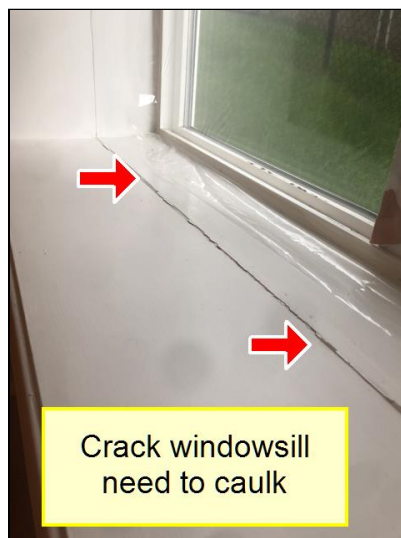
(1) Crack at the window sills at the bedroom of the basement. I recommend to caulk it.

9.4.A (1) Crack at the window sills at the bedroom of the basement. I recommend to caulk it.

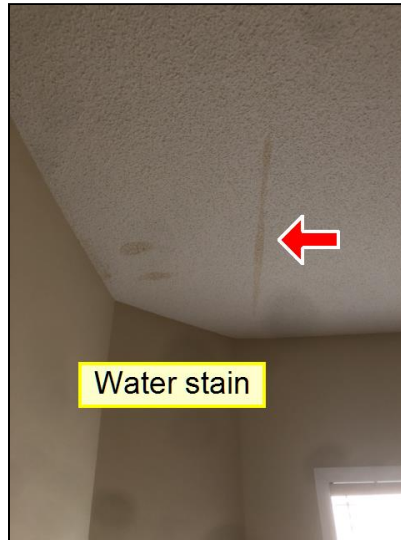
9.2.B The ceiling has a stain indicating a leak did or still exists at the Office Room. There is not no leaks detected at the time of this inspection. I recommend monitor and repair leak if detected.

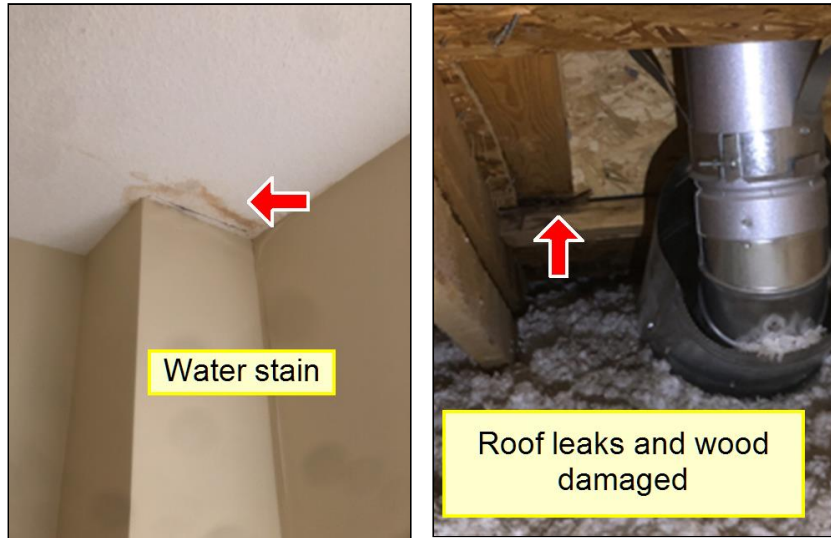
The ceiling has a water stain indicating a leak did or still exists at the guest bedroom. The cause of this ceiling damage due to leak from roof. I recommend monitor and repair leak when the roof covering is updated.

9.2.C The ceiling has a water stain indicating a leak did or still exists at the guest bedroom. The cause of this ceiling damage due to leak from roof. I recommend monitor and repair leak when the roof covering is updated.

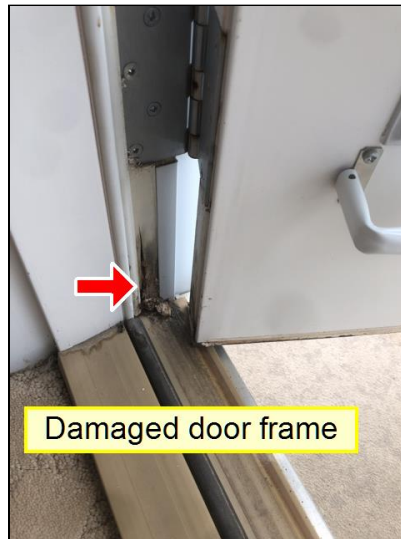
Damaged door frame at the master bedroom. Recommend to repair if need.

9.3.C Damaged door frame at the master bedroom. Recommend to repair if need.

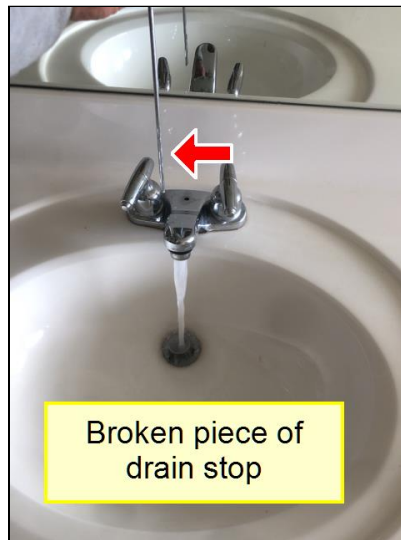
(1) Broken pieces under sink in master bathroom

9.6.C (1) Broken pieces under sink in master bathroom

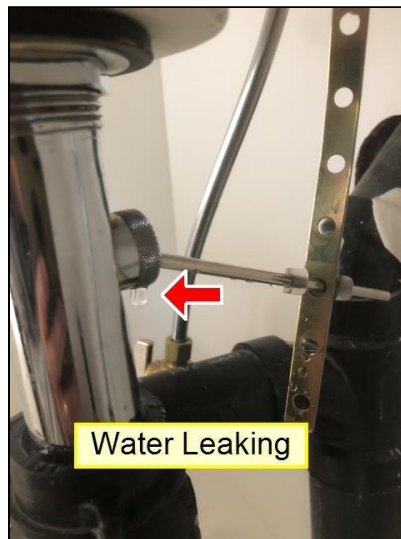
(2) It's noticeable water leak under the sink of master bathroom. Repairing is inquired.

9.6.C (2) It's noticeable water leak under the sink of master bathroom. Repairing is inquired.
