## Wright-Pro Home Inspection, LLC

# Home Inspection Report

Inspection Date: April 18, 2023

**12345 Main St.**  
**Any City, MI 48190**

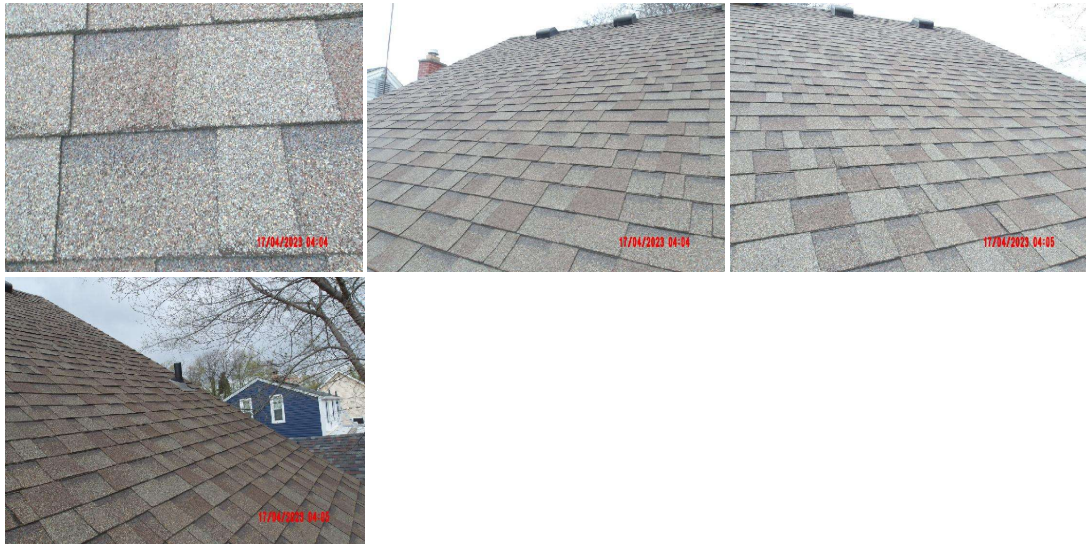
Good                      Material: Architectural/dimensional fiberglass asphalt shingle - Roof shingles are newer. Appearance reflects approximately 5 years old. Recommend checking with the current owner as to when the roof covering was actually installed and information on the installing contractor. In addition, there may be a transferable warranty that applies.

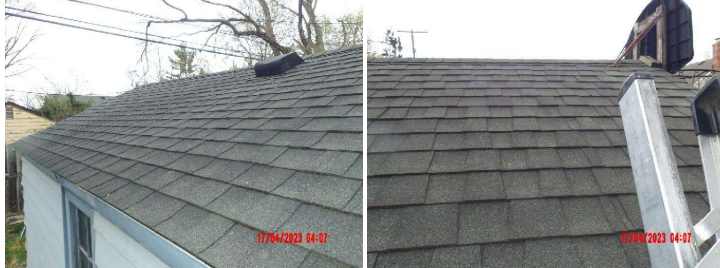
Questionable Material: Architectural/dimensional fiberglass asphalt shingle - Garage shingles are showing normal age/weather deterioration. May require replacement within the next couple of years.

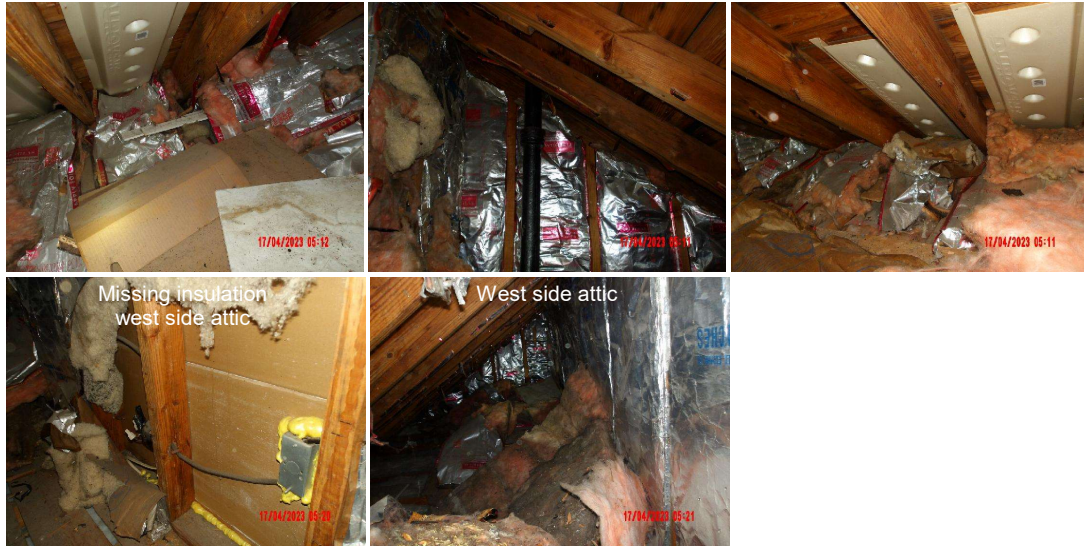
**Insulation:** Older foil faced fiberglass batts insulation. As discussed, all the insulation has been removed from between the roof rafters and left piled in the attic space and should be removed. The stud walls of the bungalow are correctly insulated, however the insulation is old and missing in some areas. Recommend patching the insulation in these areas and adding additional insulation between the floor joists. Do not install insulation up between the roof rafters as condensation moisture can be trapped between the insulation and bottom of the roof sheathing which may result in mold growth and moisture damage to the roof sheathing.

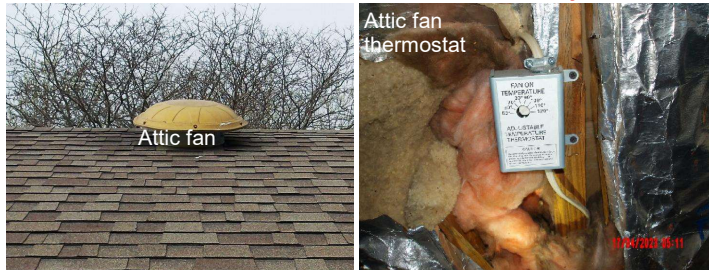
**Limited Inspection Attic Fan:** Thermostat controlled - Tested the thermostat, fan did not turn on at the time of the inspection. Recommend further evaluation by a licensed electrician.

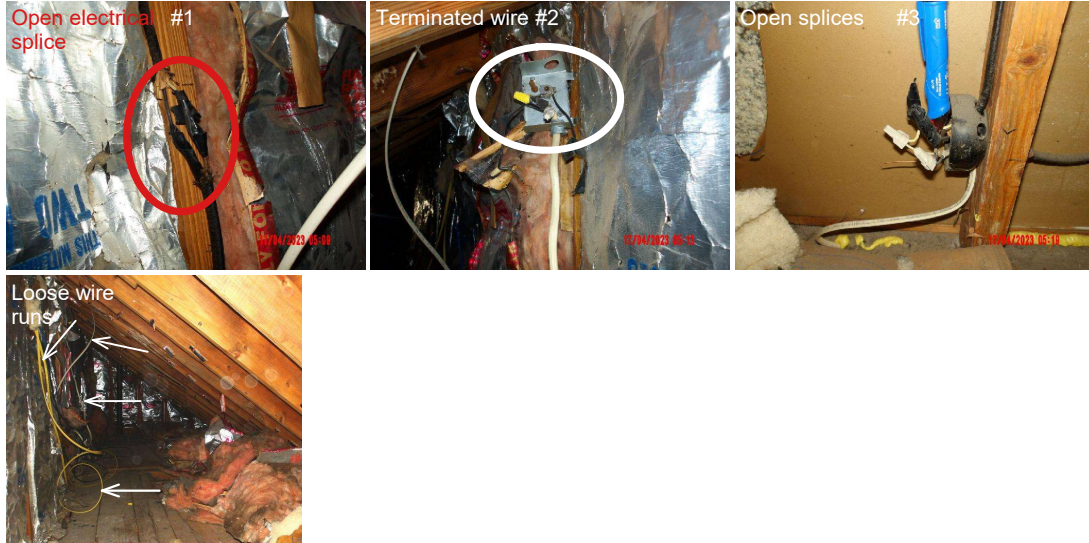
Wiring: (continued)

**Wiring:** Open electrical splices are a potential fire hazard. All 120 - 240 volt wire splices are required to be contained in a securely mounted and covered junction box. Image #1) open wire splice east side attic space. Image #2) Terminated wire connection east side. Appeared to be no power when tested. however, all terminated wire connections are required to be contained in a securely mounted and covered junction box or the wire be completely removed from its origin. #3) Open electrical splices. Crowded junction box. Junction box is too small for the amount of wire splices. Image #4) Loose, excessive wire runs should be trimmed back and properly routed to protect from possible damage.

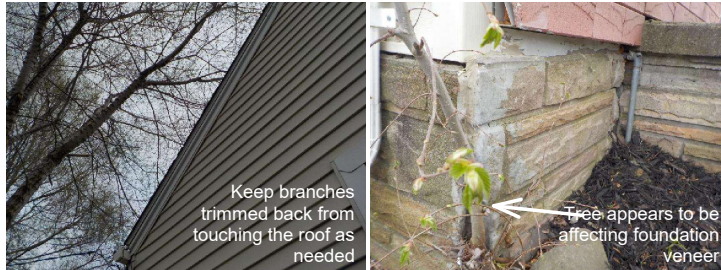
**Fair** Vegetation: Be sure to keep vegetation/tree branches cut back from the roof and structure. There is a small tree growing by the porch which seems to be affecting the foundation veneer.

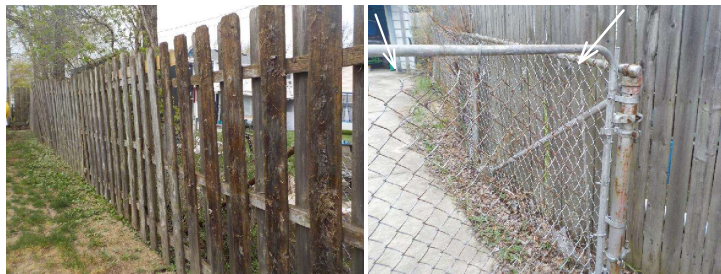
**Repair or Replace** Fences: Wood, chain link - Fence along the North side is falling in areas, not properly supported. Consider that fence may need repair or removal in the near future. Gate closes but frame is bent and the chain mesh should be better attached to the frame.

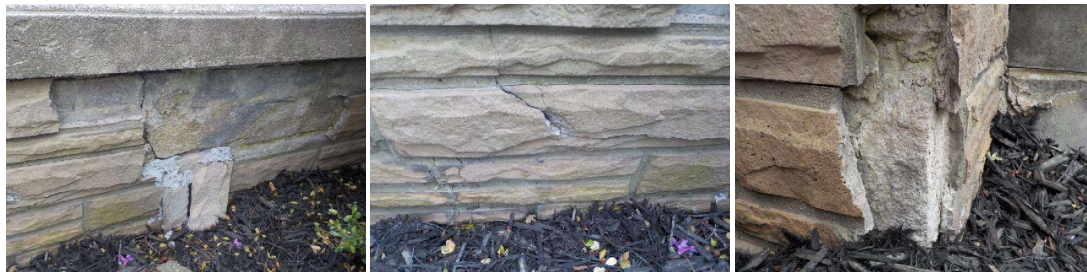
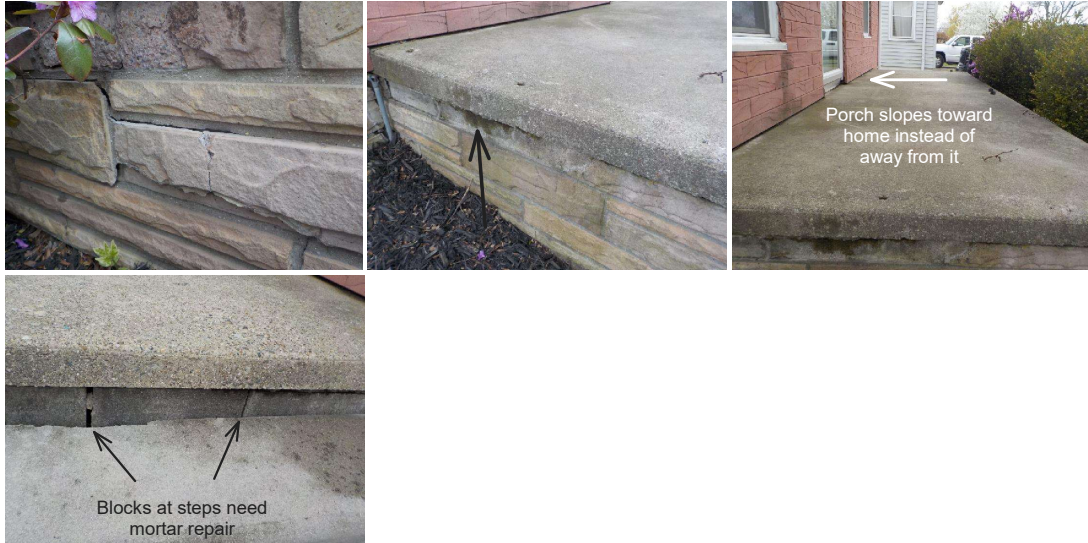
Porch: (continued)

**Repair or Replace** Porch: Concrete slab, block covered with veneer - Veneer is falling off in several areas, buckled and cracked in some areas. Block at steps is missing mortar, should be repaired to avoid moisture intrusion and further deterioration. As moisture gets behind the veneer, it will likely continue to pull away from the block structure. The porch slab is tilted somewhat toward the home – picture was taken at an angle which doesn't reflect the negative pitch, however, looking at the porch you can see how it pitches toward the home rather than away from it as it should. You may find that in heavy rain or snow, puddles and ice may accumulate at the house. Porches should be slightly angled away from the home to ensure water drains away from the structure. When veneer is corrected, a qualified contractor can further evaluate best method to correct the slope of the porch.

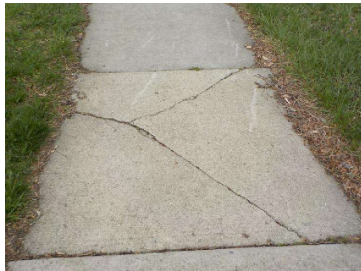
**Deck/Patio:** Concrete area  
**Steps & Stairways:** Concrete  
**Walkways:** Cracked slabs on public walk - No trip hazards exist, however, the city can require replacement of the public walk at their discretion. Upkeep of the public walk is normally the responsibility of the homeowner.

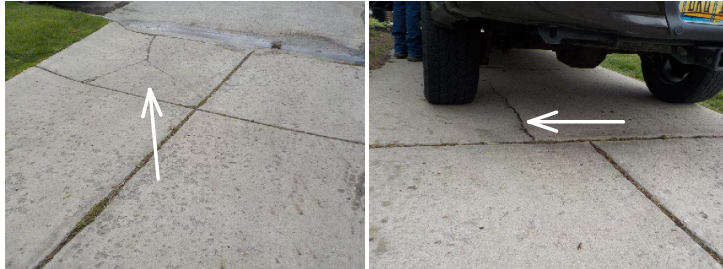
**Driveway:** Cracked slabs - A few of the slabs are cracked, however, there is no displacement of the concrete or trip hazards present. Driveway is graded neutral or positively away from the home (doesn't negatively slope toward the structure).

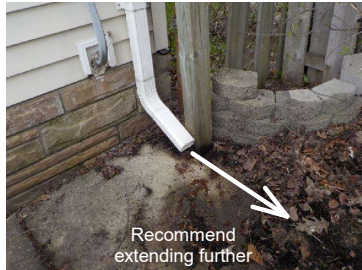
**Gutter System:** Gutter system appears to be in good condition. The minor issue is we recommend extending the downspout further away from the structure and a/c unit at the Northeast corner. Empties too close to the house.

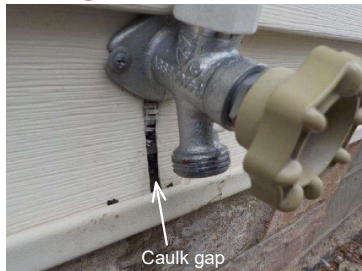
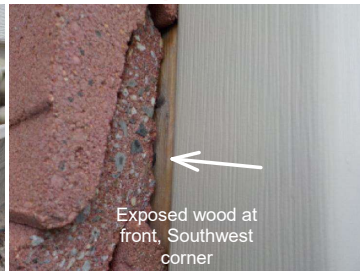
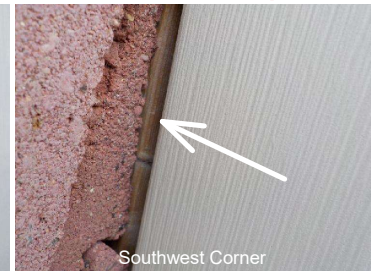
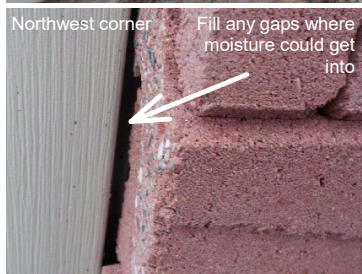
**Home Siding Type:** Veneer & vinyl siding - Siding overall was in good condition. The issues are that the vinyl siding should be caulked under the hose faucet to avoid water intrusion behind the siding in that area. The brick veneer on the front of the house has not been properly finished, leaving wood exposed at the corners. Gaps should be sealed to make a waterproof finish.

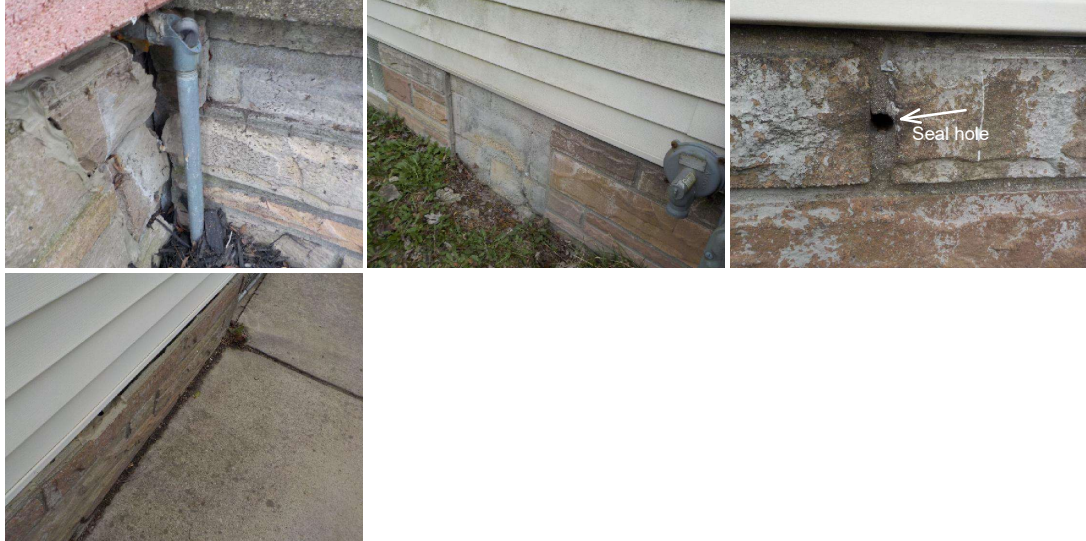
Foundation: (continued)

**Foundation:** Veneer covered, unable to see actual foundation wall from exterior - The stone veneer covering the foundation walls on the exterior is coming away in areas, missing in some areas. Moisture getting behind this veneer can cause damage to the foundation wall. As moisture gathers in areas, it will deteriorate the mortar between the blocks of the foundation. Recommend having a flashing added between the siding and the veneer to direct water over. Ideally, the veneer should be removed so the foundation can be further evaluated and properly repaired as needed (missing mortar, etc.), then sealed with a quality exterior paint. Seal any small holes in the foundation from wires, other penetrations, etc.

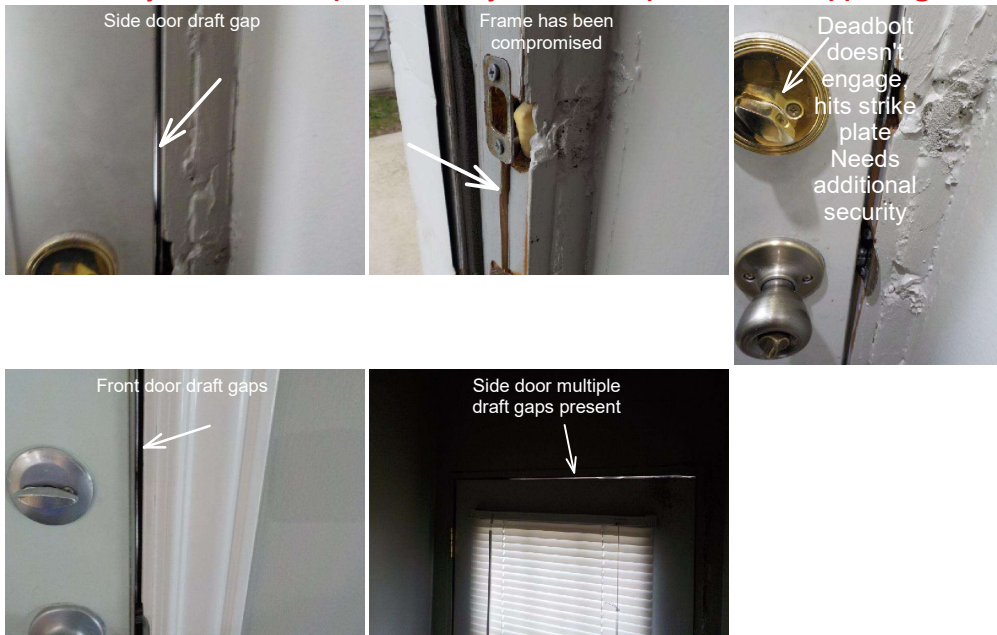
Good Hose Bibs: 2 rotary faucets with vacuum breakers  
 Good Eaves: Aluminum trimmed  
 Repair or Replace Entry Doors: **Steel entry doors have draft gaps present. Side door has several gaps. Side deadbolt lock isn't properly aligned, appears to hit strike plate. Handle lock doesn't catch, door wouldn't stay locked. Recommend adding additional security to the frame to ensure it can't be easily breached. Front storm door has 2 closers on it but still swung open easily in the wind. Closers may need to be replaced or adjusted to stop that from happening.**

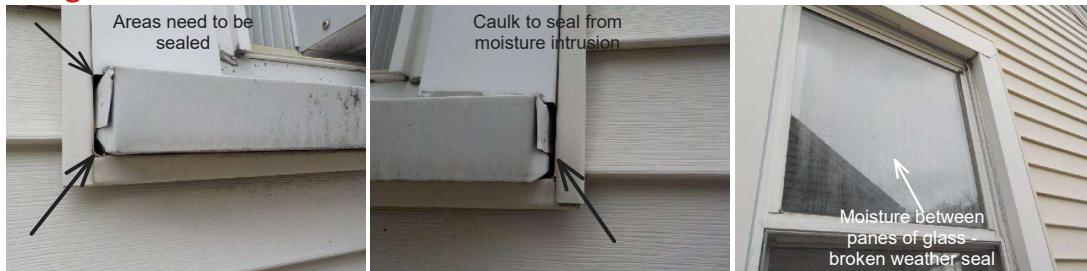
Repair or Replace Windows & Screens: Exterior inspection only - window function is covered in each room further in the report. **Windows on the South side of the home (driveway side) are gapped at the trim, recommend caulking these areas to avoid moisture working its way into the walls. This can happen with wind-driven rains and sitting snow. Some windows show moisture between the panes which suggests a broken weather seal. See more in bedroom section for interior view and ratings.**

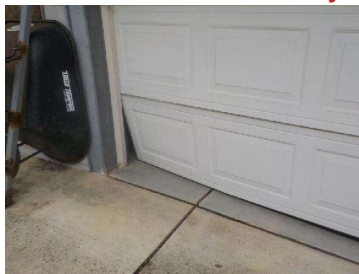
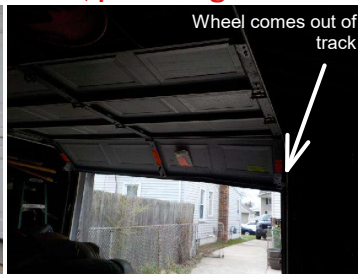
Repair or Replace Overhead Door(s): Aluminum - **Difficult, sloppy sliding operation. Door falls off track on lower left side. Wheels need adjustment, possible grease once repaired to make function easier.**

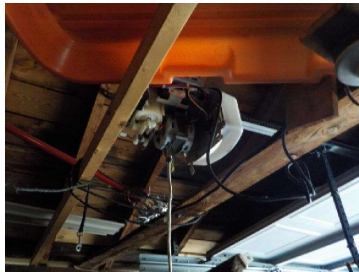
Door Opener: **Didn't work at time of inspection. Once door is repaired, likely you'll need a new opener if desired.**

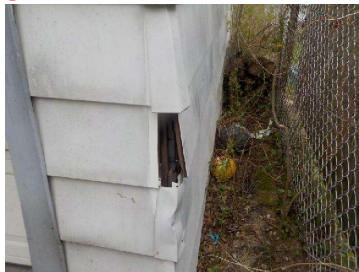
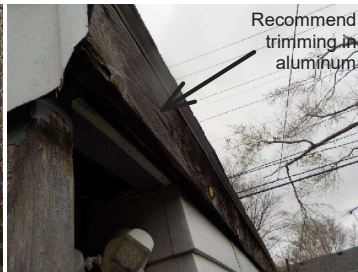
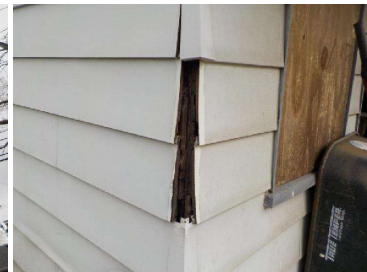
Repair or Replace Exterior Surface: Aluminum siding - **Corner sections are exposed to weather, corner trim should be replaced. Recommend having fascia (eaves) board on South side trimmed in aluminum and have gutters added (see more below). The siding shouldn't run all the way to ground level as moisture can wick up under it into the walls and it can also promote pests to nest in the wet areas. See example picture, bottom run of siding should be no less than 6 inches from the ground.**

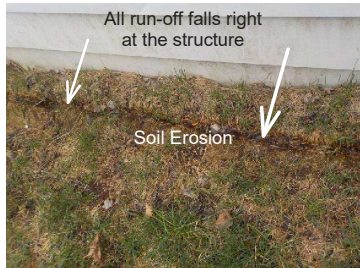
Gutters: Highly recommend - A good working gutter system will protect the walls and foundation from rot, shifting, etc. You can see where the water falls right at the structure from soil erosion. Recommend adding gutters, downspouts and downspout extensions.

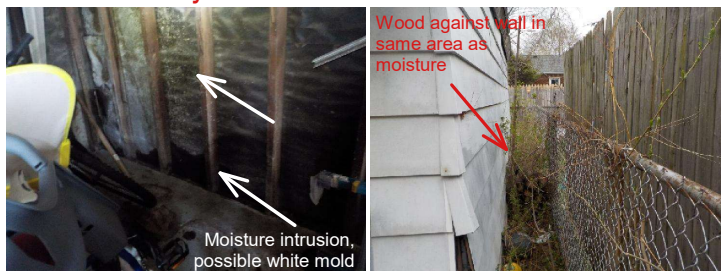
Walls: Moisture intrusion - In an area which could be seen, moisture intrusion was found. Note that wood is being stored outside of this area against the South wall. Once garage is emptied, you may find additional areas which have the same condition. Couldn't get to the area due to stored items, however, it appears there is also white mold on the wall. Mold thrives in any area which remains wet for a period of time. Recommend removing anything stored against the garage walls to avoid the walls from holding moisture. Once gutters are added as well, you can let the walls dry out and reassess their condition.

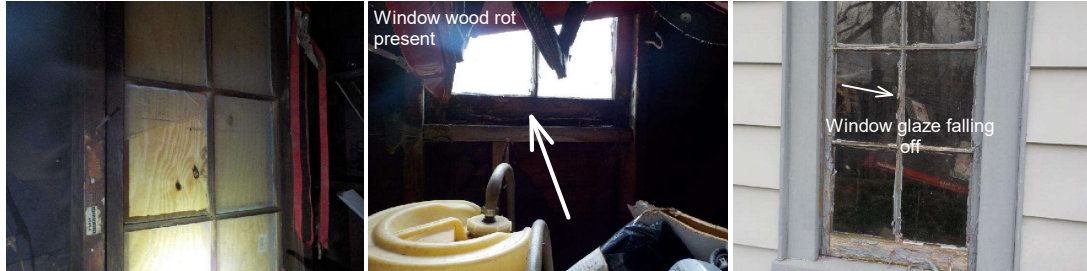
**Windows:** Old wood single-pane windows - **Old windows are deteriorated, broken, etc. The glazing is falling out which will cause the glass panes to fall out. Could become a safety issue. Recommend replacement of windows or cover them from the inside and outside – if covering with wood, be sure to use weather treated wood and caulk around edges to stop any moisture intrusion.**

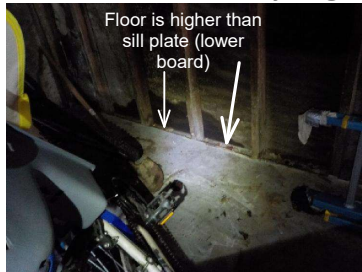
**Floor/Foundation:** Floor was 90% covered by stored items - The small area of the floor which could be seen against a wall showed the slab to be higher than the lower sill plate board. This suggests that a new floor may have been poured over the old one (?). Hard to determine without being able to see. This is another reason it is important to add gutters, so moisture doesn't sit on the sill plate (lower board that runs along the ground) in the case of heavy rain. Once this board rots out the walls may begin to move and shift.

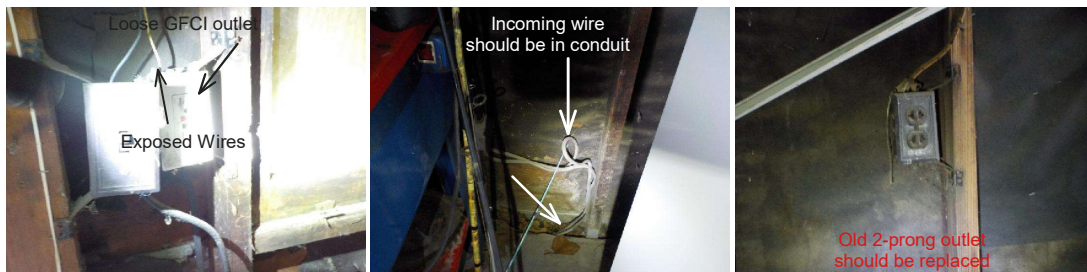
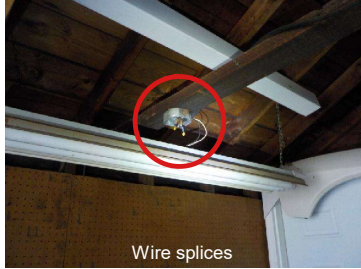
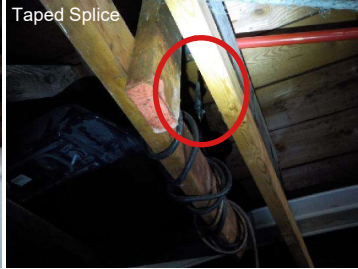
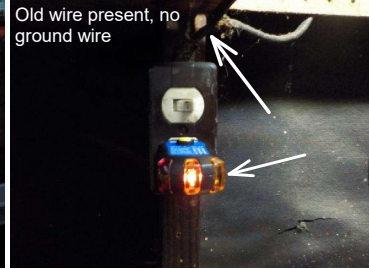
Electrical: (continued)

**Electrical:** 2-prong, 3-prong & GFCI outlets present - **Incoming wire should be secured in conduit, currently bunched up at wall. GFCI outlet which is present is very loose, needs to be secured. Other outlets in the garage are not GFCI protected. Outlet on South wall is a 2-prong and should be upgraded to a GFCI outlet. 3-prong on North wall showed no ground wire present. Lights have open or taped up splices present. All wire splices should be in a mounted and closed junction box. Shock hazards exist. Recommend a licensed electrician further evaluate and correct all issues for safe use.**

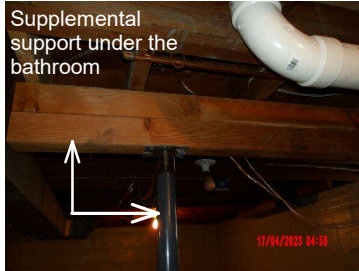
**Good** Piers/Posts: Steel I-posts / steel jack posts - One original steel I-post supporting the center support beam was replaced with a steel jack post for added support. Looks like the original post may have had rust issues. Other original main support I-posts had no issues noted. Supplemental jack post is positioned under the bathroom for what appeared to be for additional support. Did not note any sagging issues to the upper floor structures.

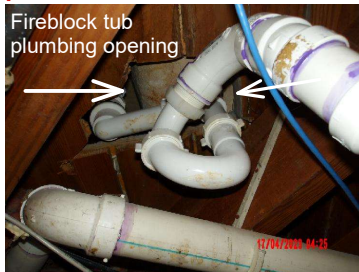
**Safety Issue** Firestops: Bath plumbing penetrations - **According to the National Fire Protection Association, unprotected vertical and horizontal penetrations can provide one of the major contributing causes of the rapid, erratic spread of smoke and fire in residential structures. These openings around plumbing, HVAC, electrical wire penetrations allow the smoke to quickly spread beyond the home's basement and into occupied floors. Recommend sealing small openings with a fire blocking caulk. Larger openings will require plywood or drywall. Further evaluated by a licensed plumber.**

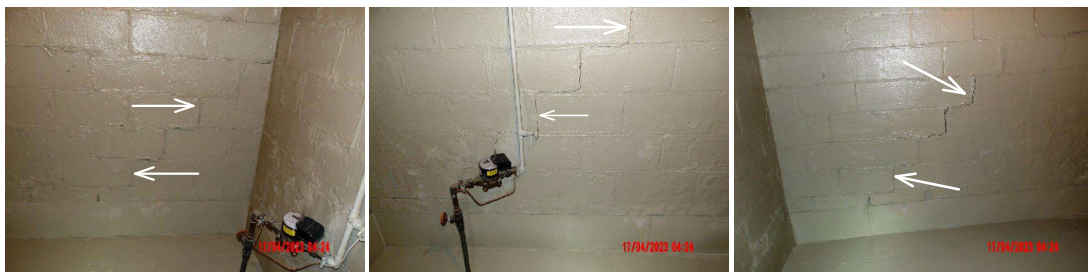
**Fair** Foundation Walls: Block and mortar - Please read basement disclaimer. As discussed, overall the basement foundation walls structurally appeared to be good. There are minor step cracks in the corners which are common to block and mortar basement foundations. See additional notes below under moisture location.

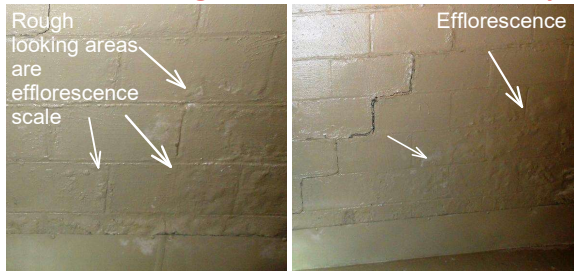
Differential Movement: No movement or displacement noted at time of the inspection.  
Moisture Location: As discussed, noted several step cracks and some areas mortar deterioration and areas of efflorescence. The basement was completely dry at the time of the inspection, however, there has been little consistent rainfall in the past couple of weeks. The main concern is if there is any moisture intrusion through any of these areas. There has been some waterproofing repairs done in the past. In addition, it appeared that the basement has been recently painted. There are areas of efflorescence that have been painted over that are popping through. these areas may seep moisture at times. Efflorescence is the deposit of crusty white mineral salts that appear on a masonry surface of concrete block, brick or mortar that have leached out from within the substrate when moisture migrates through it. Efflorescence itself is not a health issue but a potential moisture problem that can lead to mold growth which can be a health concern. Please read basement disclaimer. Recommend checking with the current owner as to any information on water proofing repairs and water intrusion. In addition, google "efflorescence cleanup" for more information. Also visit [northerncoatings.com](http://northerncoatings.com) for information on Hydro-Seal 75.

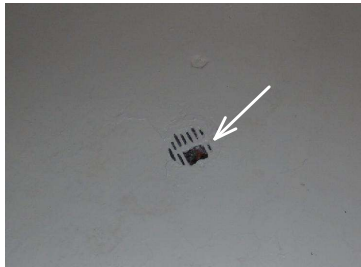
Floors: Painted concrete  
Floor Drain: Surface drain - Drain needs new cover/strainer

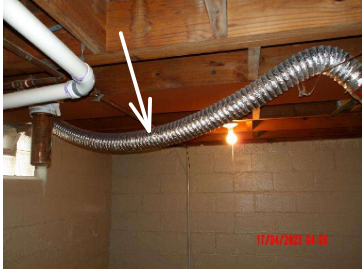
Safety Issue	Dryer Electrical: 240 VAC - <b>Requires four prong plug receptacle if electric dryer is to be used. Black and red load wires, white neutral and bare or green ground copper wire.</b>
Safety Issue	Dryer Vent: Metal foil flex duct - <b>Metal foil flex vent pipe is prone to kinking which may allow lint to accumulate causing a possible dryer fire hazard. Recommend replacing with rigid steel vent pipe secured with aluminum furnace tape to greatly reduce the possibility of a fire hazard. All dryer vents should be cleaned out annually.</b>

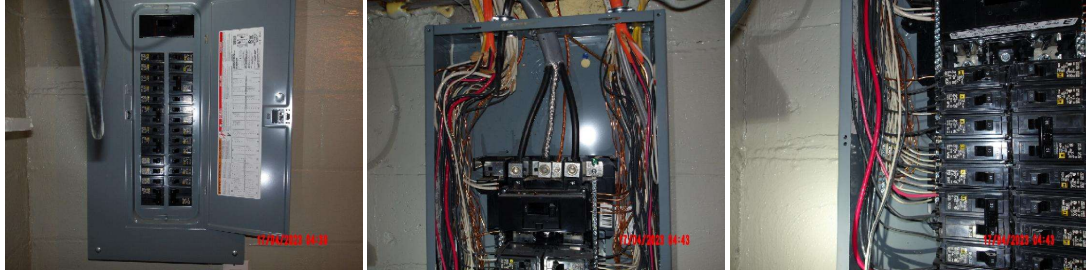
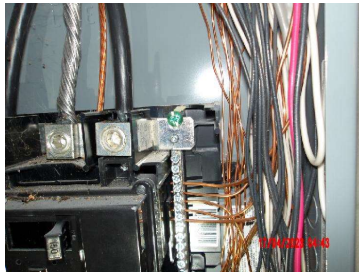
Questionable Manufacturer: Square D Homeline - **Newer 150 amp service panel is present. As discussed, the panel is crowded with too many circuits. There are many new wire runs noted. I contacted the City of Southgate and was informed that no permit was pulled for this install. Highly recommend that a licensed electrician further evaluate the panel installation and correct as necessary.**

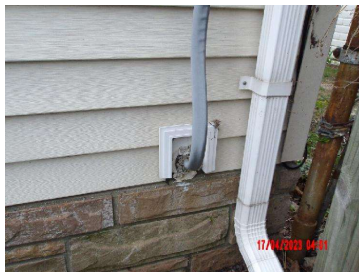
Repair or Replace Service Entrance Cable: Aluminum service entrance - **Needs to be properly secured to the home.**

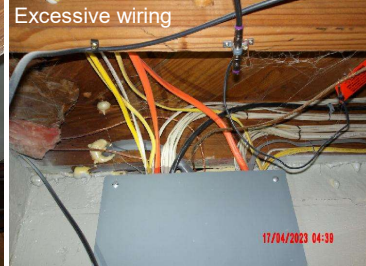
120 VAC Branch Circuits: Too many wires under staple fasteners

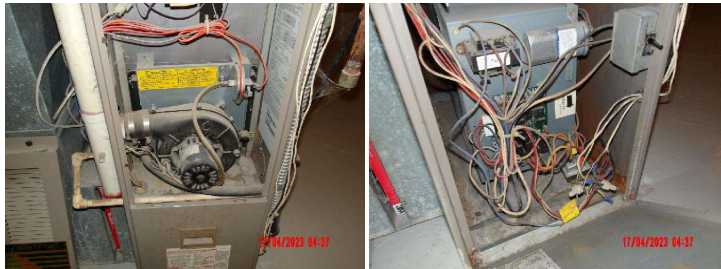
Repair or Replace Heating System Operation: Not operating at the time of the inspection - **Furnace would not light at the time of the inspection. The entire HVAC will require service and to be safety certified by a licensed HVAC contractor. Furnace is older and at the end of its average service life. Replacement is recommended.**

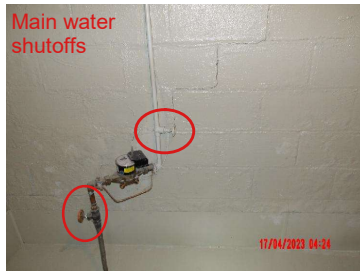
Service Line: Copper, (City water line)  
Main Water Shutoff: Basement, At water meter - Rotary valves should not be painted.

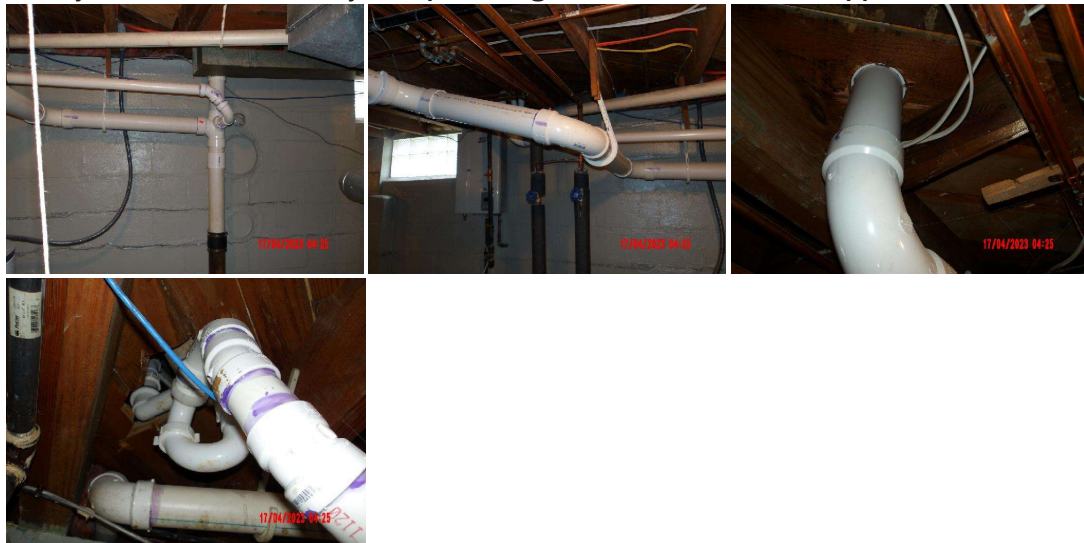
Water Lines: Copper  
Water Pressure: Adequate  
Drain Pipes: PVC - Appeared there has been underground sewer line repairs. Recommend checking with the current owner for more information on the repair. PVC clean out located in the back yard. Newer secondary PVC plumbing runs in the basement appeared to be draining good.

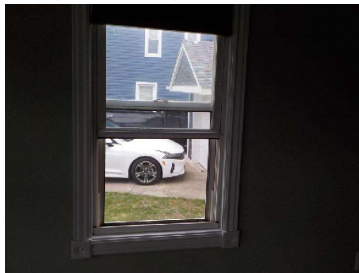
Good Floor: Carpet  
 Good Walls & Ceiling: Drywall  
 Not Present Ceiling Fan:  
 Fair Windows: Vinyl double hung, vinyl single-hung - Window on North wall falls somewhat when opened, but doesn't slam shut. Recommend monitoring during use. This suggests the balance spring is going bad and if it breaks, the window will not stay open itself. The upper pane would not pull down/release. Didn't force to avoid damaging it. No issue with front wall window.

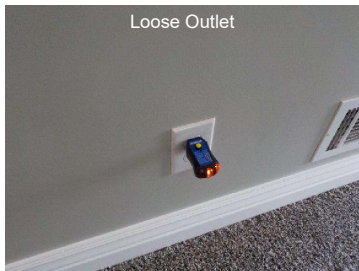
Safety Issue Electrical Outlets: 3-prong grounded outlets - **Loose outlet under the kitchen peninsula area. Needs to be secured for safe use.**

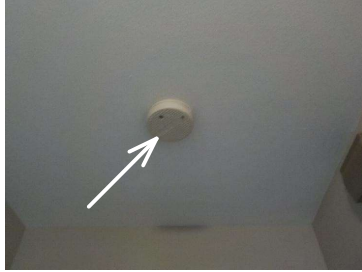
Repair or Replace Smoke Detector: Discolored - **Smoke detectors should be replaced every 10 years or once they discolor. This detector has yellowed and should be replaced immediately for safety. Recommend replacing with a combination smoke and carbon monoxide detector.**

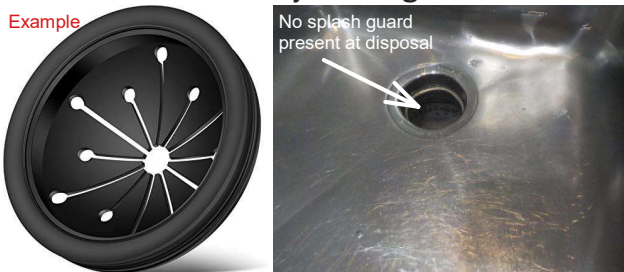
- Good** Stove/Range: Whirlpool electric range - Burners, oven and broiler tested. Plug behind stove is mounted to wall.
- Good** Stove Fan/Vent: On Microwave
- Minor Issue** Disposal: Disposal splash guard is missing - Recommend adding a splash guard before regular use. The splash guard stops water and debris from shooting up into the sink. This could be a hazard if silverware or something sharp falls into the disposal. Also protects hands and dish cloths from accidentally entering the blade area.

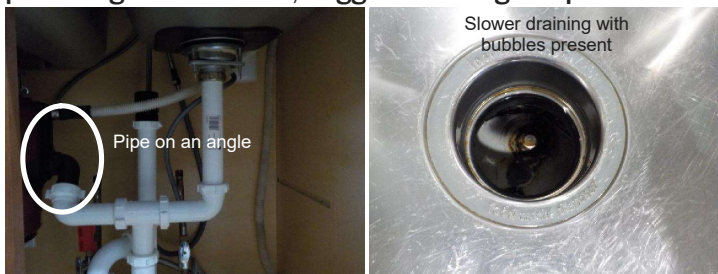
- Good** Microwave: Whirlpool
- Good** Sink: Double bowl stainless steel
- Good** Faucets/Fixtures: 1-handle with sprayer
- Fair** Plumbing/Traps: PVC "P" Trap - Disposal sink drained somewhat slowly when filled up and drained under pressure even after disposal was run and cleaned of any possible debris. Bubbles rose from the drain which suggests a clog in the venting or drainage system. However, the other sink drained good. It is possible that the angle of the disposal pipe is causing this issue. If plumbing work is done, suggests having the plumber further evaluate reason for this occurring.

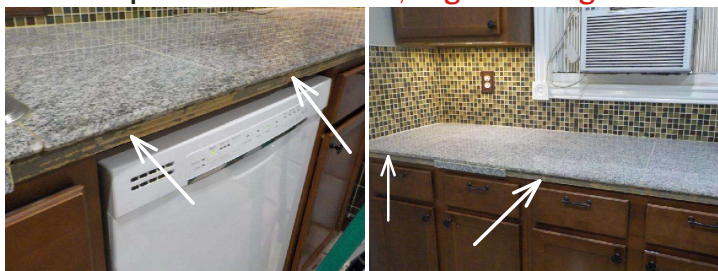
- Deficiency** Countertops: Tile - **Finish tile, edges missing.**

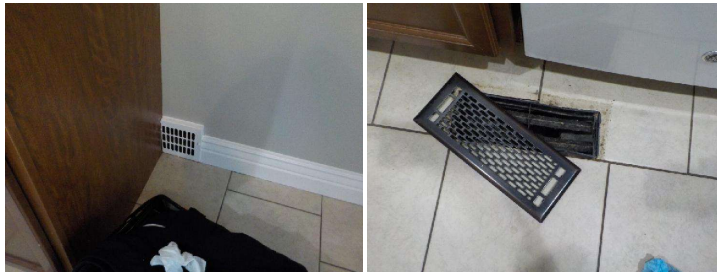
- Good Cabinets: Wood & Laminate
- Good Pests/Rodents: No evidence of pests or rodents found
- Good Ceiling Fan: In dining area
- Good Walls: Glass tile backsplash, Drywall
- Good Floor: Ceramic tile
- Good, Limited Inspection Windows: Vinyl double hung windows - Window on west wall functioned fine. Showed a manufacturer's date of 2010 (13 years old). Window on South wall had an air conditioning unit in it, unable to test function. Visually inspected only.
- Good Electrical Outlets: GFCI & GFCI protected outlets, 3-prong grounded outlets
- Good Lighting Fixtures: Inset pot lights, under cabinet lights
- Fair HVAC Source: The cold air return vent has been partially covered with the pantry cabinet. The heat vent register comes off easily (could be kicked off accidentally) is not attached to the fin mechanisms.

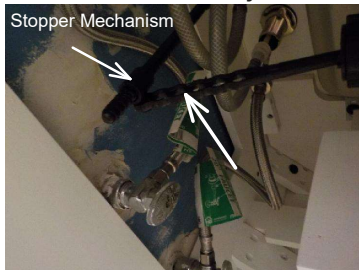
Sink Faucet: 2-handle with inoperative stopper - Plastic stopper mechanism under the sink isn't working properly. Likely will need to be replaced with a more quality mechanism. It is hooked up but bends too easily. Sink faucet had low water pressure.

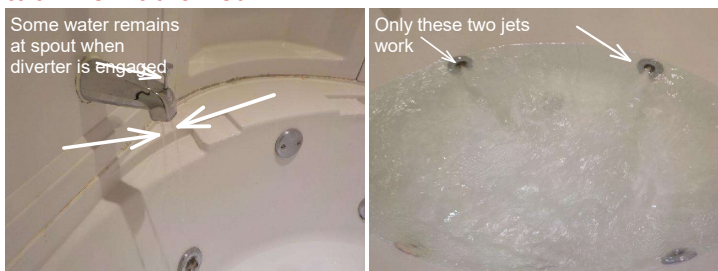
Tub Faucet/Shower: 1-handle faucet with diverter on spout - **The shower diverter works at about 80%, not all water gets to showerhead. Tub jets were full of dirt, debris. Only 2 of the 4 jets worked. Debris can form when jets are not used regularly, however if it persists, recommend contacting a plumber to clean the lines. There was a good amount of debris present in bottom of tub when it drained.**

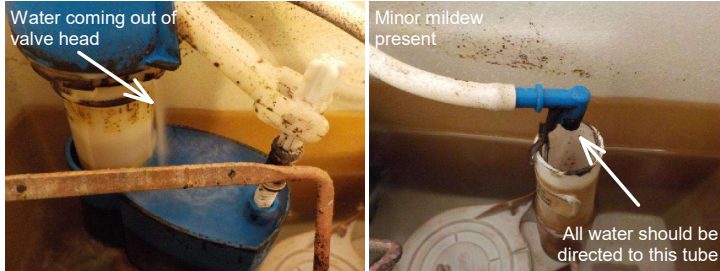
**Repair or Replace Toilet:** Toilet is loose at the floor and the tank is loose at the base. Both areas should be tightened to avoid future leaks. As discussed, this condition can worsen over time with regular use. The toilet fill/flush valve works but it is leaking from the valve head. This suggests it may be failing and may need to be replaced in the near future. However, since the leak is contained in the tank, it doesn't need immediate attention and may continue to function for some time.

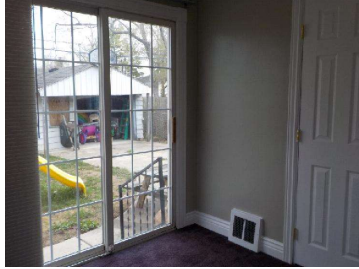
Good Closet: Small  
Fair Doors: Hollow entry & closet doors and sliding patio door - Patio door has a hard and sloppy sliding motion. Recommend cleaning the track and adding silicone spray to the track to allow it to glide more easily. Do not use a petroleum based spray as it will collect dirt and turn to gunk.

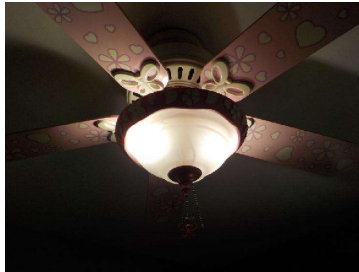
Good Floor: Carpet  
Good Walls & Ceiling: Drywall  
Deficiency Ceiling Fan: Didn't work at time of inspection - **The fan's pull chain is frozen and wouldn't turn on the fan. Will need to be dismantled to evaluate further.**

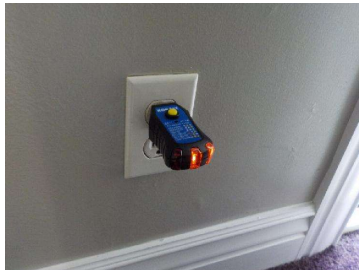
Good Window(s): Functioned okay. Dated 1977 - 46 years old - consider windows may need to be replaced in the near future - May not be weather efficient.  
Safety Issue Electrical Outlets: Loose outlet - **East wall outlet is loose and should be secured for safe use.**

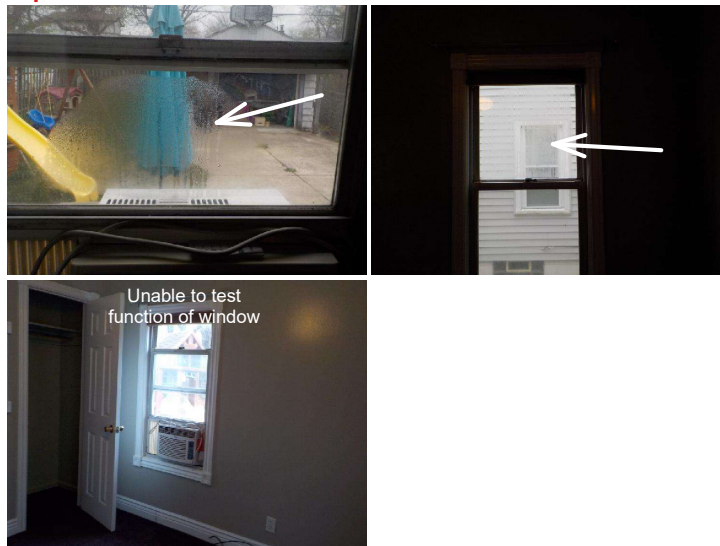
Good Walls & Ceiling: Drywall  
 Good Ceiling Fan: Switched, tested  
 Deficiency, Limited Inspection Window(s): Dated 1977 - **Only one window could be tested, air conditioning unit in the other. Both windows showed moisture between the panes which suggest broken weather seals. This condition makes the windows less energy efficient. The moisture will remain and change with changing humidity levels. The window which could be checked worked fine otherwise. However, consider that windows may need to be replaced in the near future.**

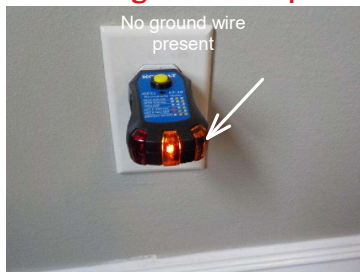
Safety Issue Electrical Outlets: 3-prong grounded outlets - **Outlet on the West wall had no ground wire present. Should be replaced with a 2-prong or a GFCI outlet for safety. Using 3-prong plugs without a ground wire present is a possible shock hazard.**

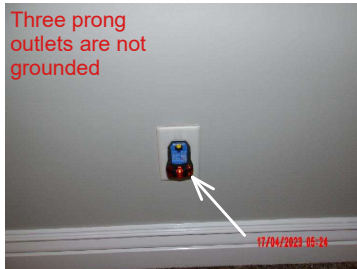
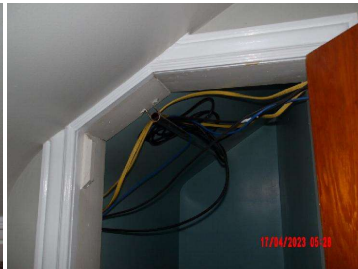
Good Doors: Hollow wood - Door at the bottom of the stairwell  
 Good Floor: Carpet covered  
 Good Walls: Drywall/plaster  
 Good Ceiling: Drywall/plaster  
 Good Ceiling Fan: Includes Light Fixture - Two fans worked properly when tested  
 Safety Issue Electrical: Three prong not grounded - **All ungrounded three prong outlets need to be grounded or replaced with two prong outlets. ungrounded three prong outlets are a potential shock hazard. Electrical wires in the closet need to be properly secured, protected from possible damage.**

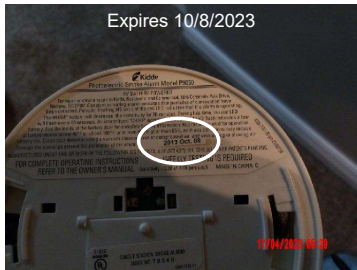
Good Lighting Fixtures: Light fixtures are ceiling & fan mounted.  
 Good HVAC Source: Electric base board supplemental heating - Working when tested  
 Repair or Replace Smoke Detector: **10 year smoke alarm should be replaced. All alarms need to be tested monthly. The National Fire Protection Association (NFPA) recommends replacing combination smoke and carbon monoxide alarms every seven to ten years.**
