# Watershed Inventory

Steve Zimmerman, M.S., Senior Ecologist  
Cecily Cunz, AICP, Environmental Planner

APPLIED ECOLOGICAL SERVICES, INC.

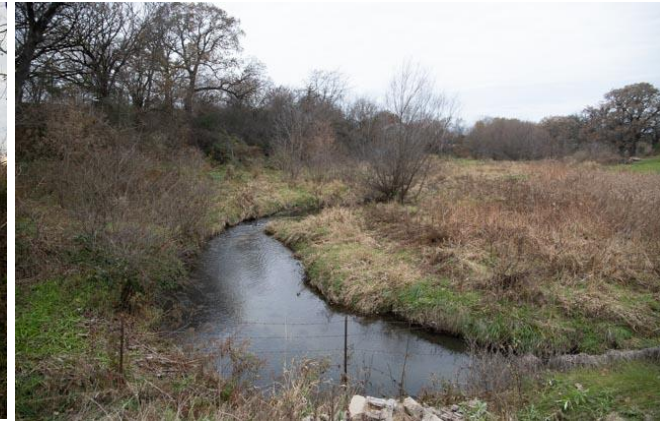
LRCTR Reach 3

RIPARIAN VEGETATION COVER (facing downstream):  
 BRIEFLY DESCRIBE RIPARIAN AREA: Composed of mixture of Oak  
Savanna/Woodland and marsh/sedge meadow. All  
is somewhat degraded

OVERALL ECO CONDITION OF RIPARIAN AREA: GOOD: \_\_\_\_\_ AVERAGE: X POOR: \_\_\_\_\_

BMP DETAILS: control invasive species and thin/  
remove second growth trees and shrub species

BMP PRIORITY: CRITICAL AREA \_\_\_\_\_ HIGH \_\_\_\_\_ MEDIUM X LOW \_\_\_\_\_  
 Explain Priority: \_\_\_\_\_

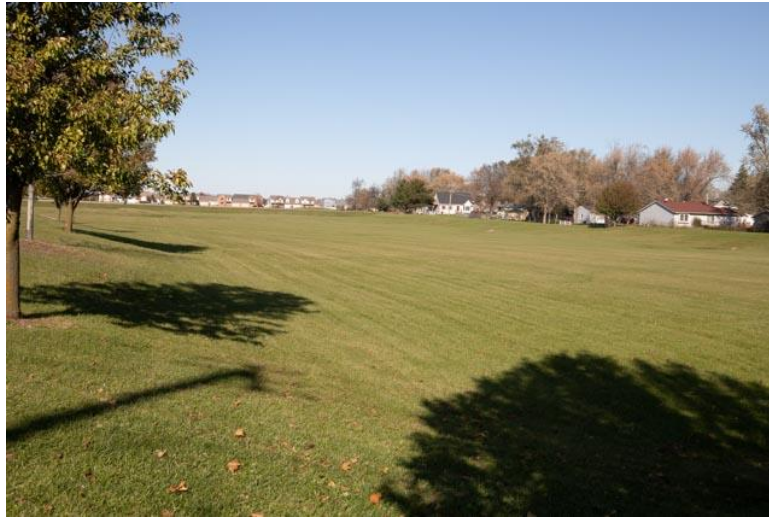
Typical Dry Bottom Turf Grass
