**REPORT  
PRE-DEMOLITION ASBESTOS  
AND LEAD PAINT SURVEY  
LOS ANGELES CITY  
DEPARTMENT OF  
RECREATION AND PARKS -  
EL SERENO RECREATION  
CENTER  
4721 KLAMATH STREET  
LOS ANGELES,  
CALIFORNIA**

**URS JOB No.  
29405516.10000  
OCTOBER 4, 2011**

**SUBJECT: PRE DEMOLITION ASBESTOS, LEAD PAINT, AND HAZARDOUS  
MATERIALS ASSESSMENT  
EL SERENO RECREATION CENTER COMMUNITY BUILDING  
4721 KLAMATH STREET  
LOS ANGELES, CA  
URS PROJECT NO. 29405516**

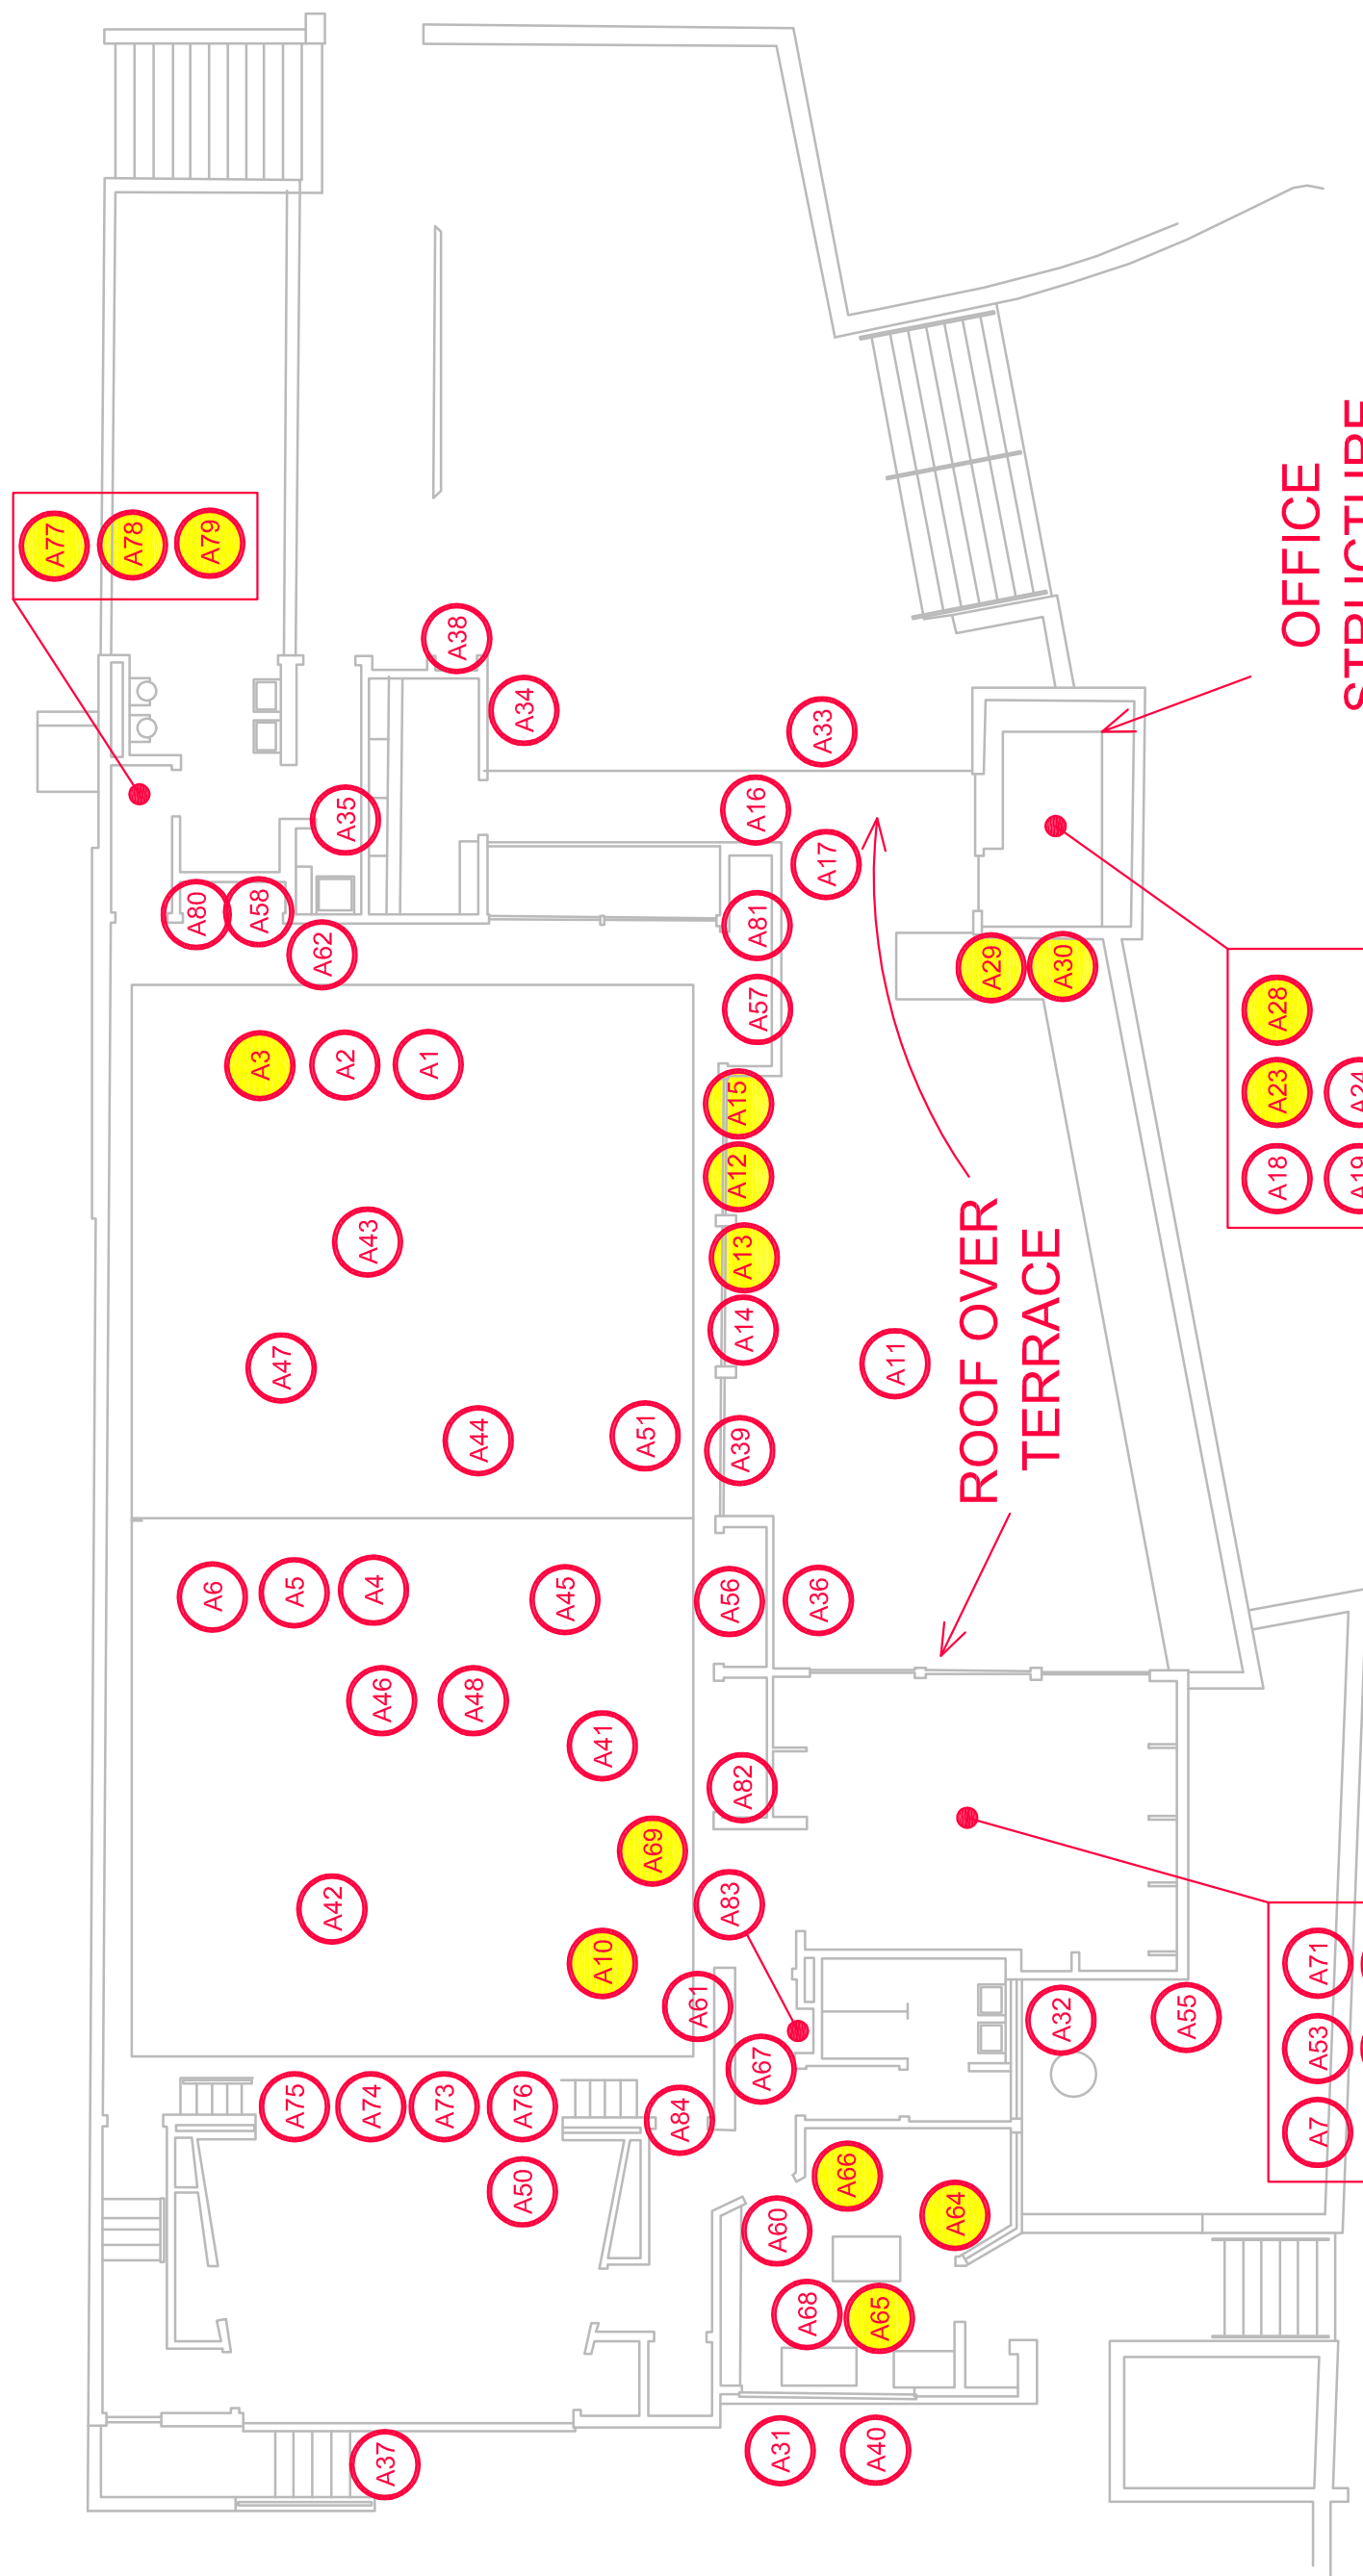
Project: DEPT. OF RECREATION AND PARKS Figure:  
CITY OF LOS ANGELES 2

URS collected a total of 84 bulk samples from the Community Building and office. The sample locations are shown on Figure 2 and the analytical results of the survey are summarized in Table 1. Table 3 summarizes the asbestos bulk sampling data such as the location of the sample, the type of material sampled, condition, and the percentage of asbestos found in the sample. Asbestos laboratory analytical results and chain-of-custody records are included as Appendix B.

YELLOW INDICATES  
ASBESTOS DETECTED

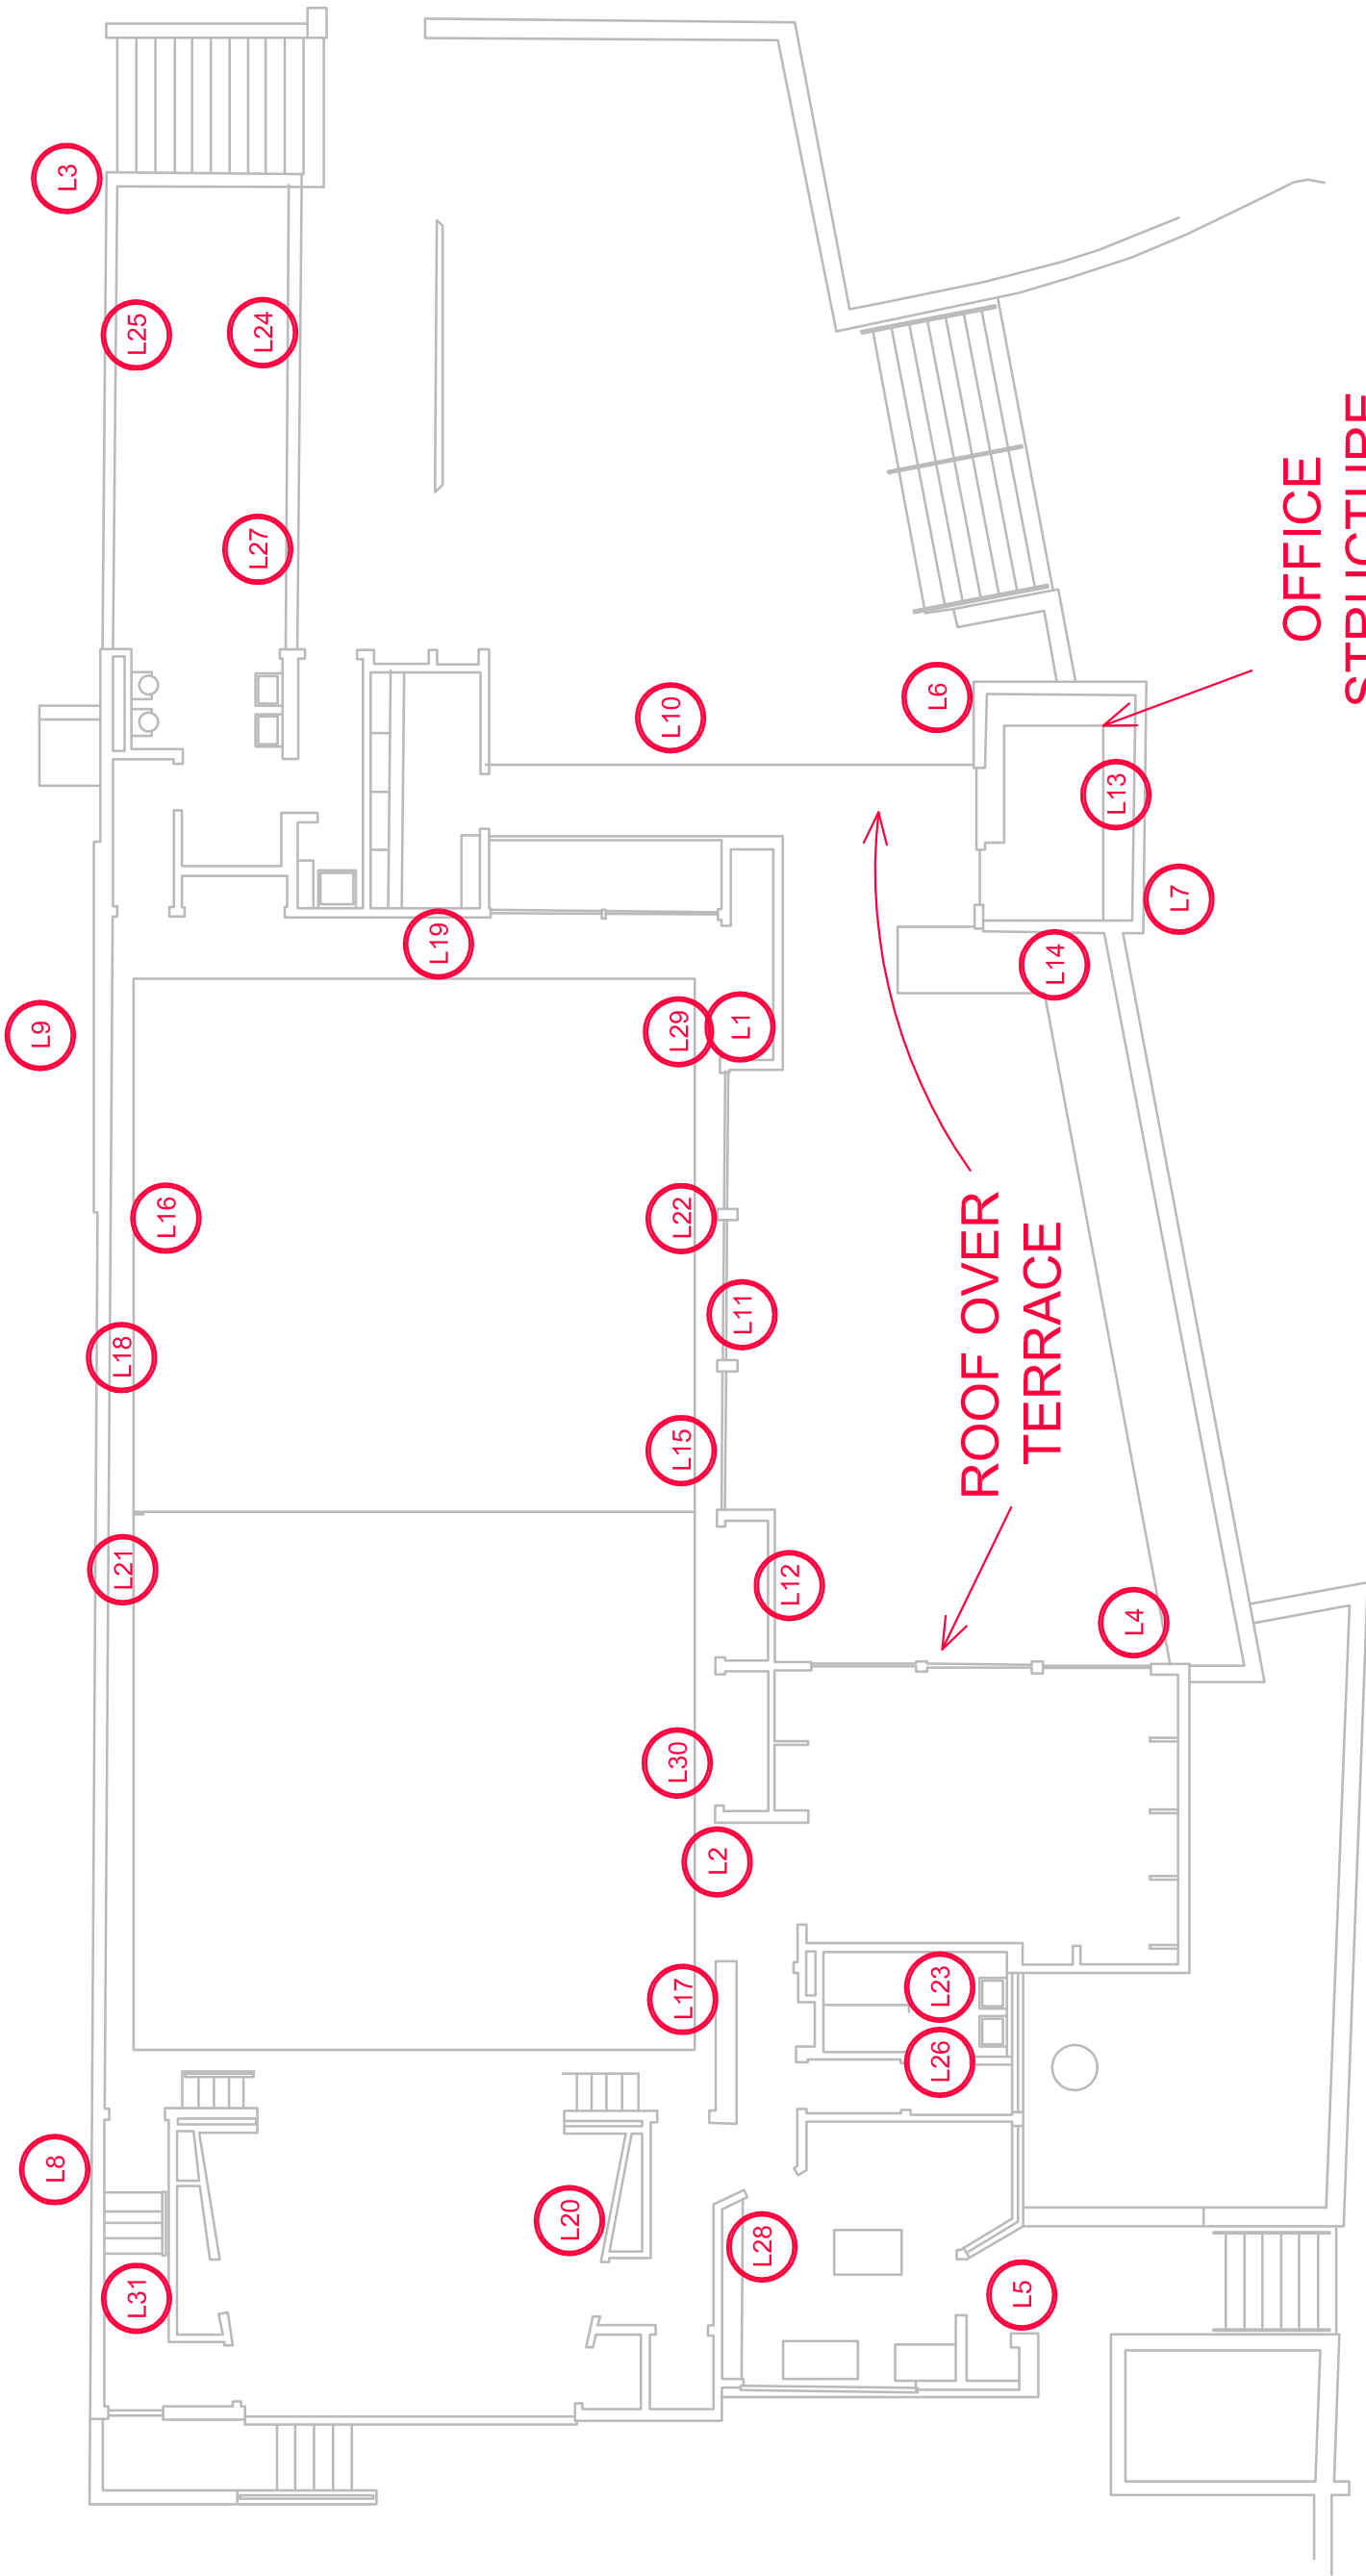
EL SERENO RECREATION CENTER  
COMMUNITY BUILDING  
LEAD-BASED PAINT BULK  
SAMPLING LOCATIONS

URS collected 31 bulk paint samples from the Community Building and office. The sample locations are shown on Figure 3, and the analytical results of the survey are summarized in Table 2. Table 4 summarizes the LBP sampling data such as the sample number, the location of the sample, the type of material sampled, condition, and the lead concentration found in each sample. Laboratory analytical results and chain-of-custody records are included as Appendix C.

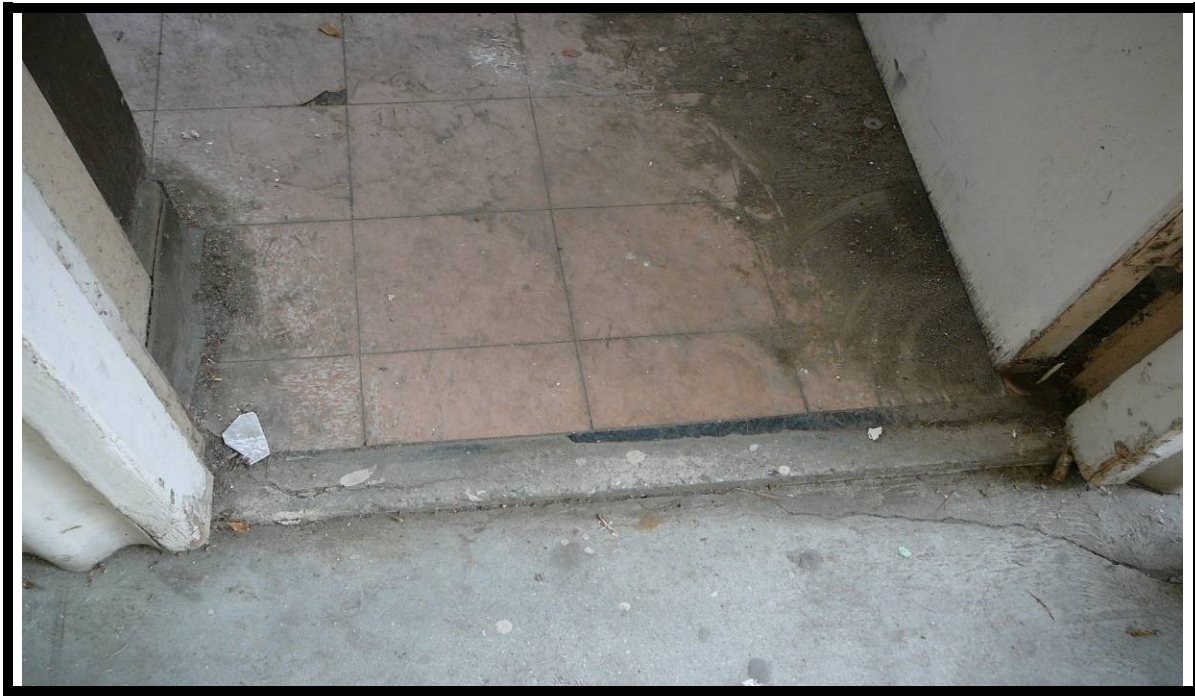
**Photograph 1:** View of the 9-inch by 9-inch asbestos containing vinyl floor tiles located in the “office” structure at the Community Building.

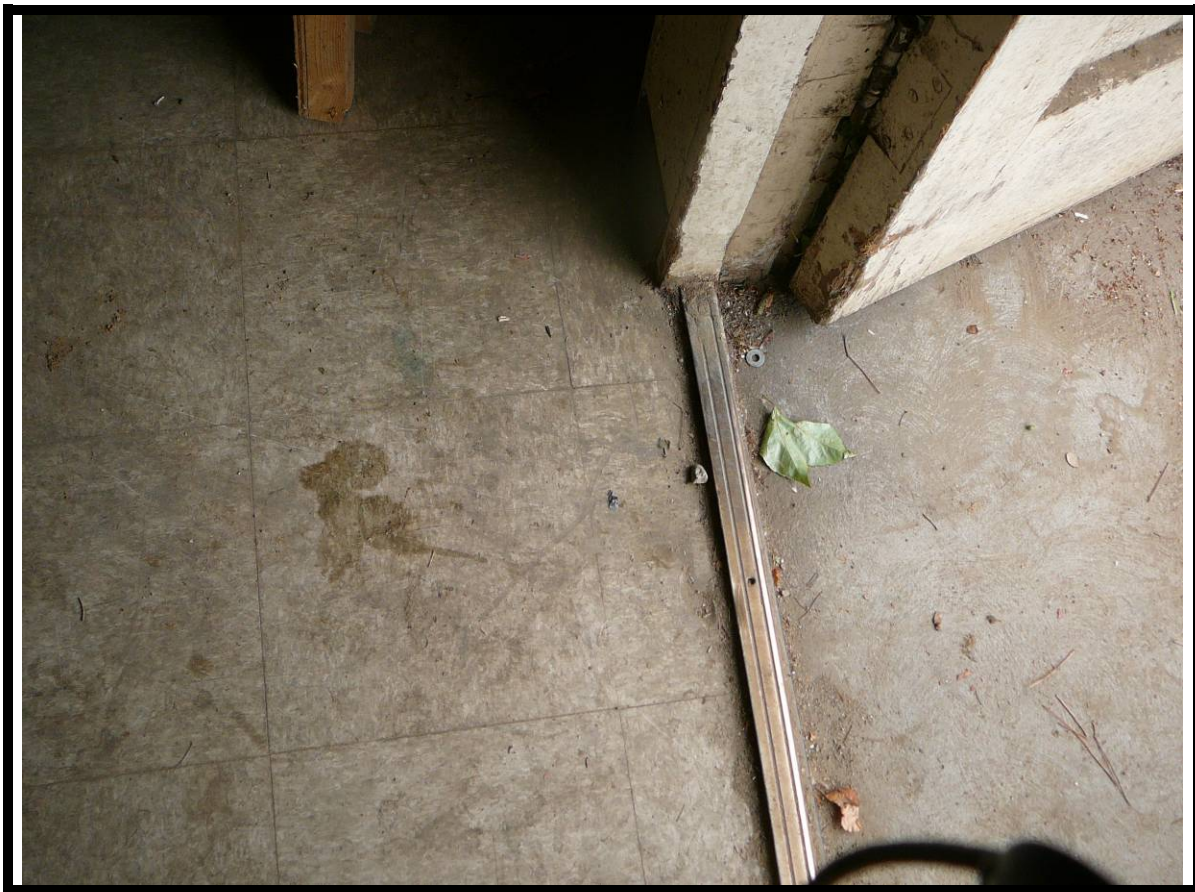
**Photograph 2:** View of the non-asbestos containing 12-inch by 12-inch vinyl floor tiles located in the auditorium and craft room of the Community Building.

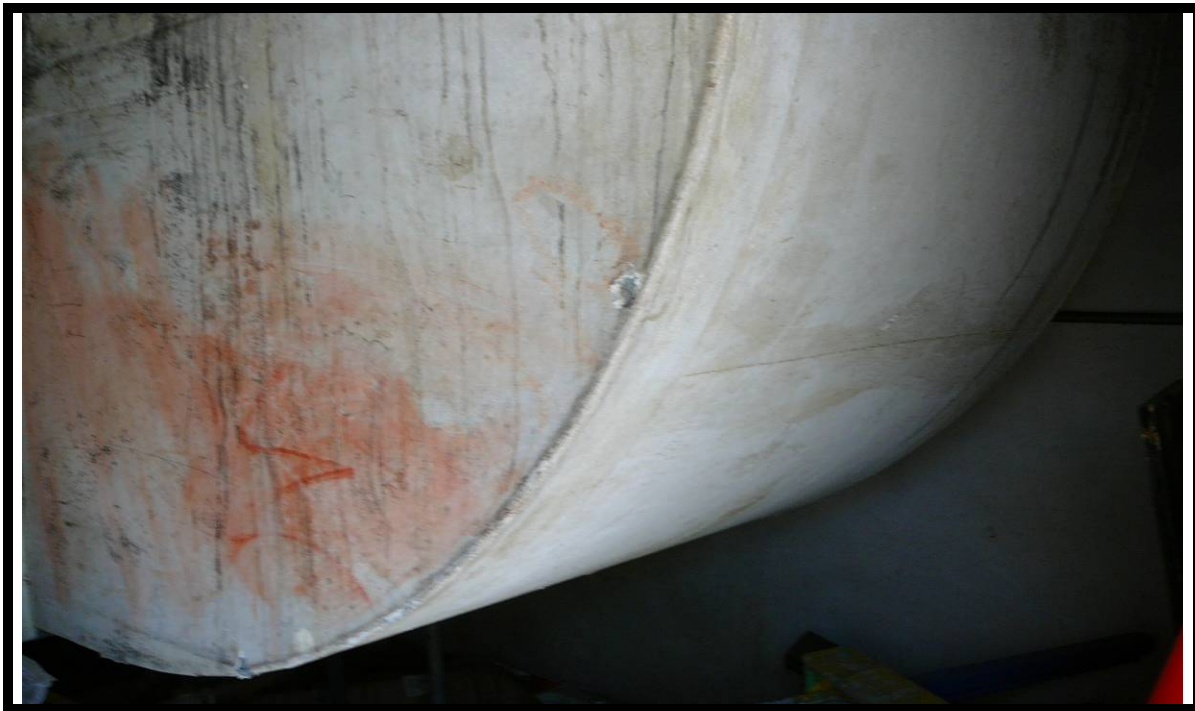
Friable ACM was found in the white insulation material covering the HVAC ducting located in the equipment room. Non-friable ACM was found in the transite vent pipes located on the roof, roofing mastic, exterior transite panels, exterior stucco material, 9-inch by 9-inch salmon-colored vinyl floor tiles and mastic located in the office, the cove base mastic material located throughout the building, and 9-inch by 9-inch green vinyl floor tiles located in the kitchen area.

**Photograph 3:** View of the asbestos containing insulation material located on the HVAC ducting in the mechanical room of the Community Building.

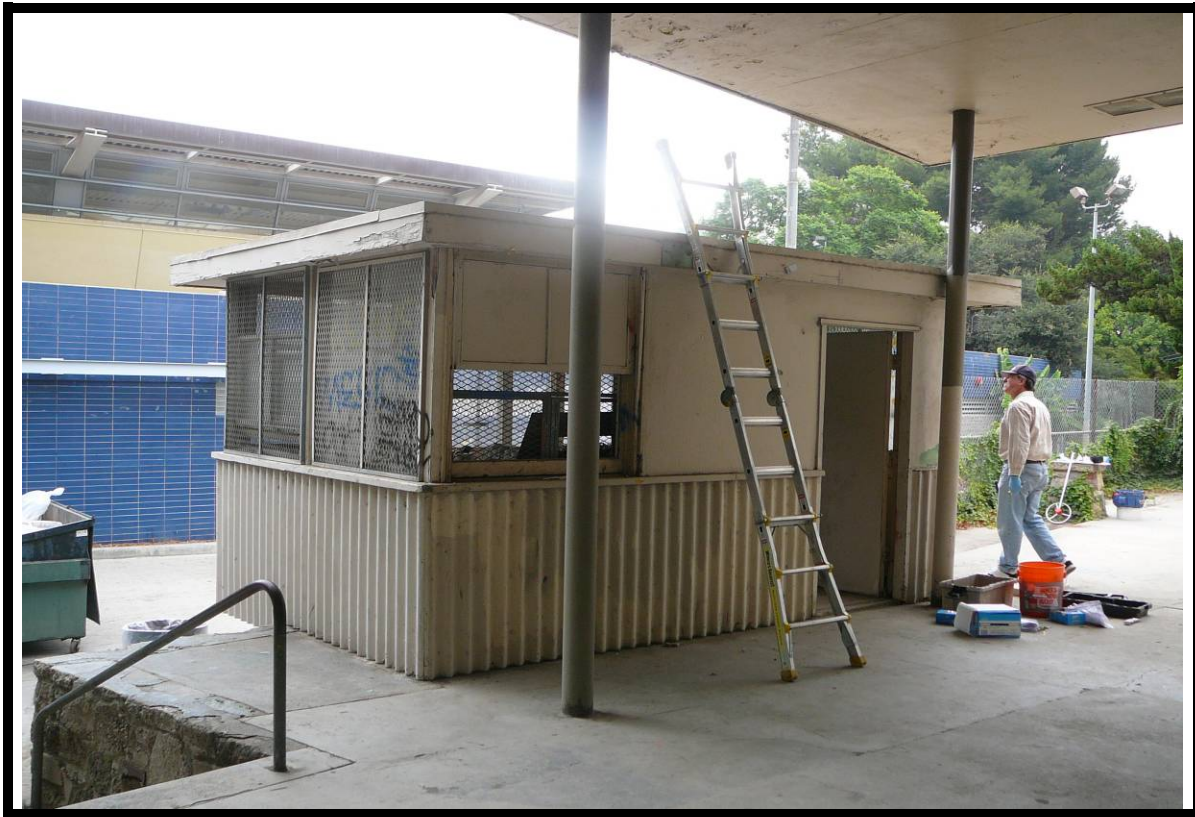
**Photograph 5:** View of the corrugated asbestos cement board material located on the lower section of the "office" structure at the Community Building.

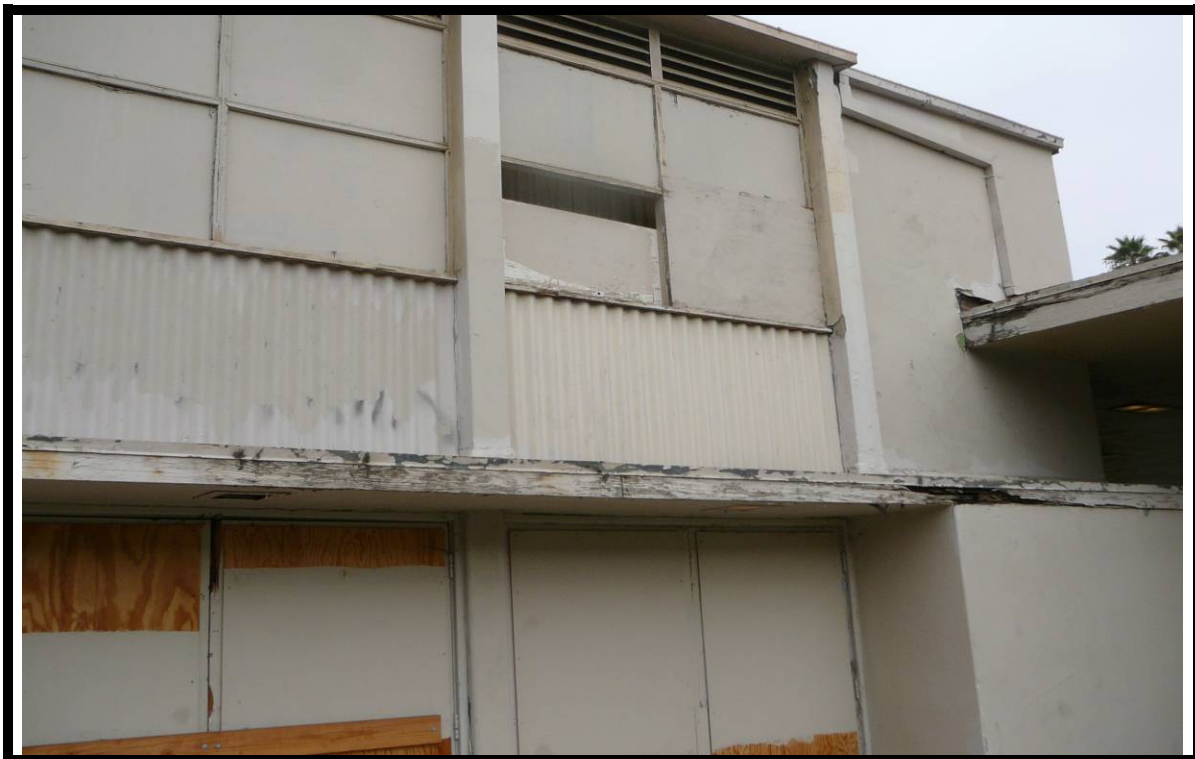
**Photograph 6:** View of the corrugated asbestos cement board material located on the exterior of the Community Building.

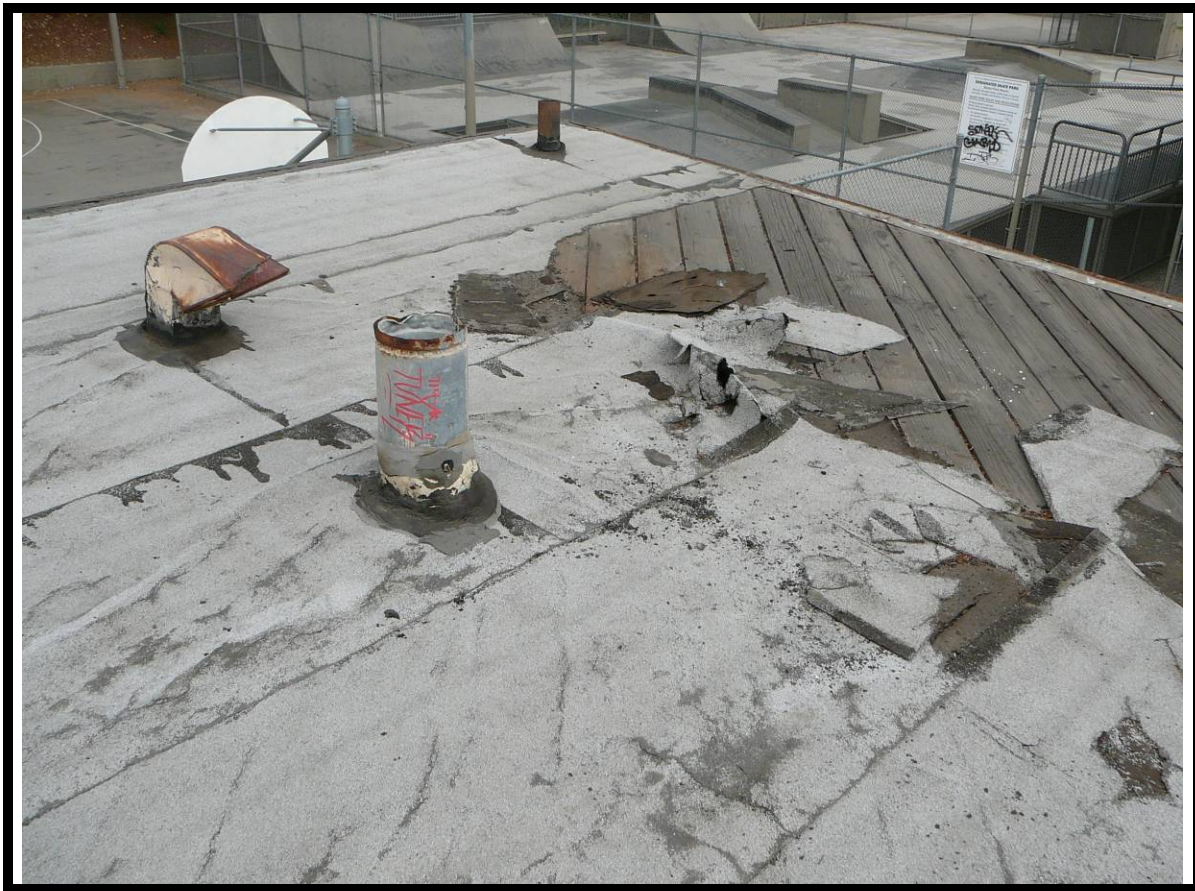
**Photograph 7:** View of the asbestos- containing roofing mastic material located on the roof of the Community Building.
