INSPECTION REPORT

From the inspection on:

June XX, 2020

IMPERIAL HOME INSPECTION
CHRIS LOWE: 805-256-5519

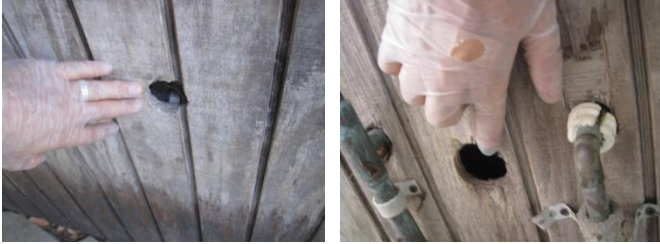
(guest house – north side of the building)

- 2-1 **HOLE:** There is a hole in the exterior siding that needs repair (to prevent moisture entry, etc.) (we recommend further evaluation/correction)

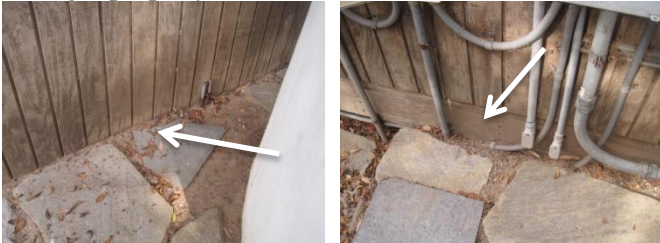
(many locations around the guest house)

- 2-2 **(IMPROPER)** Some wood on the exterior of the building touches the soil/grade. This should be further evaluated as part of a qualified termite inspection/report. Correction is recommended to prevent moisture damage (properly remove soil contact to wood)

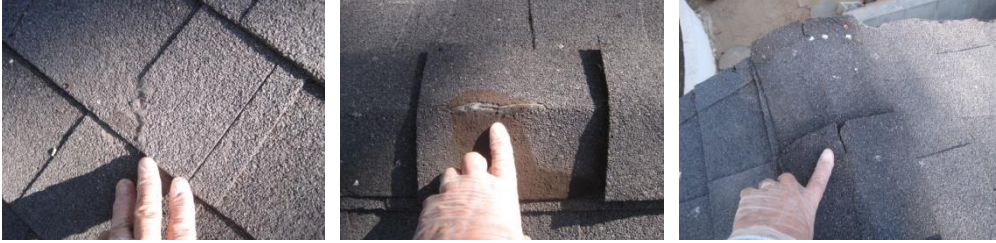
(various locations)

- 3-1 **WEAR TO THE GUEST HOUSE SHINGLES – SOME CORRECTION IS NEEDED:** The guest house roof shingles are mostly intact, but there is some wear. The inspector believes that some maintenance will be needed . Consult a qualified licensed roofer for further evaluation

NOTE: Because this roof has wear, replacement will be needed at some point. Defer to the opinion of a licensed roofing specialist

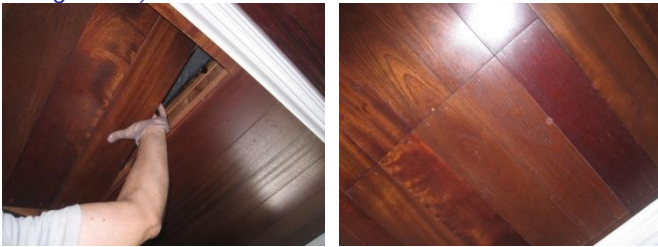
(in the upstairs studio)

NOTE: The inspector was unable to get the roof access panel to open at the top floor wet bar area (because of its configuration) – correction is recommended

(this flat roof was accessed instead by ladder today)

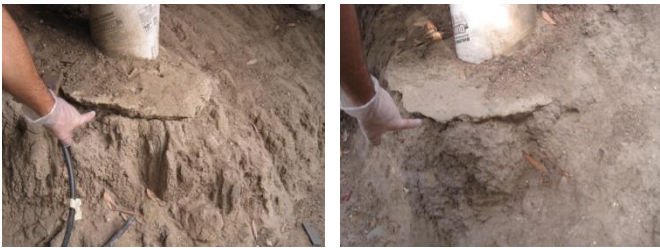
- 4-5 **MISSING SOIL SUPPORT AT PIERS/POSTS (IMPROPER) (GUEST HOUSE):** The guest house and deck have missing soil support for a beam footing (improper) – this needs correction . The inspector recommends that you have a licensed, qualified structural engineer and soil engineer review this building further

(this is building support for the guest house – soil support is very important here)

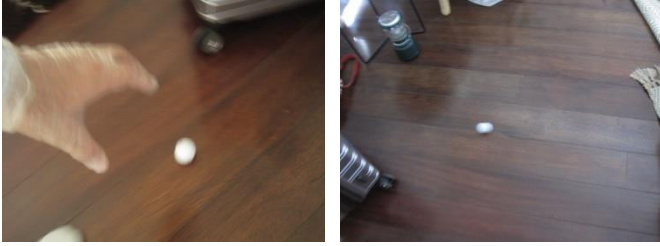
- 4 – 8 **GUEST HOUSE HAS MOVED:** There is significant noted floor slope at the guest house. The inspector recommends that a qualified structural engineer view this further

(floor sloping)

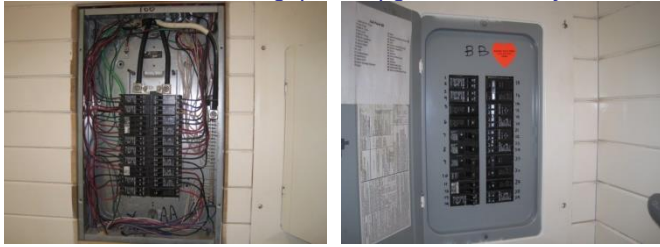
(laundry room – both sub panels)

NOTE – TWO FULL PANELS: The electrical sub panels (inside the home) are both full. If additional electrical will be needed inside this building, panel upgrades will likely be needed here

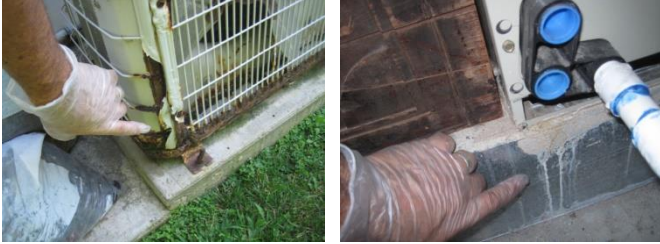
- 8-1 **ONE FURNACE NEEDS REPLACEMENT NOW:** The top-floor studio HVAC system is nonfunctional and needs replacement. Defer to the opinion of a qualified heating specialist

(areas of heavy damage) (not functional)

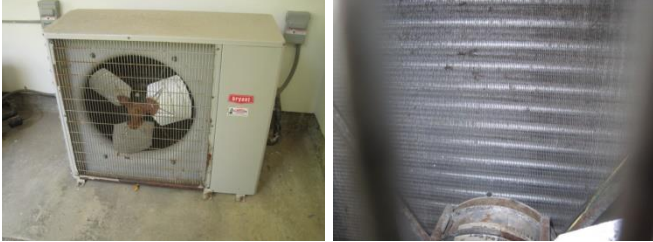
- 9-1 THE AIR CONDITIONER SYSTEMS COOLED TODAY – the temperature at supply-duct registers was generally 50 degrees, vs. 75 degrees at the return-air registers
- 9-2 STUDIO AC NEEDS REPLACEMENT: As mentioned in the “heating” section of this document, the HVAC unit needs full replacement
- 9-3 WEAR TO ONE OF THE AC CONDENSERS (BUT IT IS FUNCTIONAL TODAY): An air conditioning condenser has some rust/wear at the left exterior of the house (the inspector is unable to determine remaining life span) . Defer to the opinion of a qualified heating specialist

– The fins and fan seem to be in-tact today

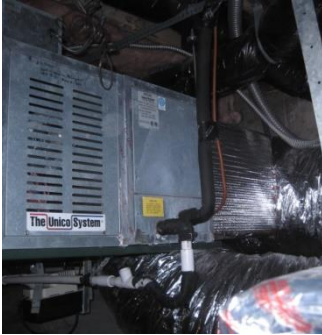
- 9-4 ALL THREE AC SYSTEMS NEED DRIP PANS: If the HVAC systems (in the downstairs heating room/closet) ever leak water, it would cause moisture to enter the interior of the home. These systems each need a proper drip pan (for mold prevention in case of leakage) (required). Defer to the opinion of a qualified heating specialist

(three units in the furnace room – no drip pans) – this needs correction

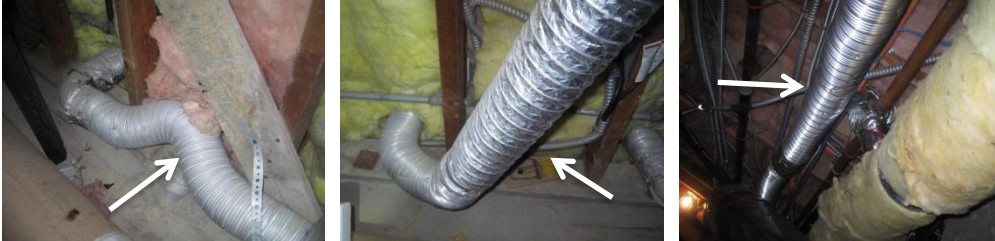
- 11 - 1 **IMPROPER DRYER VENT PIPES (HAZARD):** The dryer vents are ribbed metal (and foil) under the house – this is not allowed (for safety) and needs correction now. This should be further evaluated by a qualified plumber/heating specialist and corrected with a proper smooth metal vent as required (for blockage and damage prevention)

(this is for both of the dryer vent pipes in the downstairs furnace room and surrounding crawlspaces)
IMPORTANT: These vents are also attached with duct tape and over-spanned (also hazardous)

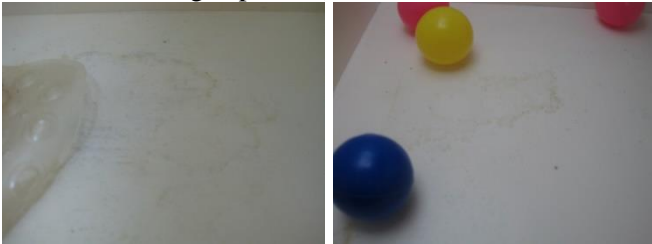
(jack-and-jill bathroom – under both sinks)

- 13 - 3 **STAINS IN A CABINET -- DRY TO THE TOUCH TODAY:** There are moisture stains in the cabinet under a bathroom sink. This area is dry to the touch at this time, however we cannot determine whether there could be a growth condition or active moisture inside the wall, etc. The only way to determine for certain is to obtain a mold inspection and a plumbing review of this area (always recommended when moisture staining is present)

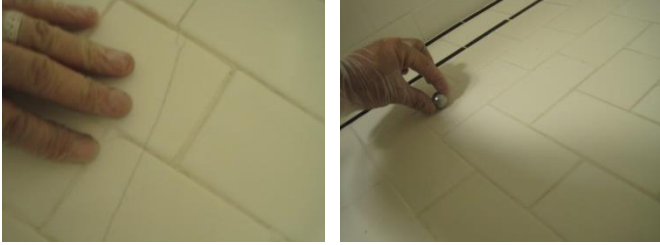
- 13 – 10 **LOOSE TILES (AND CRACKS):** There are some tile cracks and some hollow-sounding tiles at the top floor studio bathroom – correction is recommended . Have a qualified shower specialist review this further

(hollow sounding tiles, cracks)

NOTE: The inspector does not suspect a leakage concern (not verified), but recommends tile correction and further evaluation
