**Condition Assessment
&
Reserve Fund Plan
2023**

ROLLING RIDGE

Sterling, Virginia

RE: **CONDITION ASSESSMENT AND RESERVE FUND PLAN 2023**
Rolling Ridge Condominium Association
(Final Report, Revised March 23, 2023)
Sterling, Virginia
Project No. 9713

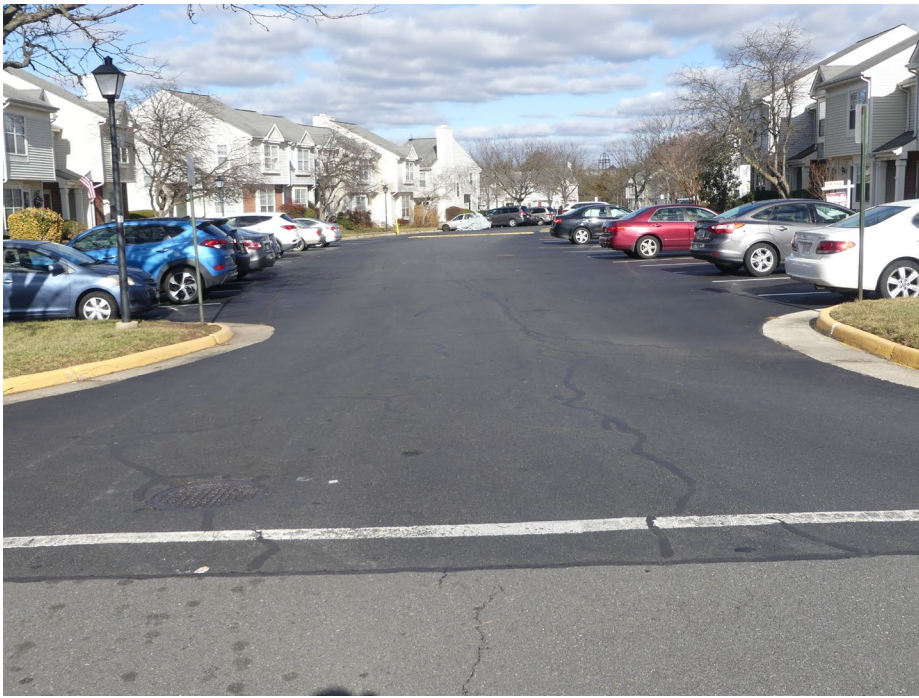
PHOTO #1
The Phase 1 asphalt (restored in 2012) driveways and parking bays are in generally fair condition. We observed a moderate quantity of deflected asphalt (indicative of sub-base damage) throughout both Calamary Circle and Marigold Circle.

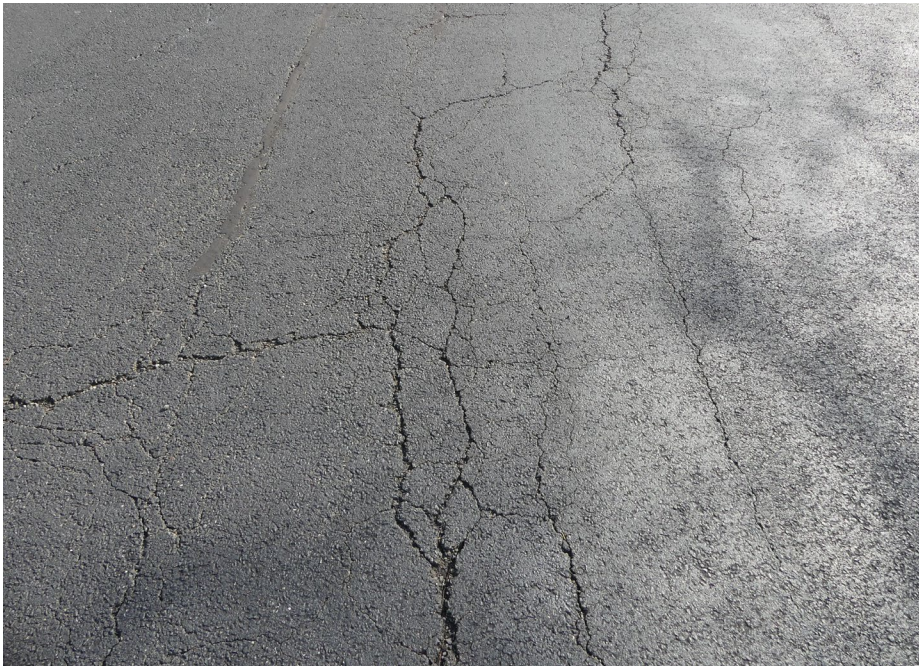
PHOTO #2
Deflected asphalt such as this requires full-depth repair during pavement maintenance projects every six years. Asphalt rejuvenator has been used to seal the pavements and appears to be holding up well.

7.4 Asphalt Full-Depth Repairs: In areas where significant alligator cracking, potholes, or deflection of the pavement surface develops, the existing asphalt surface should be removed to the stone base course and the pavement section replaced with new asphalt. Generally, this type of failure is directly associated with the strength of the base course. When the pavement is first constructed, the stone base consists of a specific grain size distribution that provides strength and rigidity to the pavement section. Over time, the stone base course can become contaminated with fine-grained soil particles from the supporting soils beneath the base course. The most positive repair to such an area is to remove the contaminated base course and replace it with new base stone to the design depth. It is appropriate to perform these types of repairs immediately prior to asphalt restoration projects. Generally, this type of repair should not be required for approximately five years after an asphalt restoration project.

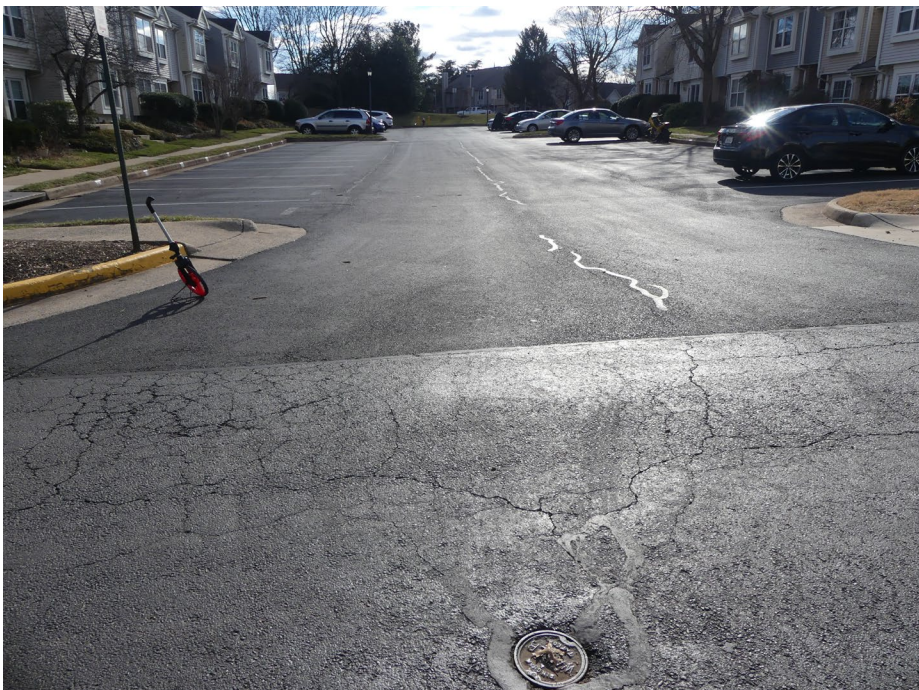
PHOTO #3
The Phase 2 asphalt, (restored around 2017) is holding up well. Very minor amounts of deflected asphalt and filled cracking were observed.

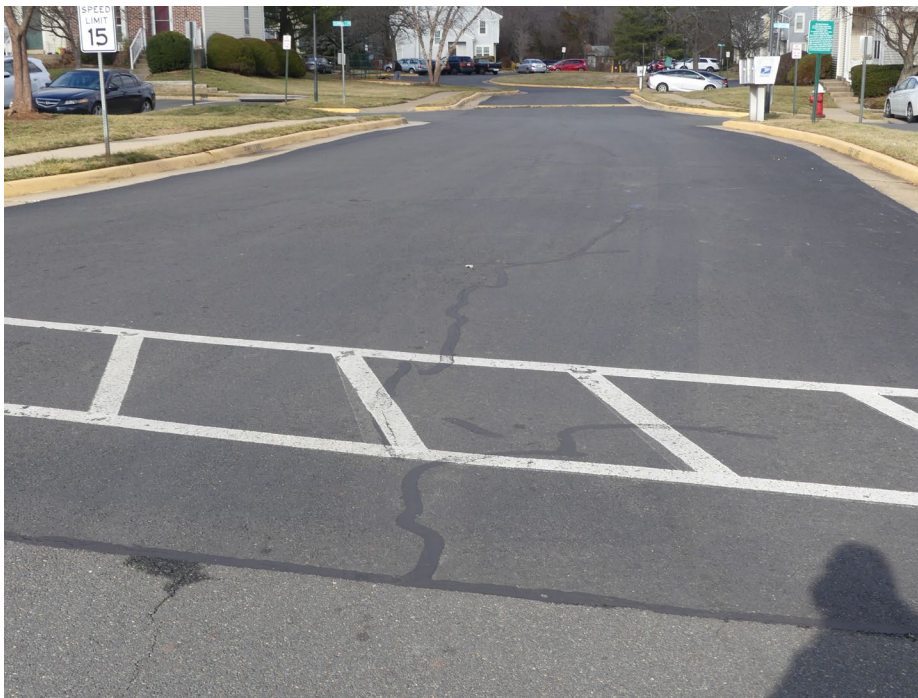
PHOTO #4
The Phase 3 pavements are in good condition with zero deflected asphalt. Most cracking has been filled.

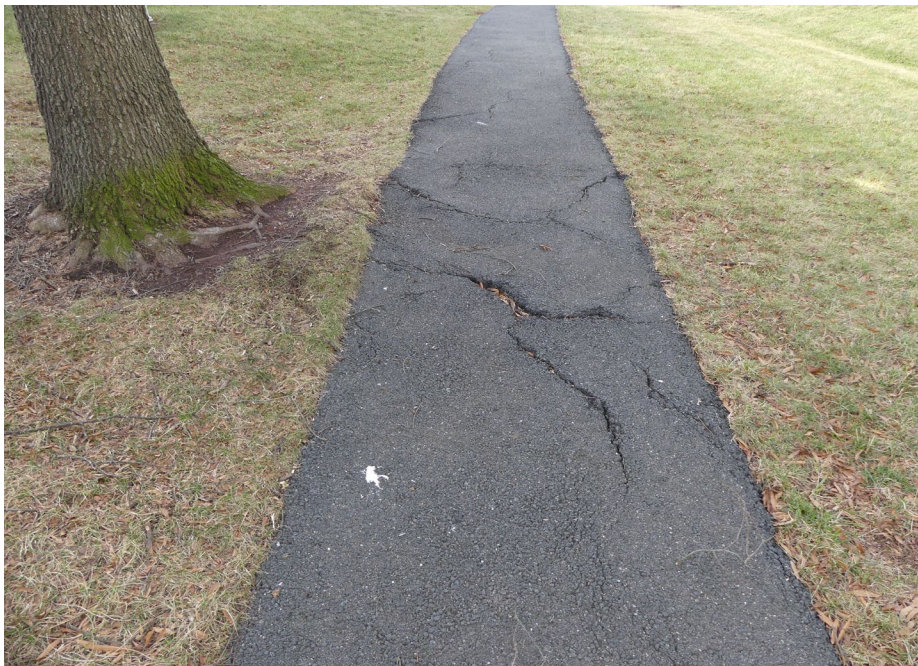
PHOTO #5
The asphalt footpaths are in fair condition. Root heaves such as this are potential tripping hazards which should be repaired expeditiously.

7.6 Asphalt Footpaths: Transverse and longitudinal cracks should be cleaned of debris and plant growth (lanced) and filled with a rubberized asphaltic compound to prevent water infiltration. Cracks and deflection of the asphalt pavement can develop in the areas where tree roots cross the path. Tree roots should be removed and damaged areas repaired. An additional maintenance issue with footpaths is vegetation control. In areas where vegetation encroaches on the paths, both underfoot and overhead, visibility is reduced, and personal injury can occur from low-growing branches. Vegetation control should be accomplished on a regular basis under the maintenance budget for safety considerations and to extend the useful service life of the pavement.

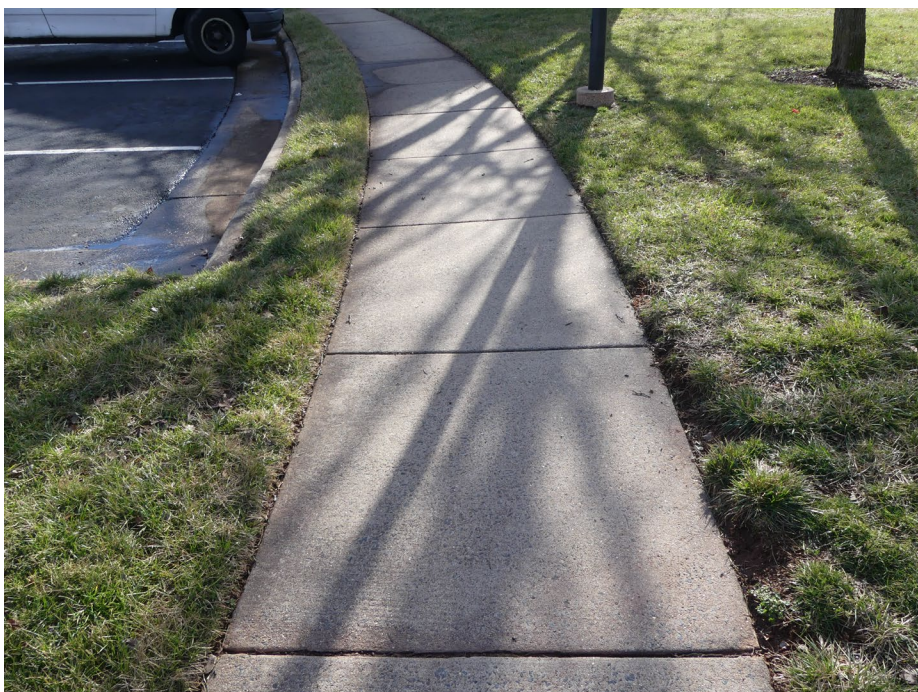
There is a significant quantity of cracked, settled, and/or heaved concrete sidewalks, which are potential tripping hazards. The liability and costs associated with personal injury lawsuits resulting primarily from sidewalk and footpath tripping hazards are too great to defer repair. It is our opinion that deficiencies which pose a hazard to pedestrians should be corrected expeditiously.

PHOTO #6
The concrete sidewalks range from fair to good condition. We observed a moderate quantity of settled, heaved, or cracked concrete panels, requiring expeditious repair to prevent personal injury.

7.7 Concrete Sidewalks: When sidewalks are cracked or scaled or sections have settled, the resulting differential or 'tripping hazard' can present a liability problem for the Association if personal injury should occur as a result. Tripping hazards should be repaired expeditiously to promote safety and prevent liability problems for the community. Generally, where practical and appropriate, concrete element repairs and replacements are scheduled in the same years to promote cost efficiencies. Replacements are usually scheduled in cycles because the necessity of full replacement at one time is unlikely. Typically, damaged or differentially settled sections can be removed by saw cutting or jack hammer and re-cast. Concrete milling of the differential surfaces is sometimes an appropriate, cost-effective alternative to re-casting. Skim coating is not an effective repair for scaled or settled concrete surfaces and, over time, will usually worsen the problem. The use of ice melting chemicals may accelerate deterioration of concrete components.

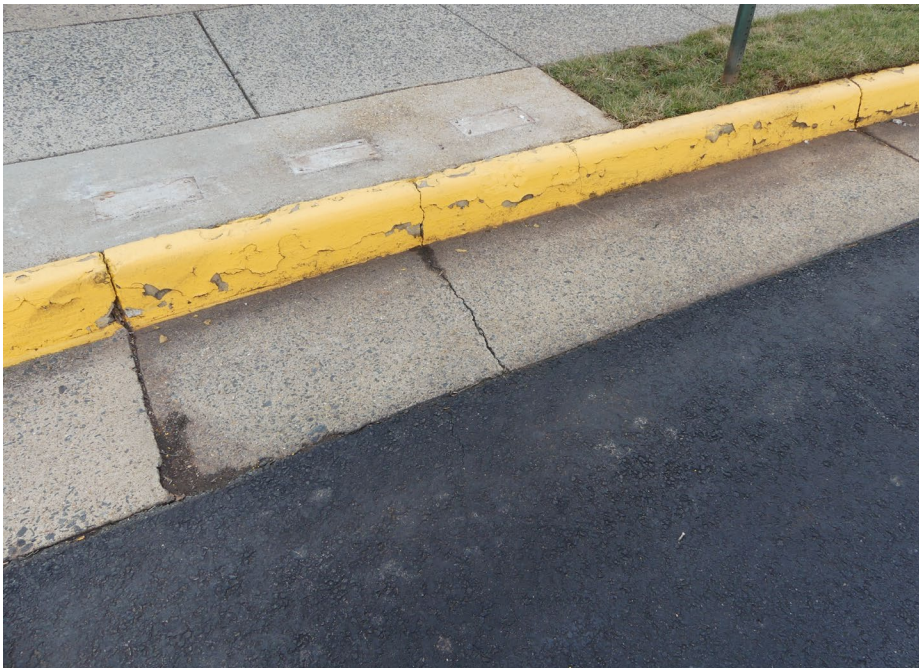
PHOTO #7
The concrete curbs and gutters also range from fair to good condition. We observed moderate cracking and settlement, requiring eventual repair/replacement.

7.8 Concrete Curbs and Gutters: Vehicle impacts, differential settlement, construction damage, and cracking and spalling of the concrete will eventually result in the need for replacement of some curb sections. A typical damaged or settled section, usually 10 feet in length, will be removed by saw cutting or jack hammer and re-cast.

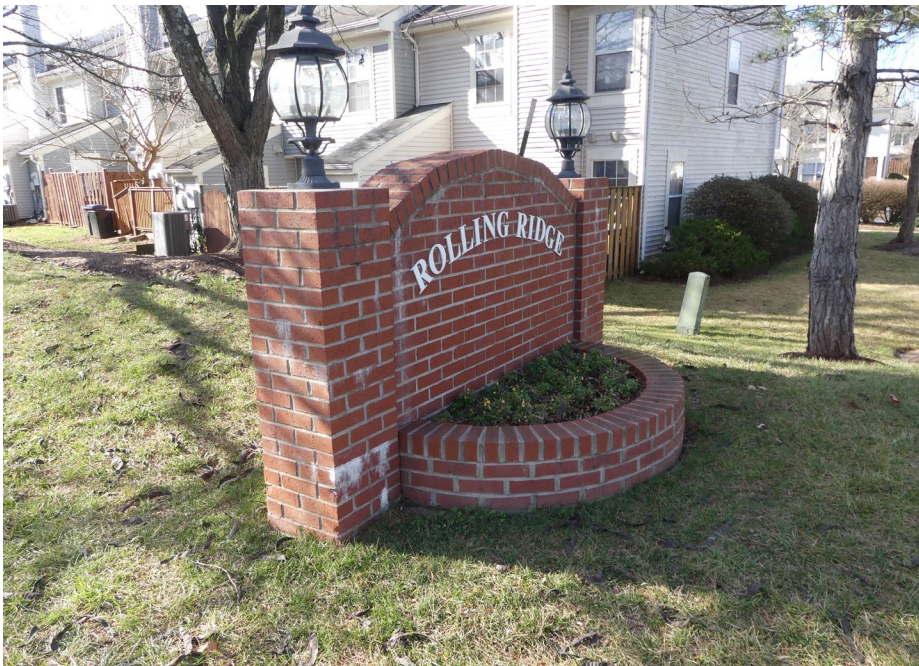
PHOTO #8
The brick-and-mortar entrance monument and monument lighting appear to be in generally good condition.

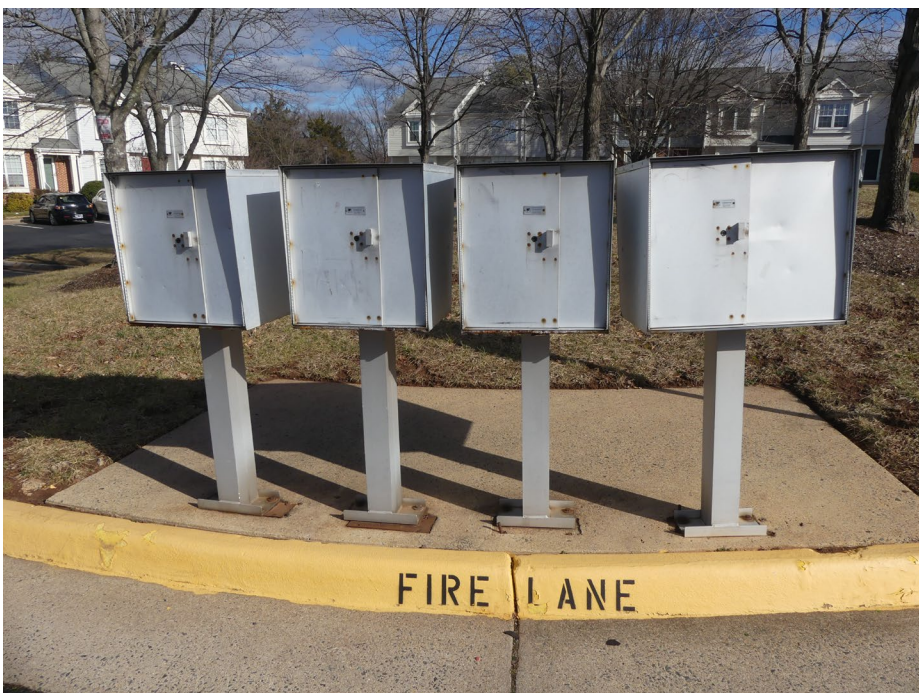
PHOTO #9
11 of the 15 mailbox modules range from poor to fair condition. We observed moderate rusting of most modules. Four of the modules were recently replaced near Canopy Terrace and are in excellent condition.

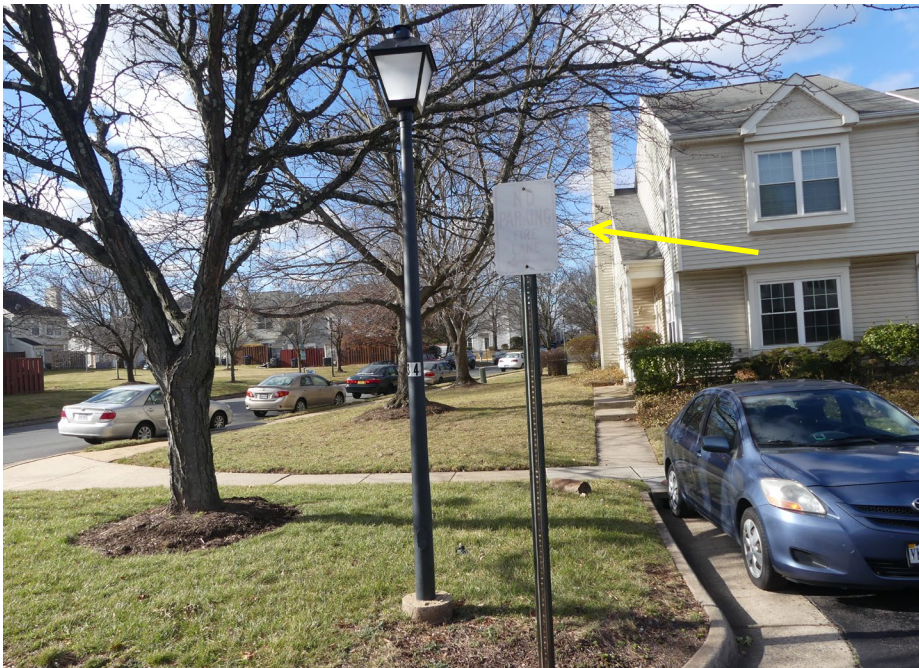
PHOTO #10

The light poles and fixtures appear to be in fair to good condition. We understand that some of the fixtures have been updated to L.E.D. Lighting was not observed after dark.

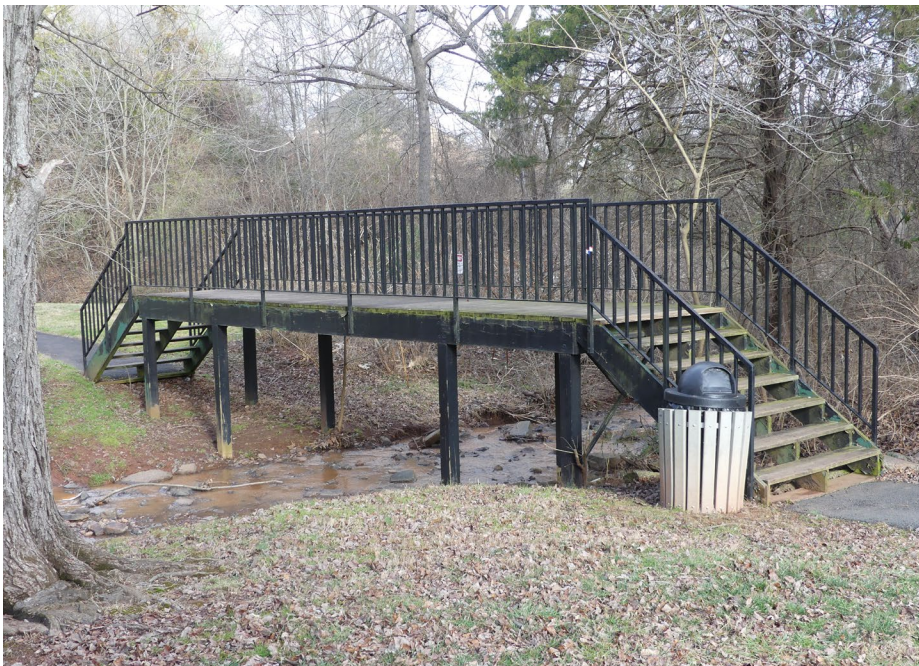
PHOTO #11

The pedestrian bridge is in fair condition. Structurally it appears to be in good condition. However, the top treads require replacement near-term. The bridge should be painted to improve appearance.

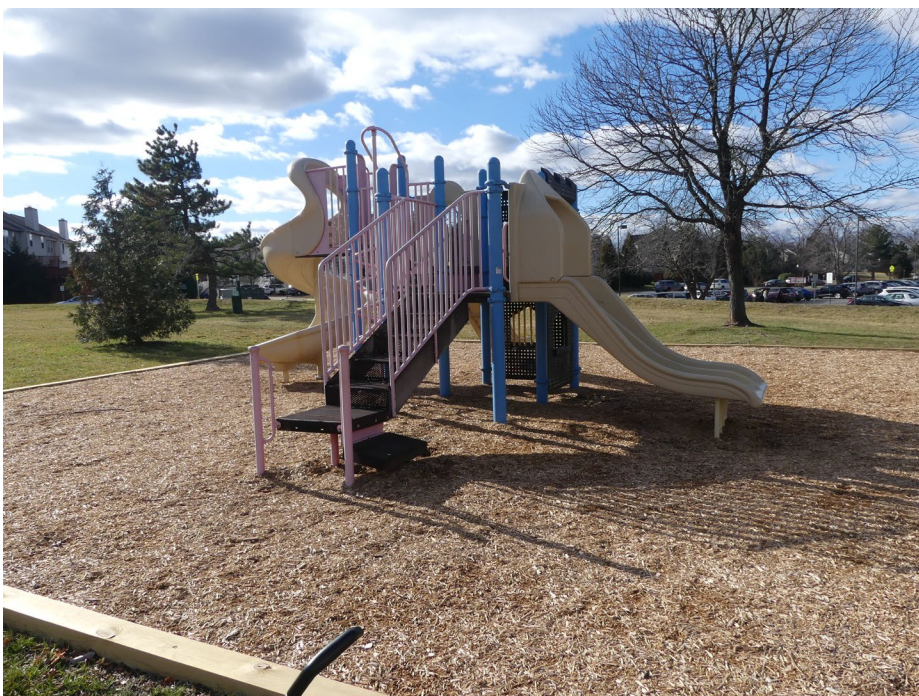
PHOTO #12

The play module wood borders and the mulch have been replaced recently and are in good condition.

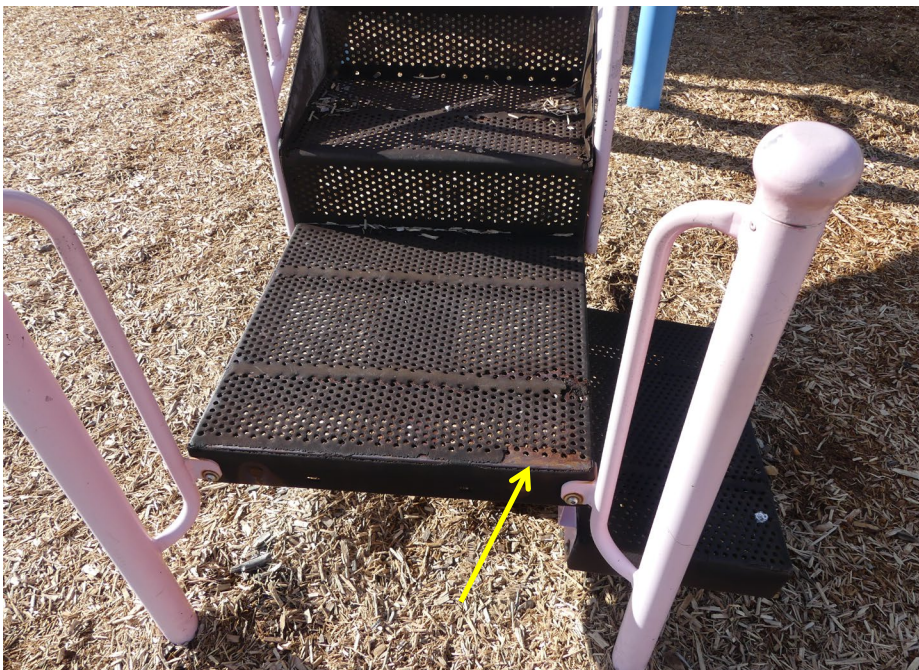
PHOTO #13
The main play module metal flooring is rusted, and it is deteriorated. The module will require replacement near-term.

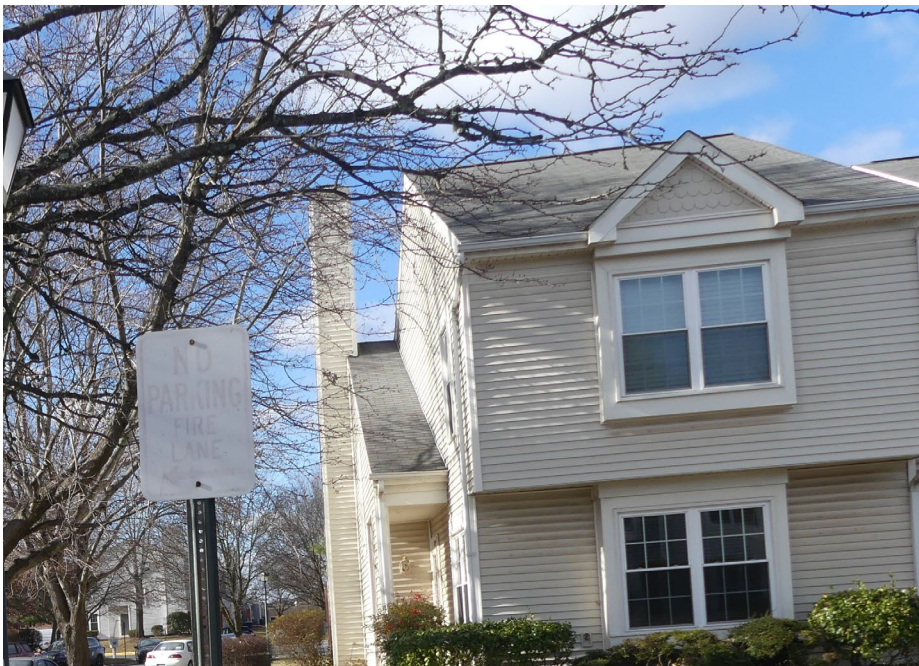
The roofing ranges from fair to good condition. We understand that the original 3-tab roofing was installed between 2002 and 2007. There have been recent problems with roofing and some leaks reported. These problem roofs (a total of eight units) were replaced by Prime Exteriors, L.L.C. in 2022 and 2023. Management provided pricing to us, as we have used an average of \$5,650 per unit. Management also requested that we phase the future building roofing. We have provided for approximately 172-unit roofing replacements over the next six years, or about 28 to 29 unit replacements each year.

PHOTO #14
Building roofing ranges from fair to good condition. We understand that eight units have had recent roofing replacements in 2022 and 2023. The remaining roofing is scheduled for full replacement between now and mid-term, in phases to help reduce major contribution increases.

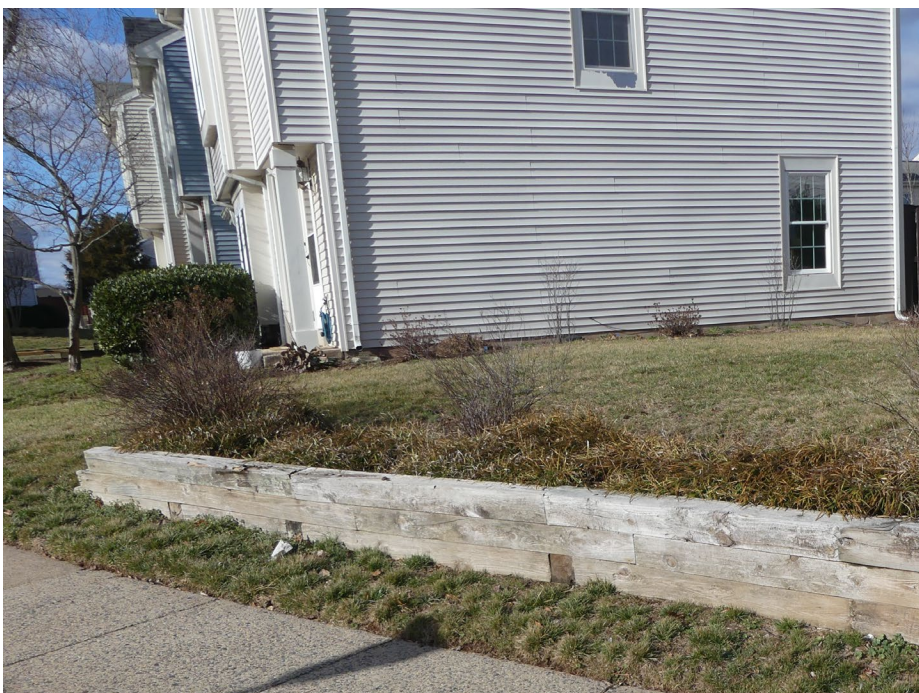
PHOTO #15
We understand that the vinyl siding and trim were restored between 2005 and 2009. The building siding, trim, and brick veneer range from fair to good condition.
