Case Study: Shaft Voltage and VFD Motor

Abstract: Repeated bearing failures were occurring, and EDE was called in to take shaft voltage measurements.

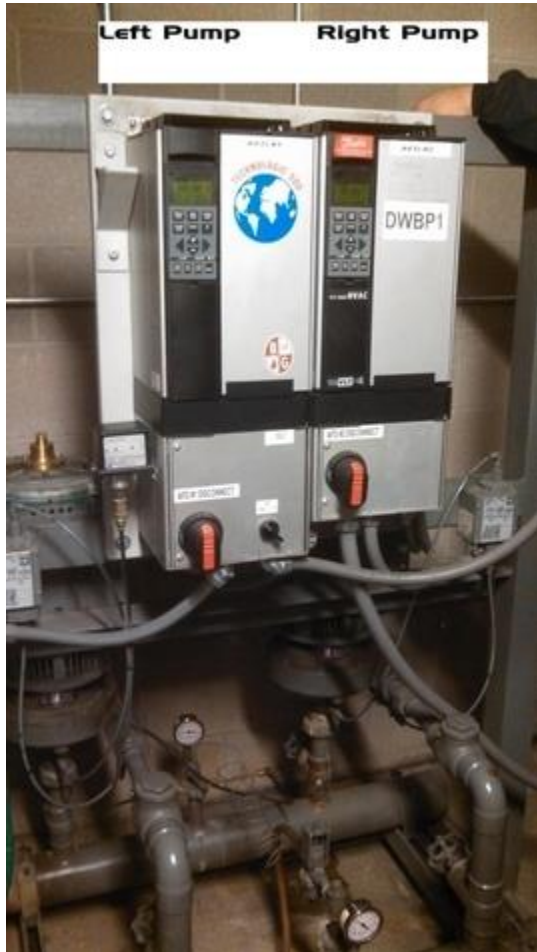
This the implementation. Pump A was where the problem was happening.

So, rotor shaft voltage measured on the “Left” side pump motor. This voltage would vary up and down all the time, and fluctuated quite a bit.

Occasional voltages greater than 8 volts Pk-Pk were detected. These fluctuations are usually indication that the bearing grease has blackened, and failed, with balls and races nearing total breakdown.

There was a lot of jitter and instability in the wave forms. A loud bearing sound was heard. The bearings are probably due for replacement.
