Home Inspection Report

123 Some Street
Somewhere, US 12345

Inspected by:
Umar Wyatt
Accurate Home Inspections LLC

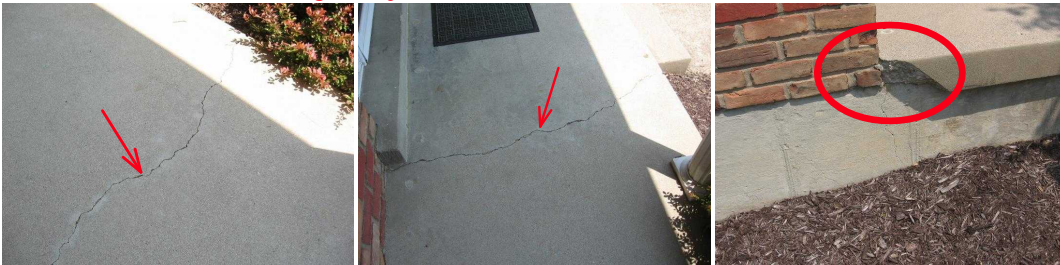
- Acceptable Driveway: Concrete
- Acceptable Walks: Concrete
- Defective Porch: Concrete - Settling away from foundation with surface cracks noted

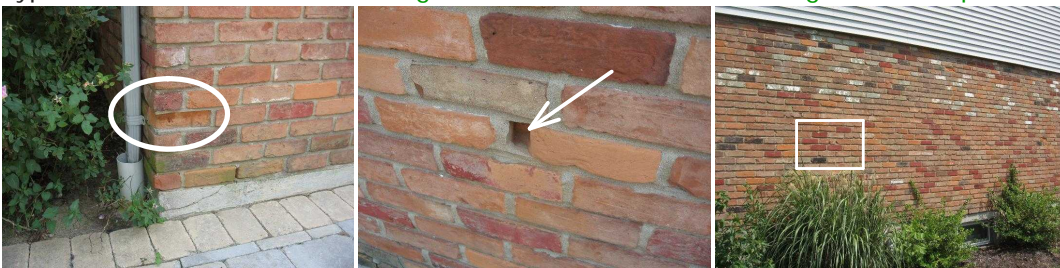
1st Floor Exterior Surface

- Marginal Type: Brick veneer - Some damaged bricks, Recommend sealing brick with penetration sealer products

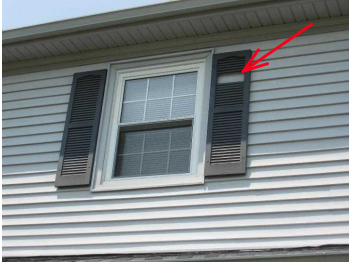
2nd Floor Exterior Surface

- Marginal Type: Vinyl siding - Damaged front shutter, Chalking noted due to age, One panel needs to be repositioned at rear elevation

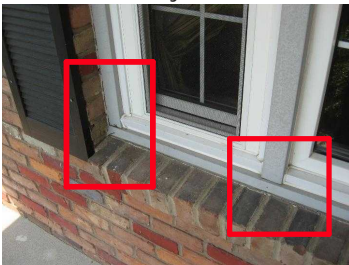
Marginal Trim: Aluminum - Chalking noted due to age, Loose nails in areas
Acceptable Fascia: Aluminum
Marginal Soffits: Vinyl - Loose/sagging at front porch
Acceptable Door Bell: Hard wired
Acceptable Entry Doors: Wood
Marginal Patio Door: Vinyl sliding - Resecure loose handle hardware, Screen damage noted
Marginal Windows: Vinyl insulated - Reseal caulking at window perimeters at brick window openings

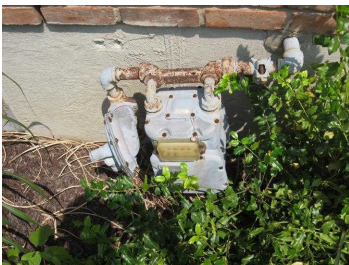
Acceptable Window Screens: Metal
Acceptable Basement Windows: Vinyl casement
Acceptable Exterior Lighting: Surface mount
Acceptable Exterior Electric Outlets: 110 VAC GFCI
Marginal Hose Bibs: Gate - Properly secure fixture(s) to exterior wall with fasteners
Acceptable Gas Meter: Exterior surface mount at side of home - Rust present, Keep bushes and shrubs away from meter

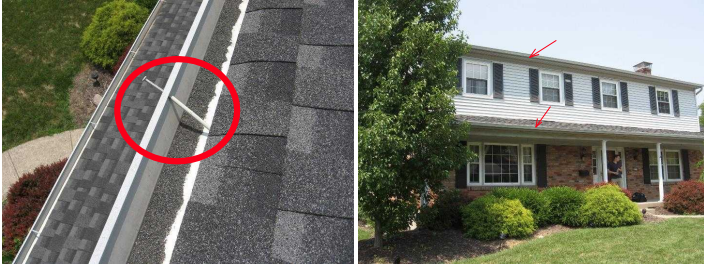
Acceptable Unable to Inspect: 0%
Acceptable Material: Fiberglass shingle
Type: Gable
Approximate Age: 5
Acceptable Flashing: Metal
Acceptable Plumbing Vents: Copper
Acceptable Electrical Mast: Underground utilities
Marginal Gutters: Aluminum - **Loose nails, Sagging gutters at front and rear**

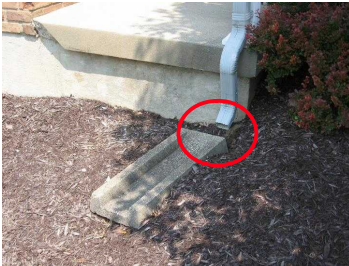
Acceptable Downspouts: Aluminum
Marginal Leader/Extension: Splash blocks - **Splash block(s) not properly installed**

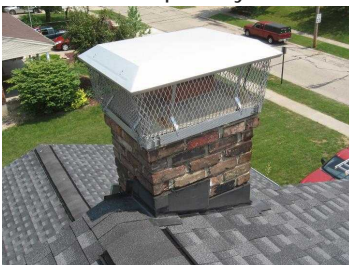
Right side Chimney

Acceptable Chimney: Brick
Not Inspected Flue/Flue Cap: Clay tile - Weather cap obstructed view of flue

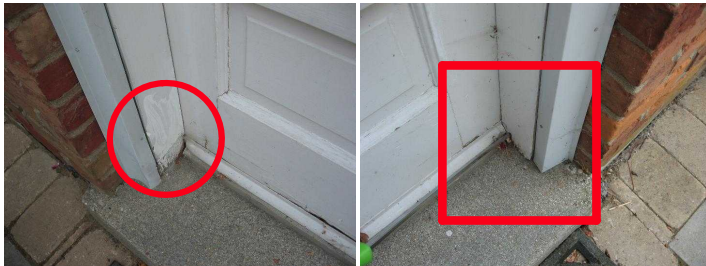
Defective Service Doors: Wood - **Wood rot at bottom of door and frame**

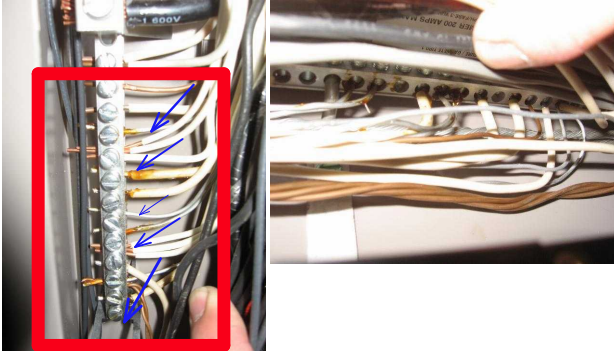
Marginal 120 VAC Branch Circuits: Copper and aluminum - *Evaluation by a licensed electrician is recommended, See aluminum wiring notes below*

Marginal Aluminum Wiring: Present at several circuits - *Aluminum branch wiring has had a history of problems relating to poor connections due to galvanic corrosion, dissimilar metals, brittle conductors and type of aluminum alloy used during the time period of 1965 through 1972. These problems create unsatisfactory conditions at connections and splice locations and therefore create potential fire hazards. Recommend wiring update for aluminum wiring by a licensed electrician, Circuits are recommended to be upgraded with special compression type connectors at splices and branch circuits to reduce the potential risks of aluminum branch wiring.(Cop-Alum Crimp System)*

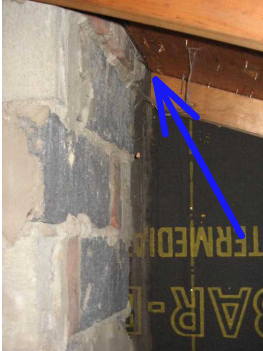
Marginal Roof Framing: 2x3/4 Truss - Wood blocking components missing at chimney perimeter

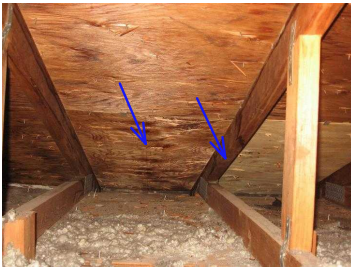
Marginal Sheathing: Plywood - Water stains and slight damage present, Areas of sheathing have been repaired

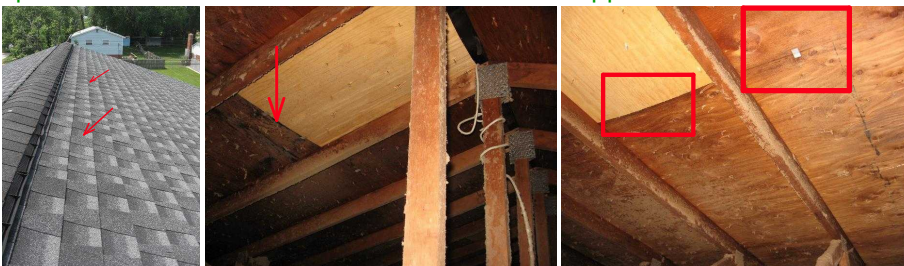
Marginal Sheathing: Plywood - Poor repair at 2 areas near ridge at rear slope - No H clips installed and repair only spanned one truss - Recommend additional support be installed

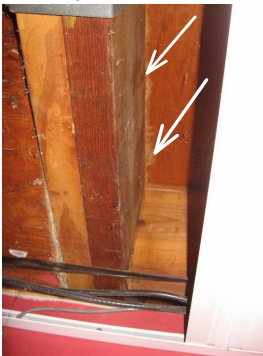
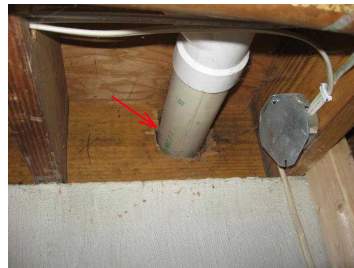
- Acceptable Structure Type: Wood frame
- Acceptable Foundation: Poured concrete
- Acceptable Differential Movement: Slight settlement present - Minor settlement at front porch, Cracks will require monitoring
- Acceptable Beams: Steel I-Beam
- Acceptable Bearing Walls: Wood frame
- Marginal Joists/Trusses: 2x10 - Areas not visible due to ceiling finishes or other obstructions, Framing joist near fireplace chimney shows evidence of previous termite infestation - No repairs required, Seal penetration as required

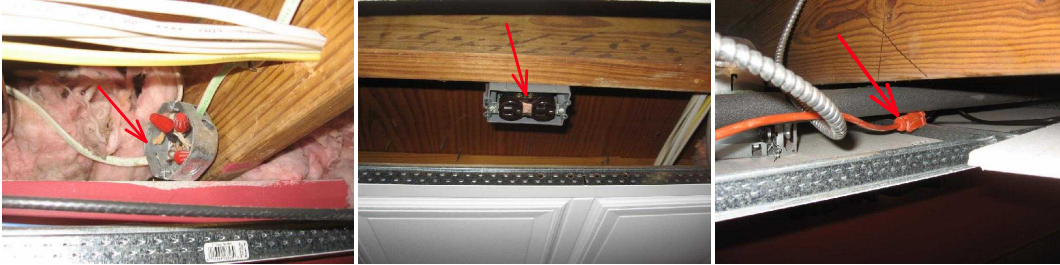
Marginal Electrical: 110 VAC - Loose junction boxes, missing and mis-sized covers, extension cord wiring to projector

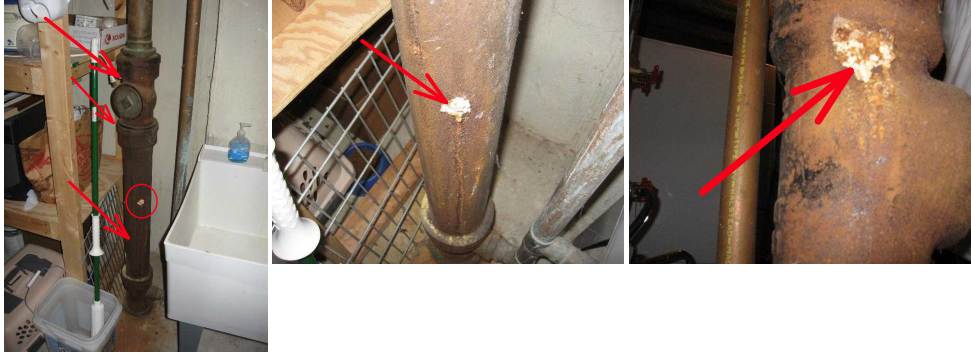
Acceptable Service Line: Copper
Acceptable Main Water Shutoff: Basement
Acceptable Water Lines: Copper
Defective Drain Pipes: Cast iron, Copper - **Pitting cast iron drain piping stack - replace affected sections where required**

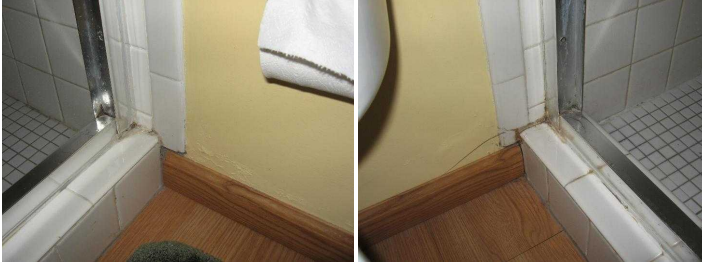
Marginal Shower/Surround: Ceramic tile - **Leaking at corner of door frame**

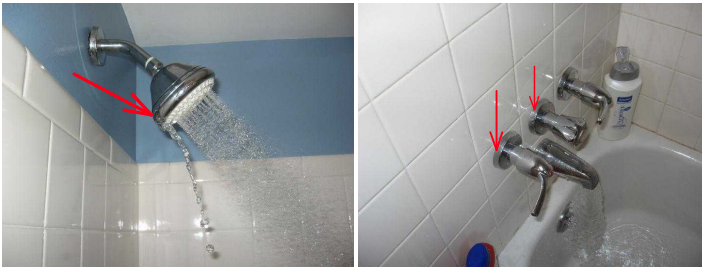
Marginal Closet: Large - **Alignment needed at closet doors**
Acceptable Ceiling: Drywall
Acceptable Walls: Drywall
Marginal Floor: Laminated flooring - **Gapping noted in planks**
Acceptable Doors: Hollow wood
Acceptable Windows: Vinyl Insulated
Acceptable Electrical: GFCI
Acceptable Counter/Cabinet: Wood
Acceptable Sink/Basin: One piece sink/counter top
Defective Faucets/Traps: Delta fixtures with a metal trap - **Leaking shower head, Loose trim rings**

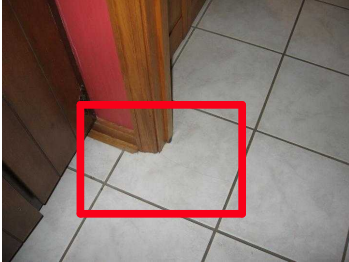
Acceptable Ceiling: Drywall
Acceptable Walls: Drywall
Marginal Floor: Ceramic tile - **Cracked tile noted**

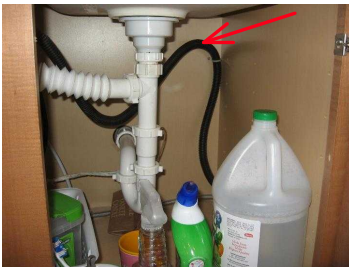
Acceptable Cooking Appliances: Frigidaire
Acceptable Disposal: General Electric
Marginal Dishwasher: Maytag - Properly secure the dishwasher discharge hose so that it creates a "high loop" above the basin drain to minimize food or water backup under dishwasher

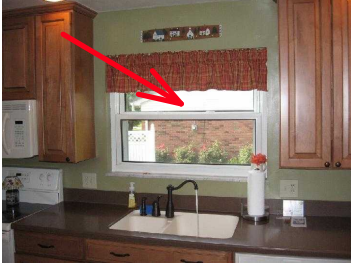
Acceptable Floor: Ceramic tile
Acceptable Doors: Hollow wood
Defective Windows: Vinyl Insulated - **Insulated glass unit seal failure**

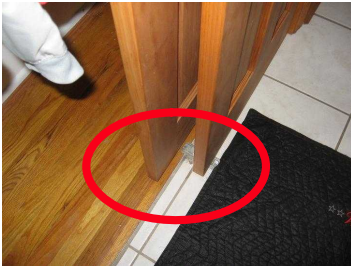
Marginal Closet: Various - **Missing door glides at bypass closet door in Foyer**

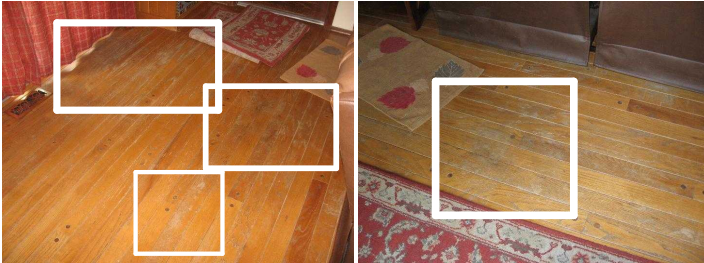
Acceptable Ceiling: Drywall
Acceptable Walls: Drywall
Marginal Floor: Ceramic tile, Carpet, Hardwood - **Worn wood finish in Family room**

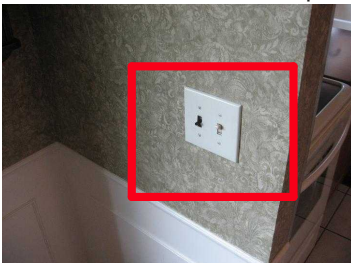
Acceptable Doors: Solid wood
Acceptable Windows: Vinyl Insulated
Acceptable Electrical: 110 VAC - Replace missing dimmer switch in Dining room
