30 Apr 2003

From: Customer Liaison Officer  
To: Quality Assurance Officer

Subj: FA-18 HYDRAULIC SYSTEM SERVICING

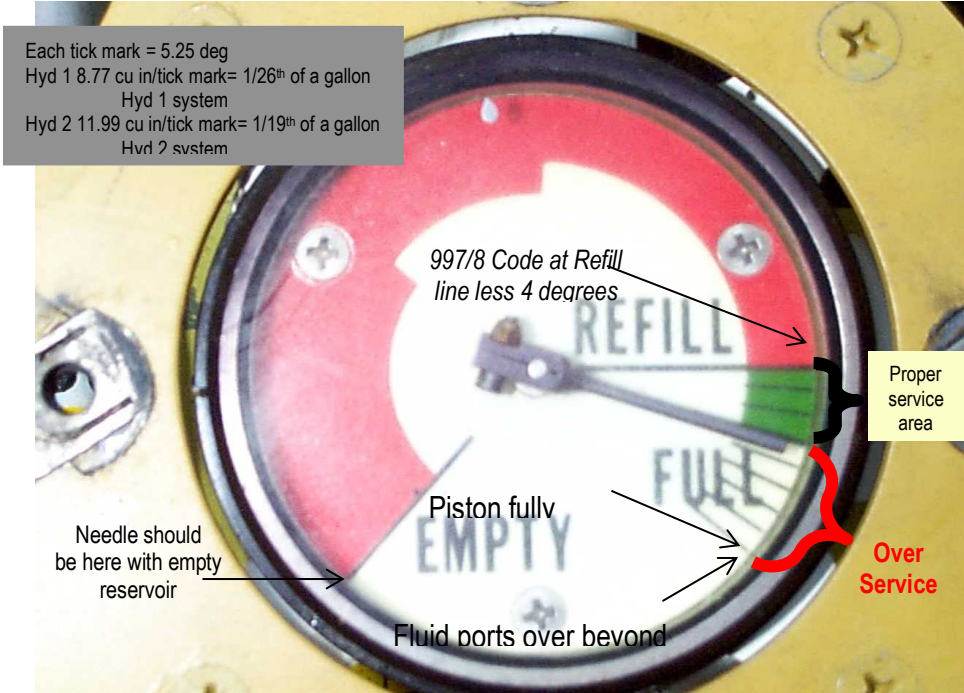
# Reservoir Level Gauge

- Air contamination detection can positively be identified by the following
  - Reservoir fluid level change before and after first engine start
    - Delta signifies free air content of system and each system can drop no more than the following amount:

- HS-1 = 1 tick mark
      - HS-2 = 3 tick marks
  - Flight control surface deflection without pressurized system
    - "...if the control surface deflects a few inches or more with not 'too much force' or 'effort', then there is need to do some further inspecting and/or air bleeding of the hyd system" (Ref (5)).

**Direct Cause:** 997 (Hyd 1 low) and 998 (Hyd 2 low) are the result of a mechanical interface that pops the code whenever the needle on the gauge dips below the Refill line less 4 degrees (slightly less than 1 tick mark which is 5.25 degrees).
