Confidential Inspection Report

LOCATED AT:
324 N June St
Los Angeles, California 90004

INSPECTED ON:
Tuesday, November 22, 2022

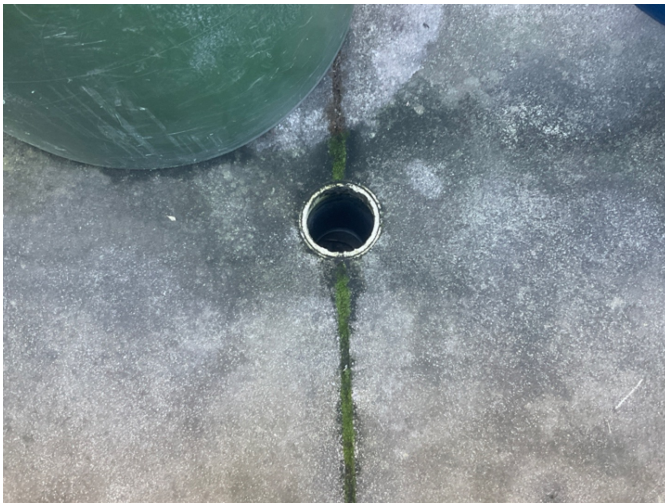
13: There are missing or broken area drain covers at the property area drains. This will allow leaves and other debris to enter the drain lines and possibly create blockages. It would be wise to have the lines flushed to their termination point and the broken covers replaced.

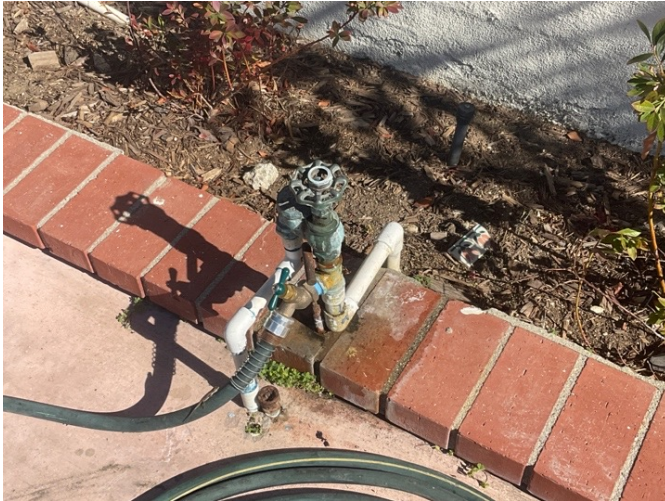
14: A shut off valve at the rear planter is leaking and will need repair or replacement.

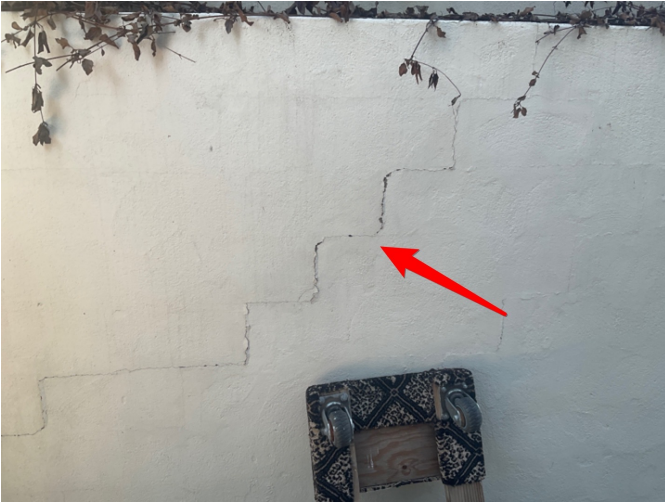
17: There are typical cracks or grout joint separations in the north side CMU yard walls. This is not uncommon and the walls are reasonably firm and not in any danger of falling at this time.

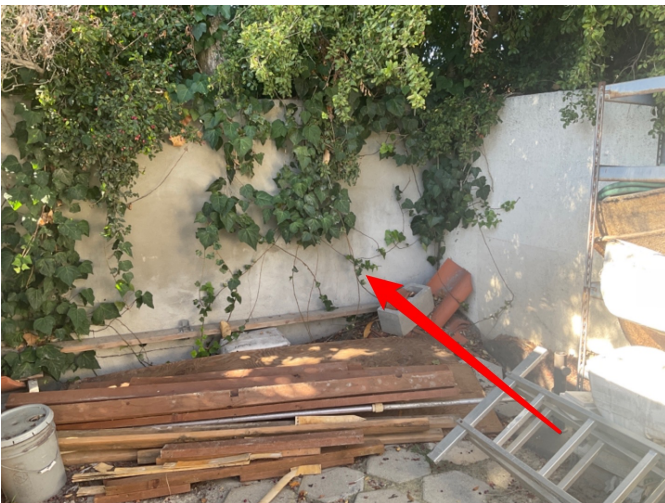
18: The rear CMU yard wall, behind the pool equipment, can be easily moved, and should be evaluated by a masonry contractor.

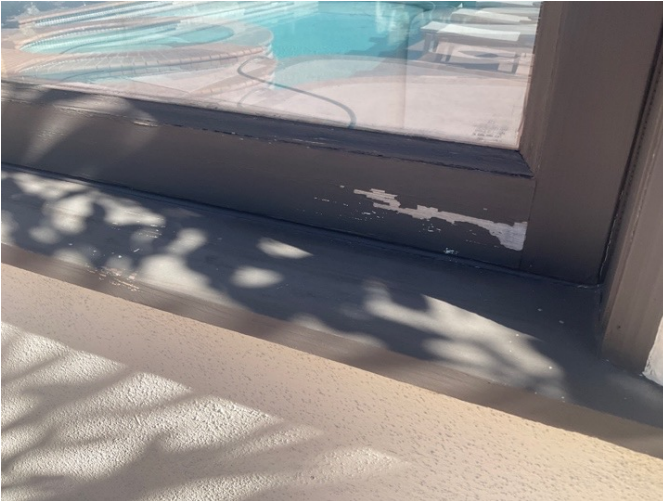
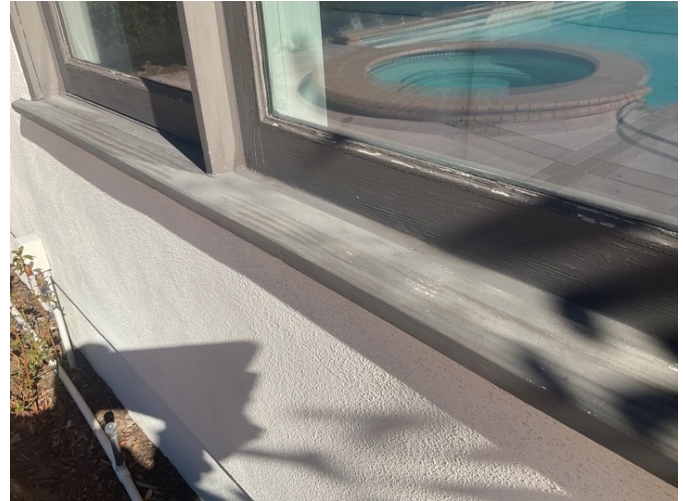
29: The windows are generally in poor condition with missing handles, water damage, and broken seals. They will likely require significant repair or possibly replacement in the near term.

30: The windows need painting or resealing.

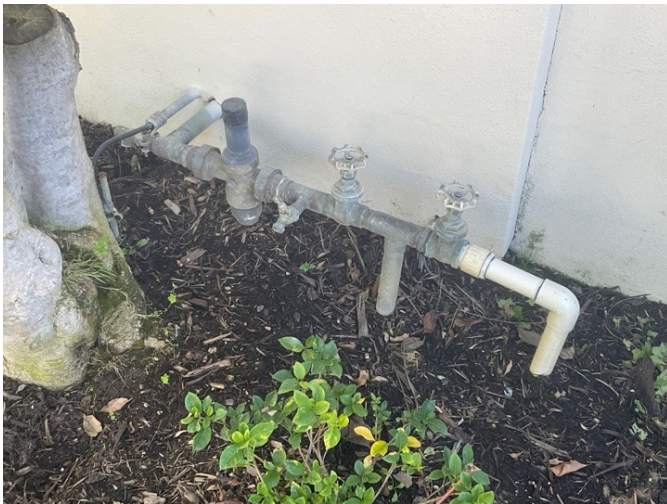
82: The main water shut-off valve is located at the front of the home.

83: The main shut off valve consists of a gate valve rather than the ball valve. Gate valves will deteriorate, rust, and freeze up over time. We recommend replacement as an upgrade in the near term.

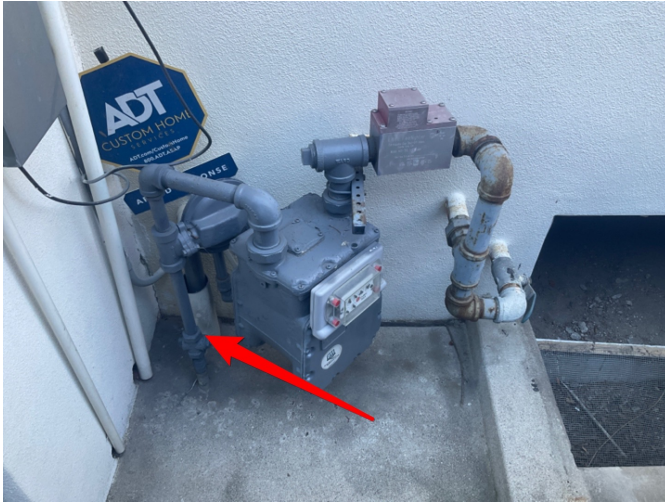
95: The gas main shut-off is located in the north sideyard.

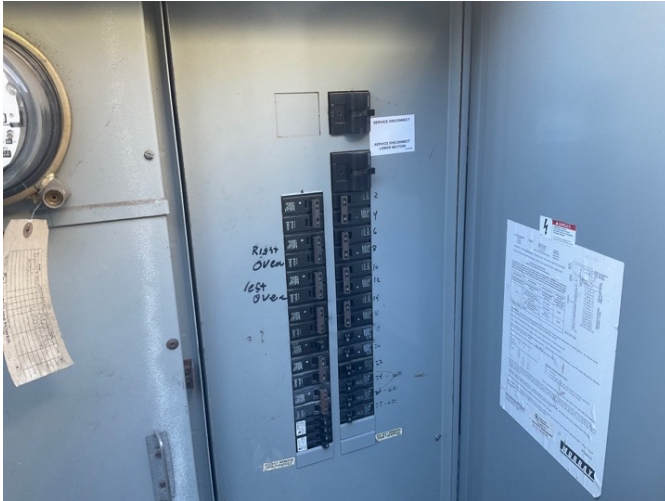
121: Various circuits within the main panel are not labeled but should be.

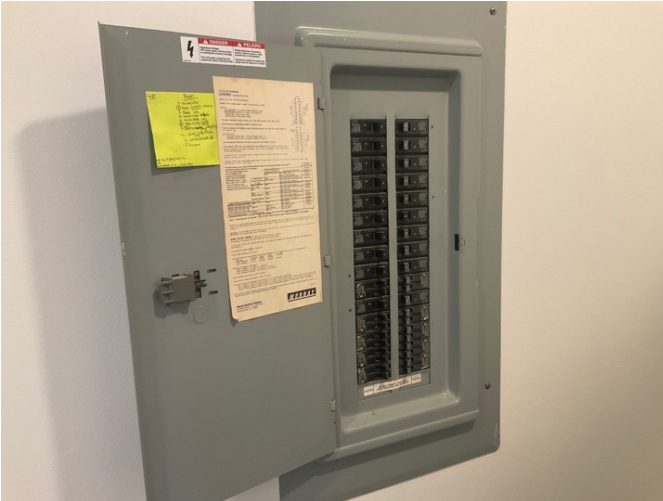
128: The electrical subpanel has no visible deficiencies.

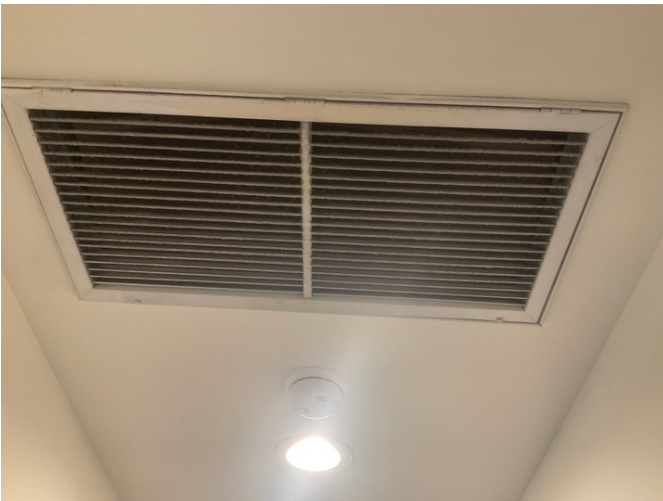
147: The filters are dirty and should be cleaned or replaced.

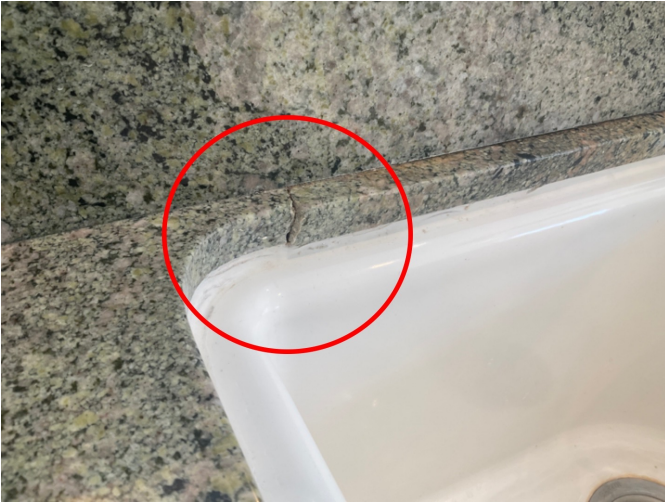
165: The sink countertop has cosmetic damage.

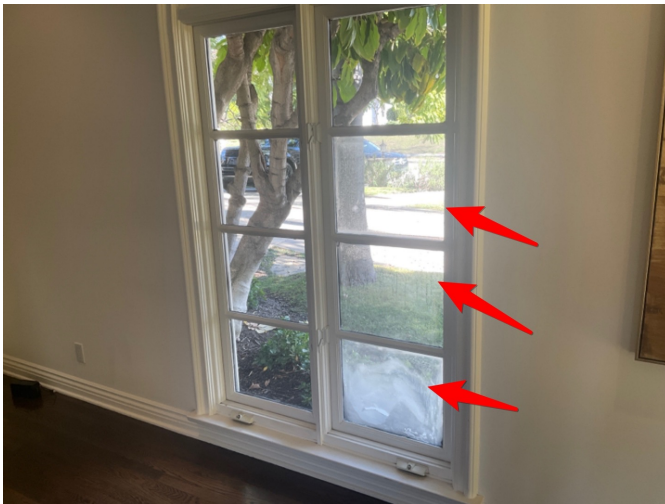
184: We were unable to test the windows where the crank handles are not installed. The windows should be fitted with crank handles and tested prior to the close of escrow.

185: Three dual-glazed windows have broken hermetic seals. As a result, condensation can be seen between the glass. Although cosmetic, replacement of the windows may be desired.

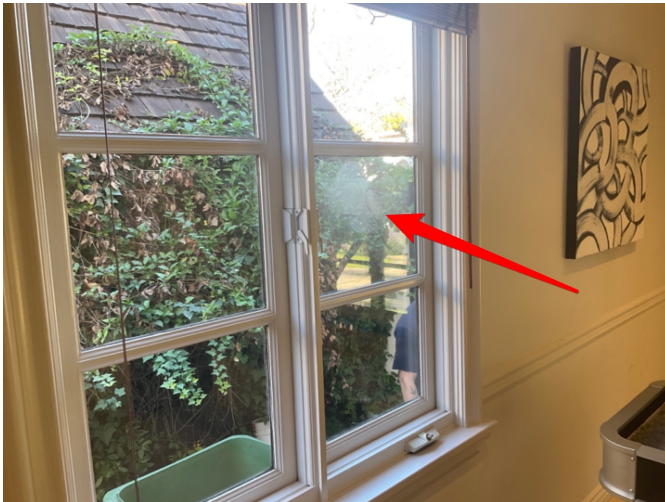
192: Three window cranks are missing.

193: One dual-glazed window has a broken hermetic seal. As a result, condensation can be seen between the glass. Although cosmetic, replacement of the window may be desired.

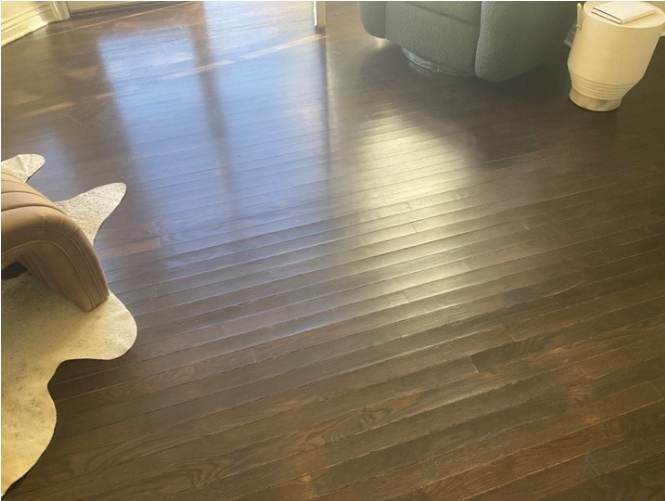
197: The wood floor is slightly cupped. This normally results when the wood is exposed to moisture, but it can also occur if the material was not properly acclimated to the area before installation. The condition of the material is considered minor at this time; however, the flooring should be monitored.

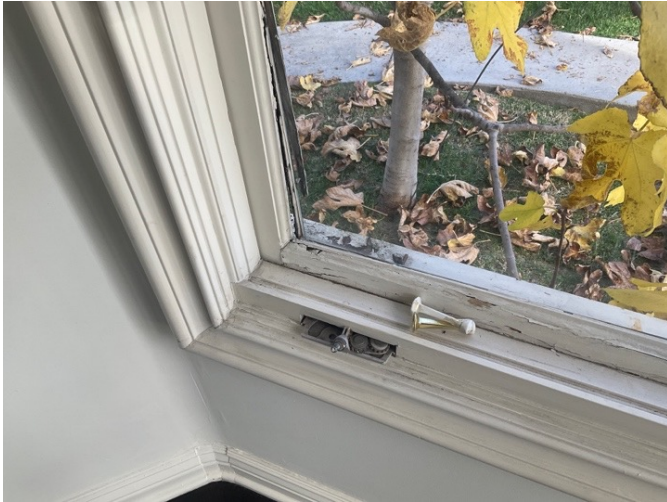
201: The window south window is degraded and will need service.

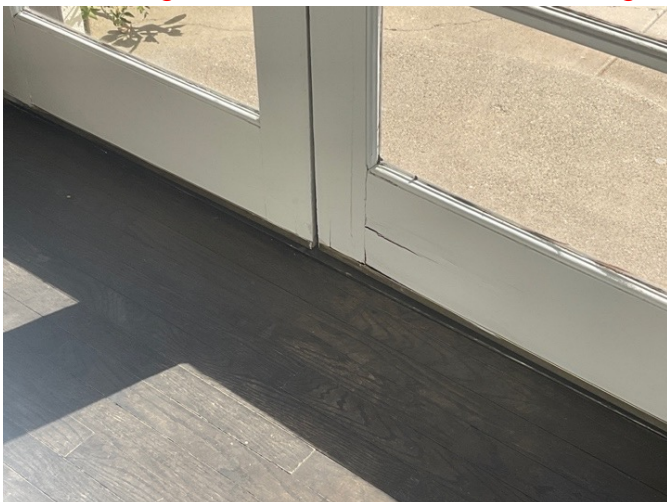
205: The double-keyed deadbolt at the exterior passage left side door should be removed and replaced with a thumb latch lock for emergency exit and rescue purposes.

206: The right side exterior doors are damaged.

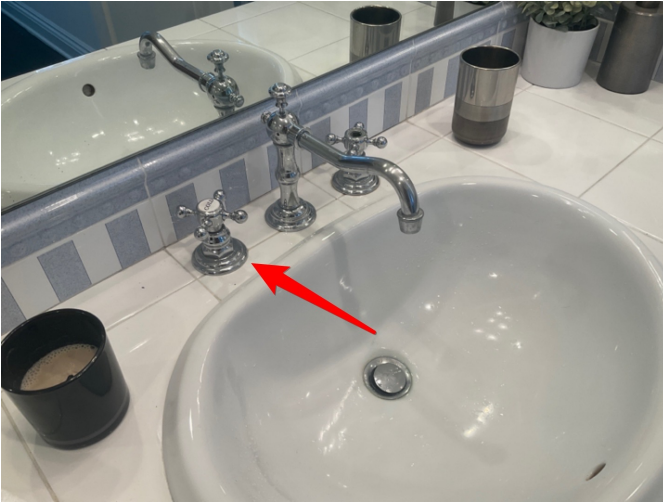
222: The hot sink faucet is loose and should be secured to prevent possible leakage.

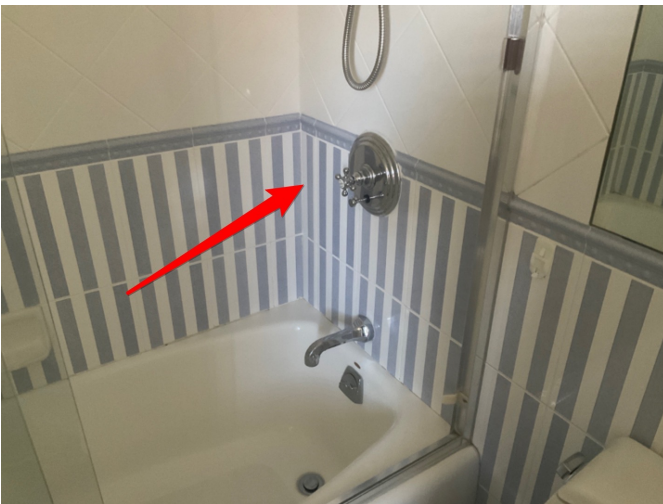
224: The faucet handle is loose.

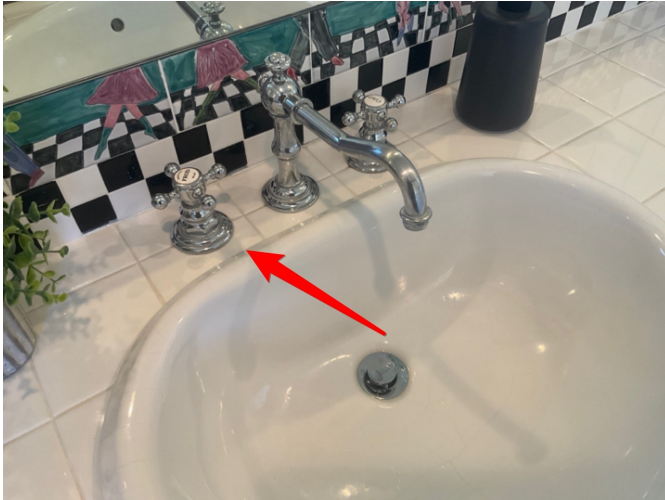
257: The hot water sink faucet is not functional.

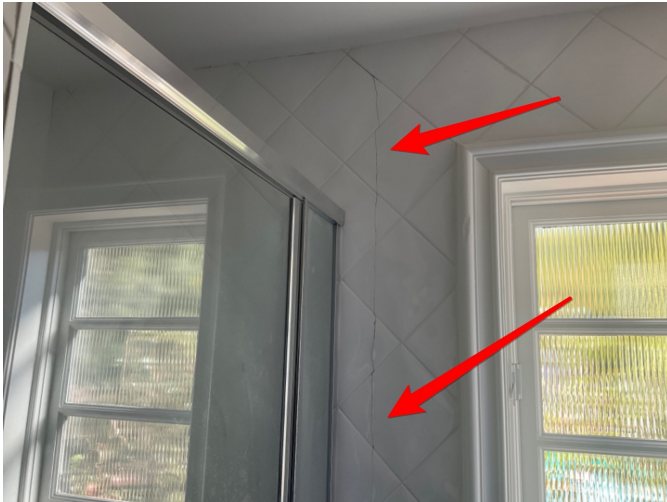
297: The wall tiles near the shower have cracks. This is likely the result of normal movement associated with minor settlement, wind or past earthquakes. Although cosmetic, you should be aware that such cracks can continue to reappear, particularly if they are not repaired correctly.

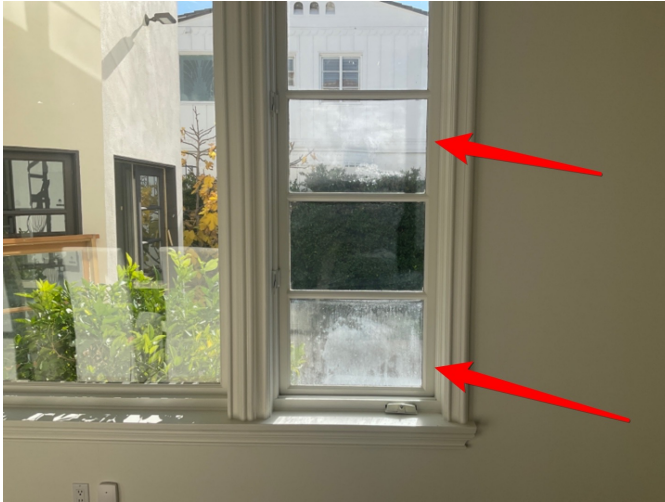
339: The windows need to be serviced to be openable.

340: Two dual-glazed windows are foggy and may have broken hermetic seals (condensation noted between panes). The windows will likely require replacement.

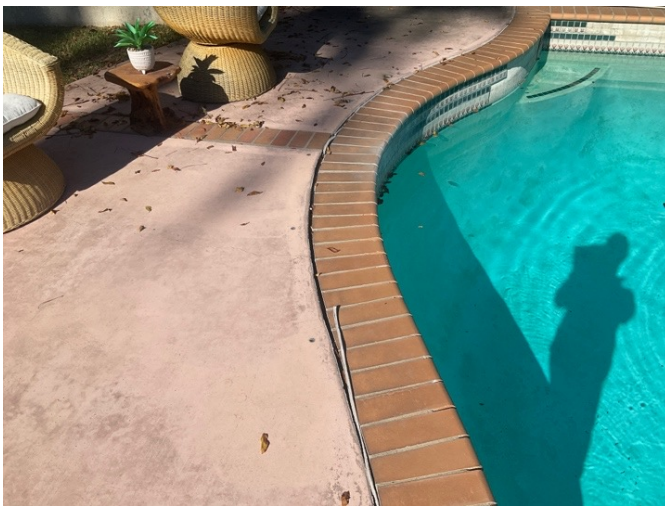
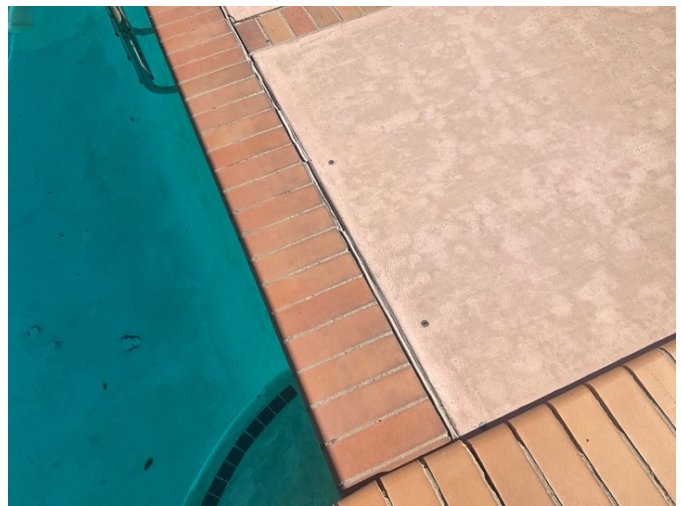
368: The pool deck is significantly cracked and lifted. The deck should be evaluated by a specialist and repaired or replaced.

369: The caulk in the expansion joint of the deck has deteriorated and cracked. This should be resealed to forestall moisture intrusion below the deck.

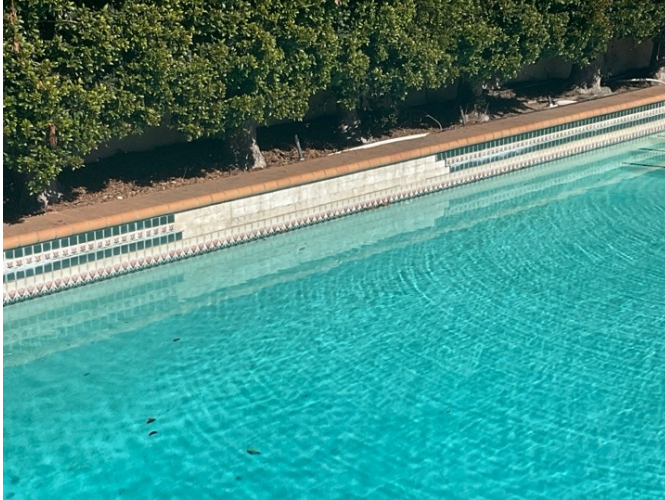
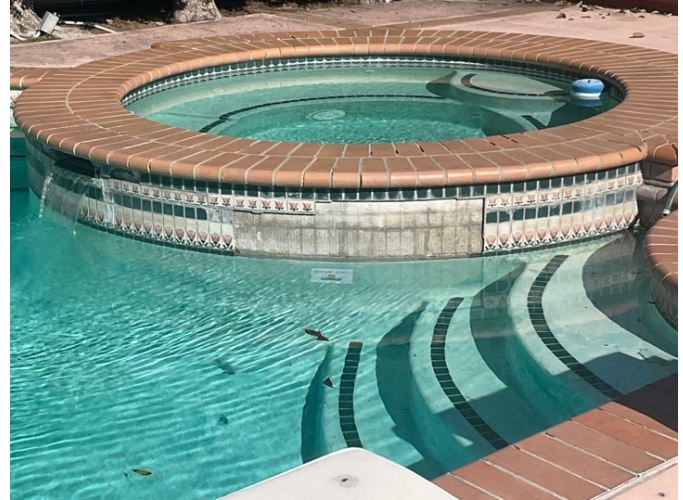
371: Several pool tiles are missing. You may wish to consult a pool contractor as replacement is needed.

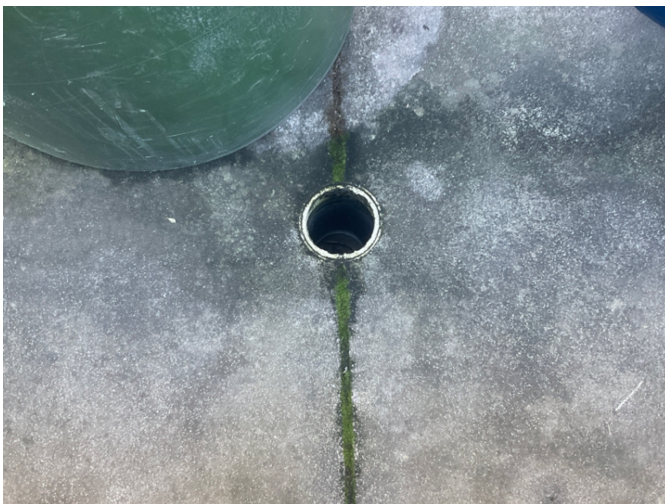
s-13: There are missing or broken area drain covers at the property area drains. This will allow leaves and other debris to enter the drain lines and possibly create blockages. It would be wise to have the lines flushed to their termination point and the broken covers replaced.

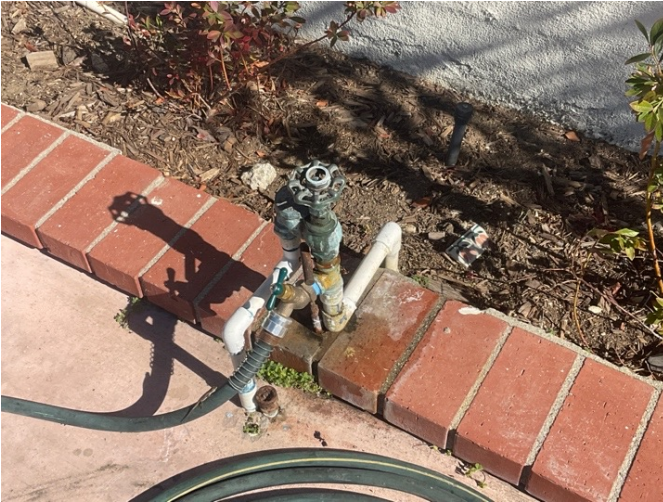
s-14: A shut off valve at the rear planter is leaking and will need repair or replacement.

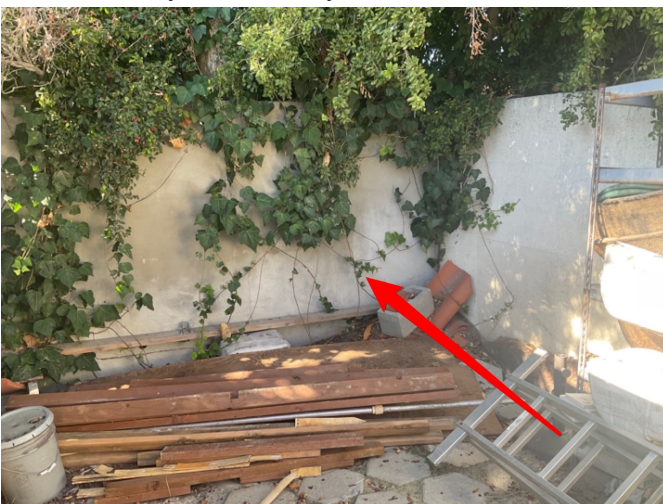
s-18: The rear CMU yard wall, behind the pool equipment, can be easily moved, and should be evaluated by a masonry contractor.

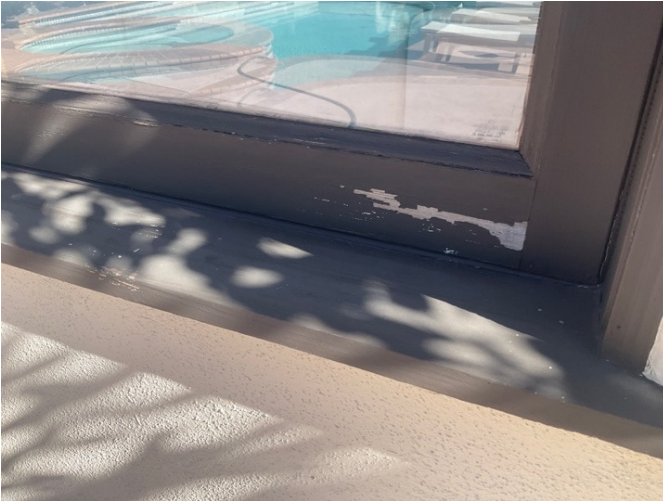
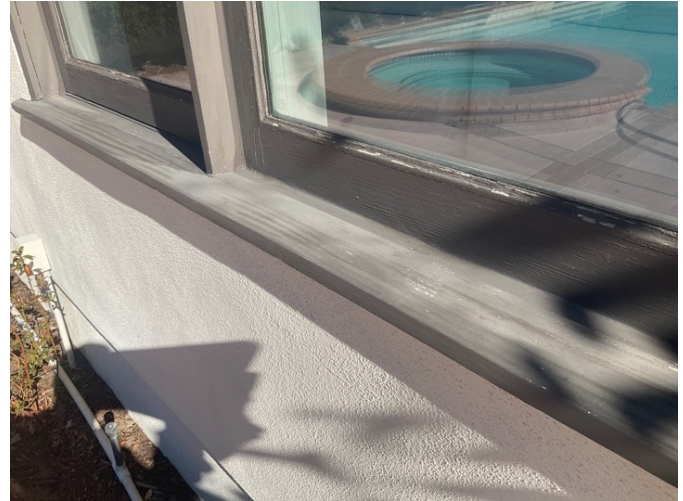
s-29: The windows are generally in poor condition with missing handles, water damage, and broken seals. They will likely require significant repair or possibly replacement in the near term.

s-30: The windows need painting or resealing.

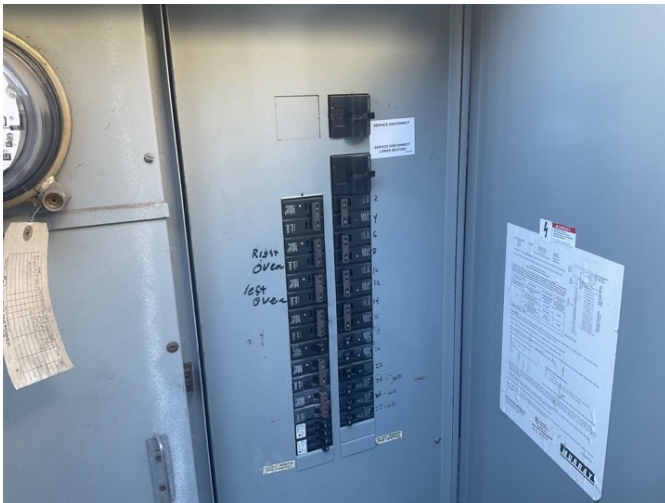
s-121: Various circuits within the main panel are not labeled but should be.

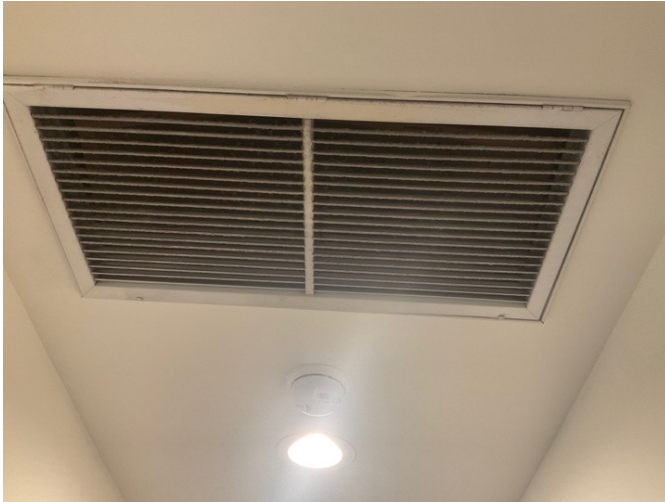
s-147: The filters are dirty and should be cleaned or replaced.

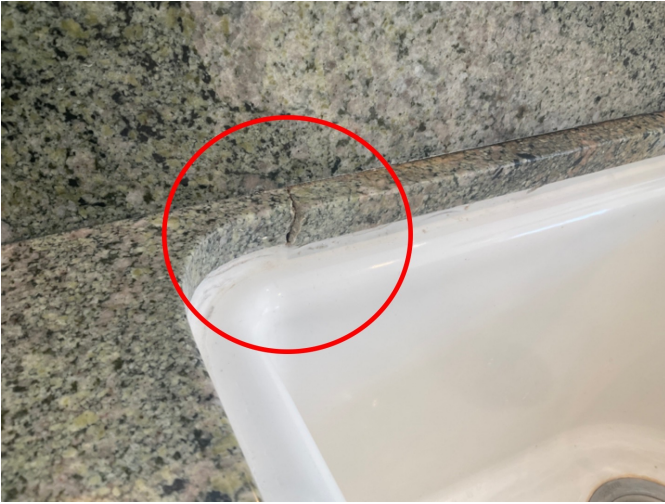
s-165: The sink countertop has cosmetic damage.

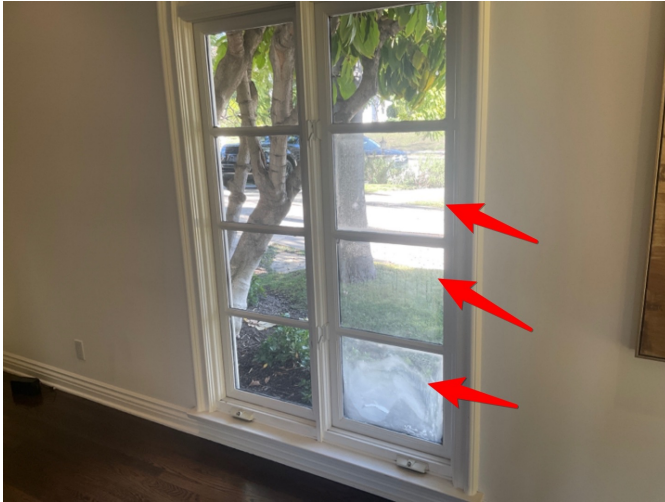
s-184: We were unable to test the windows where the crank handles are not installed. The windows should be fitted with crank handles and tested prior to the close of escrow.

s-185: Three dual-glazed windows have broken hermetic seals. As a result, condensation can be seen between the glass. Although cosmetic, replacement of the windows may be desired.

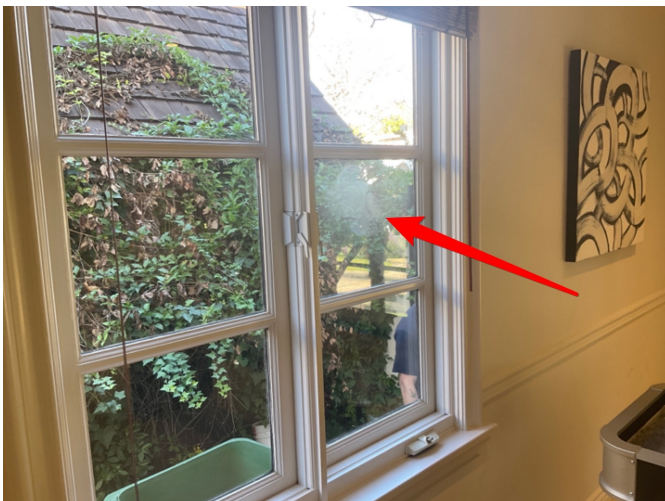
s-192: Three window cranks are missing.

s-193: One dual-glazed window has a broken hermetic seal. As a result, condensation can be seen between the glass. Although cosmetic, replacement of the window may be desired.

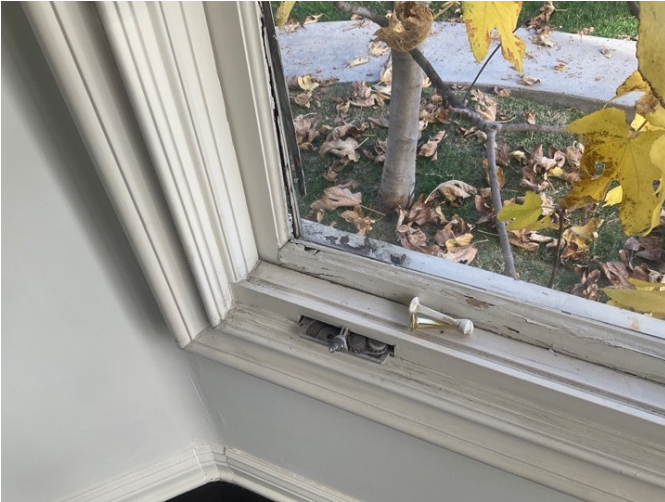
s-201: The window south window is degraded and will need service.

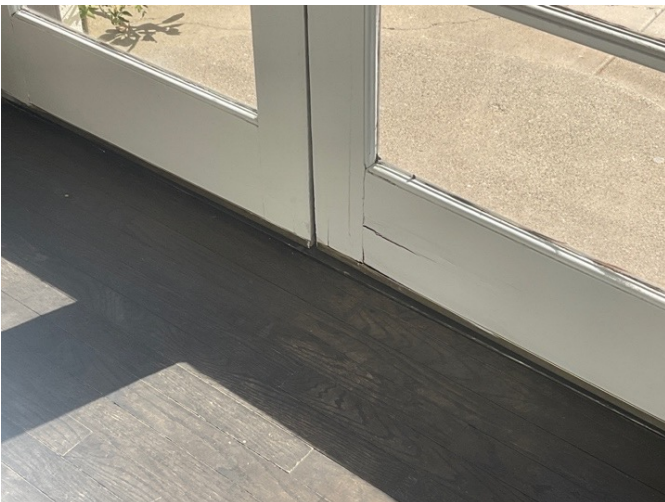
s-205: The double-keyed deadbolt at the exterior passage left side door should be removed and replaced with a thumb latch lock for emergency exit and rescue purposes.

s-206: The right side exterior doors are damaged.

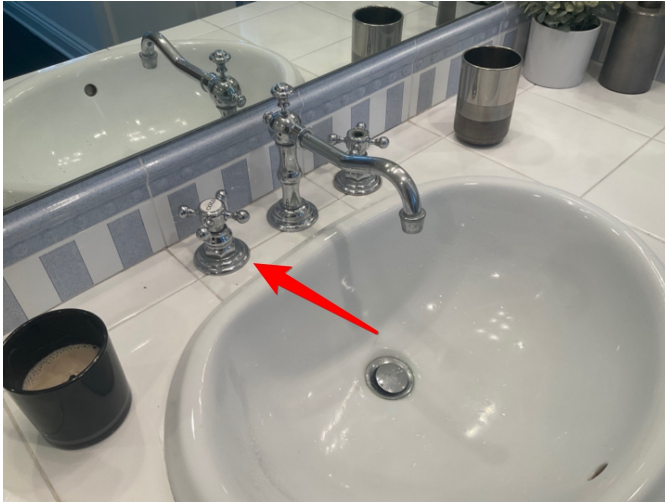
s-222: The hot sink faucet is loose and should be secured to prevent possible leakage.

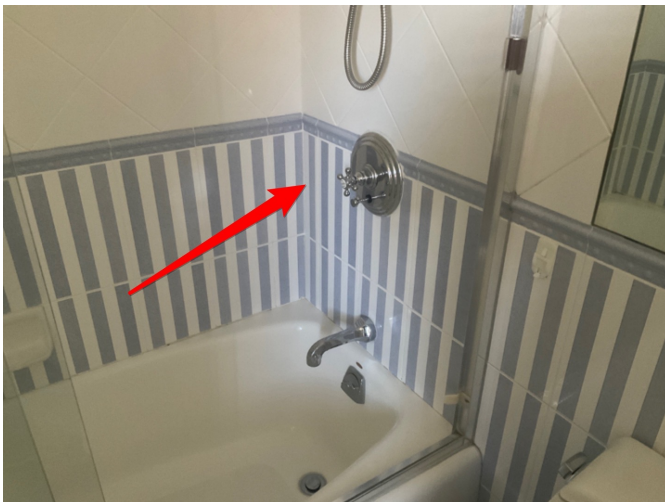
s-224: The faucet handle is loose.

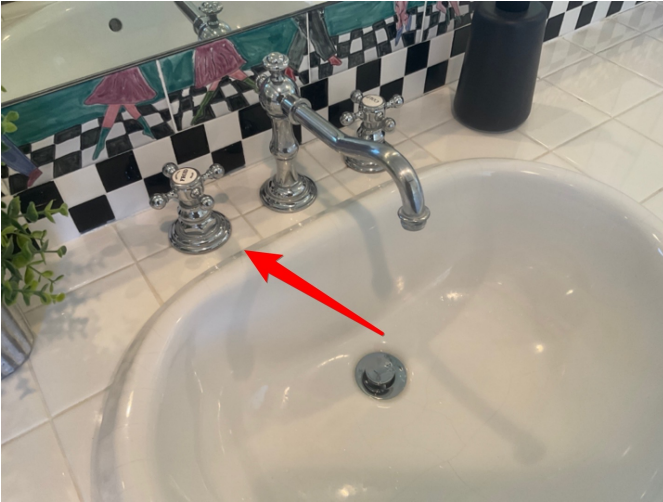
s-257: The hot water sink faucet is not functional.

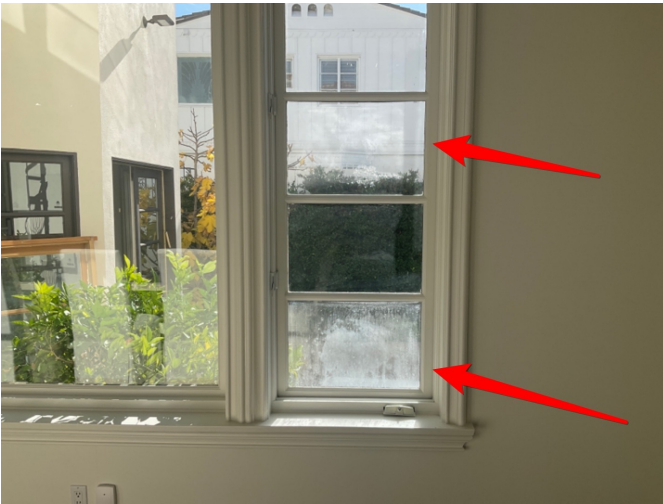
s-339: The windows need to be serviced to be openable.

s-340: Two dual-glazed windows are foggy and may have broken hermetic seals (condensation noted between panes). The windows will likely require replacement.

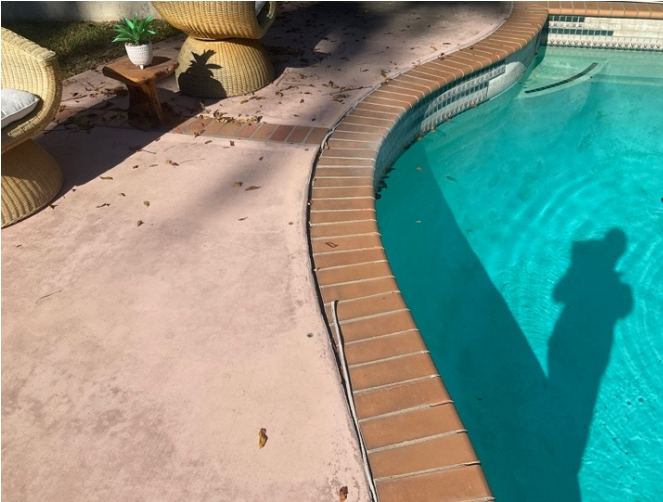
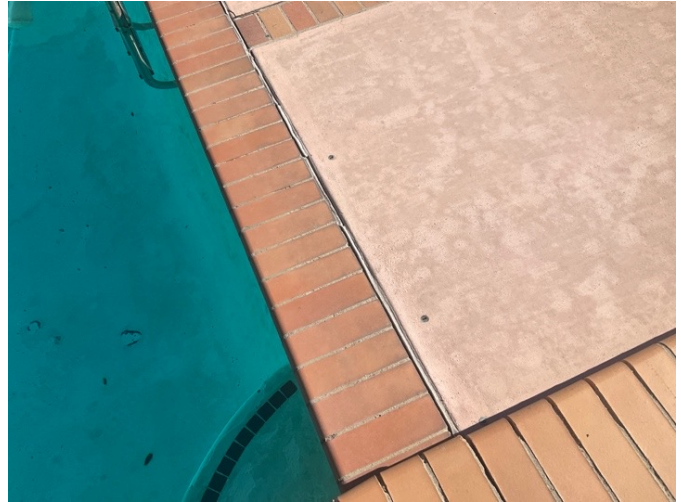
s-369: The caulk in the expansion joint of the deck has deteriorated and cracked. This should be resealed to forestall moisture intrusion below the deck.

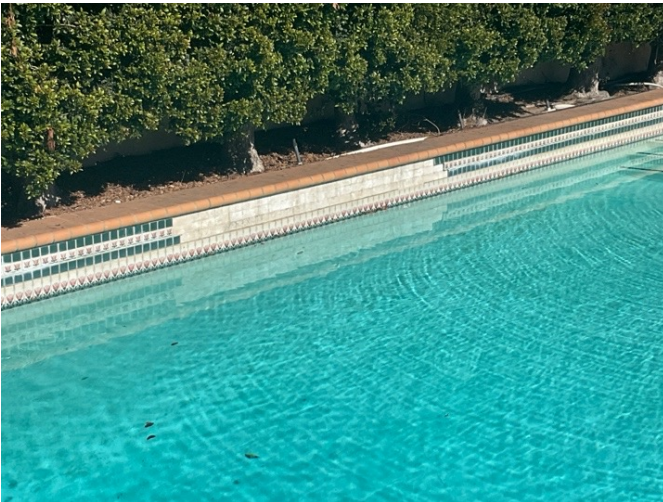
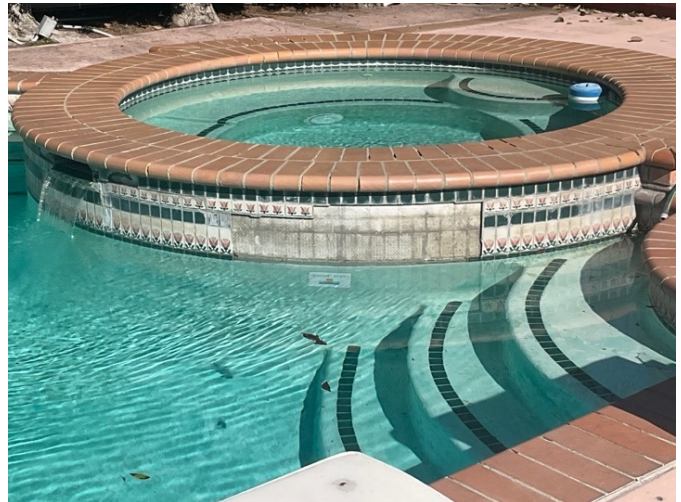
s-371: Several pool tiles are missing. You may wish to consult a pool contractor as replacement is needed.
