Complete Home Inspections LLC

Home Inspection Report

1234 Anywhere St
Anytown, Anystate 12345

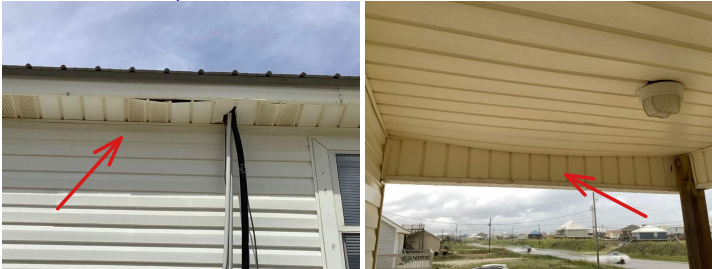
Soffits: Vinyl, Aluminum - **Loose; gapped around the AC lines and the end of the front porch (east side); recommend repair.**

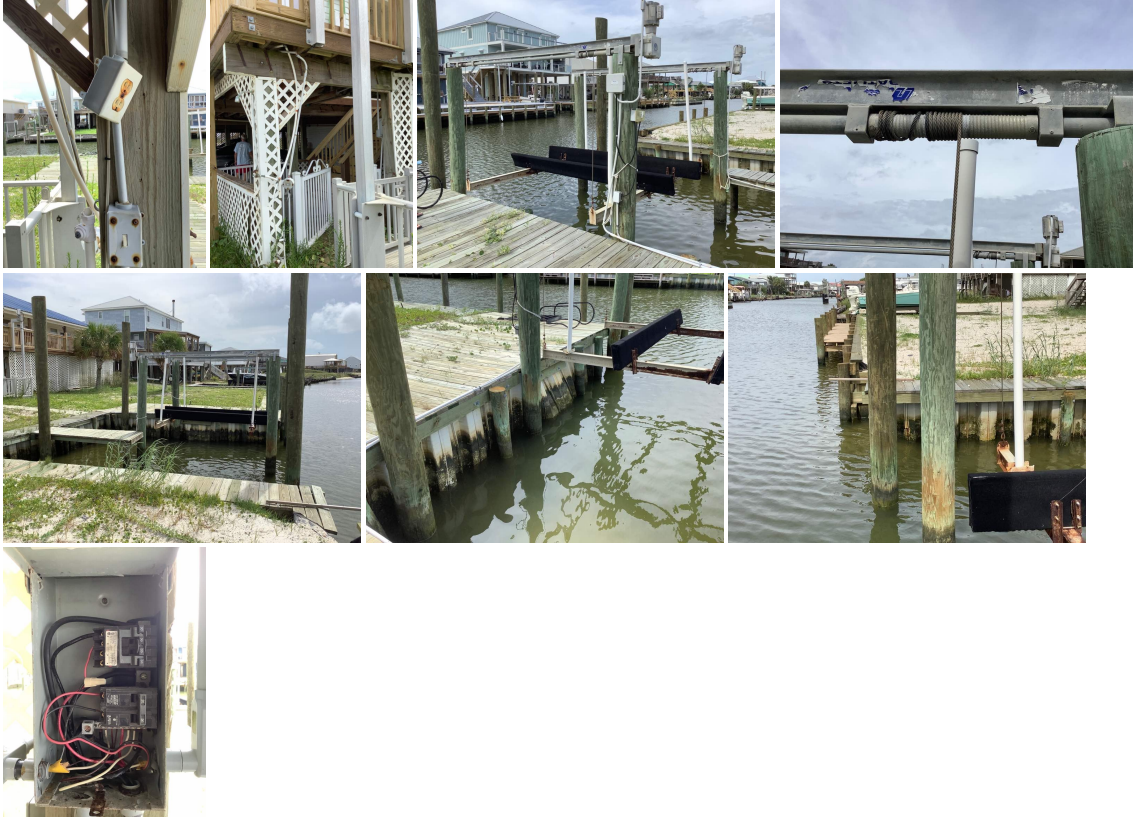
13. Defective Exterior Electric Outlets: 110 VAC GFCI - Loose wiring & steel guide cable to the house lift/ elevator. Steel cables to the boat lifts are cross threaded and are missing cable guides. Paneling/ Sheeting to the bulkhead in the dock/ lift bay is bowed outward from settling. Recommend the bulkhead, the boat lift and the house elevator to be professionally evaluated and repaired.

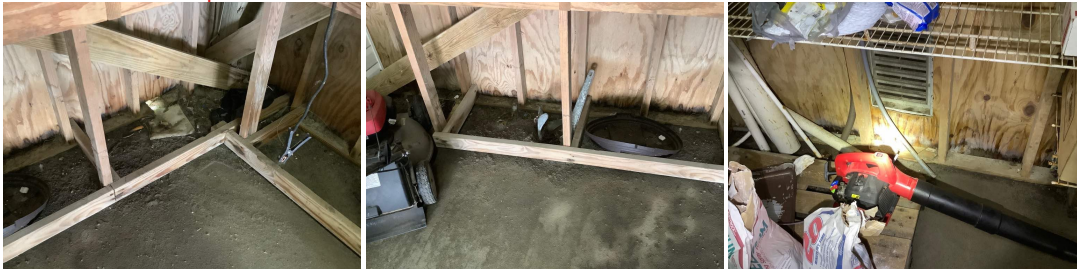
10. Defective Walls: Exposed framing - Evidence of frequent flooding; moisture damage noted; recommend professional evaluation and repair.

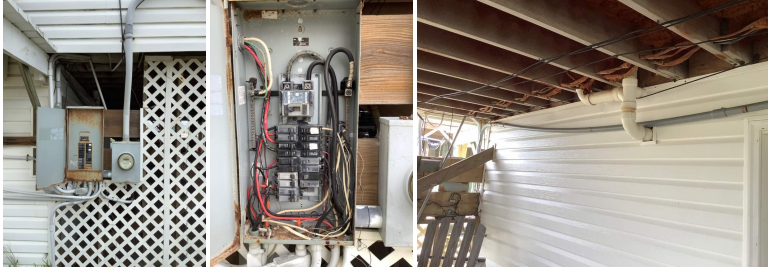
1. Service Size Amps: 200 Volts: 110-240 VAC
2. Acceptable Service: Copper - Support brackets for the house service feed are deteriorated; recommend repair.

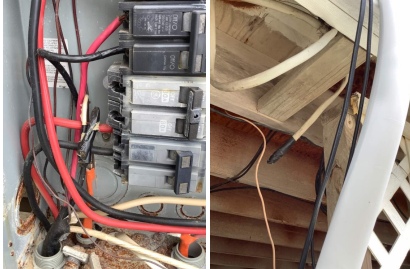
9. Acceptable Manufacturer: Cutler-Hammer
10. Maximum Capacity: 200 Amps
11. Acceptable Main Breaker Size: 200 Amps
12. Defective Breakers: Copper - **Loose/ disconnected wiring noted; not in service. Recommend wiring to be removed.**

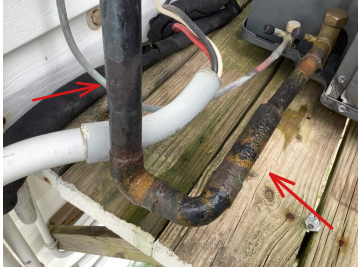
10. Marginal Refrigerant Lines: Low pressure and high pressure - **Insulated sheathing is damaged; recommend be replaced**

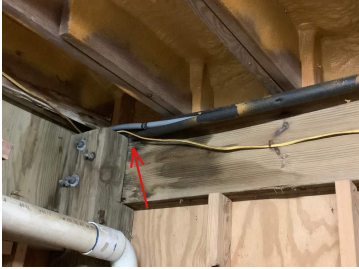
Water Lines: Polybutelene, ABS - Evidence of previous leakage; poly-butylene noted in the carport; recommend professional evaluation and repair.

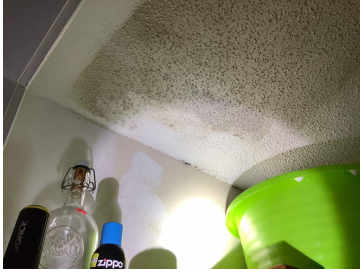
18. Defective Ceiling: Sheetrock - Ceiling is stained and mildewed from a previous leak from the vent stack; recommend the damaged wallboard to be repaired/ replaced.

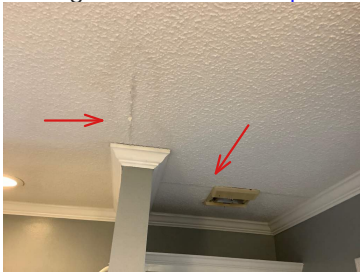
32. Not Present Closet:
33. Marginal Ceiling: Sheet - Cracks present; recommend repair.

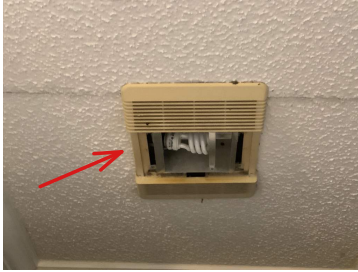
47. Marginal Ventilation: Electric ventilation fan and window - [Cover for the ceiling fan to the guest bathroom needs repair.](#)

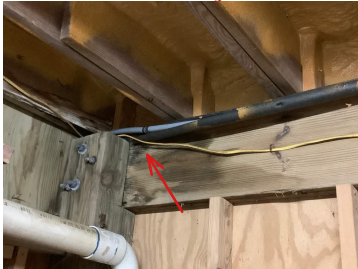
1. Acceptable Cooking Appliances: General Electric
2. Acceptable Ventilator: General Electric
3. Acceptable Disposal: In-Sinkerator
4. Acceptable Dishwasher: Whirlpool
5. Air Gap Present? Yes
6. Not Present Trash Compactor:
7. Acceptable Refrigerator: General Electric
8. Acceptable Microwave: General Electric
9. Acceptable Sink: Porcelain Coated
10. Acceptable Electrical: 110 VAC GFCI
11. Defective Plumbing/Fixtures: Poly-Butylene, PVC - **The house is about 80% plumbed with Poly-Butylene piping which has a noted history of failure & litigation. recommend a consultation with a licensed plumbing professional.**

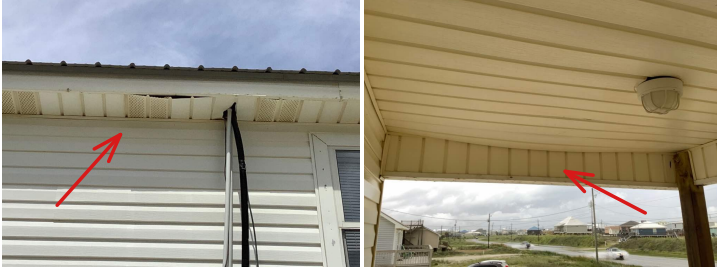
1. Soffits: Vinyl, Aluminum - [Loose; gapped around the AC lines and the end of the front porch \(east side\); recommend repair.](#)

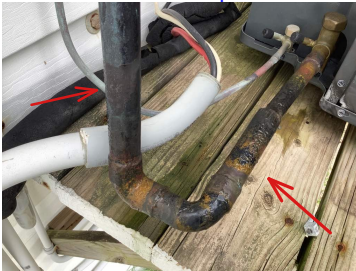
2. Attic Heat Pump AC System Refrigerant Lines: Low pressure and high pressure - [Insulated sheathing is damaged; recommend be replaced](#)

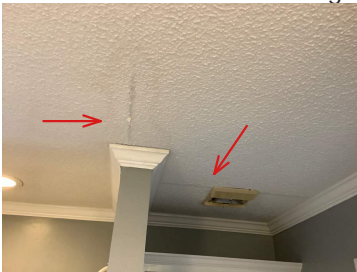
6. Master; main floor Bathroom Windows: Aluminum slider - [Tension springs are disconnected; recommend repair.](#)
7. Guest bath Bathroom Ceiling: Sheet - [Cracks present; recommend repair.](#)

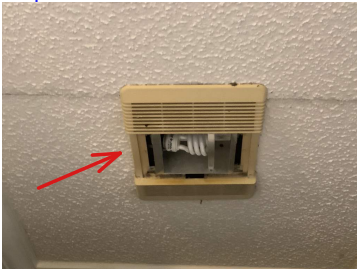
8. Guest bath Bathroom Ventilation: Electric ventilation fan and window - [Cover for the ceiling fan to the guest bathroom needs repair.](#)

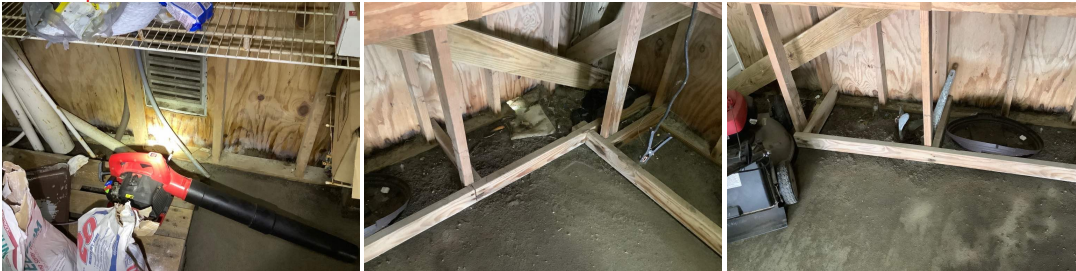
1. Grading: Moderate slope - **Improper soil slope towards foundation, recommend the addition of fill dirt to improve grade**
2. Swale: Adequate slope and depth for drainage - **Evidence of water pooling under the house/ carport due to flat grade and lack of swale; wall paneling and framing are moisture damaged from frequent flooding. Recommend professional evaluation and repair.**

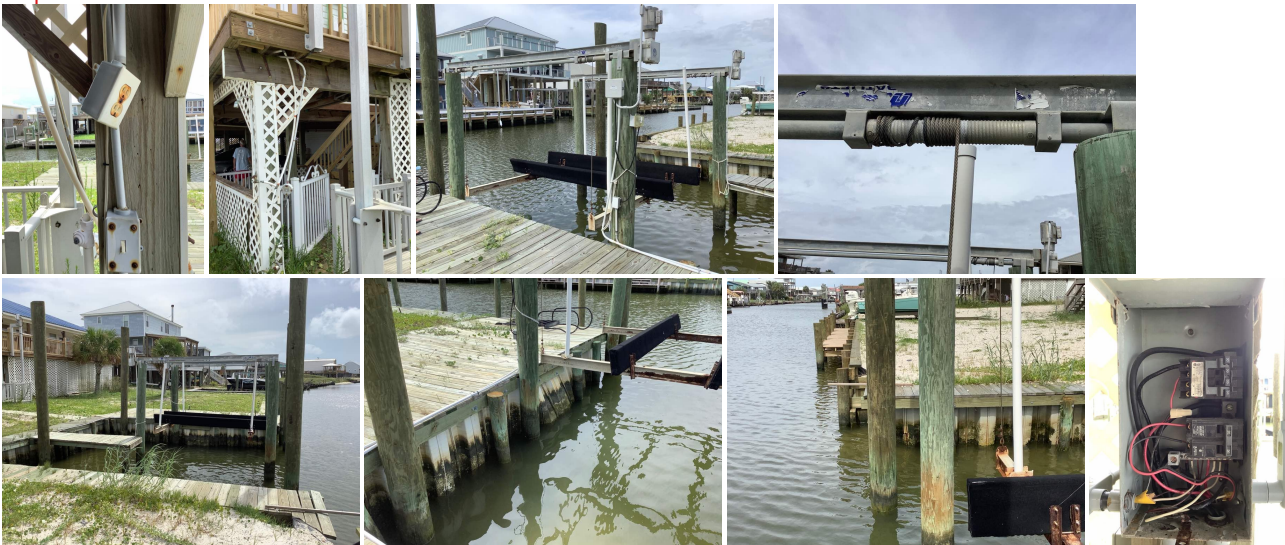
4. Exterior Electric Outlets: 110 VAC GFCI - **Loose wiring & steel guide cable to the house lift/ elevator. Steel cables to the boat lifts are cross threaded and are missing cable guides. Paneling/ Sheeting to the bulkhead in the dock/ lift bay is bowed outward from settling. Recommend the bulkhead, the boat lift and the house elevator to be professionally evaluated and repaired.**

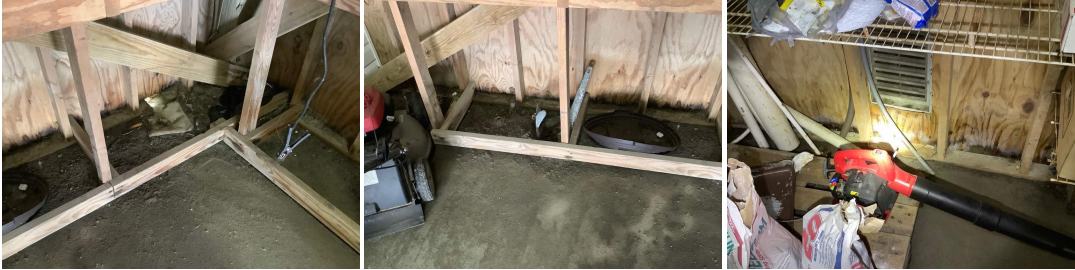
5. Parking under the house Garage Walls: Exposed framing - Evidence of frequent flooding; moisture damage noted; recommend professional evaluation and repair.

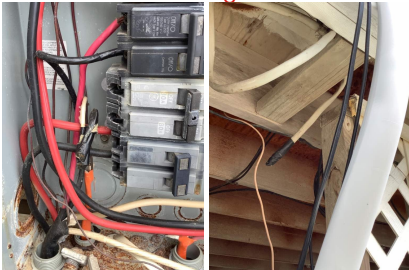
7. Ground: None present - No grounding rod present; recommend professional evaluation and repair.
8. West side of the house; exterior Electric Panel Breakers: Copper - Loose/ disconnected wiring noted; not in service. Recommend wiring to be removed.

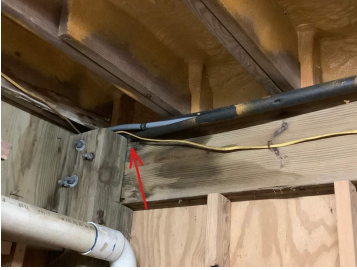
10. Water Lines: Polybutelene, ABS - Evidence of previous leakage; poly-butylene noted in the carport; recommend professional evaluation and repair.

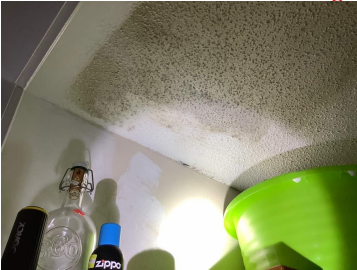
11. Master; main floor Bathroom Ceiling: Sheetrock - Ceiling is stained and mildewed from a previous leak from the vent stack; recommend the damaged wallboard to be repaired/ replaced.

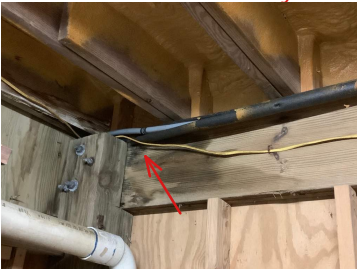
13. Main floor Kitchen Plumbing/Fixtures: Poly-Butylene, PVC - The house is about 80% plumbed with Poly-Butylene piping which has a noted history of failure & litigation. recommend a consultation with a licensed plumbing professional.
