CONEJOS RIVER

DIVERSION INFRASTRUCTURE INVENTORY

Structure Name: BALL BROS OVERFLOW NO 1

Date: April 16, 2019

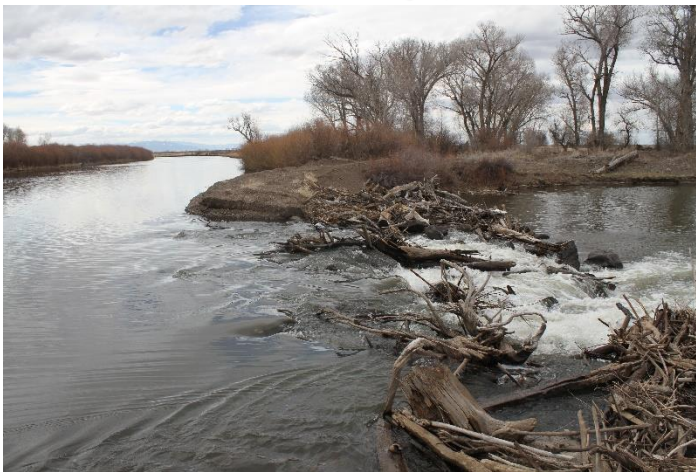
Diversion dam looking upstream

Structure Description: This structure is located approximately 1.2 miles upstream of County Rd 28 and is the last structure on the Conejos River before its confluence with the Rio Grande. It is located approximately 0.4 miles downstream of a secondary channel which receives water during high flows. If the secondary channel is captured by the river, this structure would likely be affected. Some lateral channel migration has occurred upstream of the diversion, which is located on the outside of a meander in the river, near its apex. A stacked boulder diversion dam with soil fill directs water to a short feeder channel on the south side of the channel. The diversion dam forms a barrier to fish passage, especially at low flows. It also accumulates woody debris and requires regular maintenance.

Repair(s) or Improvement(s) Currently Needed: The SMP Technical Advisory Team (TAT) recommends improving or replacing the diversion. A new diversion would function better for water users, allow sediment and debris to pass through this point in the river, and be less vulnerable to failure during high flows. The TAT also recommends incorporating fish passage into any diversion improvements to increase aquatic habitat connectivity.
