CONEJOS RIVER

DIVERSION INFRASTRUCTURE INVENTORY

Structure Name: LOS SAUCES D

Date: April 16, 2019

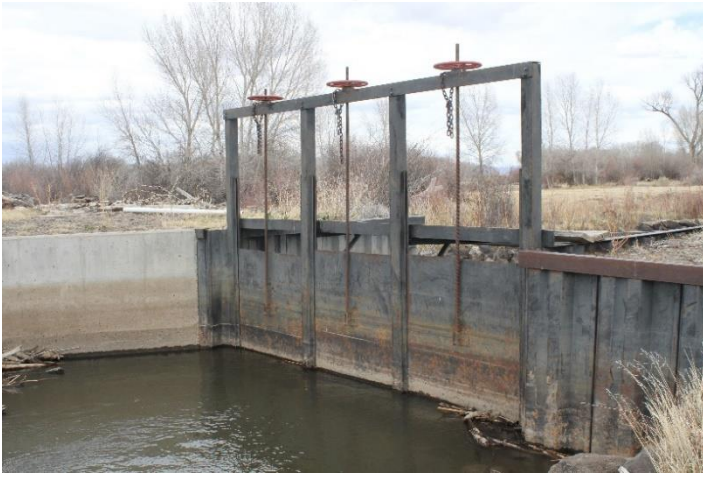
Headgate looking downstream

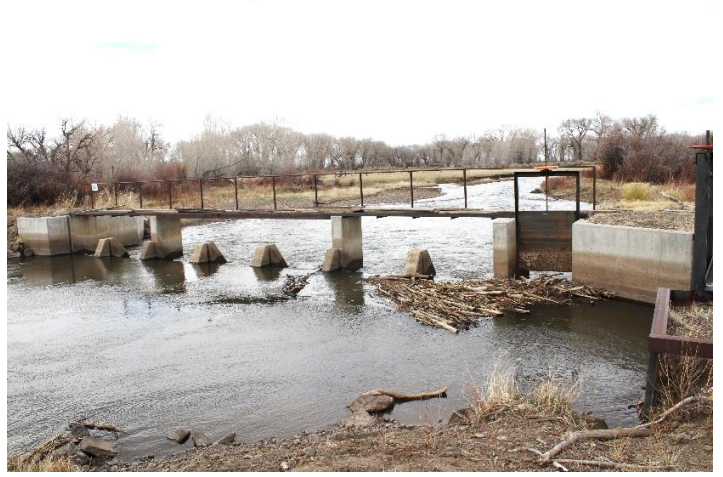
Headgate and diversion dam

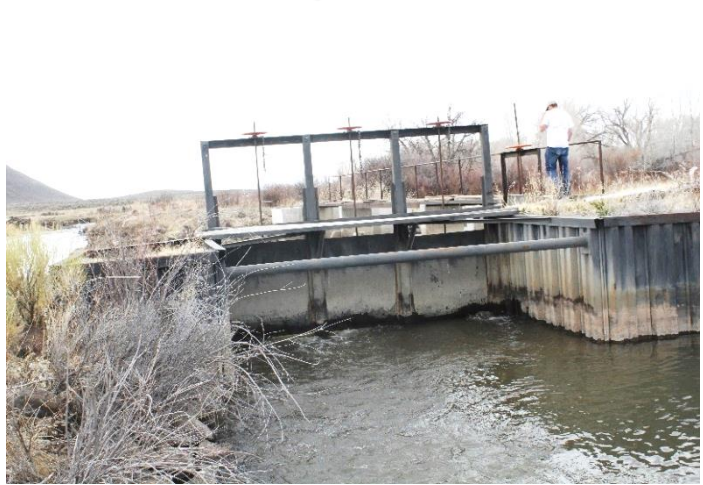
Headgate outlet

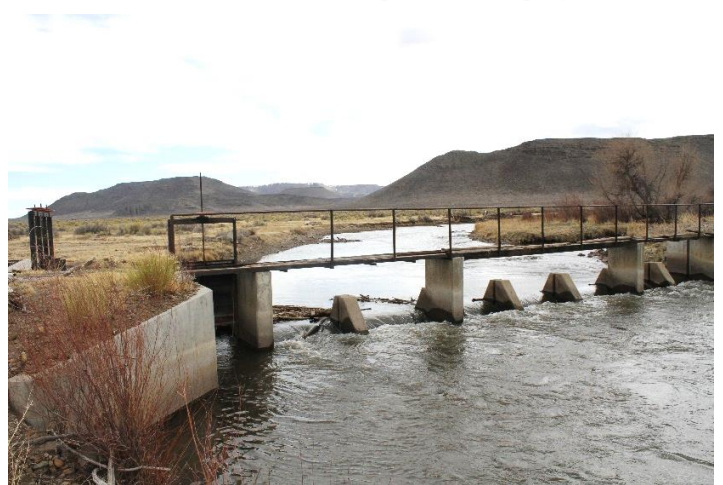
Diversion dam and headgate looking upstream

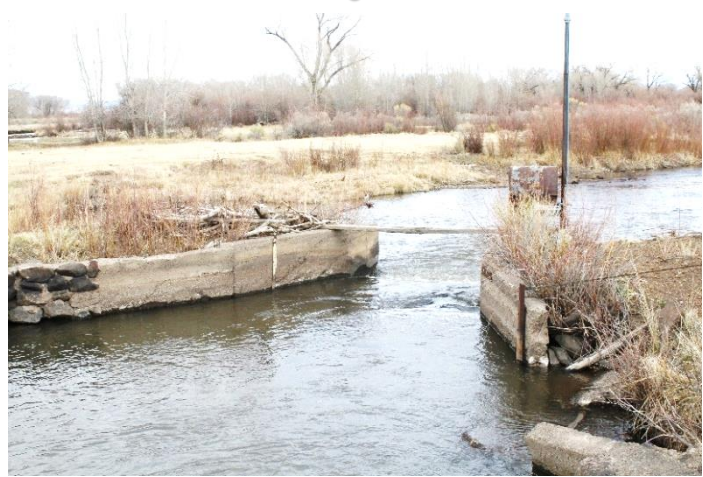
Flume looking downstream

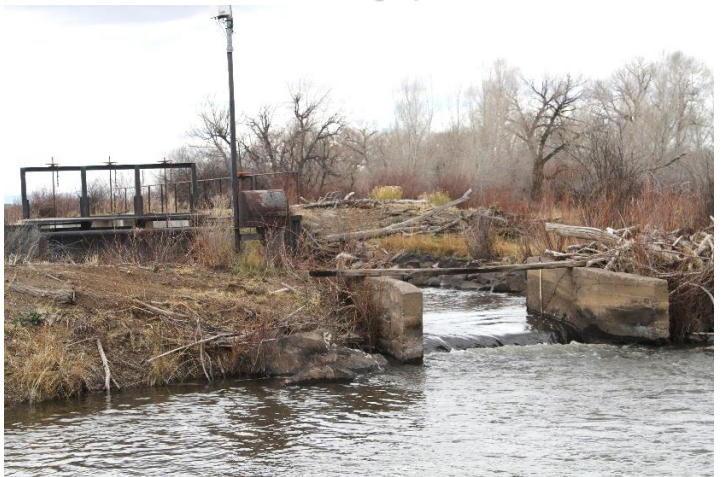
Flume looking upstream

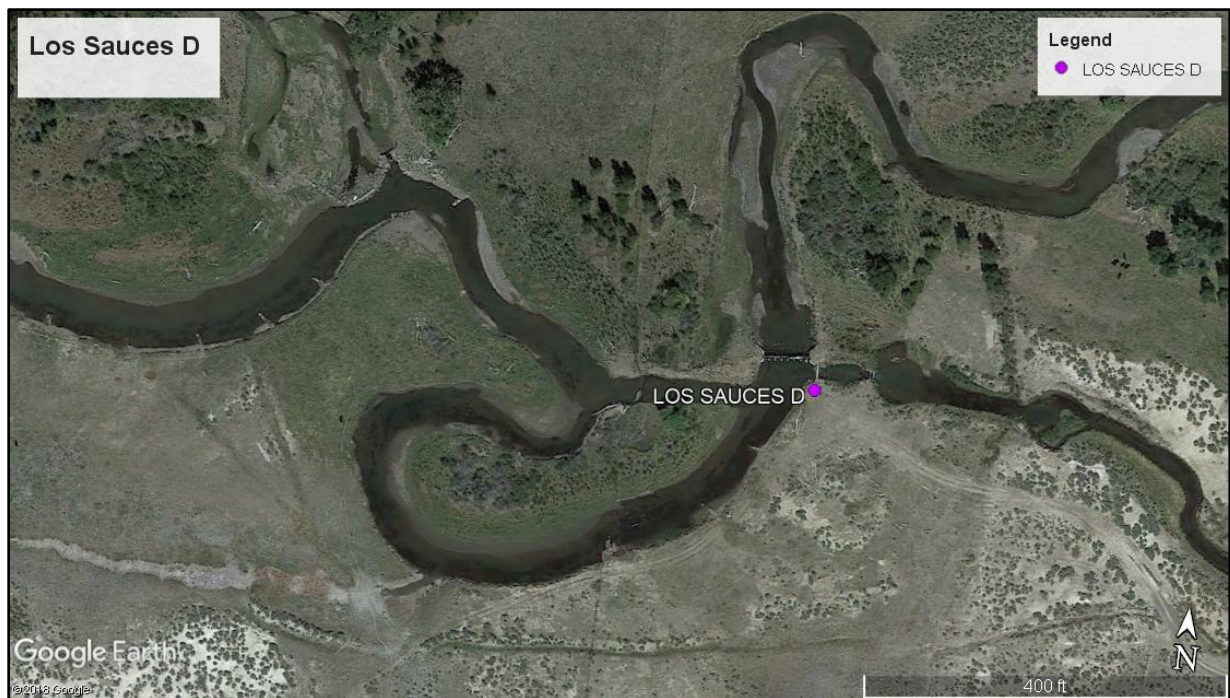
River upstream of Los Sauces Ditch, showing j-hooks.

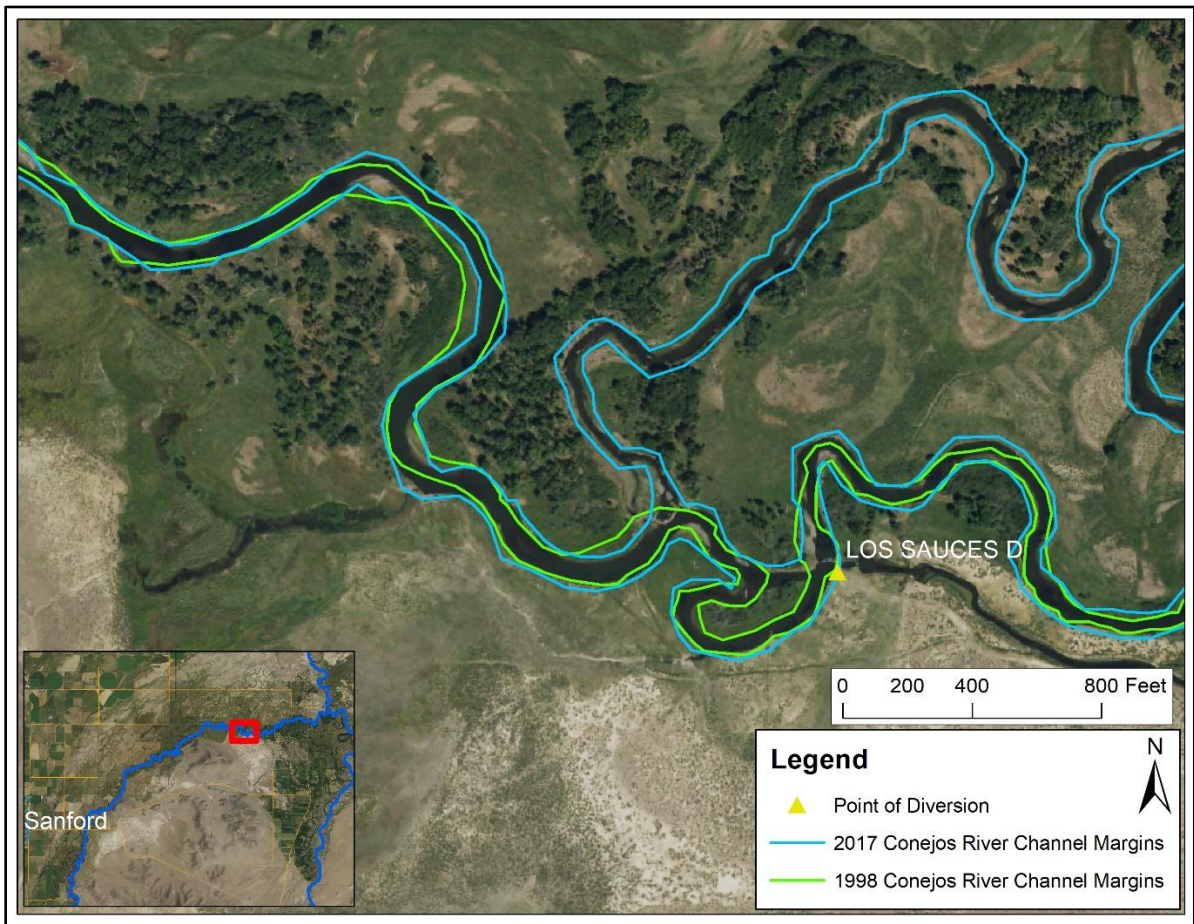
Map of headgate location with 1998 and 2015 channel margins overlaid.

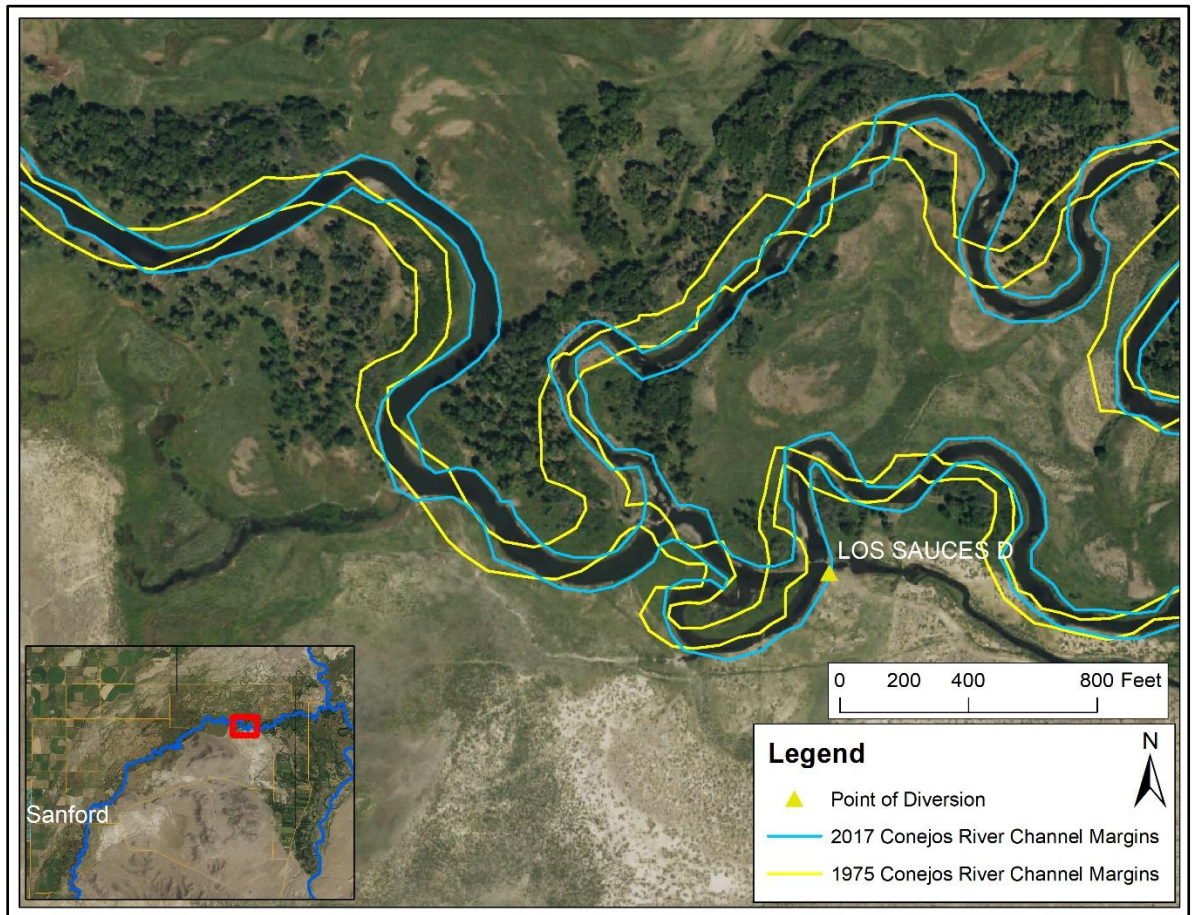
Map of headgate location with 1975 and 2015 channel margins overlaid.

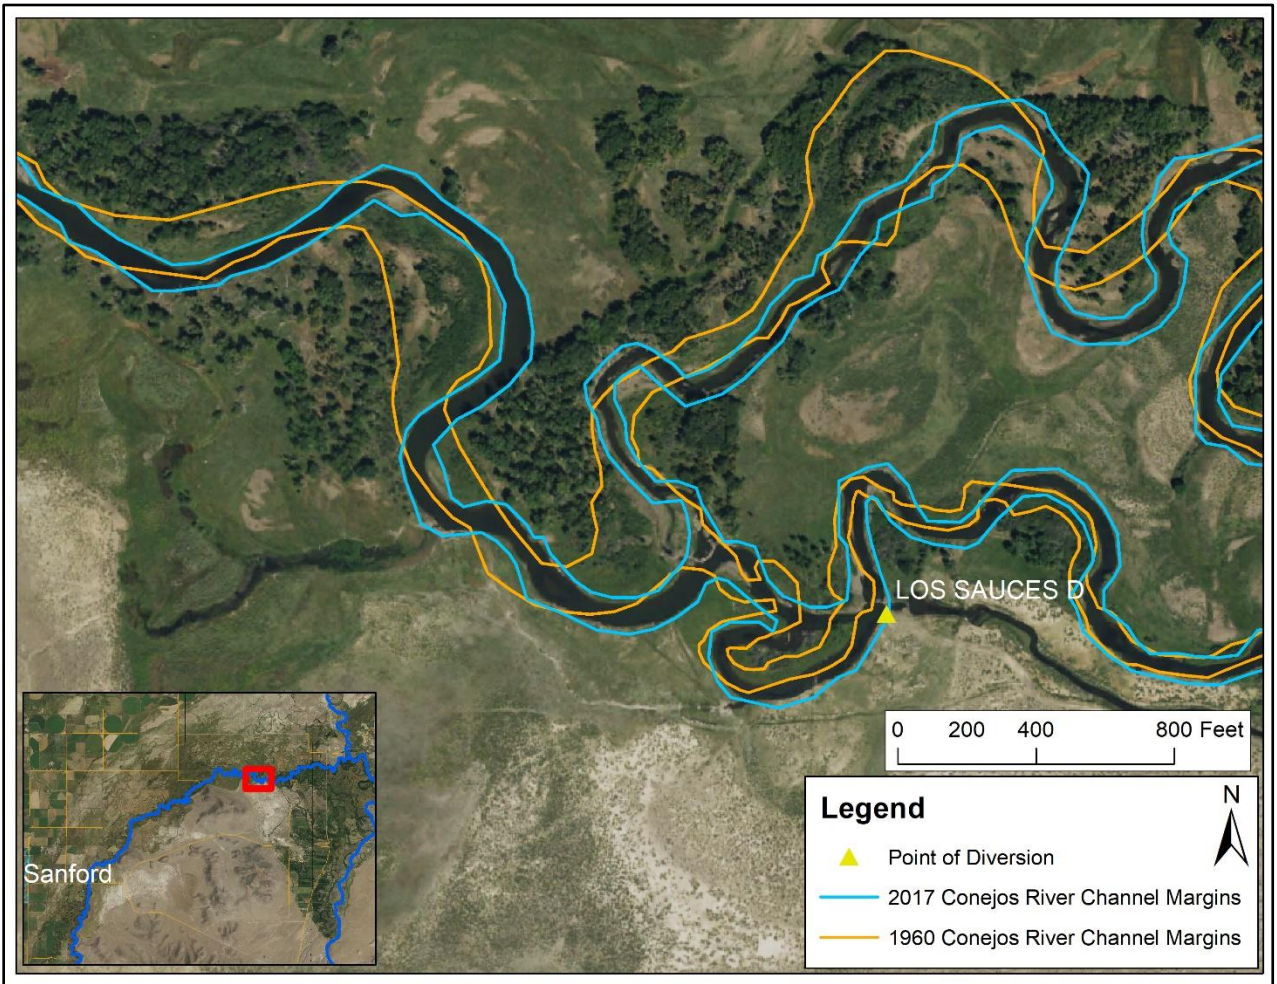
Map of headgate location with 1960 and 2015 channel margins overlaid.
