CONEJOS RIVER

DIVERSION INFRASTRUCTURE INVENTORY

Structure Name: SAN RAFAEL CONEJOS D

Date: April 2, 2019

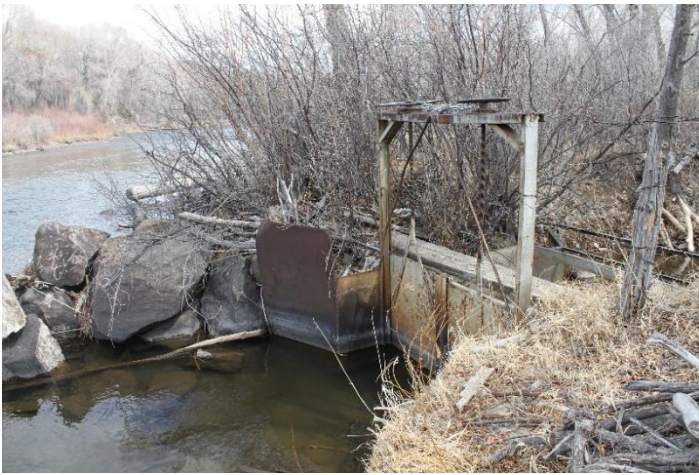
Headgate looking downstream

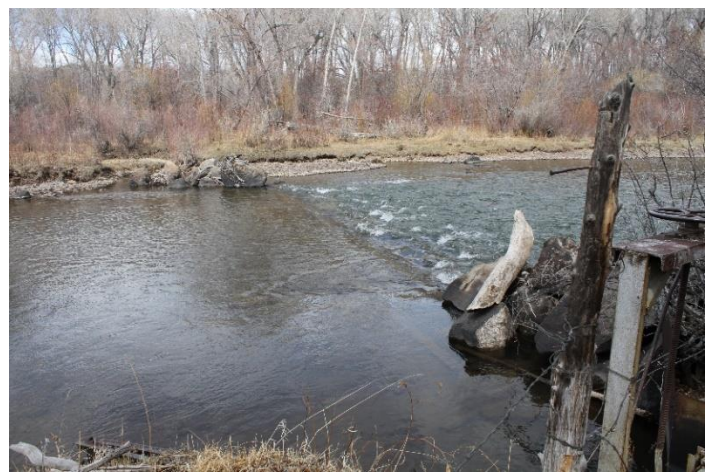
Headgate and diversion dam

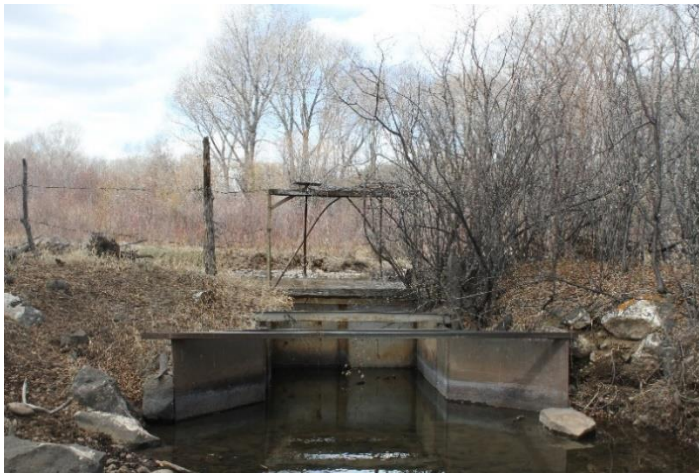
Headgate outlet

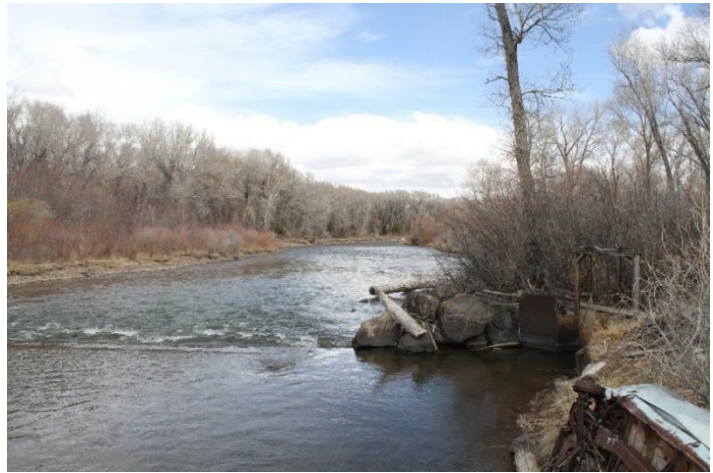
Diversion dam looking downstream

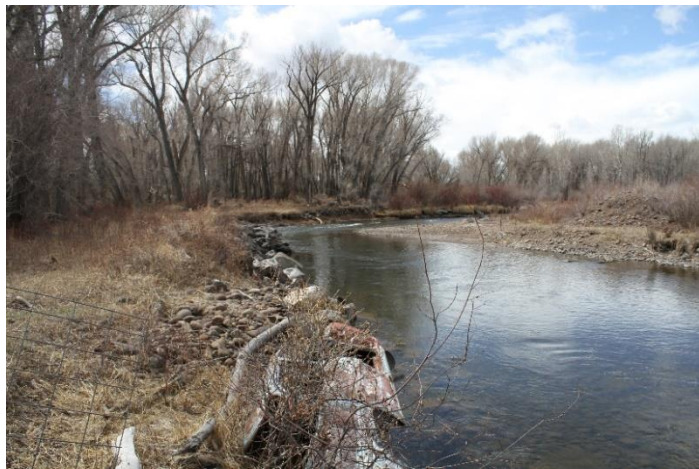
Structure Description: The river is unstable both upstream and downstream of this structure. Large riprap and vehicles are used to stabilize bank upstream of headgate. The diversion dam is made up of a molasses tank and large boulders that diverts water from the mainstem Conejos River to the headgate, which is located on the east bank of the river. The diversion functions moderately well, however water users have difficulty diverting at low flows. Although the channel has migrated significantly in the past, more recent channel migration analysis shows the channel is relatively stable in this area (see maps below).

Bank stabilization upstream of headgate

Repair(s) or Improvement(s) Currently Needed: Given the issues identified at this structure, the SMP Technical Advisory Team (TAT) recommends making some adjustments and improvements to the diversion dam and replacing existing bank stabilization materials with improved bank stabilization structures. Diversion improvements and bank stabilization would improve river function and allow water users to divert water more effectively).

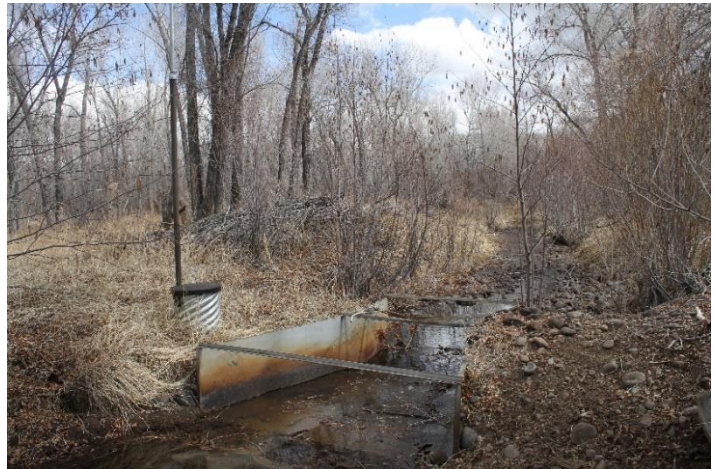
Flume looking downstream

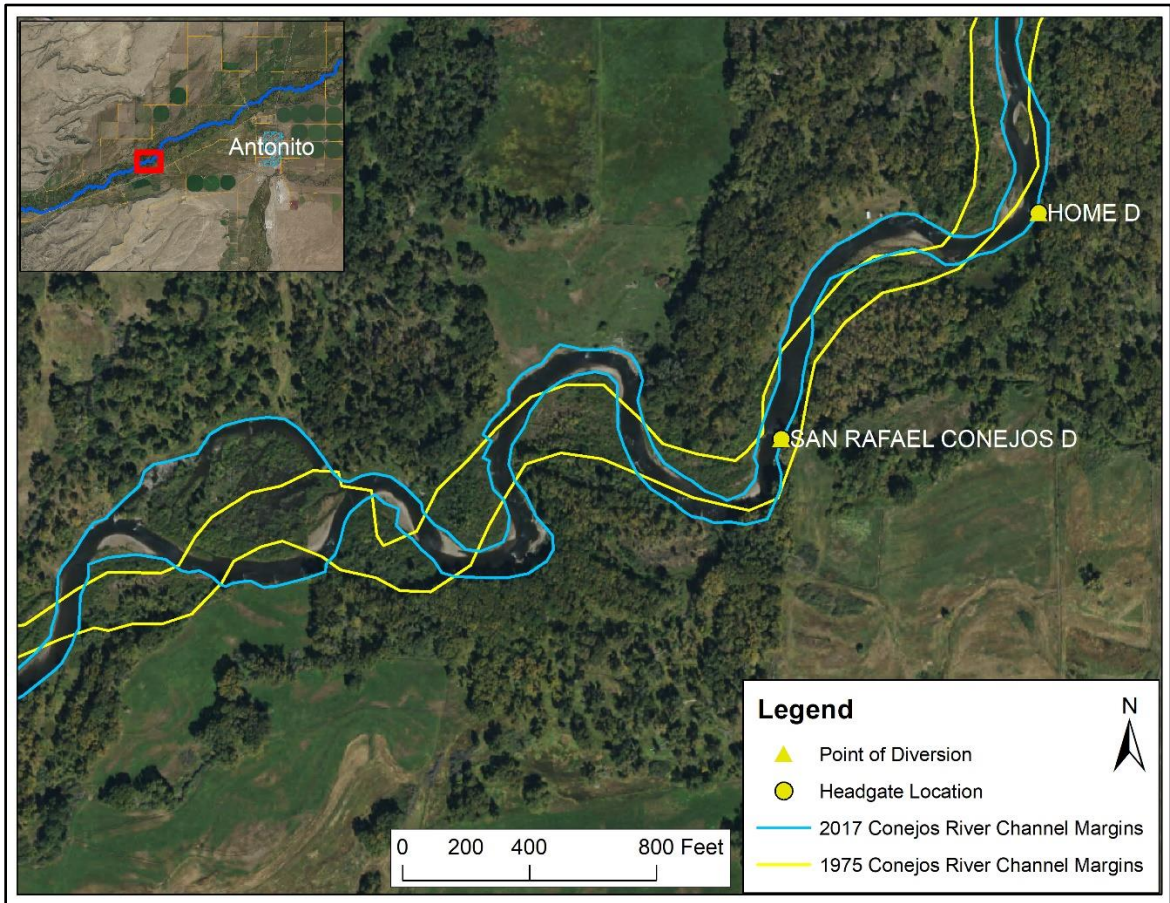
San Rafael Conejos Ditch point of diversion with 1975 and 2017 channel margins overlaid.
