CONEJOS RIVER DIVERSION INFRASTRUCTURE INVENTORY

Structure Name: TOWN OF ANTONITO D

Date: April 2019

Conejos River Stream
Management Plan

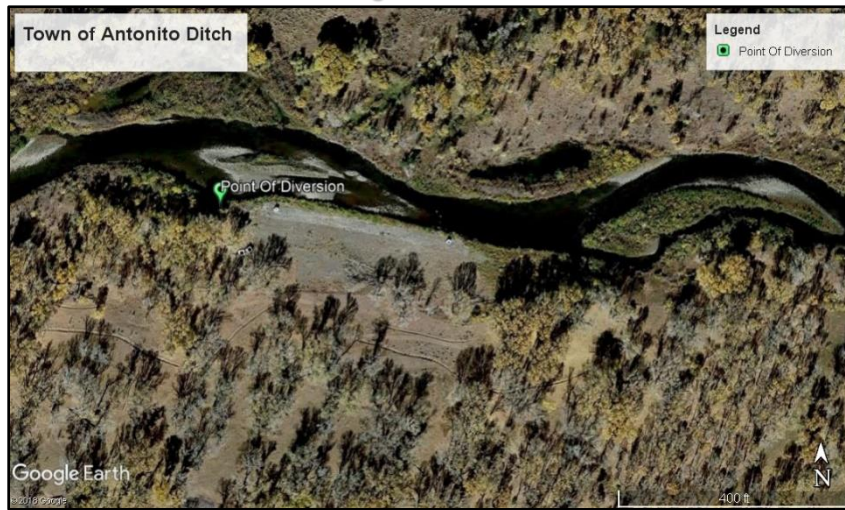
Aerial image of diversion location

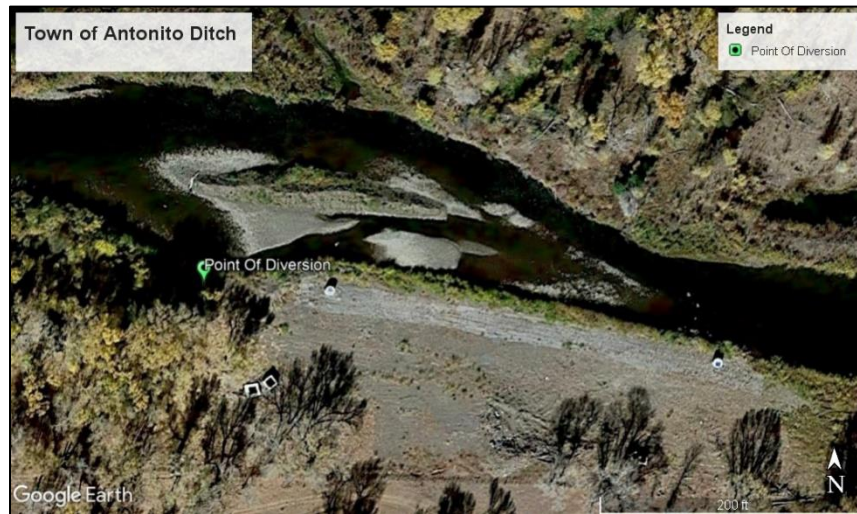
Close up aerial image of diversion location

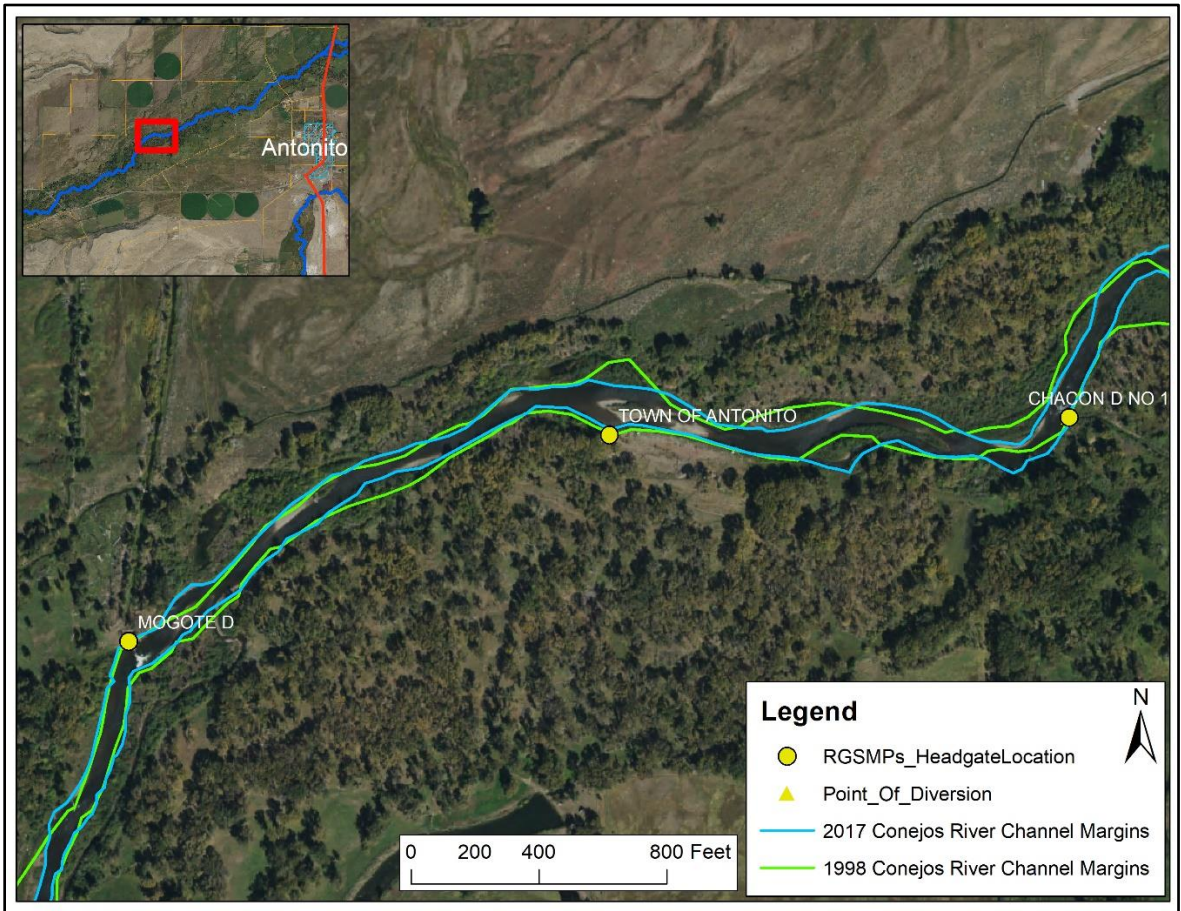
Point of diversion with 1998 and 2017 channel margins overlaid

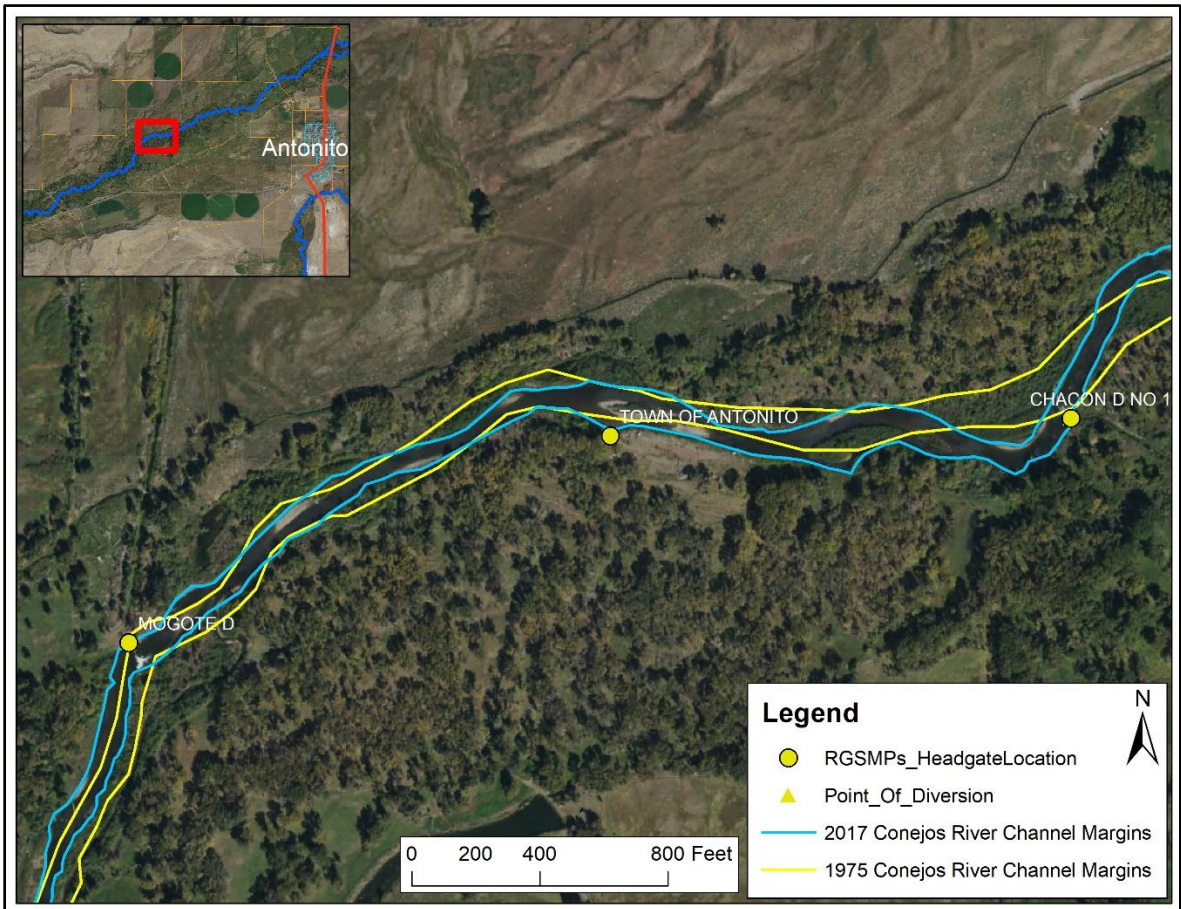
Point of diversion with 1975 and 2017 channel margins overlaid
