CONEJOS RIVER DIVERSION INFRASTRUCTURE INVENTORY

Structure Name: GARCIA D

GARCIA DITCH

Conejos River Stream Management Plan

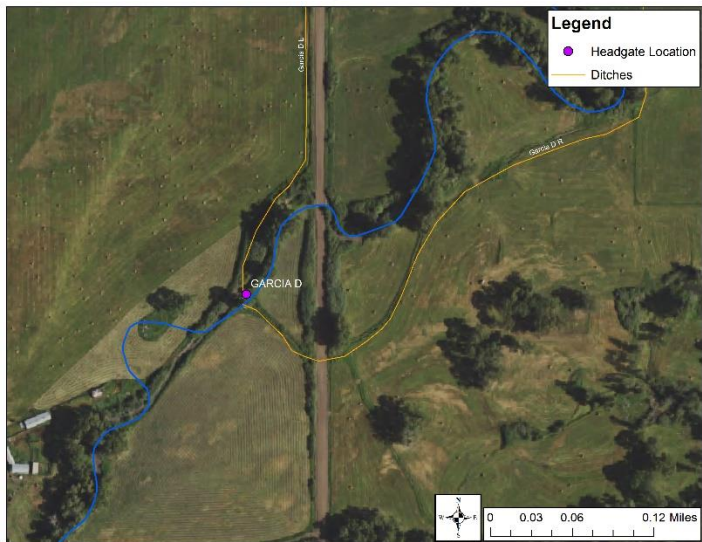
Aerial image of structure

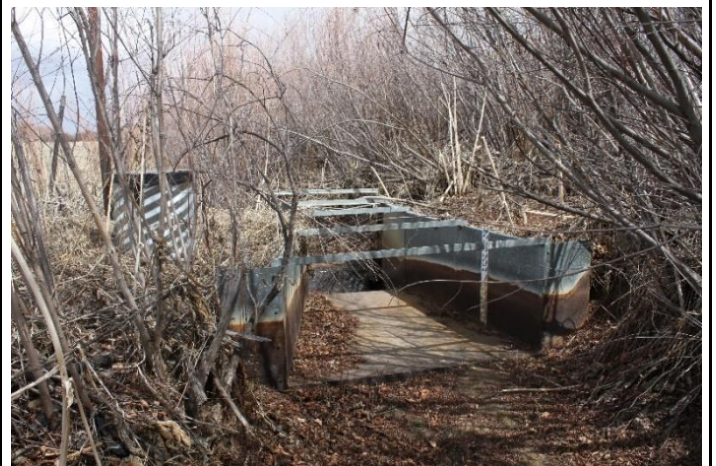
Flume looking downstream
