RIO GRANDE DIVERSION INFRASTRUCTURE INVENTORY

Structure Name: RIO GRANDE SPLITTER

Date: April 9, 2019

Rio Grande Stream Management Plan

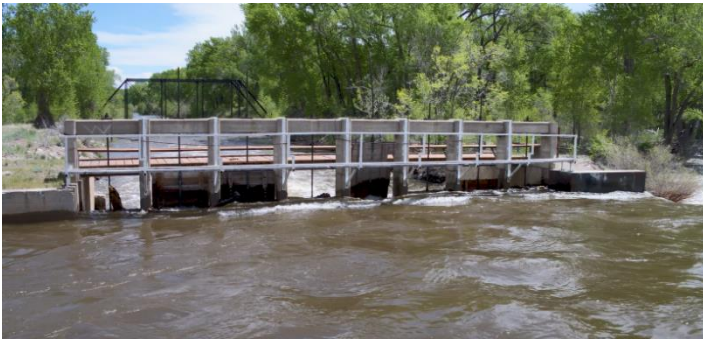
Headgate for North Channel Rio Grande looking downstream

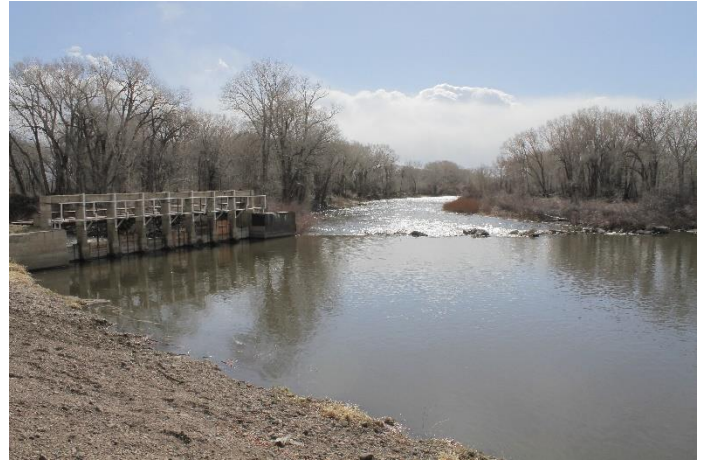
Structure Description: The Rio Grande Splitter is the river structure that controls flow to the North and South Channels of the Rio Grande. A concrete headwall with eight 3 ft wide wooden headgates controls flows to the North Channel. A diversion dam made up of boulders and woody debris controls flows to the South Channel. Although the headworks controlling flow to the North Channel functions well, the push-up diversion dam on the South Channel functions poorly, collects woody debris, and heavy equipment is regularly used to maintain the structure. Downstream of the diversion dam, the south bank of the South Channel is eroding and lacks riparian vegetation. The diversion dam also poses a significant obstacle to recreational boat passage and fish passage to the South Channel.

Headgate and diversion dam

Repair(s) or Improvement(s) Currently Needed: Given the challenges faced by water users and the risk to recreational boating, the SMP Technical Advisory Team (TAT) recommends replacing the current diversion with a more functional and lower maintenance structure. CPW recommends fish passage at this location. The TAT recommends also creating safe boat passage and allowing for debris and sediment transport at the diversion. As part of the diversion dam replacement, bank and vegetation revegetation is recommended.

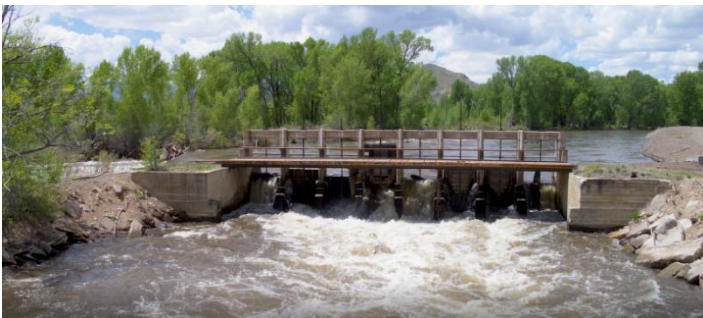
Headgate outlet

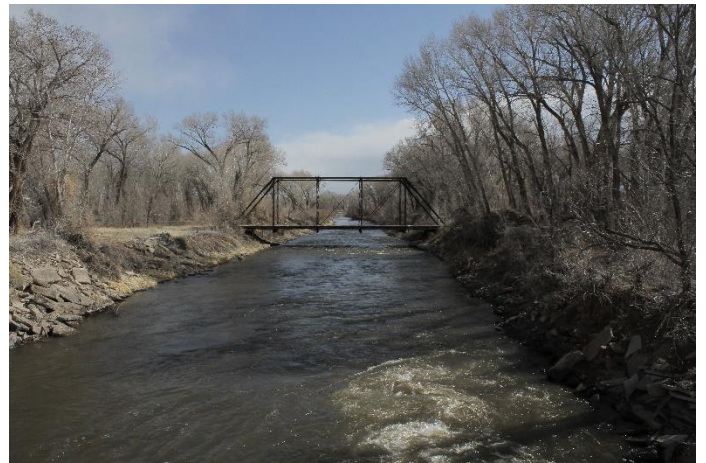
North Channel Rio Grande looking downstream

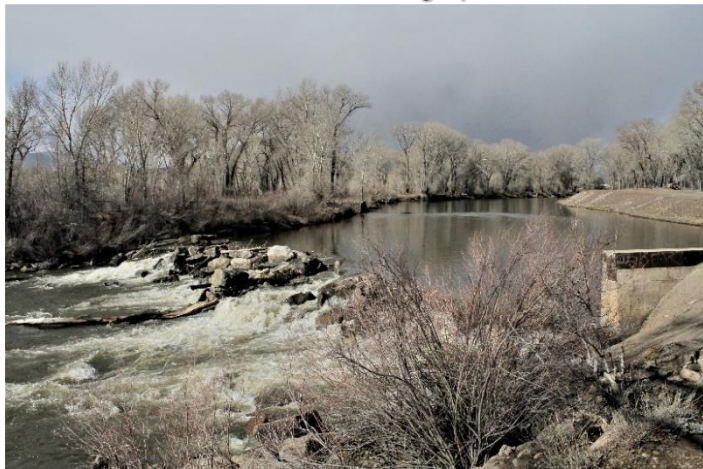
Diversion dam looking upstream

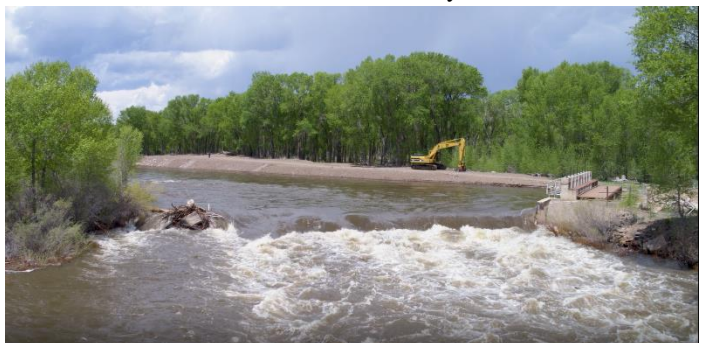
Diversion dam

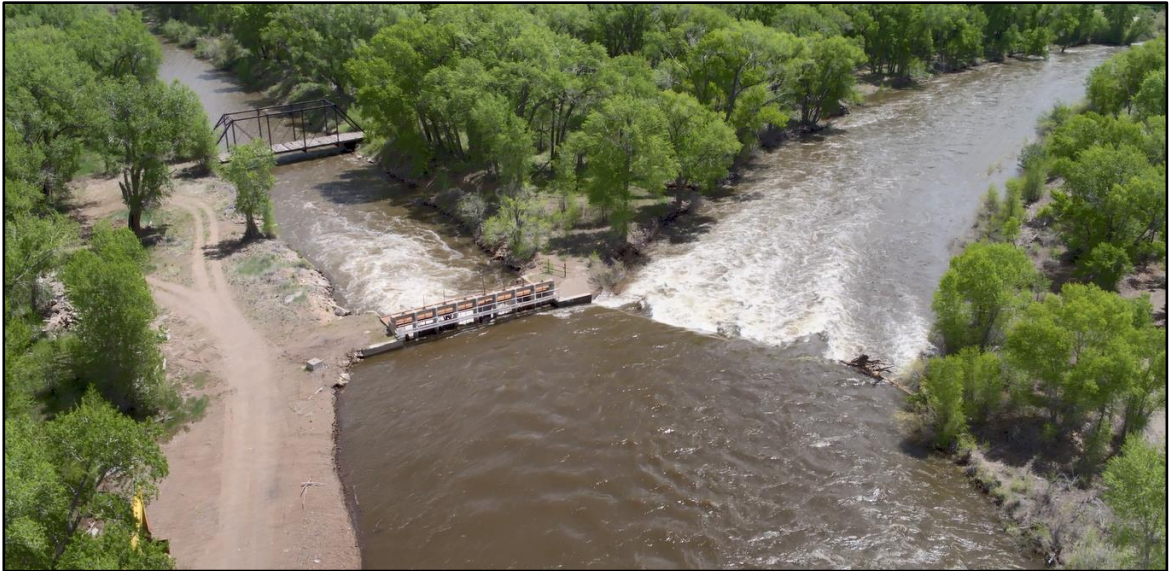
Aerial view of Rio Grande Splitter looking downstream.
Photo taken during spring runoff 2019 (Photo: Stuart Penny).

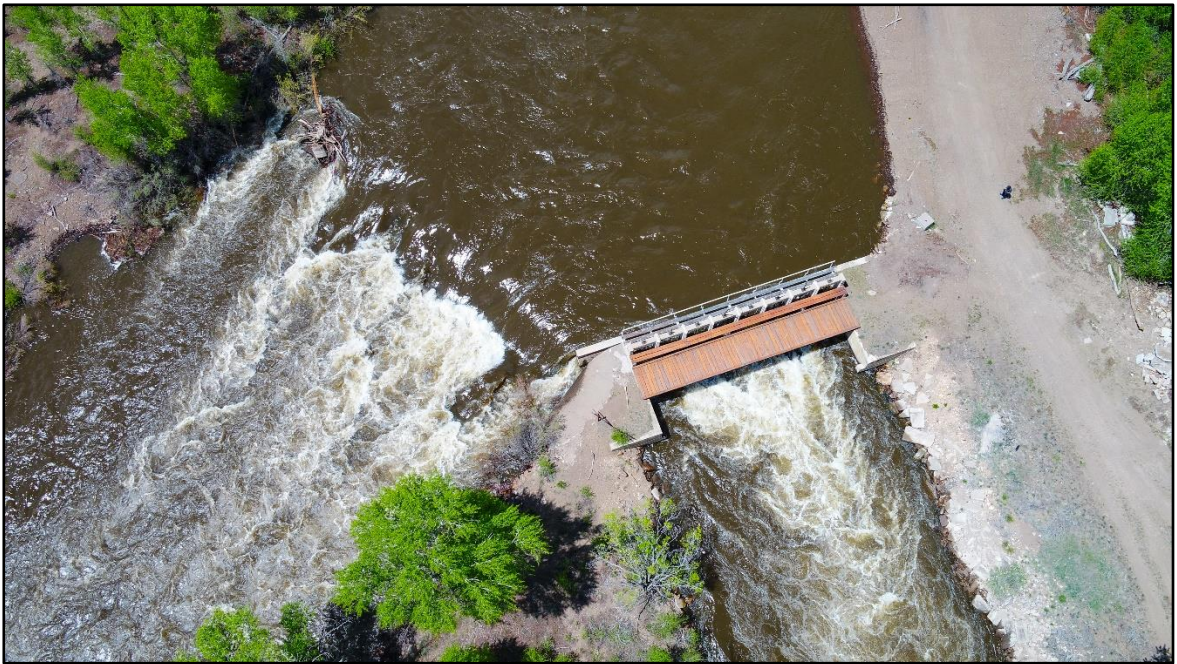
Aerial view of Rio Grande Splitter looking upstream (Photo: Stuart Penny).

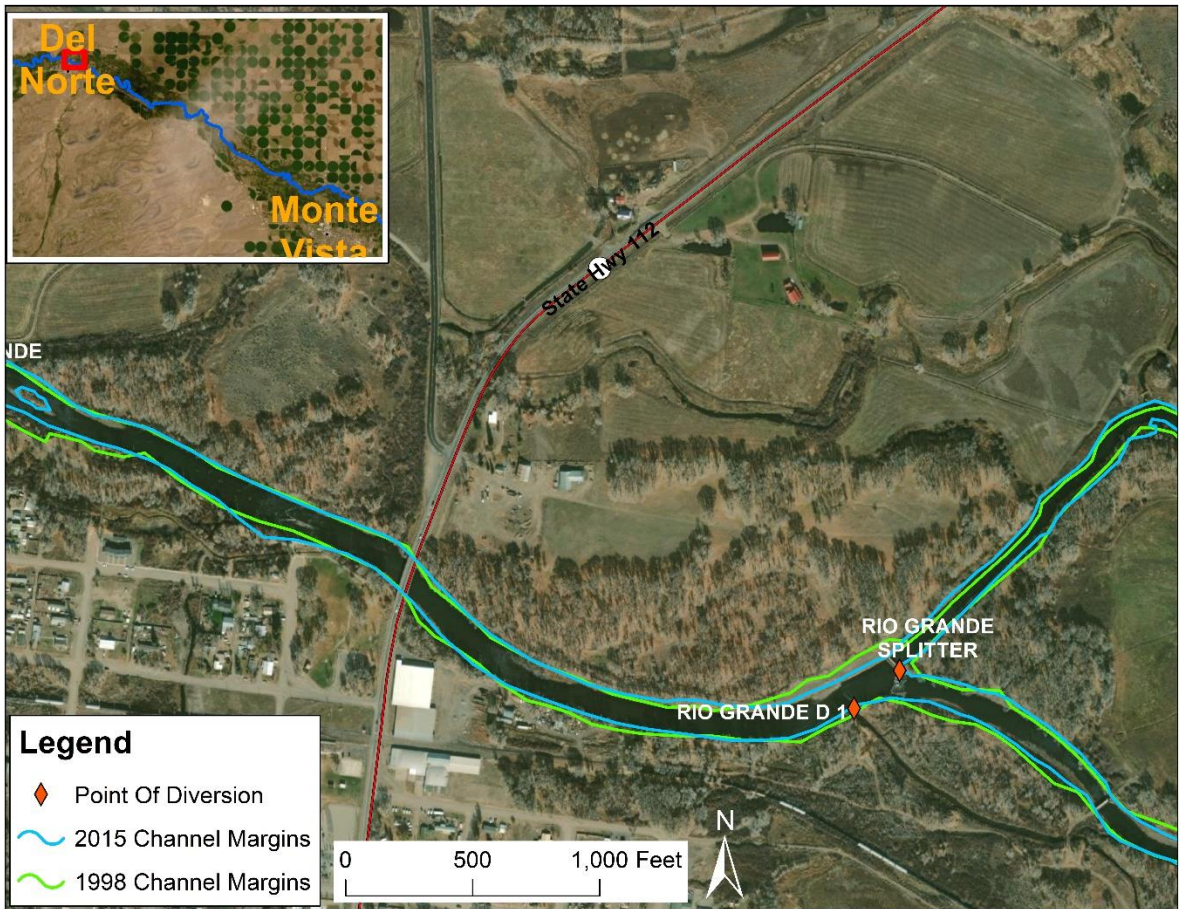
Rio Grande Splitter point of diversion with 1998 and 2015 channel margins overlaid

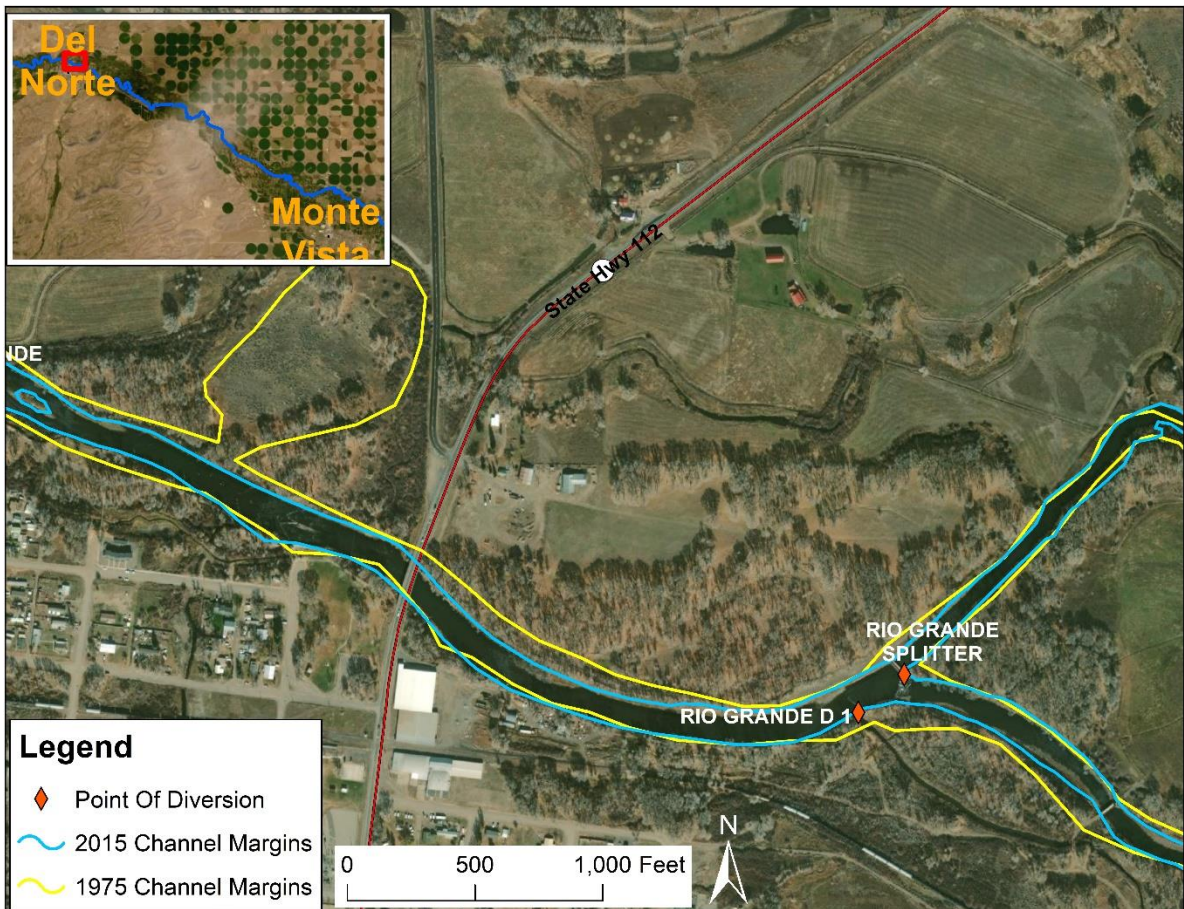
Rio Grande Splitter point of diversion with 1975 and 2015 channel margins overlaid
