RIO GRANDE DIVERSION INFRASTRUCTURE INVENTORY

Structure Name: ANTLERS PARK D

Date: May 7, 2019

ANTLERS PARK DITCH

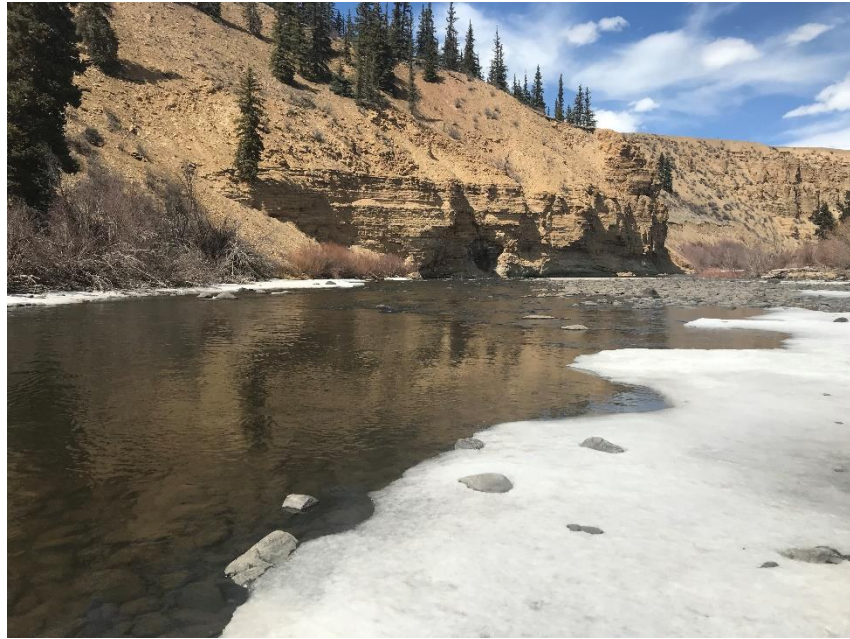
Structure Description: This structure is located roughly 1 mile downstream of Marshall Park campground and has no diversion dam. The structure cannot access its full decree due to the ditch's location on the river and the poor condition of the headgate.

Rio Grande downstream of diversion dam

Repair(s) or Improvement(s) Currently Needed: Given these issues, the SMP Technical Advisory Team (TAT) recommends installing a new headgate and improving or relocating the diversion dam to effectively divert water at all flows.
