RIO GRANDE DIVERSION INFRASTRUCTURE INVENTORY

Structure Name: DYER D

DYER DITCH

**Rio Grande Stream
Management Plan**

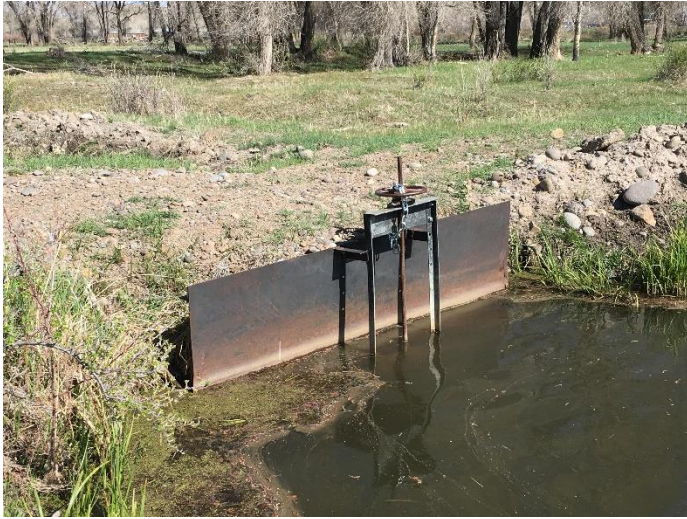
Headgate looking downstream

Repair(s) or Improvement(s) Currently Needed: The Technical Advisory Team (TAT) recommends repairing or replacing the headgate, including lifting it, as it is typically underwater. Additionally, bank stabilization near the diversion is recommended to mitigate erosion and prevent future channel avulsion.

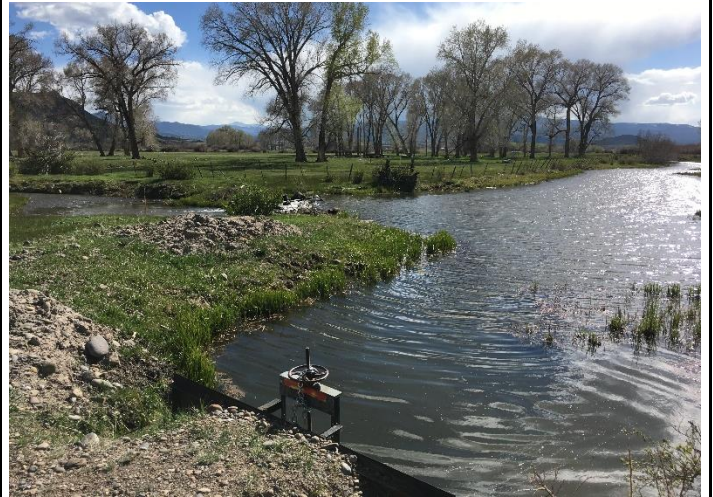
Headgate and diversion dam

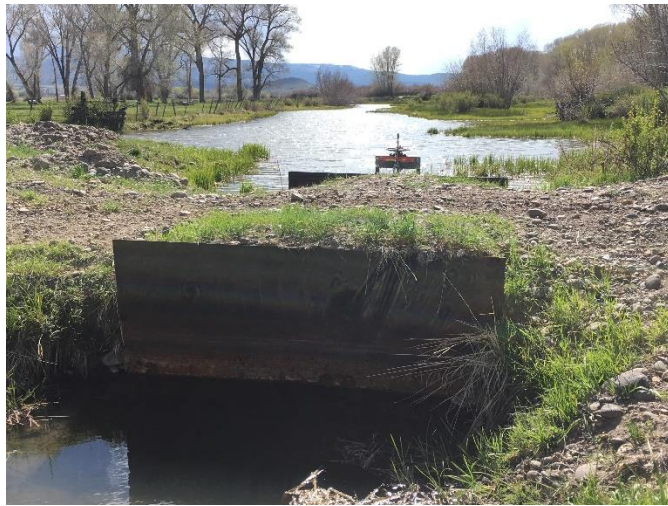
Headgate outlet

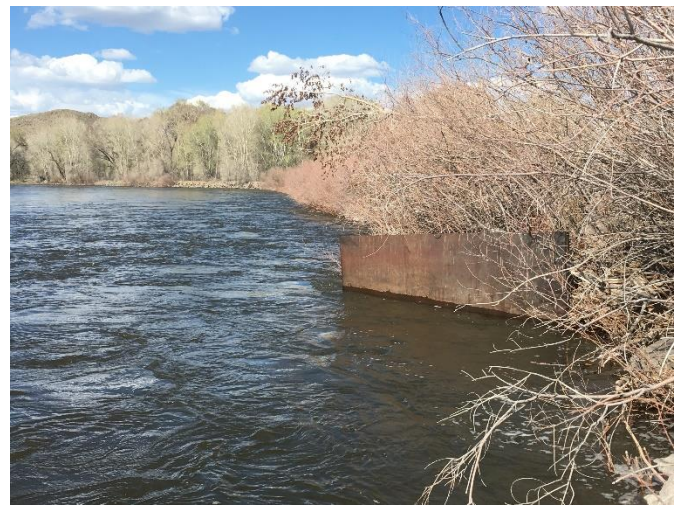
Diversion dam and headgate on Rio Grande

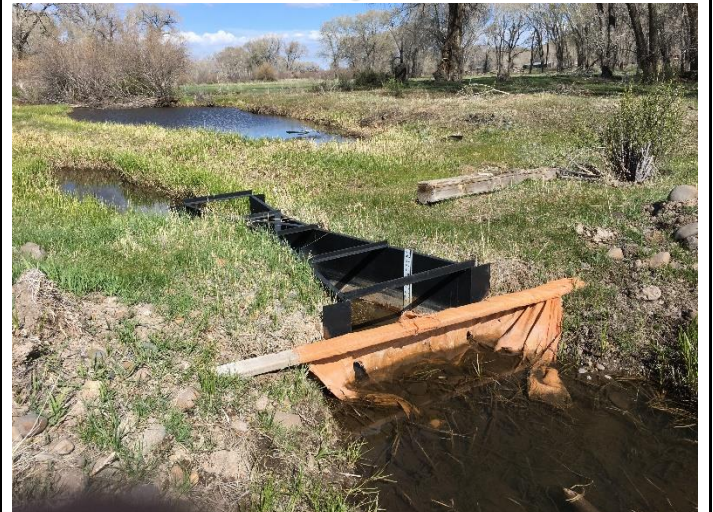
Flume looking downstream

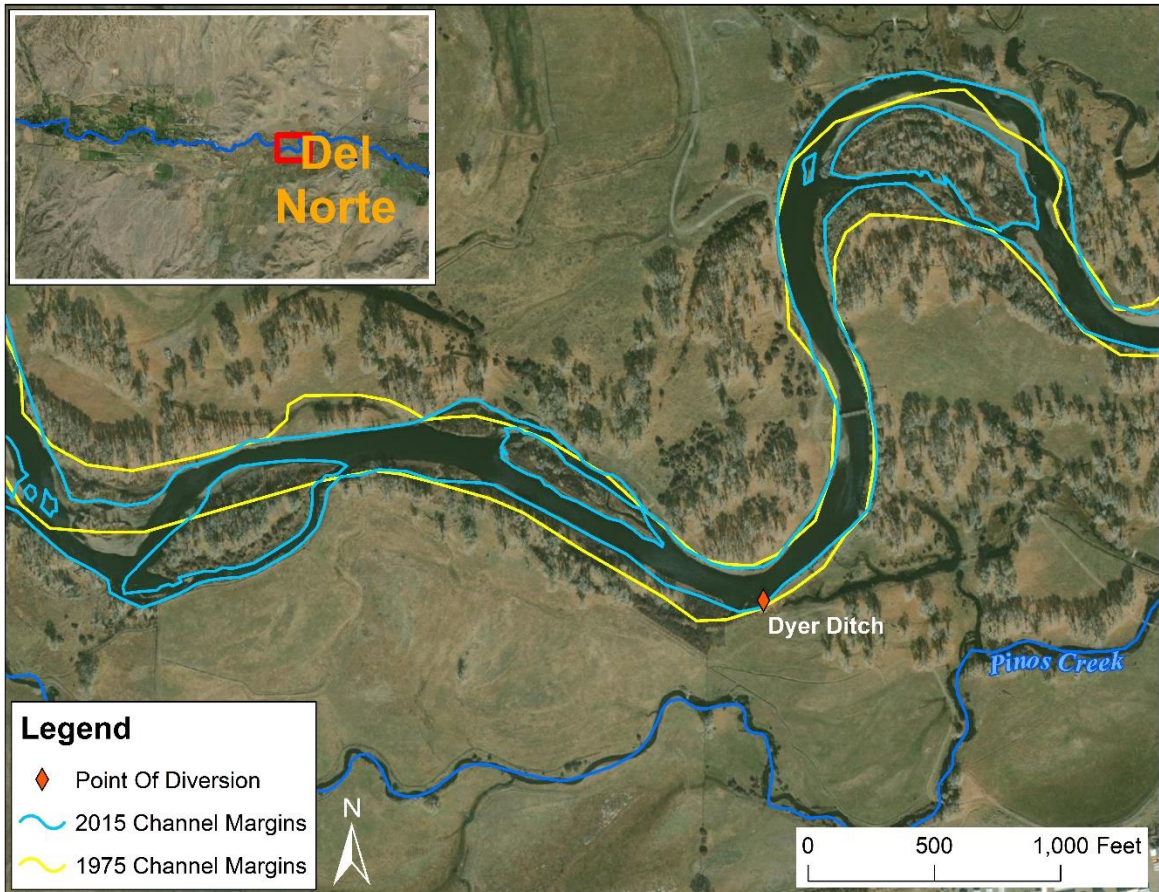
Structure Description: The Rio Grande has remained relatively stable in this area since at least 1960, however erosion on the south bank downstream of the diversion appears to have increased in recent years. A headwall with a culvert along the south bank of the Rio Grande directs water to a high flowchannel that services this ditch and the Del Norte Town Ditch. A diversion dam on the feeder channel directs water to the headgate and functions well. The headgate, however, jams and does not seal properly. Water not diverted by the Dyer Ditch remains in the overflow channel, which merges with Pinos Creek and returns to the Rio Grande just downstream of the Rio Grande Canal. There is a depressed area along the bank of the Rio Grande just downstream of this structure's diversion which will allow river flows of greater than 5000 cfs to overtop the bank and flow along a high flow channel. This channel flows back to the river downstream of the Rio Grande Canal headgate. This is an emergency overflow measure to prevent the Rio Grande Canal headgate from being washed out during high flows.

Point of diversion and headgate locations of Dyer Ditch with 1975 and 2015 channel margins overlaid.

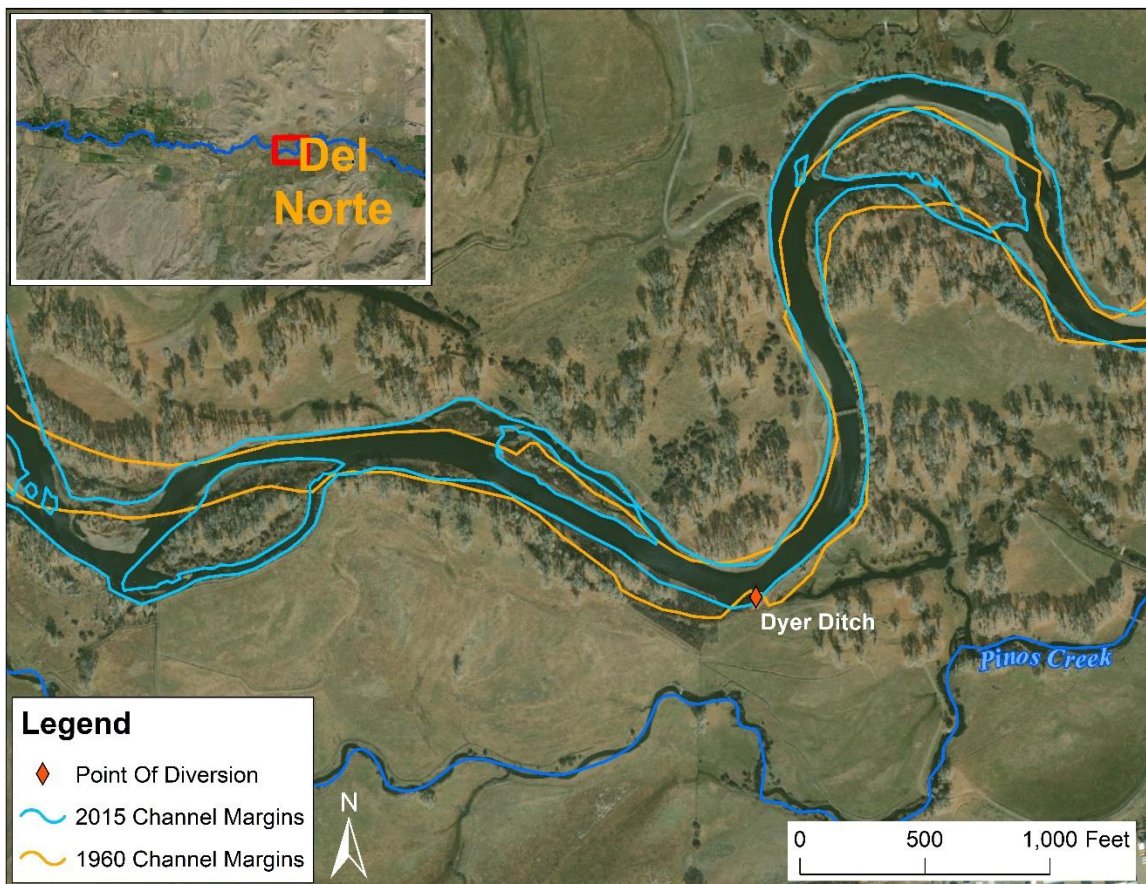
Dyer Ditch with 1960 and 2015 channel margins overlaid.
