RIO GRANDE DIVERSION INFRASTRUCTURE INVENTORY

Structure Name: PRAIRIE DITCH

Date: April 9, 2019

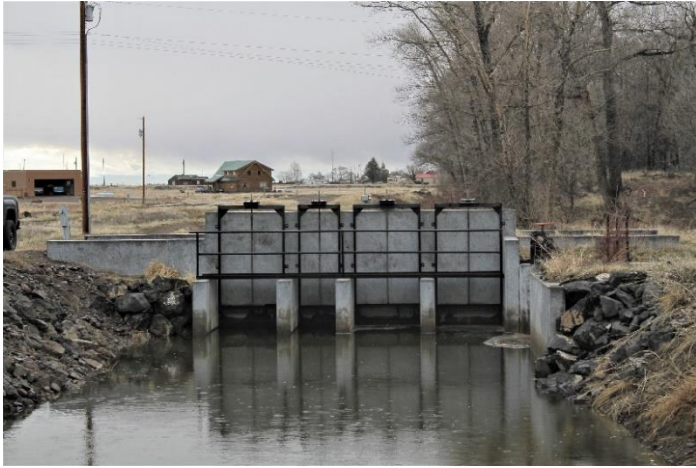
Headgate looking downstream

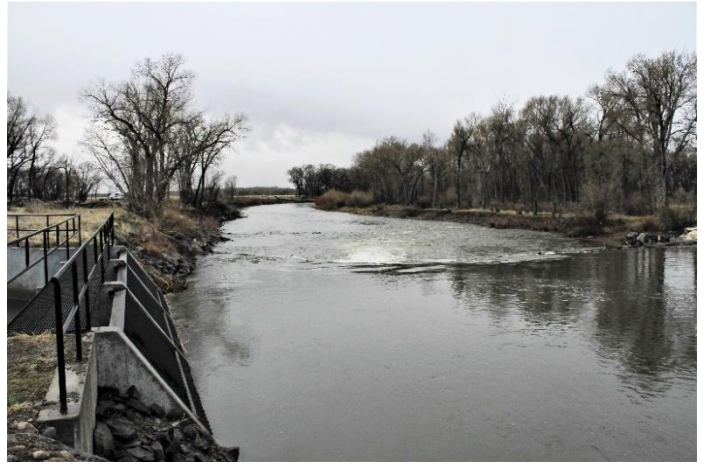
Trash rack and diversion dam

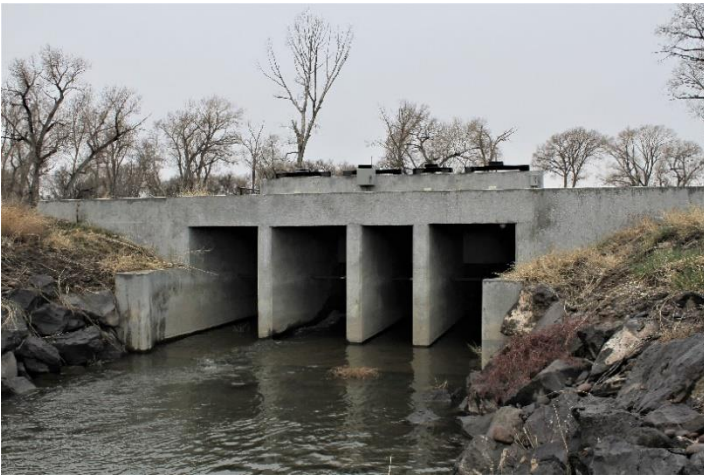
Headgate outlet

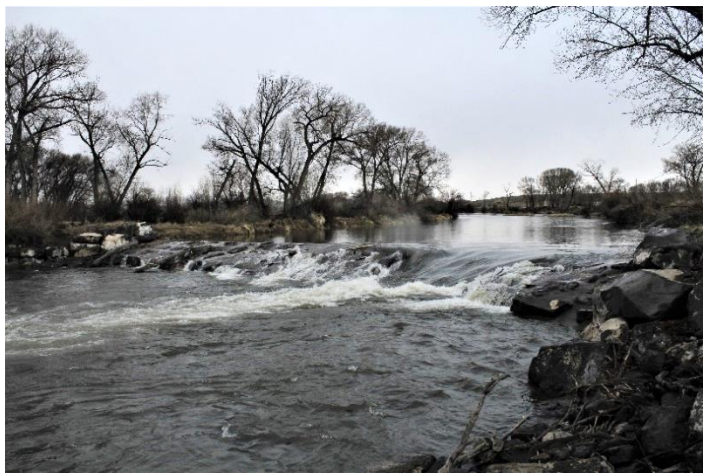
Diversion dam looking upstream

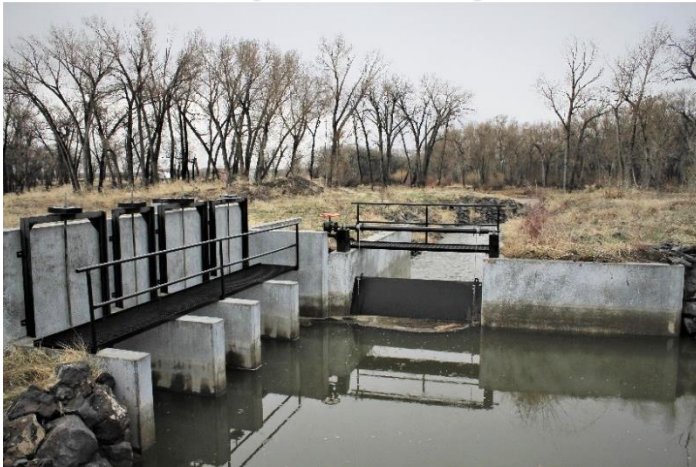
Headgates and sluice gate

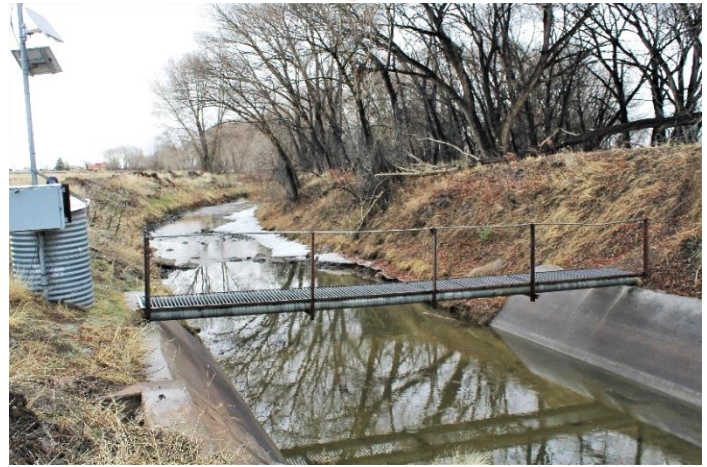
Flume looking downstream
