# RIO GRANDE DIVERSION INFRASTRUCTURE INVENTORY

**Structure Name:** SAN LUIS VALLEY CANAL

**Date:** April 10, 2019

PHOTO LOG

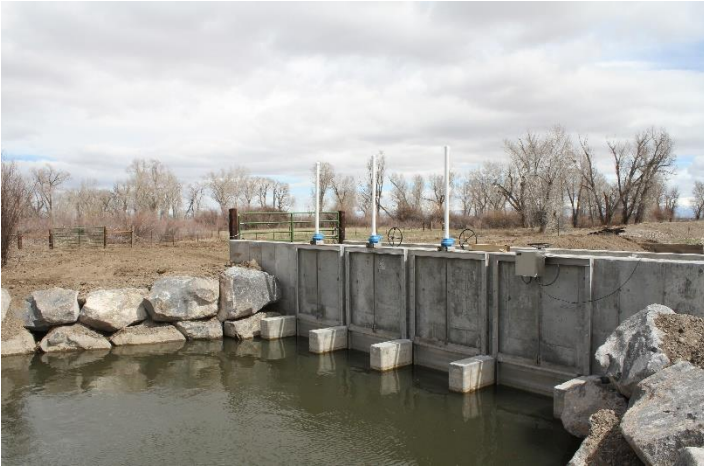
Headgate looking downstream

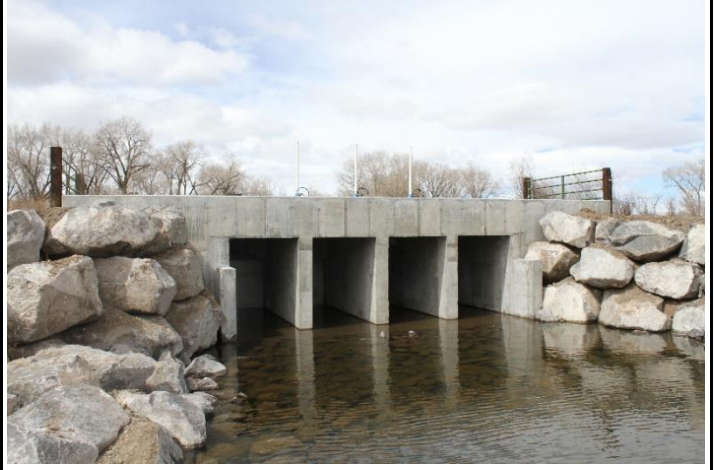
Headgate outlet

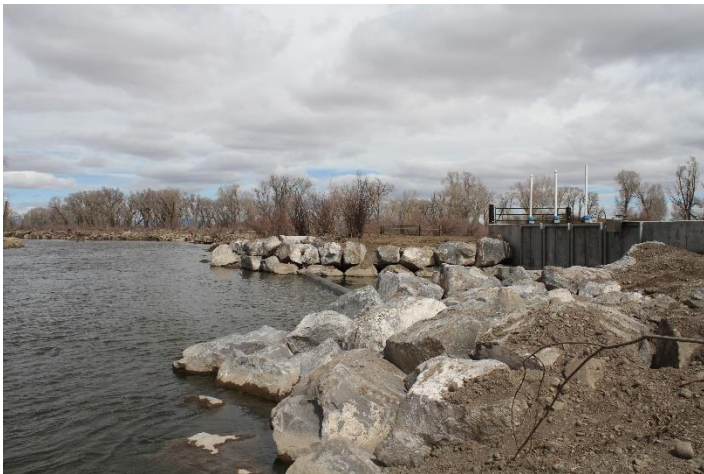
Headgate and surrounding streambanks

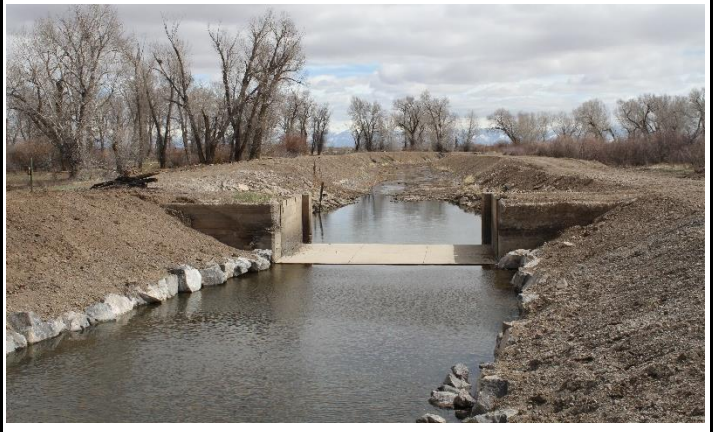
Old headgate, which will be used as measurement device

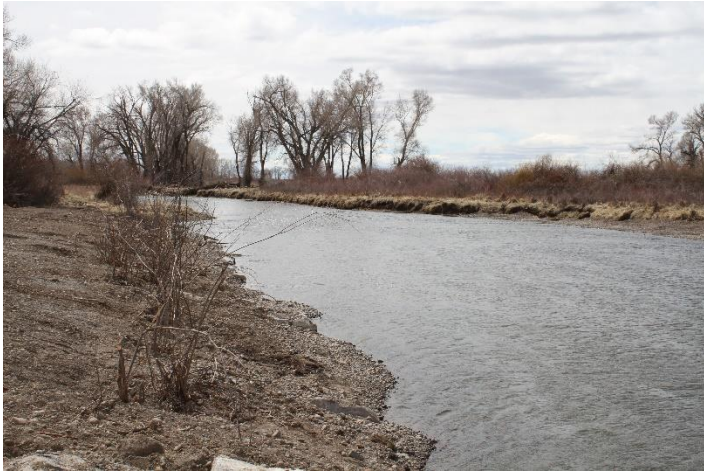
Rio Grande looking downstream of headgate

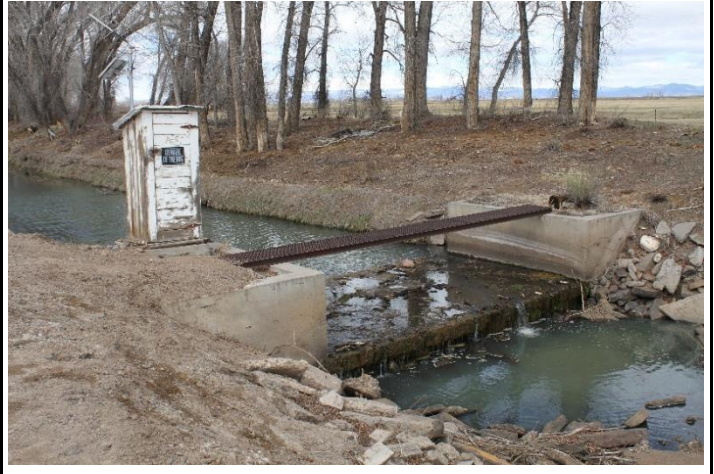
Flume looking upstream

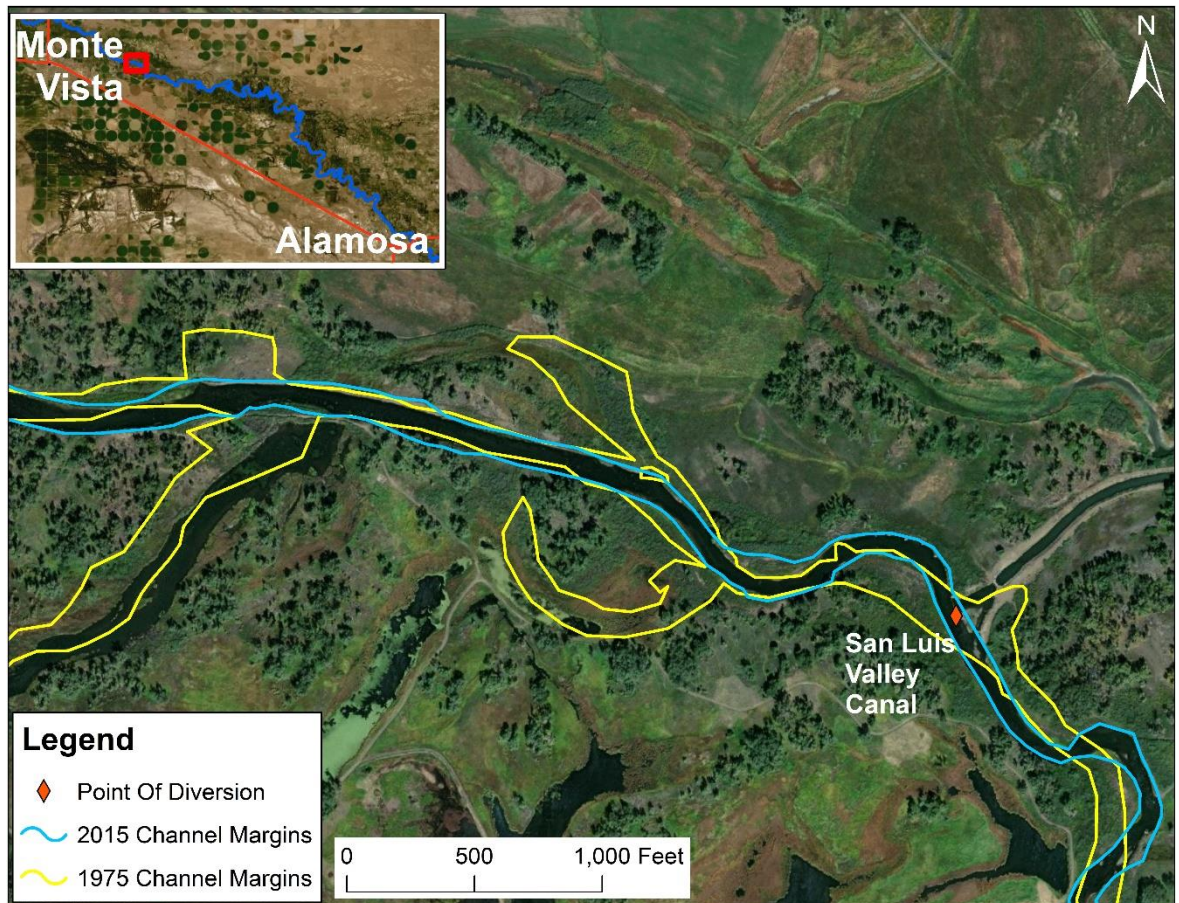
**Structure Description:** This structure is located in the transition zone between two broad meanders in the river. Since 1975, the channel has migrated both upstream and downstream of this structure. The meander immediately upstream of the diversion has been tightening and migrating to the northwest. Just downstream of the diversion, the river is migrating to the southwest, away from the diversion, and the next downstream meander is also tightening. Channel capacity is limited in this part of the river, which has caused the bank upstream of the structure to breach during past high flow events. During the spring 2019 runoff, the bank downstream of the newly installed headgate breached, allowing water to enter the ditch around the headgate (see maps below).

Headgate location with 1998 and 2015 channel margins overlaid

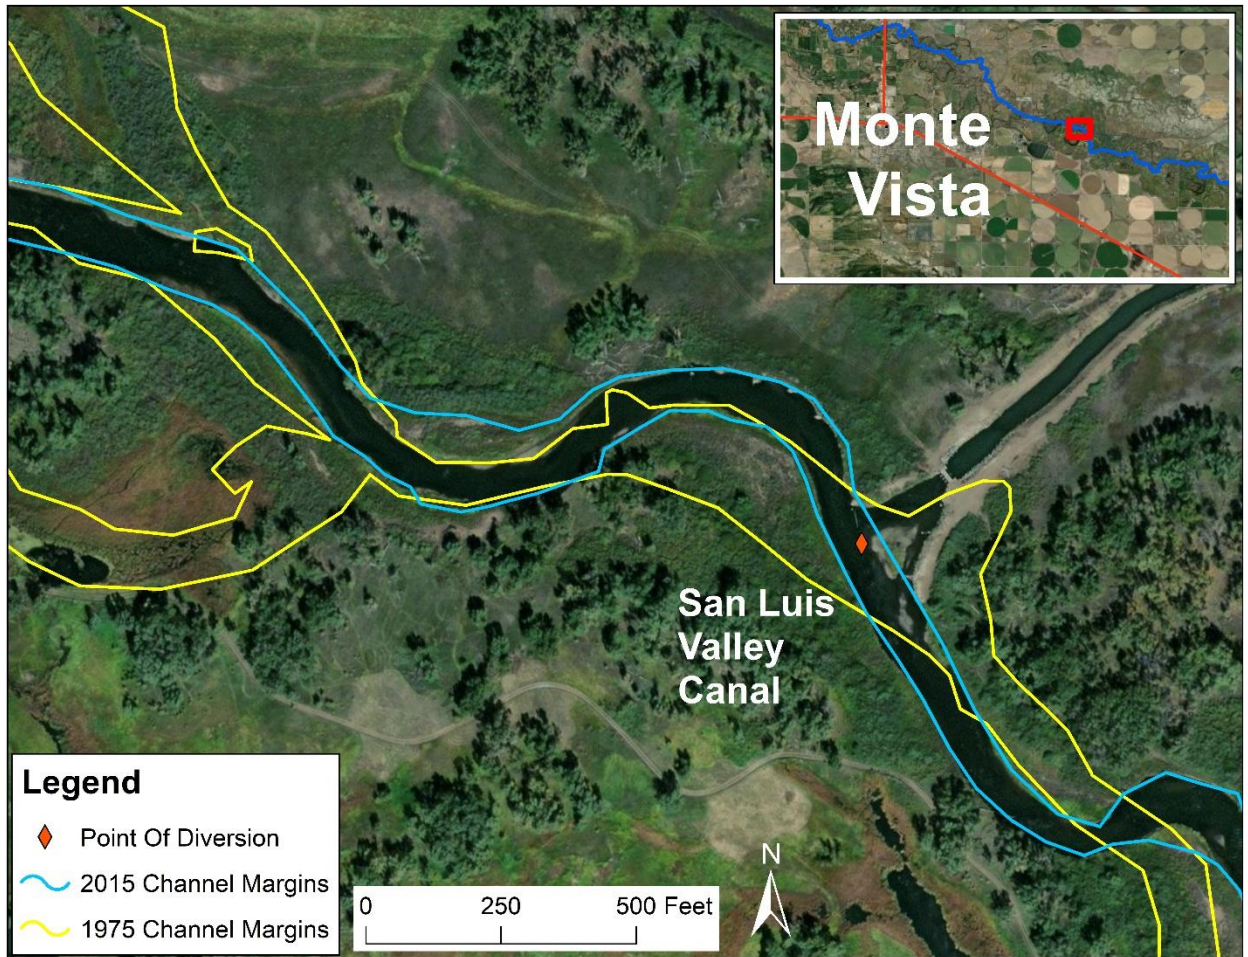
Headgate location with 1975 and 2015 channel margins overlaid

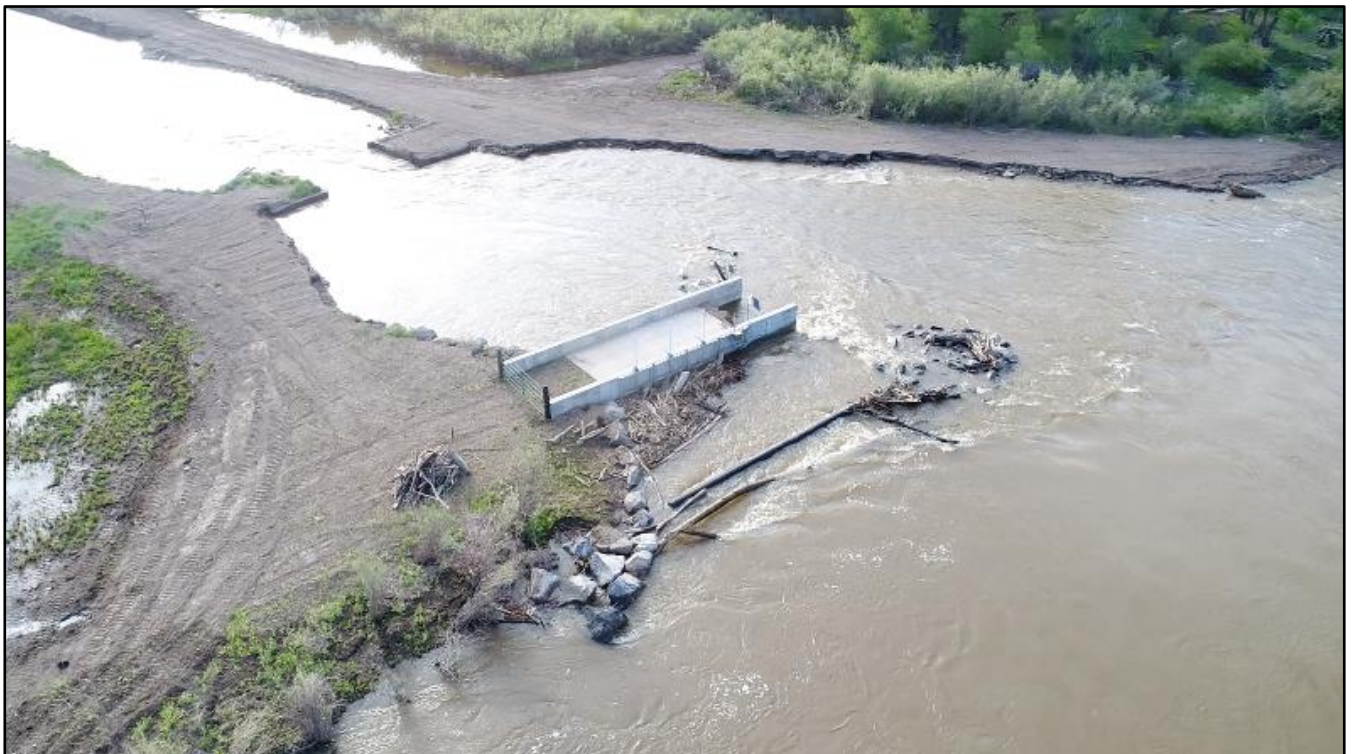
Zoomed map of headgate location with 1975 and 2015 channel margins overlaid.

Aerial photograph of bank failure adjacent to recently installed headgate.  
Photo taken Spring 2019.

**Repair(s) or Improvement(s) Currently Needed:** Although the headgate has been repaired, the SMP Technical Advisory Team (TAT) recommends regular monitoring given the potential risk of breaching.
