# RIO GRANDE DIVERSION INFRASTRUCTURE INVENTORY

**Structure Name:** WESTSIDE D

**Date:** April 11, 2019

Rio Grande Stream  
Management Plan

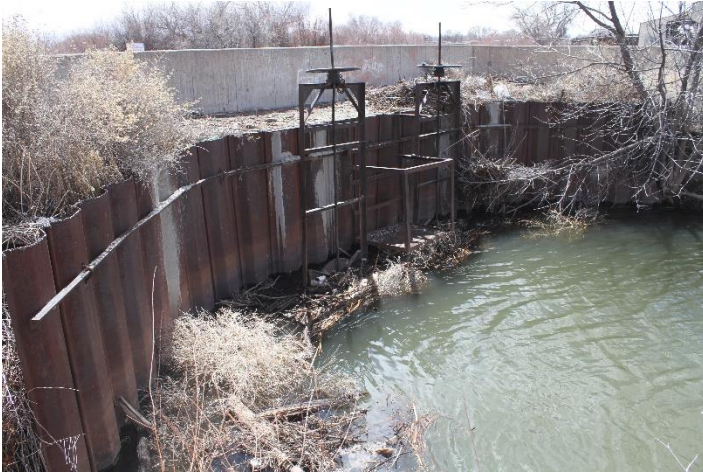
Headgate looking downstream

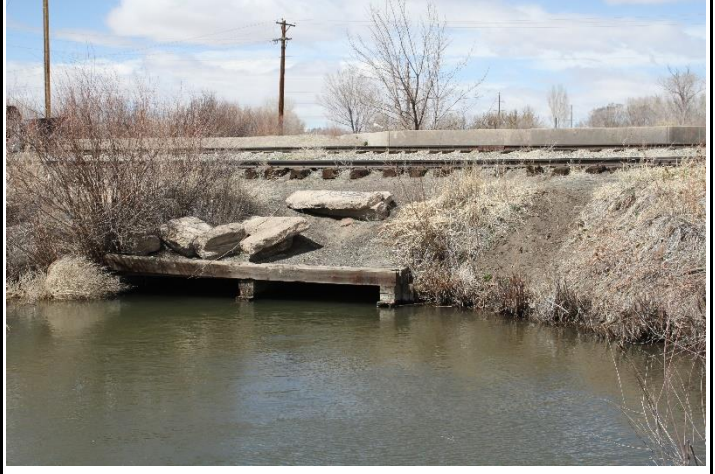
Headgate outlet

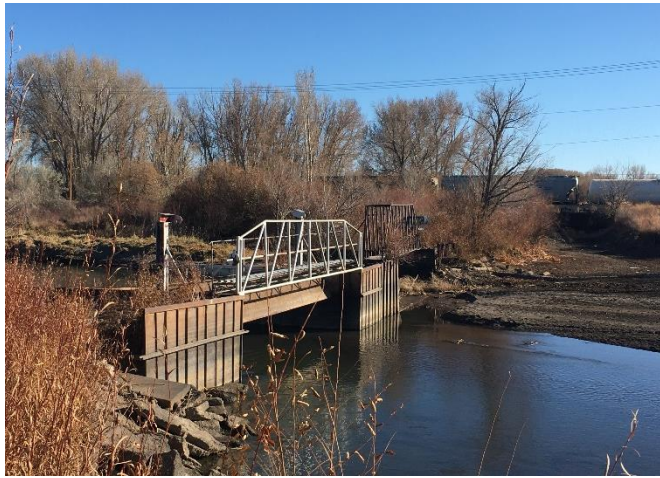
Diversion dam looking downstream

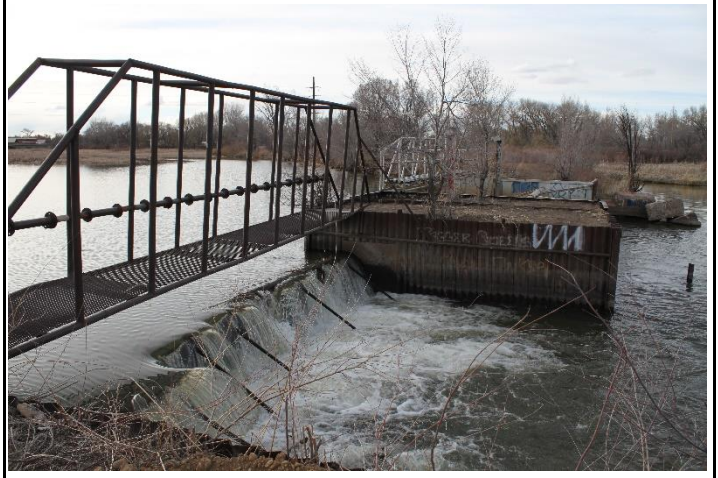
Diversion dam looking upstream

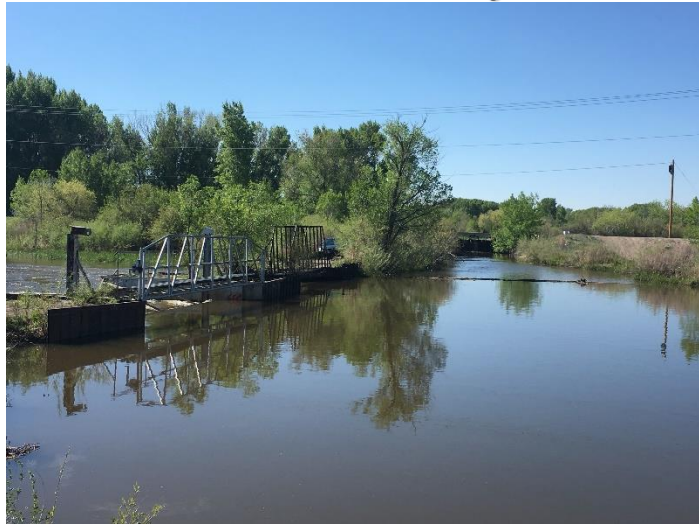
**Structure Description:** A corrugated sheet metal diversion with a 20 ft steel weir and a 20 ft radial gate spanning the river directs river flow to a short feeder channel and services the headgates. There is a log trash boom across the entrance of the feeder channel. At the headgates, which are aging and difficult to operate, the ditch enters a culvert before passing through the flume. Upstream of the diversion, the channel has migrated south (see 1975 and 1960 channel margin maps), although significant migration is limited by the levees and thus lateral migration has not affected the diversion's ability to function. The diversion gates do not have sufficient capacity to pass flood flows. For this reason, during high flow events, the river bank north of the structure can fail, leading to significant flows bypassing the structure via the failed bank. High flow scenarios could also potentially lead to flooding upstream of the diversion or in East Alamosa due to a backwater effect. Significant debris and sediment are deposited upstream of this diversion due to the structure's limited sediment transport capacity along with regularly low river velocities. This structure impacts the sediment transport regime and channel capacity of the river upstream of the diversion. The diversion effectively diverts water, however it is difficult and time consuming to operate. During 2019 spring runoff, the levee forming the bank north of the diversion washed out (see report card) and has occurred in the past.

Diversion dam and headgate

**Repair(s) or Improvement(s) Currently Needed:** Given the poor condition of the infrastructure and its impact on river function, the SMP Technical Advisory Team (TAT) recommends replacing the diversion and headgate with new structures. Colorado Parks and Wildlife (CPW) recommends fish passage at this location and the TAT recommends boat passage and increased sediment transport capacity, especially considering the increasing popularity of recreational boating in the Alamosa area. A new headgate would reduce water user maintenance needs and increase ditch efficiency. A new diversion would allow for fish and boat passage, reduce the risk of flooding in East Alamosa, and would reestablish natural sediment transport processes in this location. Diversion structure improvements were also identified in the 2017 Rio Grande River Corridor Feasibility Study. If improvements are made that allow for boat passage, a safe takeout location adjacent to or downstream of the diversion is also recommended.

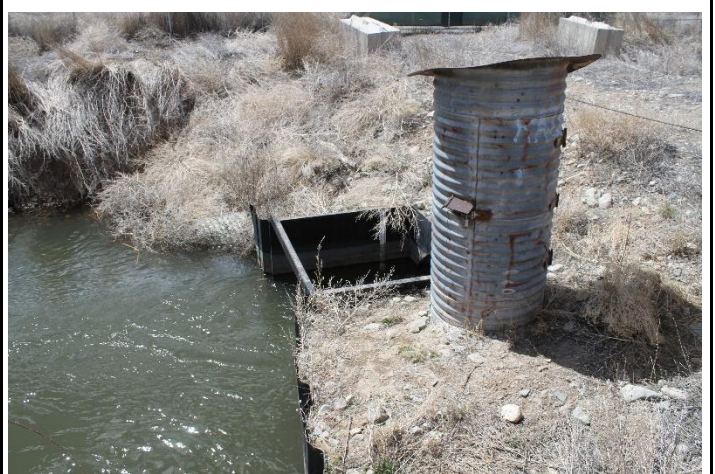
Measurement Structure

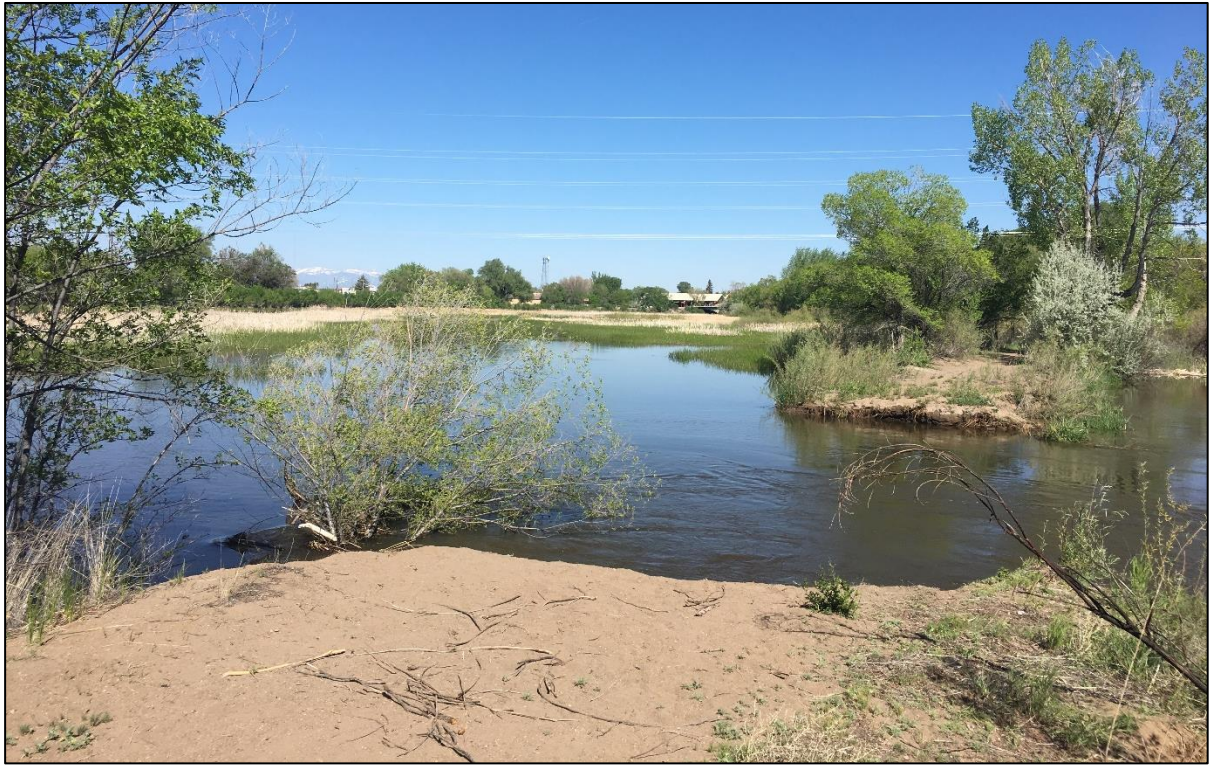
Failed levee north of diversion dam during Spring 2019 runoff

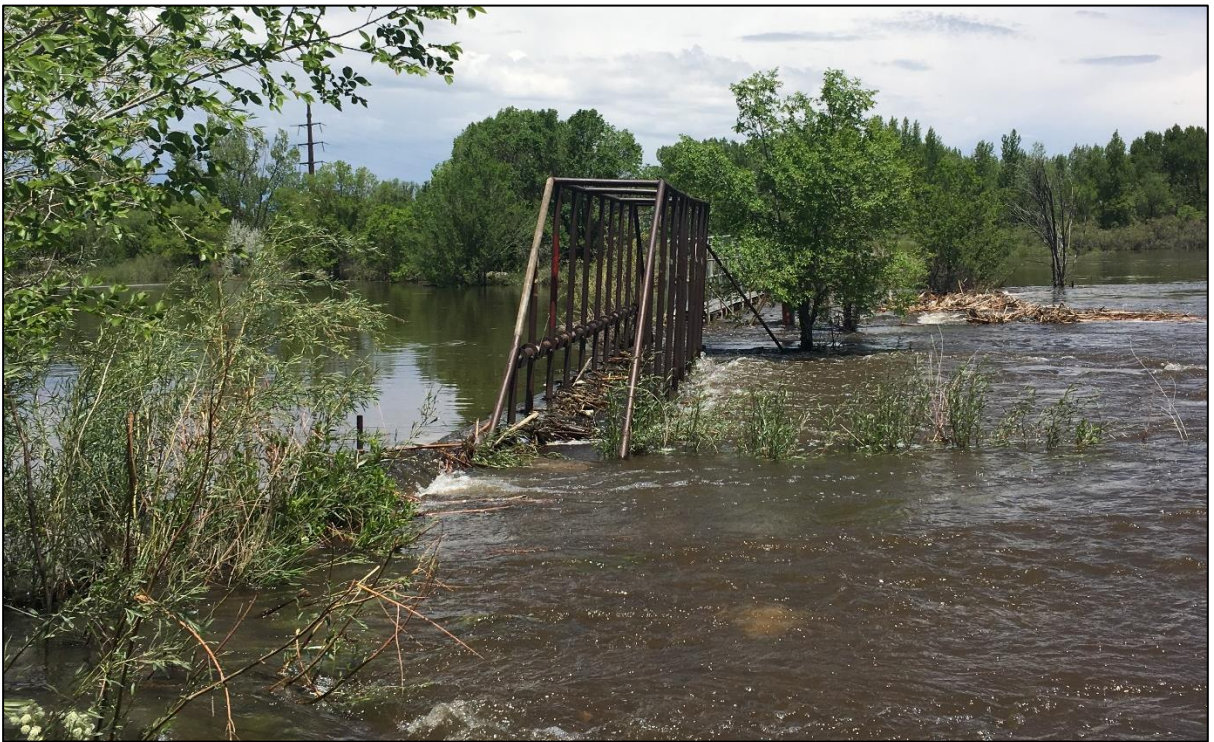
Flooded diversion dam during Spring 2019 runoff

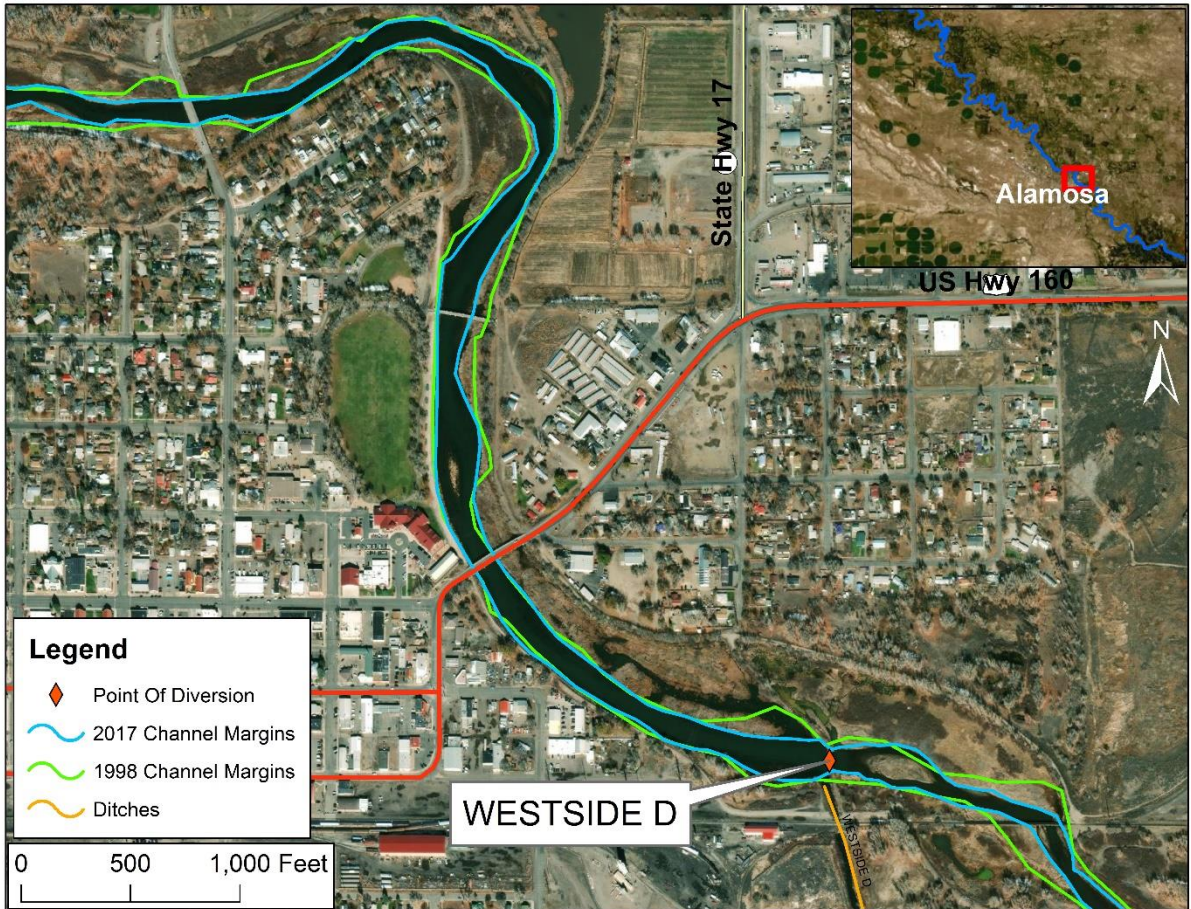
Headgate location with 1998 and 2017 channel margins overlaid

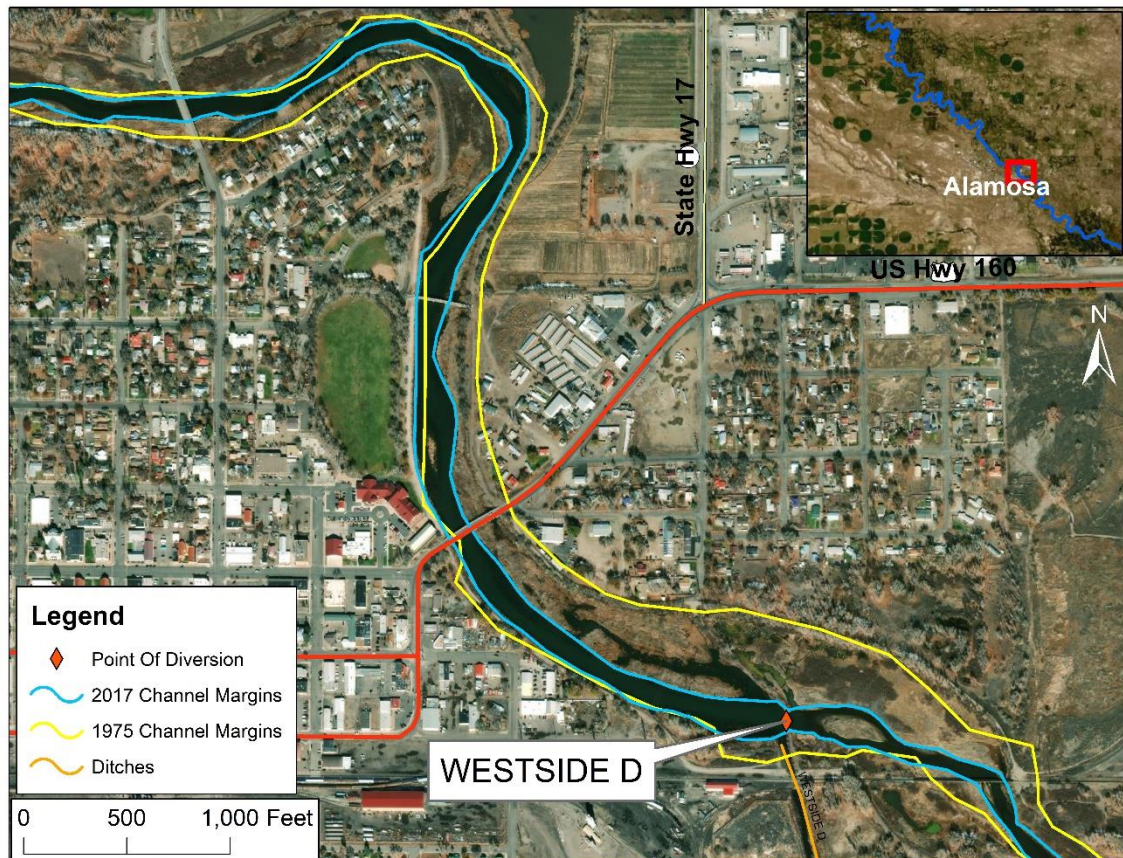
Headgate location with 1975 and 2017 channel margins overlaid
