Rio Grande Stream Management Plan

Rio Grande Basin Roundtable and the
Stream Management Plan Technical Advisory Team

Rio Grande Headwaters Restoration Project
623 E Fourth St
Alamosa, CO 81101

2020

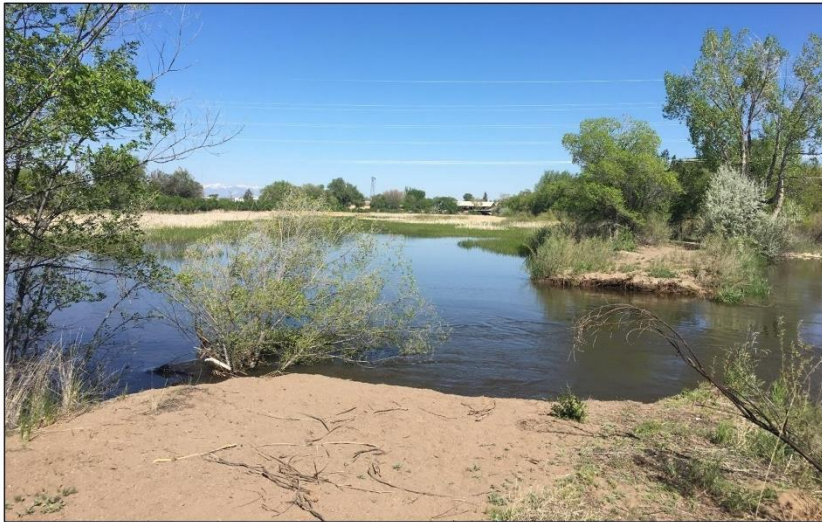
Failed levee north of diversion dam during Spring 2019 runoff.

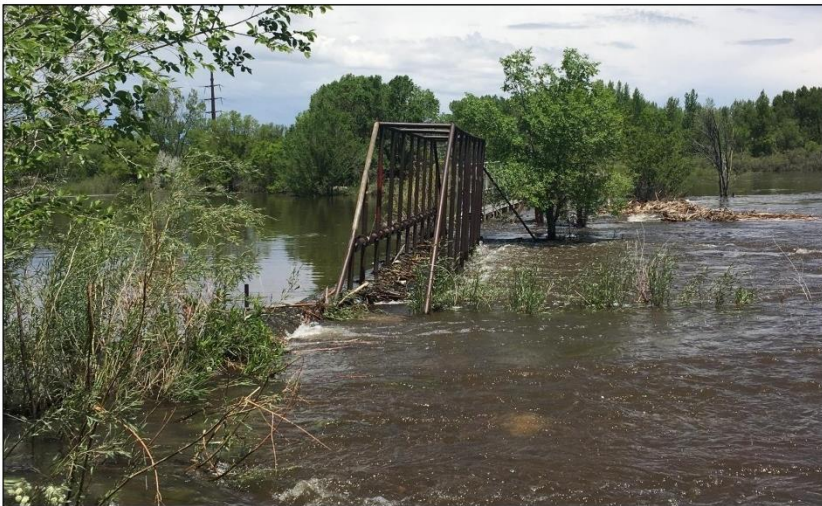
Flooded diversion dam during Spring 2019 runoff.

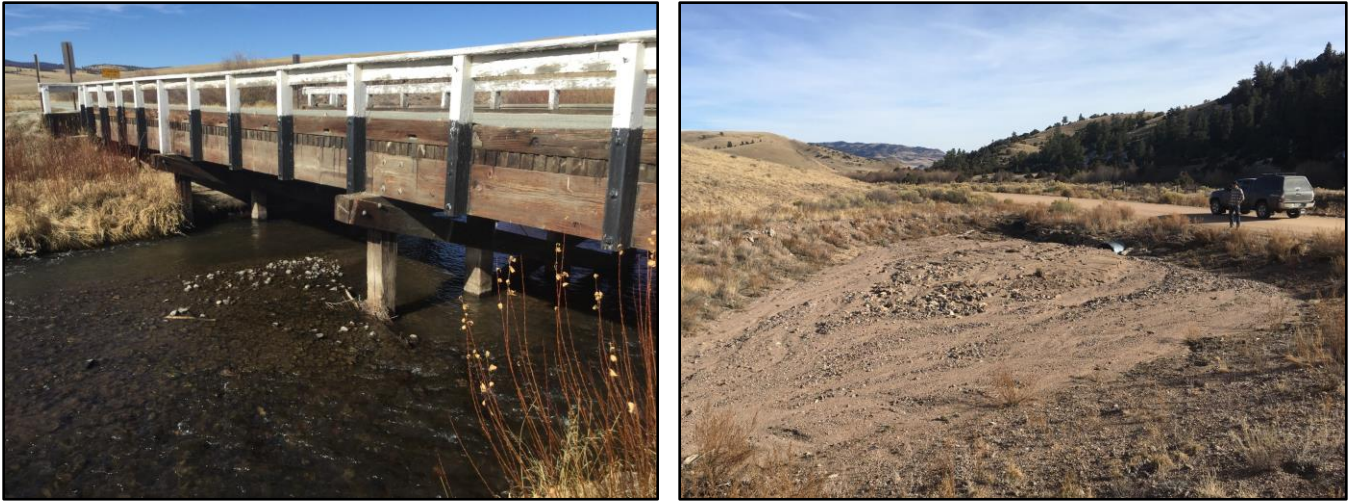
Figure 2.12: (Left) Bridge over Saguache Creek with a pier in the middle of the bridge that may collect debris during a flood. (Right) Undersized culverts failing to transport sediment in a dry wash in Saguache County.

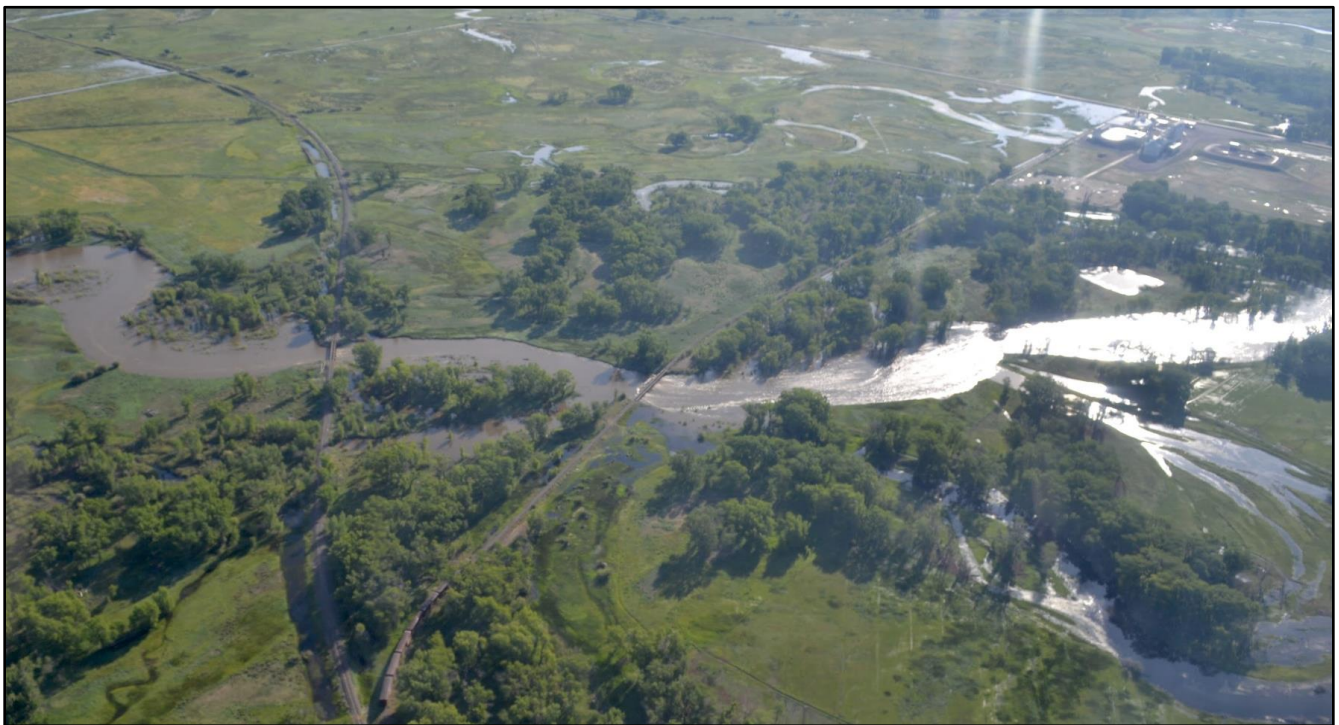
Roads oriented so they constrict the active river corridor can increase flow depths, shear stresses, and sediment transport capacities of streams. These constrictions can affect reaches upstream and downstream. Road and railroad bed encroachment does not appear to be significantly affecting the geomorphic stability of any of the streams in the SMP study area (Figure 2.13).

Figure 2.13: Railroad lines and bridges crossing the Rio Grande near flood stage, June 2019.

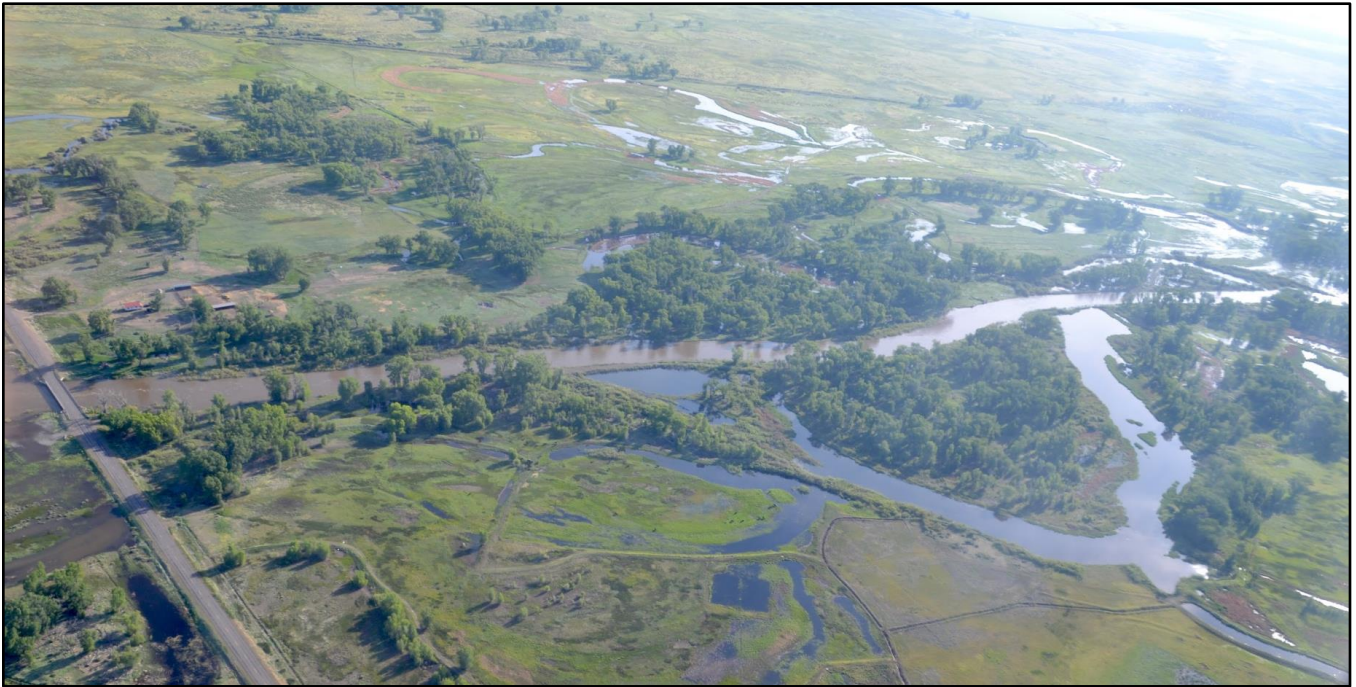
Channelization (i.e., straightening of channel meanders; removal of large wood and/or beavers; filling of side channels to force a stream into a single-thread) and stream bank armoring (i.e., placement of rock riprap, concrete barriers, or other materials to prevent channel migration or widening) has occurred on the SMP study streams and adversely affects natural channel processes and stream health. Figure 2.14 shows a channelized portion of the Rio Grande.

Figure 2.14: Channelization of the Rio Grande at the Soldiers Home Road (County Road 3E).

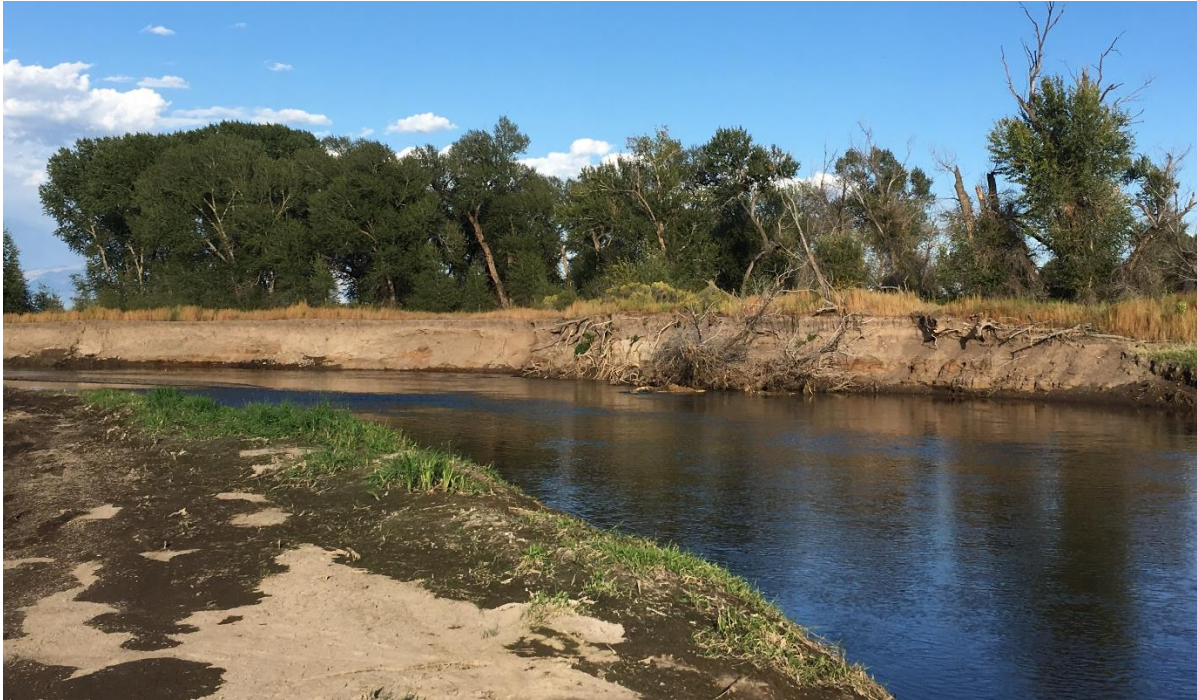
These features can cause river-floodplain disconnection (i.e., the river is unable to access its floodplain at high flows where it otherwise would have). Stream response to floodplain disconnection and/or bank armoring typically results in the transfer of erosive energy to the opposite bank, a downstream reach, or toward the channel bed.

Figure 2.15: River-floodplain disconnection on the Rio Grande upstream of Alamosa.

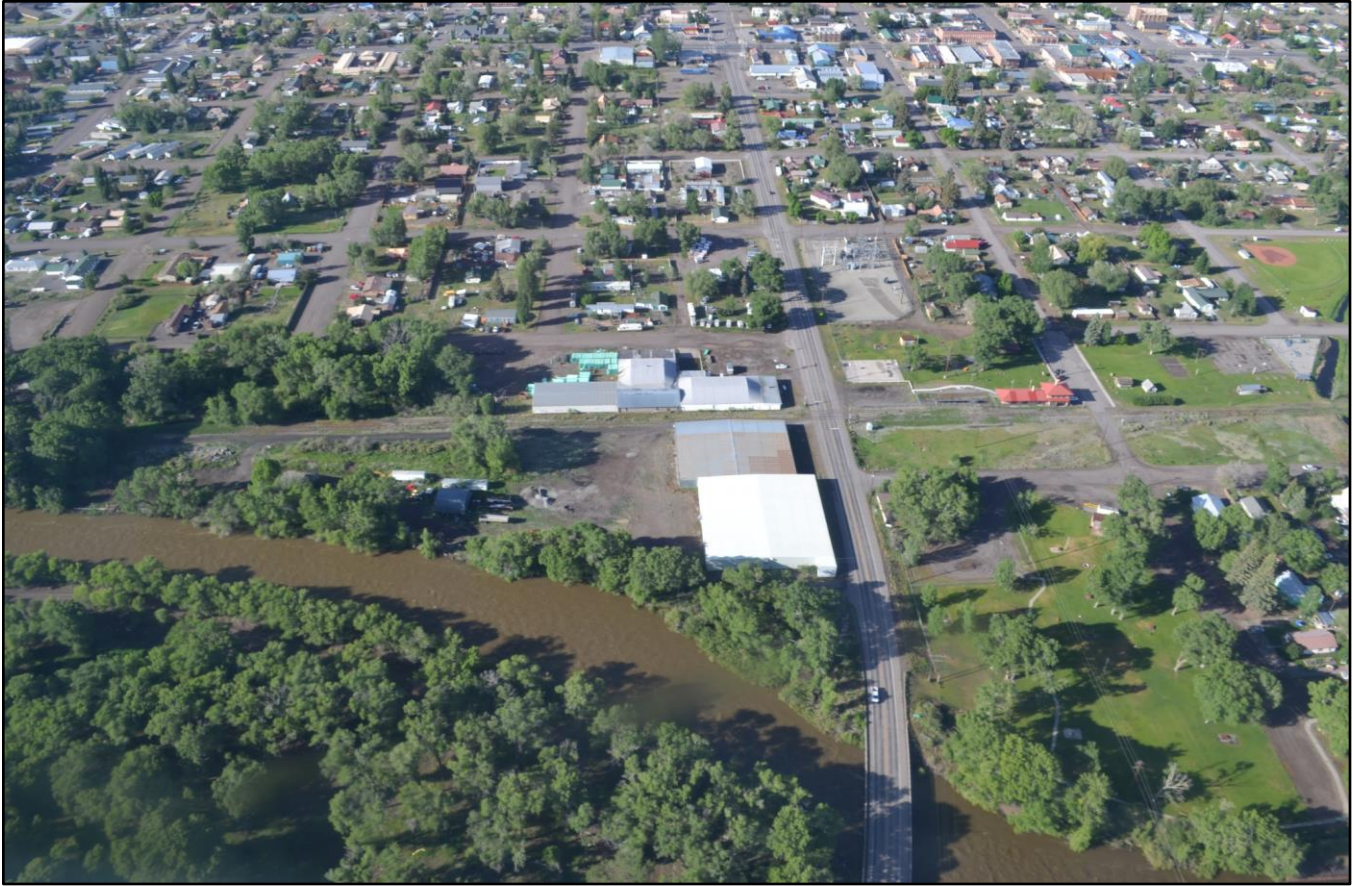
Land conversion can alter or eliminate floodplain complexity, side channels, wetlands, riparian vegetation, overflow relief channels, and other important geomorphic and ecological components of streams. Riparian vegetation and wetlands along some SMP reaches are impacted by fill and/or floodplain/riparian area conversion resulting from development, overgrazing, and nonnative species dominance. Riparian vegetation throughout the floodplain and river corridor, not just along the main channel, is critical to energy dissipation, stream shading, bank stability, wildlife habitat, and many other natural stream processes. Overgrazing and/or development fill brought into the corridor erases the evidence of past channel migration, possibly creating a false sense of protection from fluvial erosion to those that occupy the land. Furthermore, development creates the expectation (e.g., stable banks) that these rivers will remain in their current location indefinitely and therefore current and future generations will be willing and able to invest in the costs (both monetary and ecological) that will be required to resist natural channel processes (e.g., bank erosion and channel migration) (Figure 2.16).

Figure 2.16: Development in the active river corridor of the Rio Grande in the Town of Del Norte.

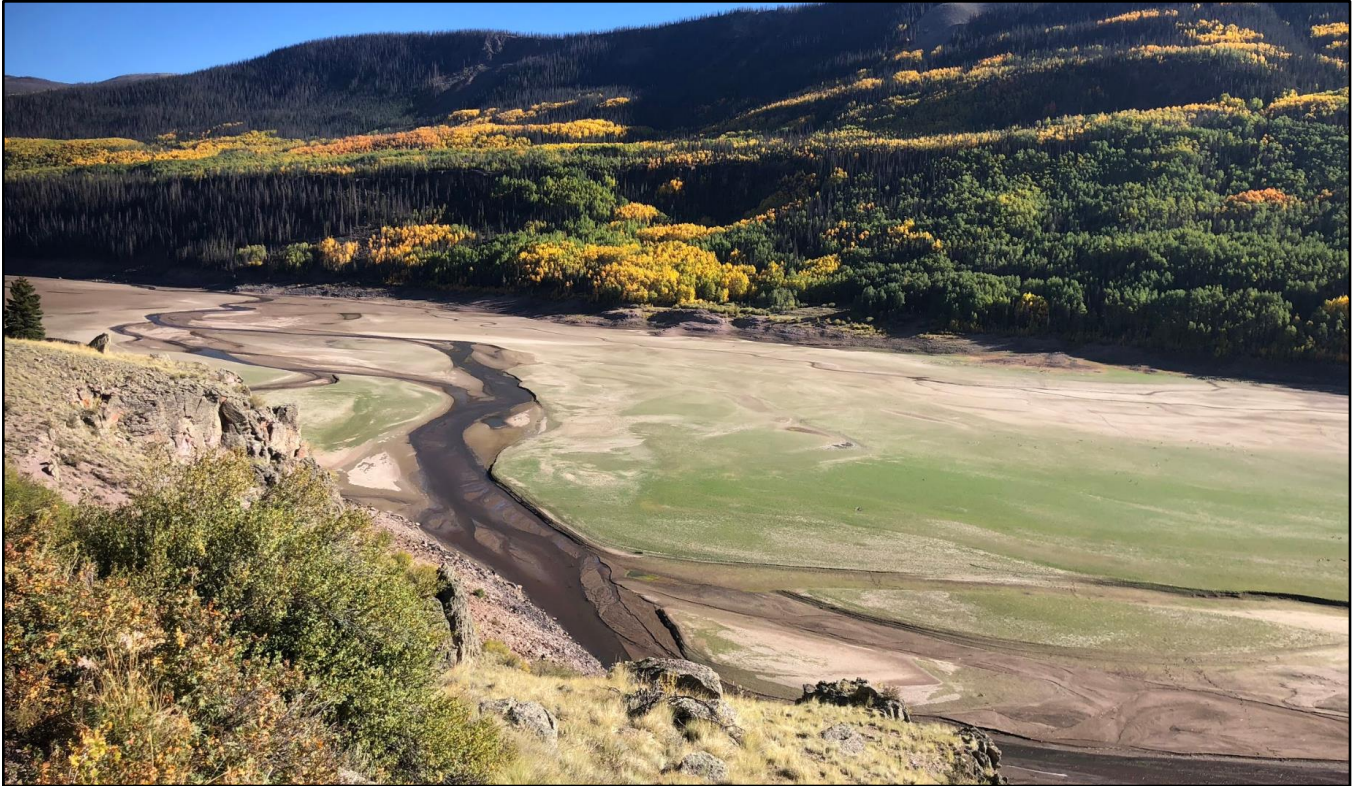
While Saguache Creek is a free-flowing stream, large dams affect both the Rio Grande and Conejos River. Dams affect these rivers both by reducing sediment transport, by trapping sediment behind them (Figure 2.17), as well as by reducing the peak flows that might otherwise provide channel-forming flows to flush fines, mobilize sediments, and do other geomorphic work. The Rio Grande is controlled by the earthen dam of the Rio Grande Reservoir which sits approximately 20 miles west of Creede. To a lesser degree, flows are also affected by Continental and Santa Maria reservoirs, which flow into Clear Creek. The Platoro dam on Conejos River is located roughly 1 mile above the town of Platoro, Colorado. Because these reservoirs are required to pass inflows during spring runoff, peak runoff is only altered when reservoir inflows surpass reservoir outlet capacity.

Figure 2.17: Sediment trapped behind the Rio Grande Reservoir (seen during dam repairs which had the reservoir drained during the fall of 2018).
