SAGUACHE CREEK DIVERSION INFRASTRUCTURE INVENTORY

Structure Name: COMMODORE D

Date: April 4, 2019

COMMODORE DITCH

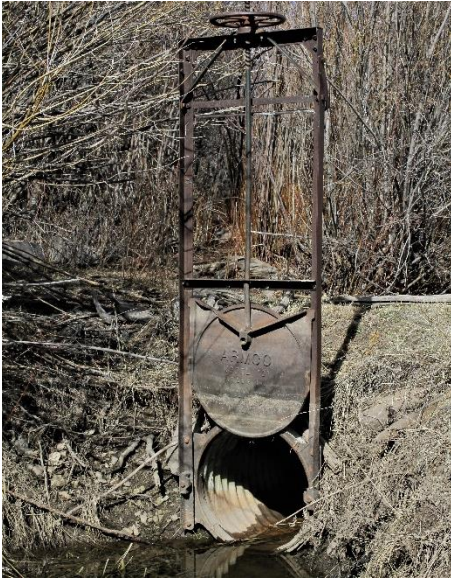
Headgate looking downstream

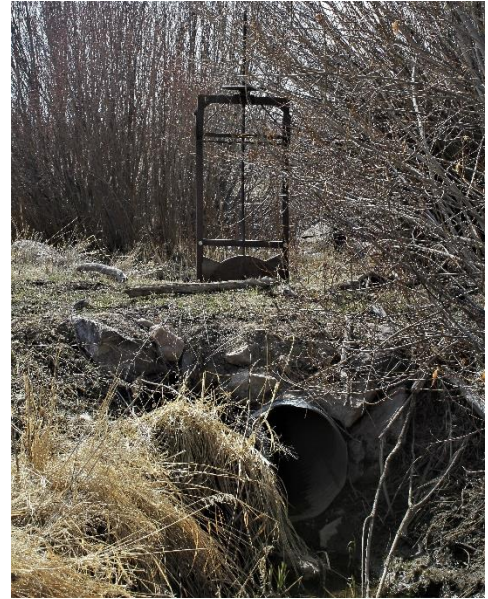
Headgate outlet

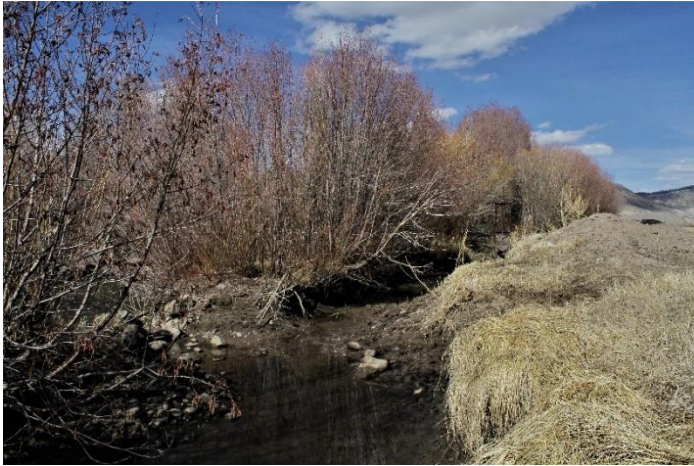
Feeder ditch and overflow channel

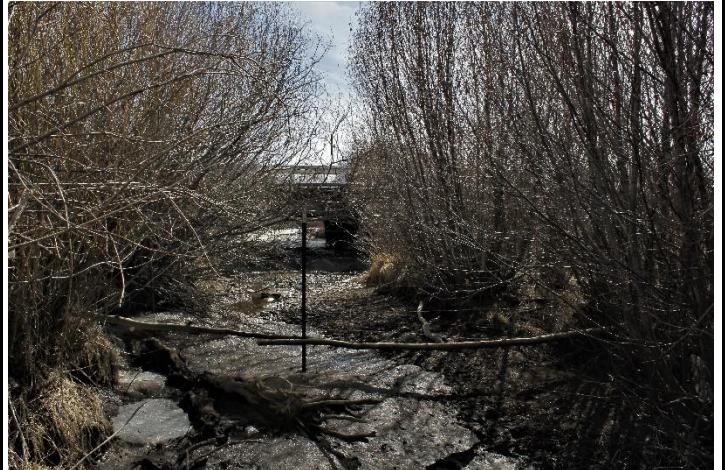
Feeder ditch looking upstream

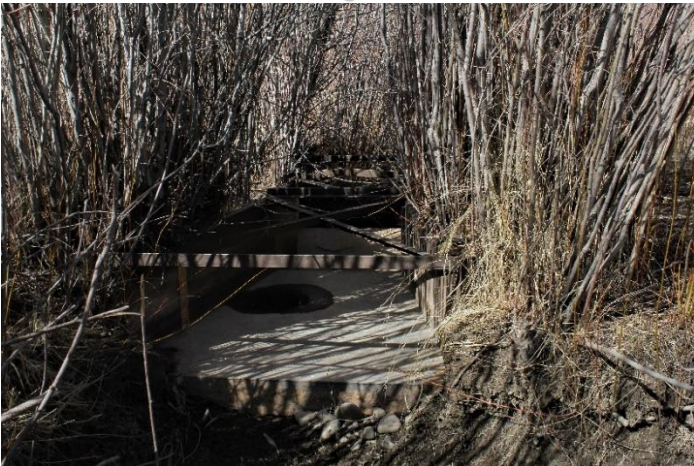
Structure Description: This structure is located just downstream of the Highway 114 bridge. There is no diversion dam for this ditch. Just downstream of Hwy 114, water flows into a short feeder channel on the east bank of the stream and then to the headgate. The headgate functions well. The flume is eroding on its downstream side.

Flume looking downstream

Repair(s) or Improvement(s) Currently Needed: The SMP Technical Advisory Team (TAT) recommends bank stabilization, riparian revegetation, and flume improvement. Stabilization and revegetation would help protect the diversion dam and headgate, as well as the Hwy 114 bridge. Filling the area below the flume would help ensure long-term measurement accuracy.

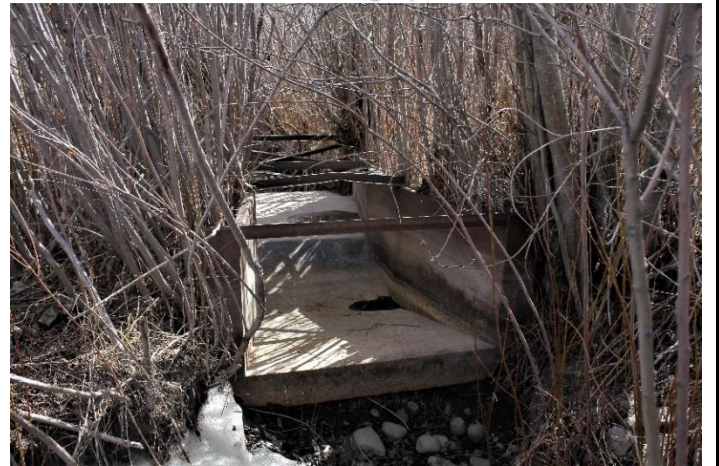
Flume looking upstream
