SAGUACHE CREEK DIVERSION INFRASTRUCTURE INVENTORY

Structure Name: FARRINGTON D 2

Date: August 8, 2019

Saguache Creek Stream
Management Plan

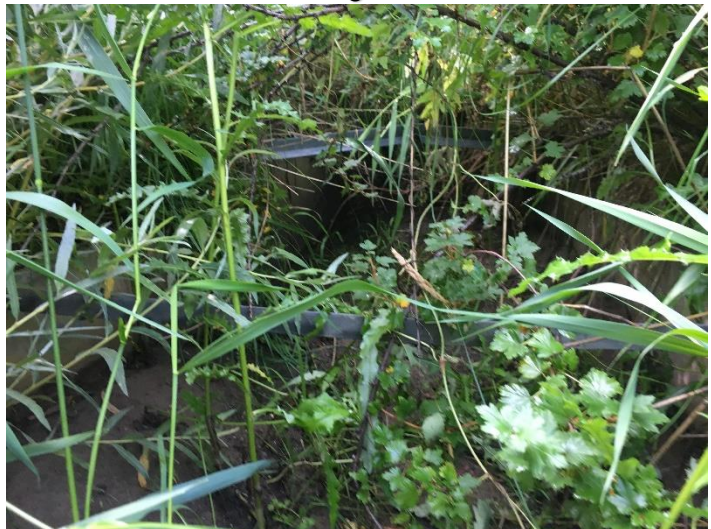
Flume looking downstream

Structure Description: This diversion is located on the outside of a tight meander. Bedrock features on the stream's southwest side prevent it from migrating in that direction. A stacked rock diversion dam with a utility pole directs water to the headgate, located on the south bank of the stream. The diversion creates a fish barrier at low flows and disrupts sediment transport capacity at this location. The flume's ability to function is hindered due to sedimentation and dense vegetation.

Repair(s) or Improvement(s) Currently Needed: The SMP Technical Advisory Team (TAT) recommends modifying the diversion to create fish passage and improve sediment transport capacity and cleaning the flume for improved measurement accuracy.
