SAGUACHE CREEK DIVERSION INFRASTRUCTURE INVENTORY

Structure Name: HODDING D 5

Date: April 12, 2019

Saguache Creek Stream Management Plan

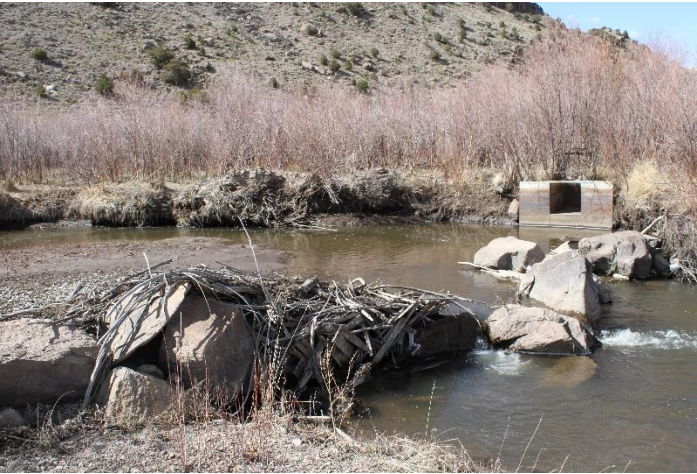
Diversion dam and headgate

Structure Description: This diversion is located on the outside of a meander. A boulder diversion dam directs flow to the headgate, which is located on the north bank of the stream. Upstream of the diversion, the channel is very wide. The diversion has created a small island in its middle that forms two channels, one leading to the headgate. Similar to Monk Ditch 3, a scour pool and island have formed downstream of the diversion dam. The meander downstream of the diversion is eroding.

Repair(s) or Improvement(s) Currently Needed: Given these issues, the TAT recommends diversion dam improvement, bank stabilization, and repairing or replacing the flume. A new diversion would allow the ditch to effectively divert water at low flows and reduce its impact on fish passage and sediment transport processes. A new flume would improve accuracy.
