# SAGUACHE CREEK DIVERSION INFRASTRUCTURE INVENTORY

**Structure Name:** MALONE D

**Date:** August 8, 2019

MALONE DITCH

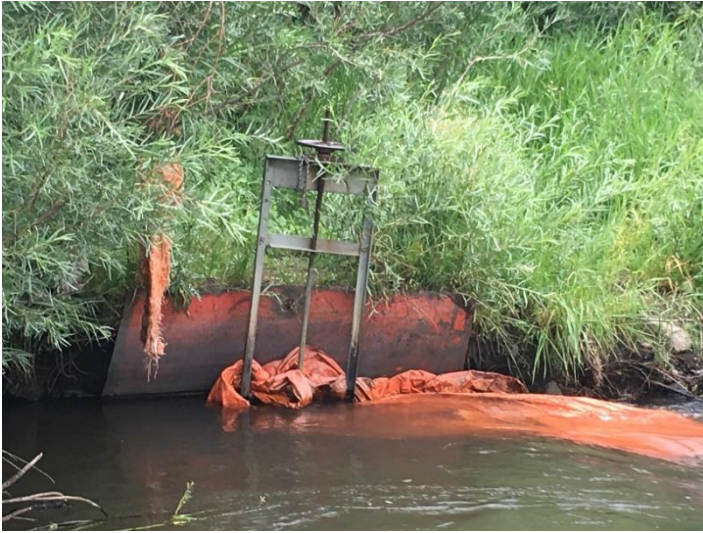
**Structure Description:** This structure is located on the outside of a short meander. A stacked rock diversion dam directs water to the headgate, located on the north bank of the stream. During 2019 spring runoff, the diversion dam partially washed out. The landowner was able to temporarily repair the diversion dam, but is likely to fail again in the future. The headgate functions moderately well but leaks.

Headgate looking downstream

**Repair(s) or Improvement(s) Currently Needed:** The SMP Technical Advisory Team (TAT) recommends replacing the diversion dam and repairing the headgate leak. A new diversion and headgate would reduce maintenance and increase efficiency.

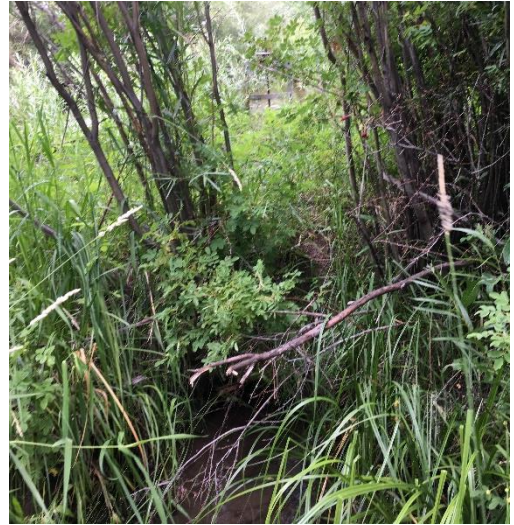
Headgate outlet

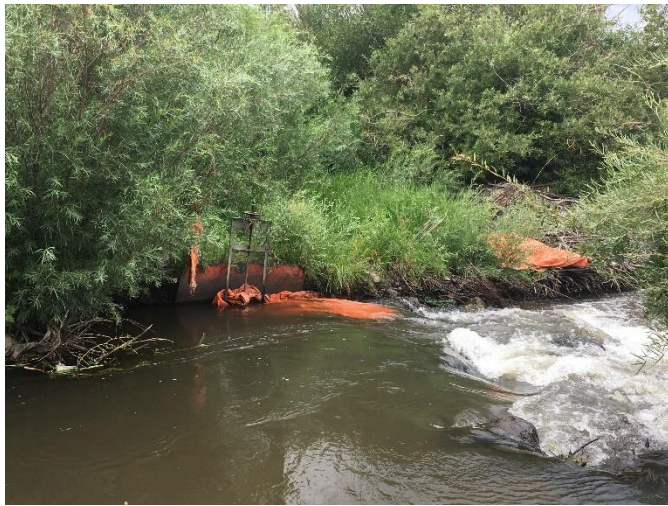
Headgate and diversion dam

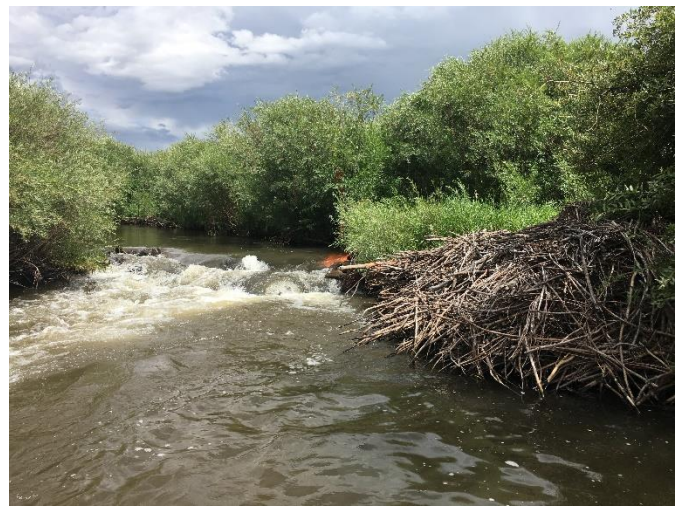
Diversion dam looking upstream

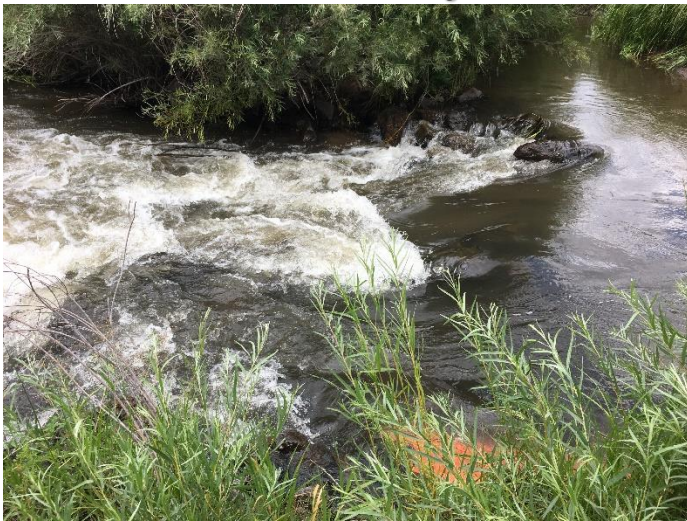
Diversion dam looking west

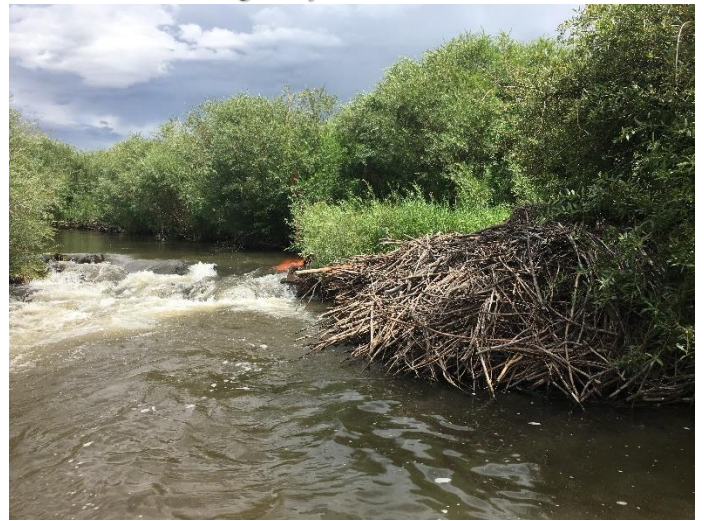
Beaver lodge adjacent to diversion dam
