SAGUACHE CREEK DIVERSION INFRASTRUCTURE INVENTORY

Structure Name: MILL D

Date: April 4, 2019

Saguache Creek Stream Management Plan

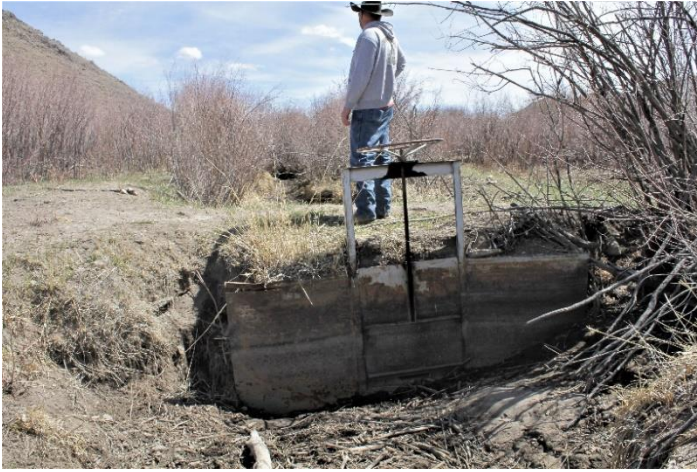
Headgate looking downstream

Structure Description: A diversion dam made up of boulders and t-posts directs water to the headgate on the north bank of the stream. The headgate functions poorly due to sediment and woody debris accumulation. The diversion dam functions effectively despite woody debris accumulation. The stream in this location is very sinuous and there is potential for channel avulsion to occur.

Repair(s) or Improvement(s) Currently Needed: Given the issues identified at this structure, the SMP Technical Advisory Team (TAT) recommends bank stabilization and riparian revegetation upstream of the diversion, and installation of a trash rack in front of the headgate. Bank stabilization would help prevent ditch failure and a trash rack in front of the headgate would reduce maintenance. Alternatively, the point of diversion could be relocated downstream to the next meander, where the diversion may require less maintenance.
