SAGUACHE CREEK DIVERSION INFRASTRUCTURE INVENTORY

Structure Name: MOSES GOFF D 1

Date: April 11, 2019

Saguache Creek Stream Management Plan

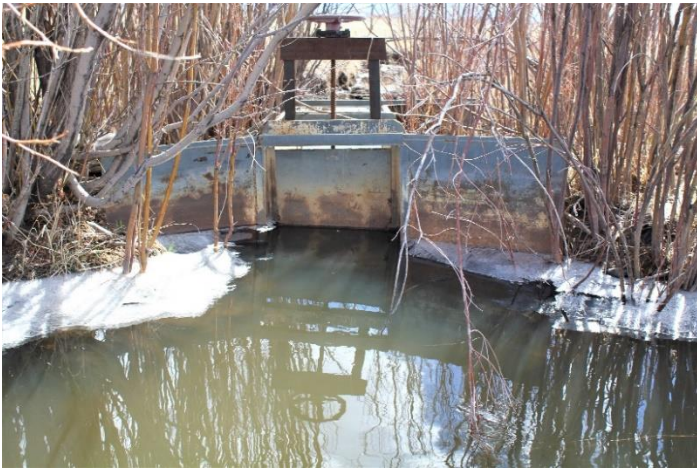
Structure Description: The diversion dam is a 2' wide culvert with steel wing walls. The headgate is on the east bank of the stream, and, despite being tilted, it functions effectively.

Headgate looking downstream

Repair(s) or Improvement(s) Currently Needed: The headgate may require repair in the future, however no immediate repair needs were noted.

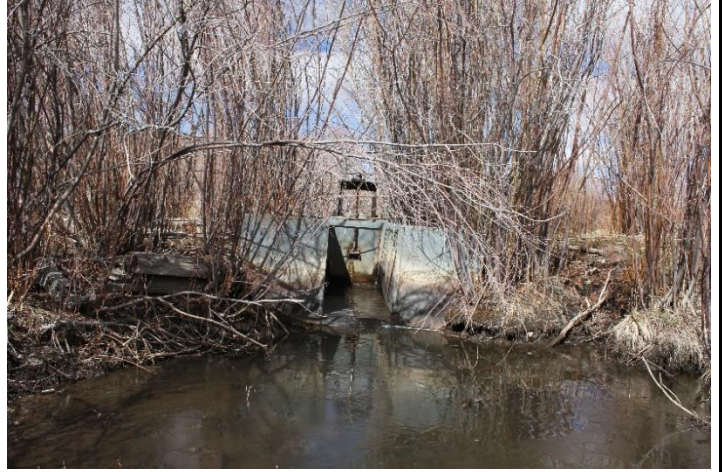
Headgate outlet

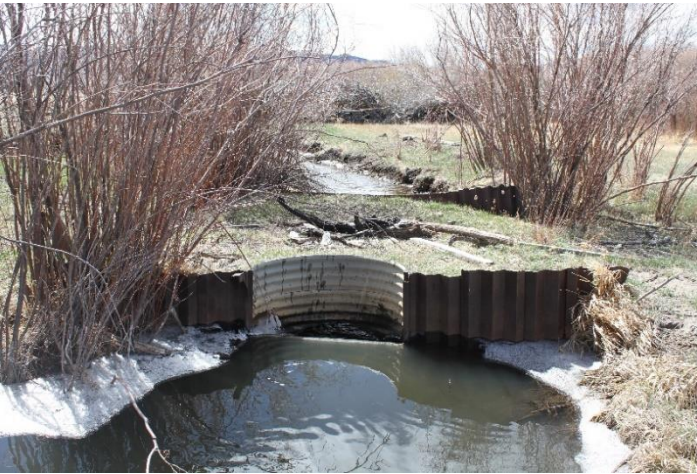
Diversion dam looking downstream

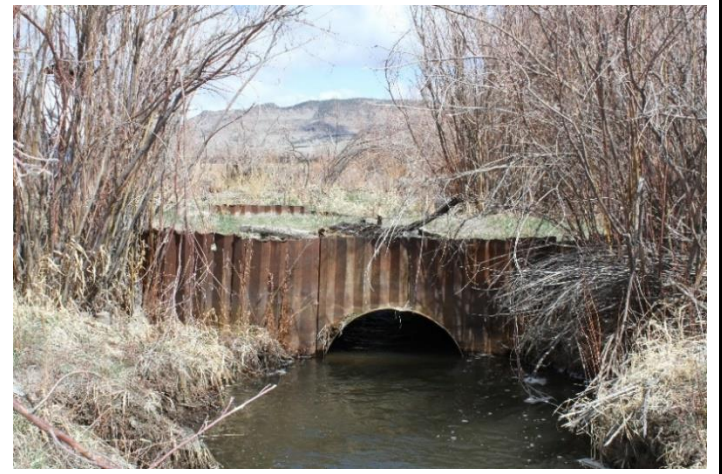
Diversion dam looking upstream

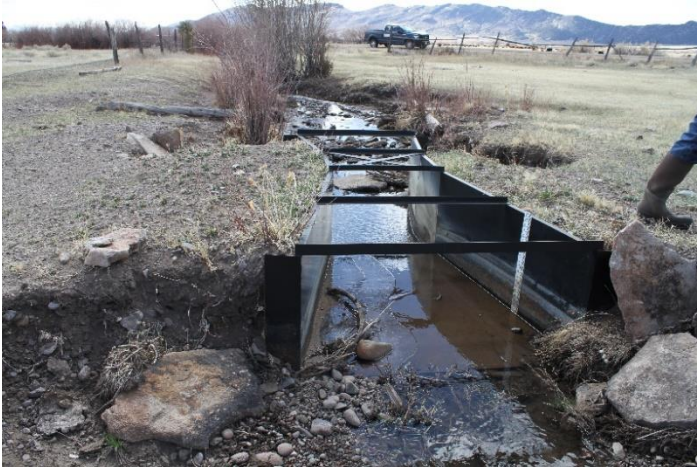
Flume looking downstream

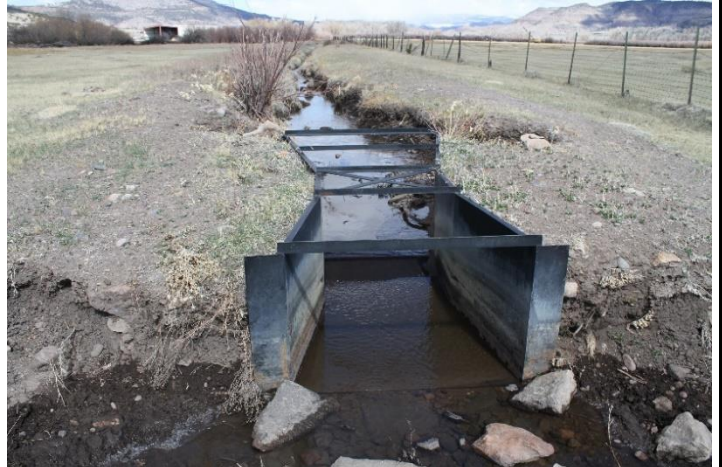
Flume looking upstream
