SAGUACHE CREEK DIVERSION INFRASTRUCTURE INVENTORY

Structure Name: MUNRO D 2

Date: April 11, 2019

Saguache Creek Stream Management Plan

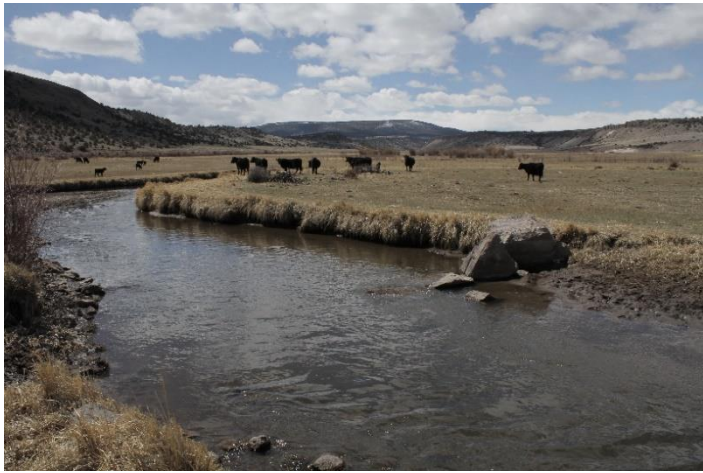
Diversion dam looking upstream

Structure Description: This diversion is located at the downstream end of a meander. A few boulders form the diversion dam, which functions poorly. The streambank upstream of the diversion is eroding and could cause the stream to bypass the headgate. The flume has sunken and woody vegetation has caused its side walls to collapse.

Repair(s) or Improvement(s) Currently Needed: Given these issues, the SMP Technical Advisory Team (TAT) recommends installing a new diversion, repairing or replacing the flume, and implementing bank stabilization upstream of the headgate to prevent further erosion. A more functional diversion would improve ditch function and flume repairs would improve long-term measurement accuracy. Alternatively, to reduce maintenance and stream impacts, this diversion could be relocated and consolidated with Friese Ditch 1.
