SAGUACHE CREEK DIVERSION INFRASTRUCTURE INVENTORY

Structure Name: NEHLS COMPANY D

Date: April 3, 2019

Saguache Creek Stream
Management Plan

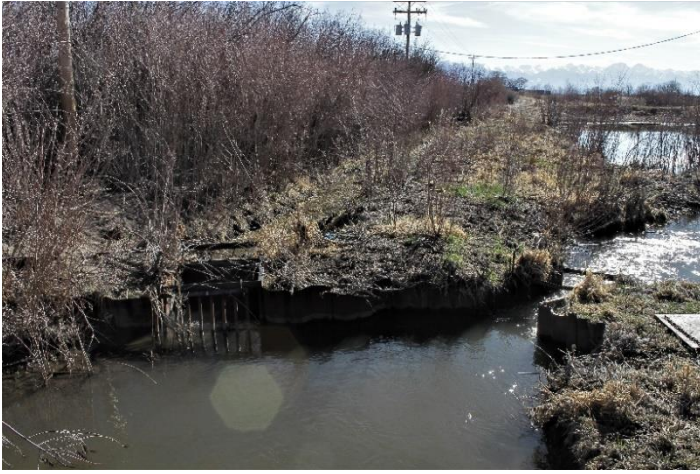
Headgate looking downstream

Repair(s) or Improvement(s) Currently Needed: As described above, the SMP Technical Advisory Team (TAT) recommends implementing riparian revegetation upstream of the diversion and installing a sluice gate adjacent to the headgate.

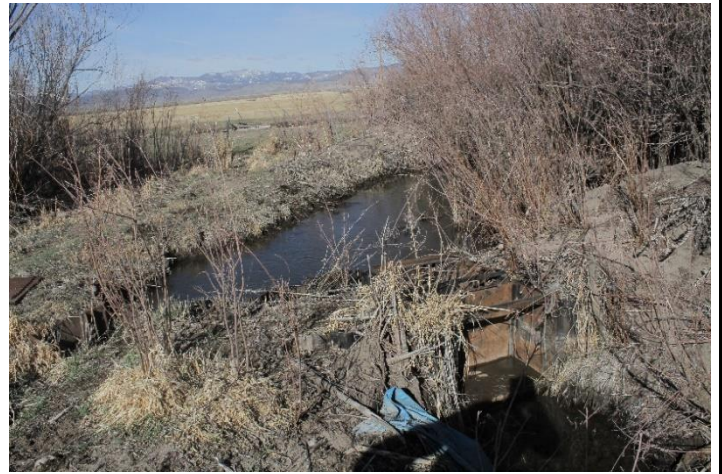
Headgate outlet

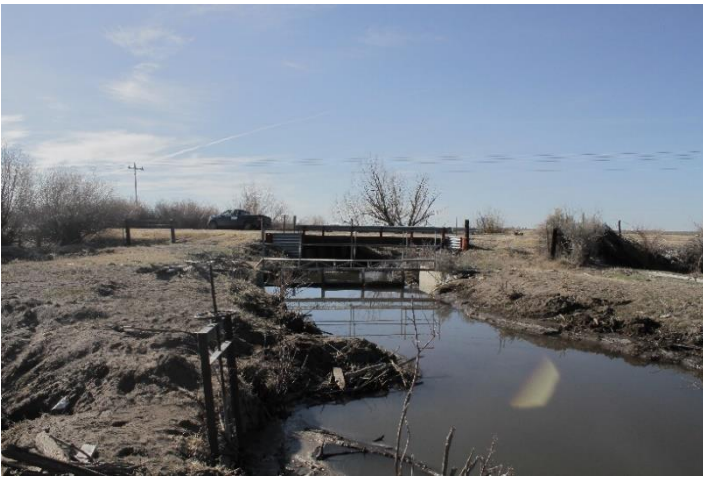
Diversion dam looking downstream

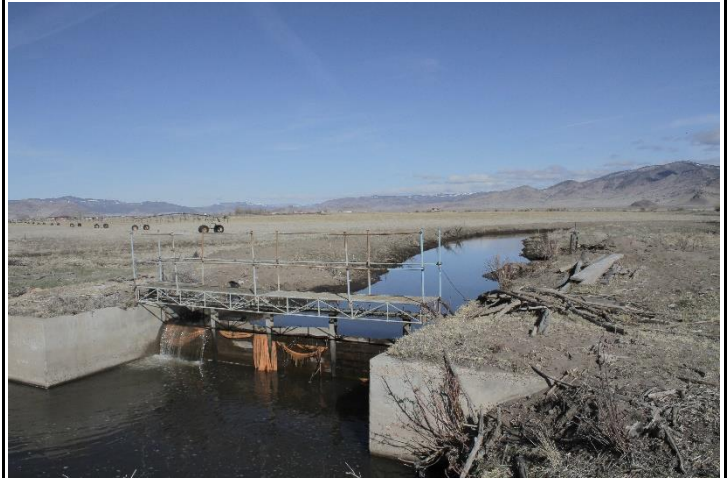
Diversion dam looking upstream

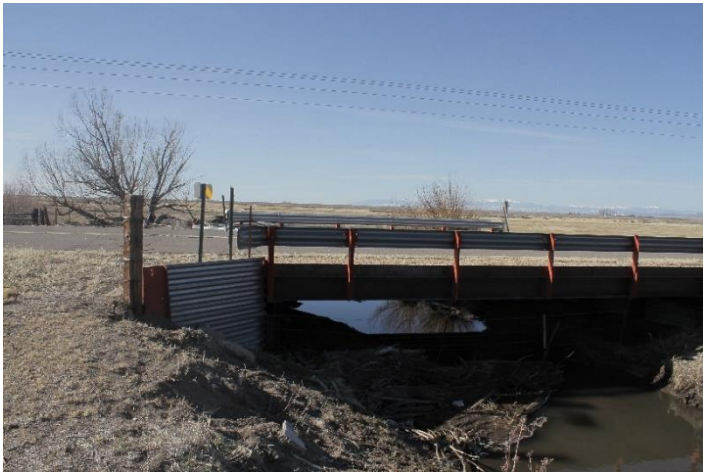
Braun Bridge looking downstream

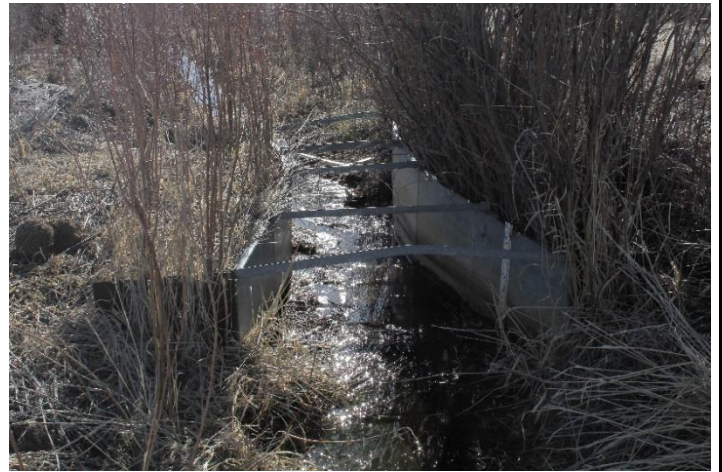
Flume looking downstream
