# SAGUACHE CREEK DIVERSION INFRASTRUCTURE INVENTORY

**Structure Name:** VAN ALLEN D & DOWNER 53

VAN ALLEN DITCH & DOWNER 53 DITCH

Saguache Creek Stream  
Management Plan

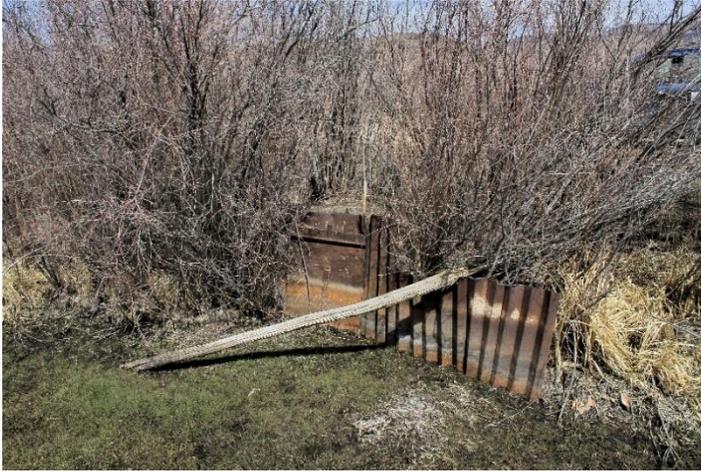
**Structure Description:** This diversion is located just upstream of County Rd Z. The Jaques Ditch headgate serves as the diversion dam, directing water to the headgate, which travels north under County Rd Z via a culvert. The headgate leaks and functions poorly. Downstream of Rd Z where the flume is located, the ditch is very wide. Both Van Allen Ditch & Downer 53 and Jaques Ditch pick up return flows from the Saguache Town drain and the wastewater treatment facility.

Headgate looking downstream

**Repair(s) or Improvement(s) Currently Needed:** The SMP Technical Advisory Team (TAT) recommends repairing the headgate leak to reduce maintenance and improve efficiency.

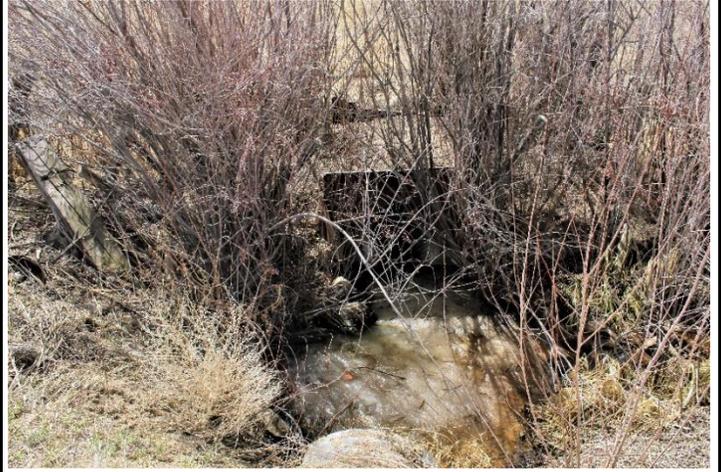
Headgate outlet

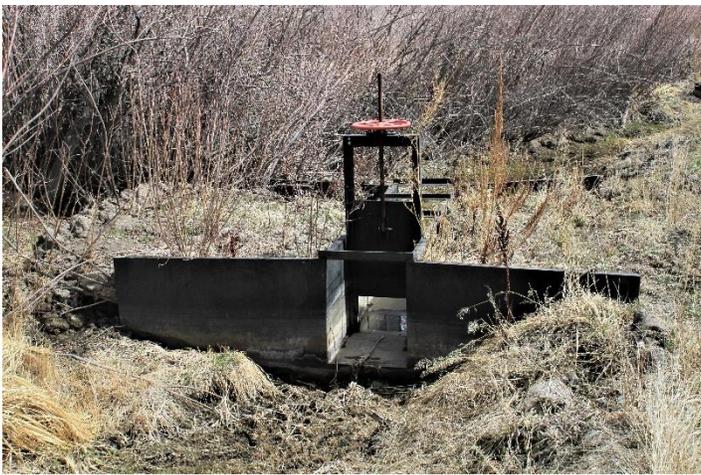
Diversion dam (JACQUES D)

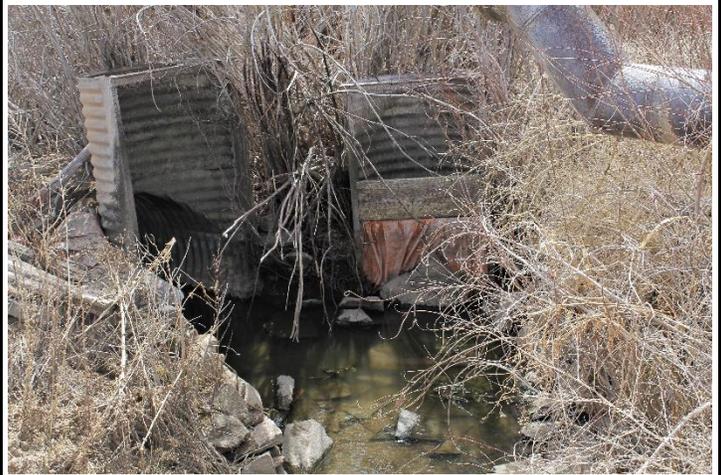
Culvert for ditch under County Rd Z

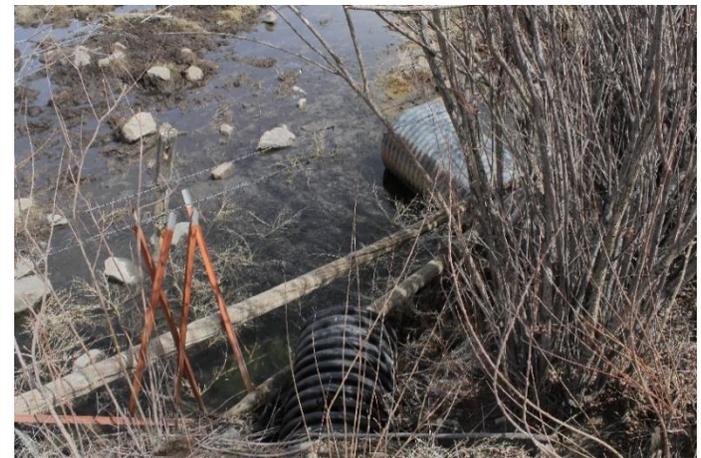
County Rd Z culvert outlet

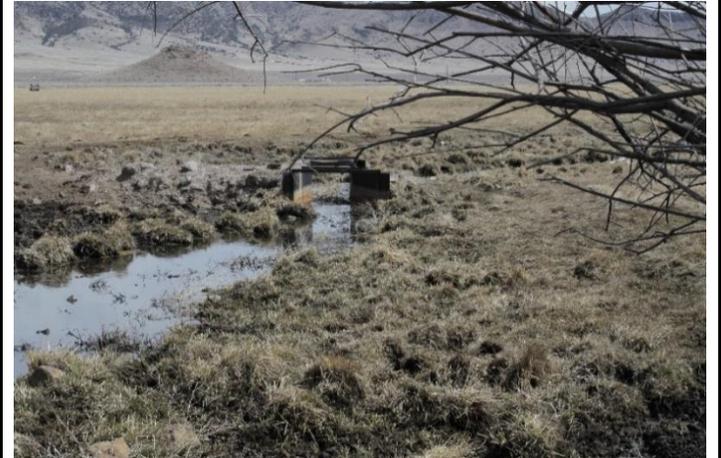
Flume looking downstream
