# SAGUACHE CREEK DIVERSION INFRASTRUCTURE INVENTORY

**Structure Name:** FARRINGTON D 1

**Date:** April 11, 2019

Saguache Creek Stream  
Management Plan

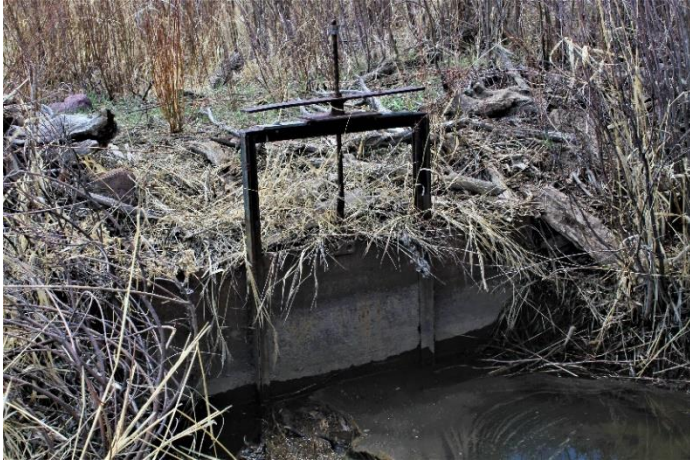
**Structure Description:** This diversion is located on the outside of a meander just southwest of Hwy 114. A boulder diversion dam directs water to a feeder channel, approximately 350 ft long, which is located on the northeast bank. The stream is wide in this location, and thus the diversion dam is supplemented with large hay bales to more effectively divert water from the stream. This diversion limits the stream's sediment transport capacity at this location and creates a barrier to fish passage due to its height. The headgate is difficult to operate because the adjustment handle is too close to the steel frame.

Headgate looking downstream

**Repair(s) or Improvement(s) Currently Needed:** The SMP Technical Advisory Team (TAT) recommends improving the diversion and replacing the headgate handle. A new diversion would reduce maintenance and improve fish passage as well as sediment transport at this location. Replacing the headgate handle would increase efficiency and reduce maintenance.

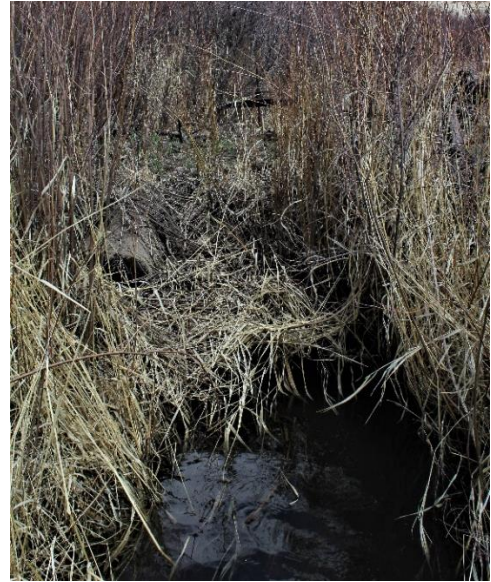
Headgate outlet

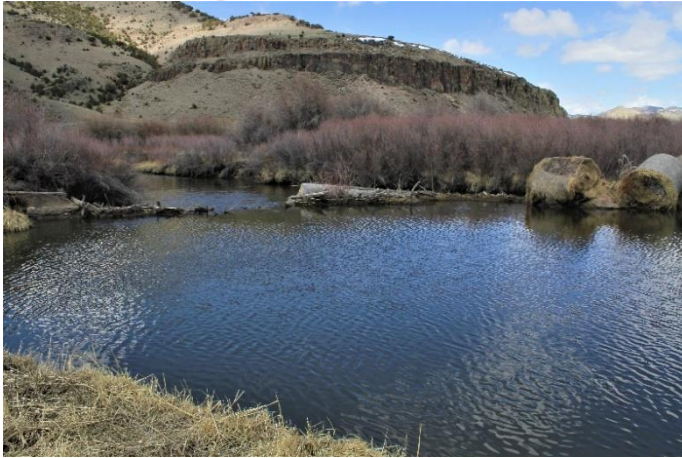
Headgate and diversion dam

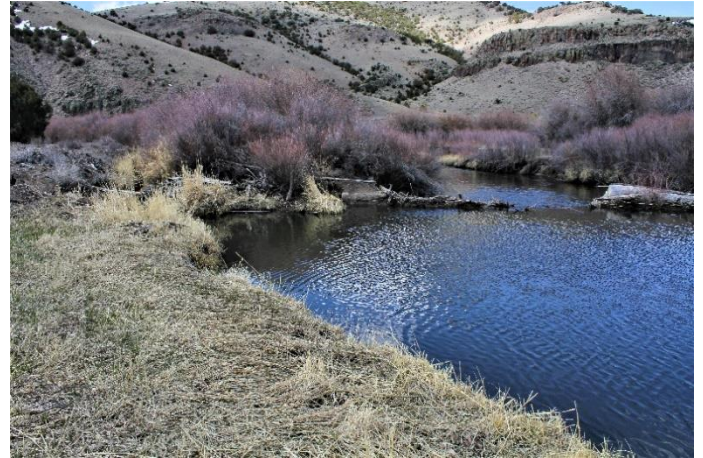
Diversion dam and feeder ditch

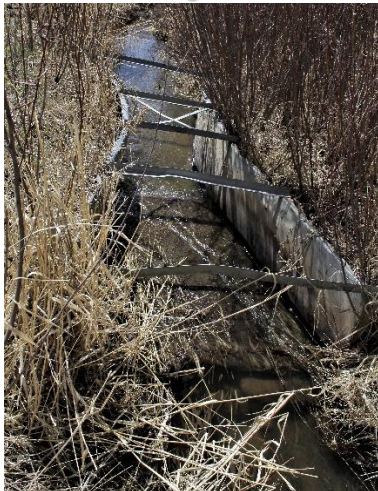
Flume looking downstream

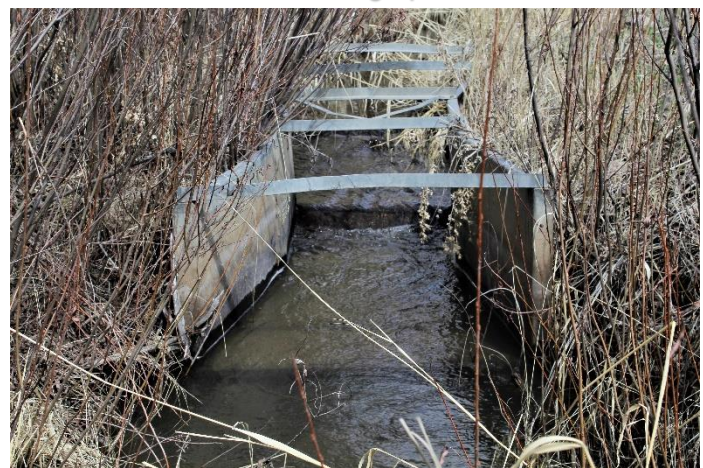
Flume looking upstream
