SAGUACHE CREEK DIVERSION INFRASTRUCTURE INVENTORY

Structure Name: FORD D

Date: April 11, 2019

**Saguache Creek Stream
Management Plan**

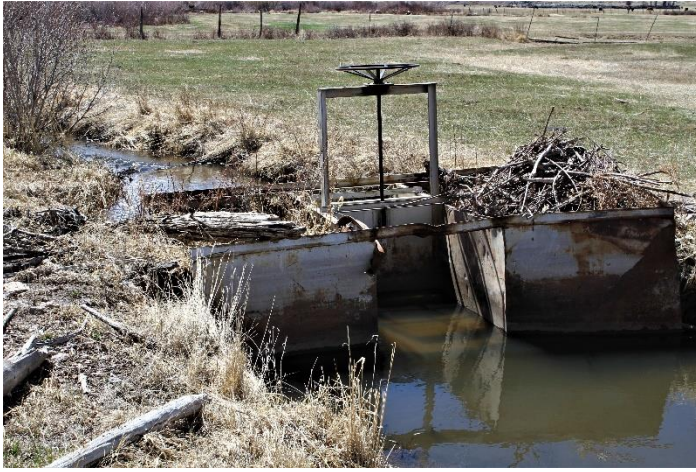
Structure Description: This diversion is located on the outside of a meander. A boulder diversion dam on either side of a mid-channel island directs water to a short feeder channel located on the north bank. The headgate functions well but experiences debris accumulation due to its location. The downstream bank of the feeder channel is eroding and could fail during high flows.

Headgate looking downstream

Repair(s) or Improvement(s) Currently Needed: Given the issues identified at this structure, the SMP Technical Advisory Team (TAT) recommends installing a trash rack, improving or relocating the diversion, and implementing bank stabilization. A trash rack would mitigate debris accumulation at the headgate. Bank stabilization upstream of the diversion and on the feeder channel would help prevent ditch failure. Diversion improvements using stacked rocks would reduce maintenance. Alternatively, the point of diversion could also be relocated to mitigate erosion and debris accumulation issues.

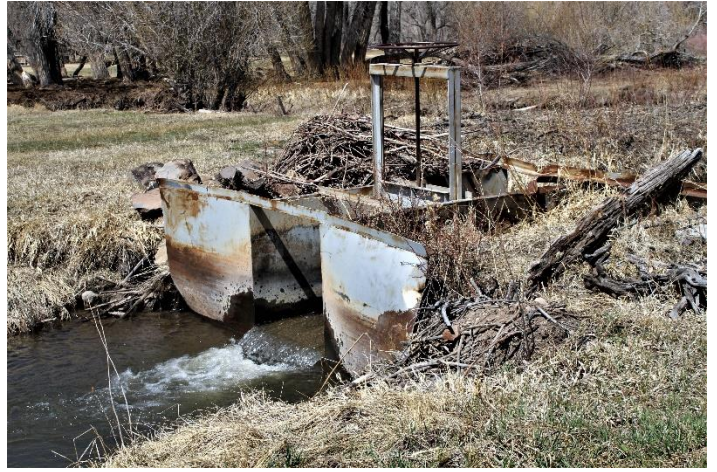
Headgate outlet

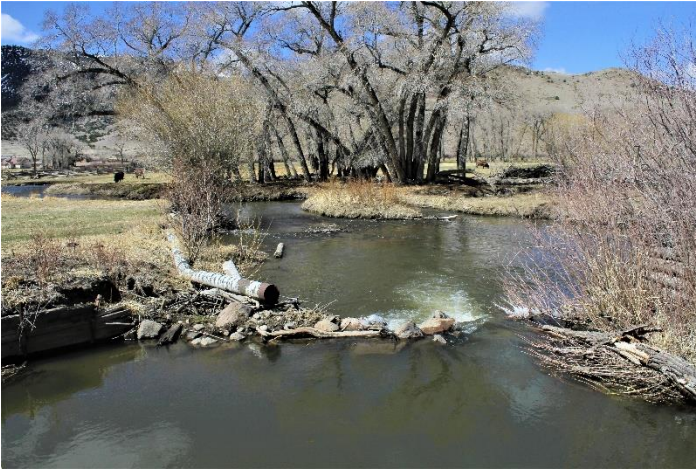
Diversion dam

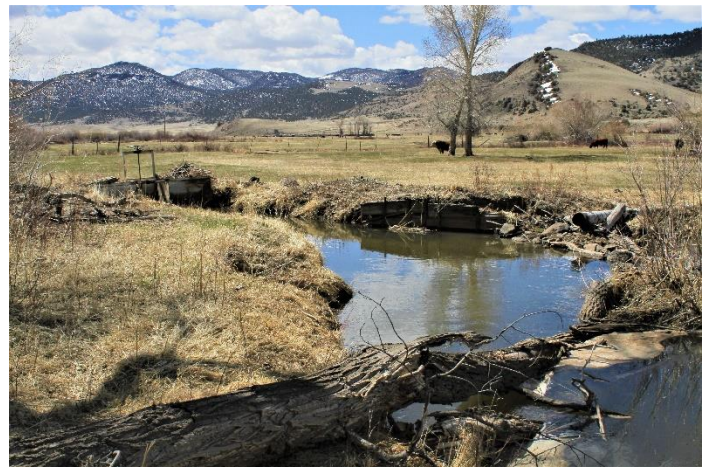
Diversion dam and feeder ditch

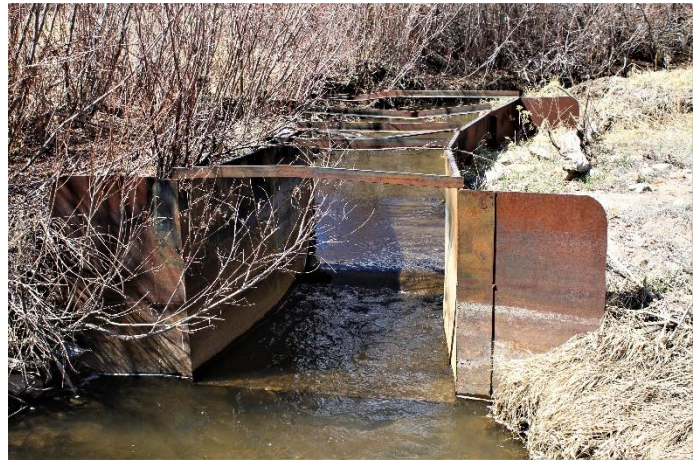
Flume looking downstream

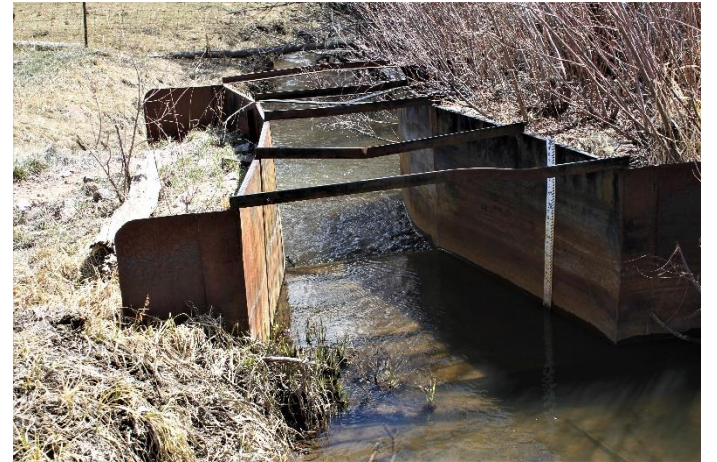
Flume looking upstream
