# SAGUACHE CREEK DIVERSION INFRASTRUCTURE INVENTORY

**Structure Name:** FULLERTON D 2

**Date:** July 3, 2019

Saguache Creek Stream Management Plan

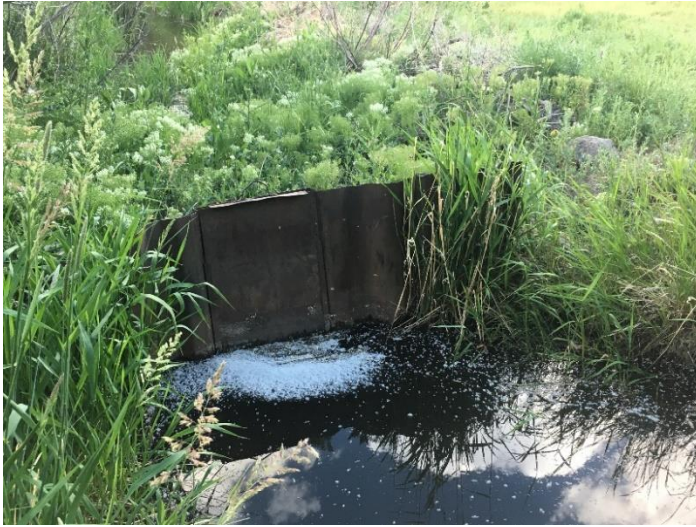
Headgate looking downstream

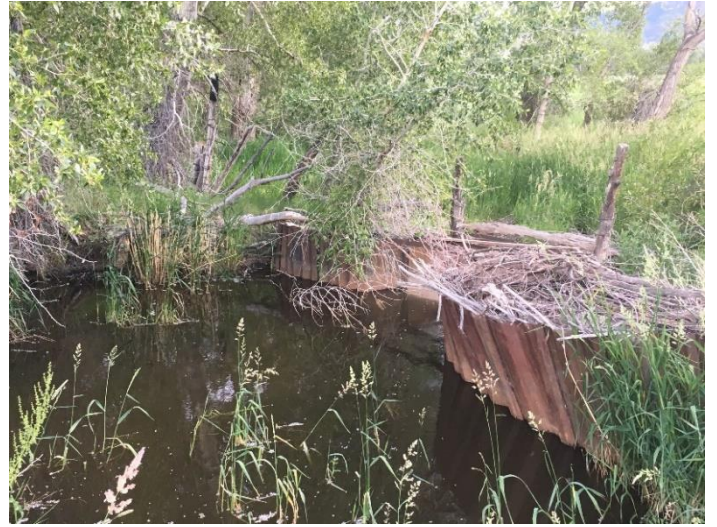
**Structure Description:** This diversion is just downstream of County Rd 42. A check board diversion dam directs water to the headgate, located on the south bank of the channel. Sediment accumulation is an issue for this ditch, especially below the headgate. Woody debris also impacts the diversion structure and culvert under County Rd 42.

Diversion dam looking downstream

**Repair(s) or Improvement(s) Currently Needed:** The diversion dam can get clogged with woody debris, leading to extensive maintenance and administration challenges on the Werner Arroyo. Although there is no clear long-term solution to the debris accumulation, the SMP Technical Advisory Team (TAT) recommends regular debris clearing. Additionally, the flume is tilted and the TAT recommends leveling it.

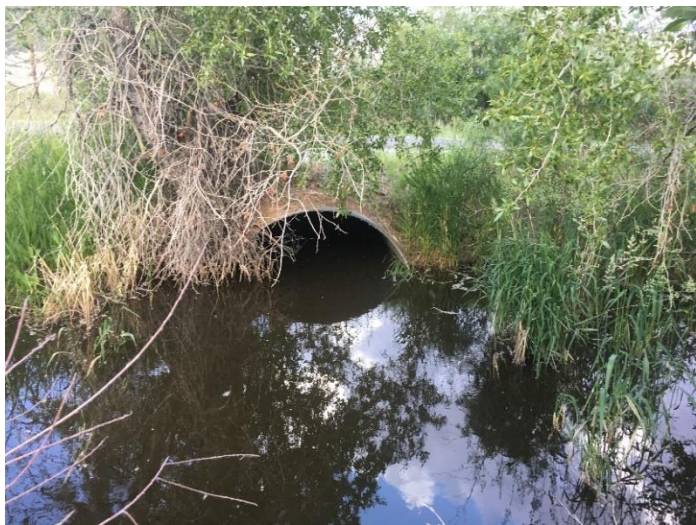
Headgate and diversion dam

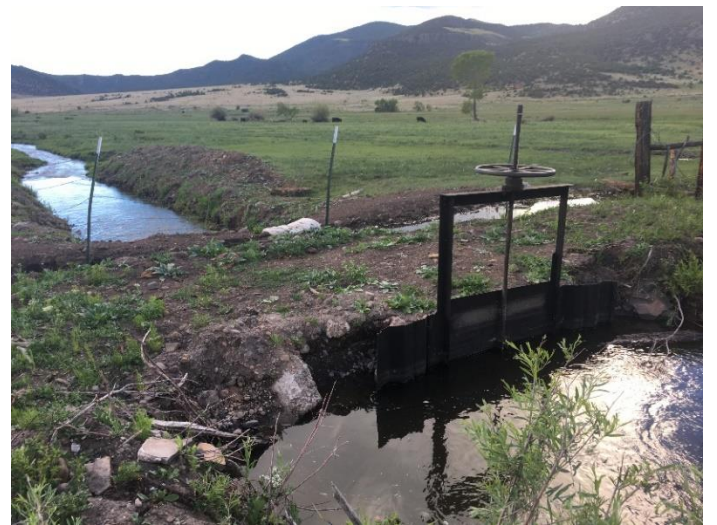
Werner Arroya headgate

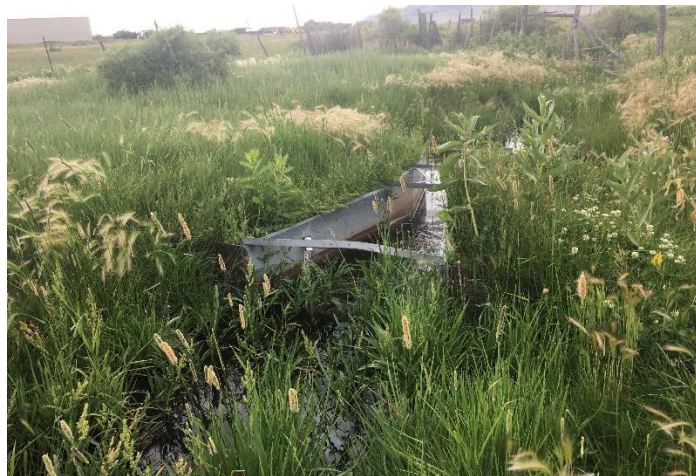
Flume looking downstream

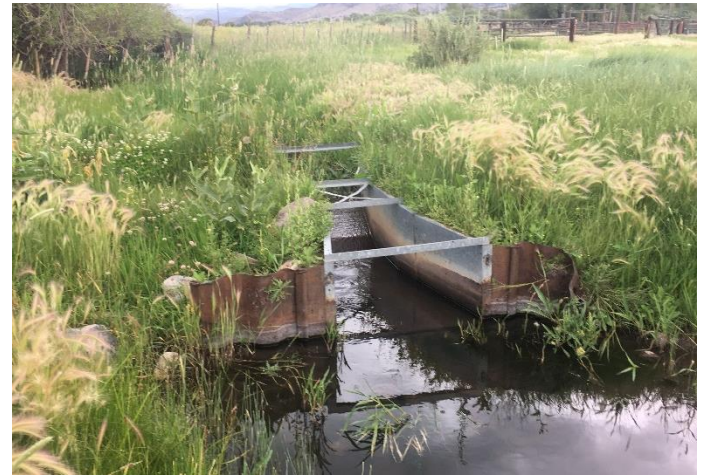
Flume looking upstream
