SAGUACHE CREEK DIVERSION INFRASTRUCTURE INVENTORY

Structure Name: MONK D 3

Date: April 12, 2019

Saguache Creek Stream Management Plan

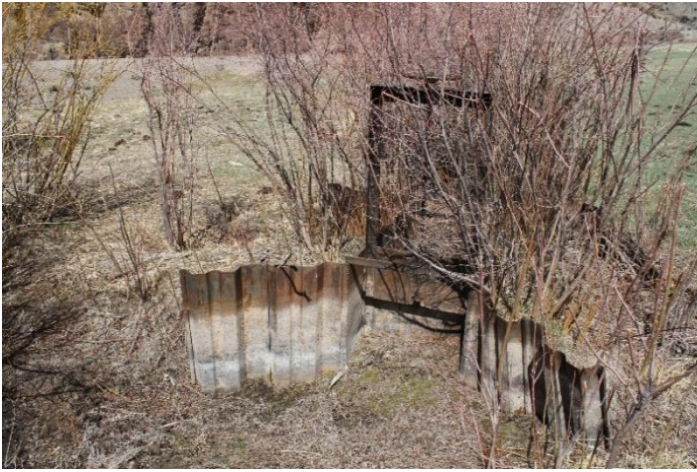
Structure Description: This diversion is located at the apex of a meander. A narrow boulder diversion dam directs water to the headgate, which is located on the north bank of the stream. The headgate is tilted and difficult to operate. The dam constricts the channel, leading to downstream scour and forming a barrier to fish passage at low flows. An island has formed due to the scour pool and subsequent sediment deposition just downstream of the pool. This has caused the channel downstream of the diversion to become wide and shallow. Downstream of the diversion, there are several streambanks that are sloughing and channel avulsion is likely but would not affect downstream structures.

Headgate looking downstream

Repair(s) or Improvement(s) Currently Needed: The SMP Technical Advisory Team (TAT) recommends replacing the diversion and resetting the headgate for ease of use. The TAT also recommends creating fish passage at this location. A new diversion could be rebuilt to be wider and shorter to minimize its impact on the stream and allow for fish passage.

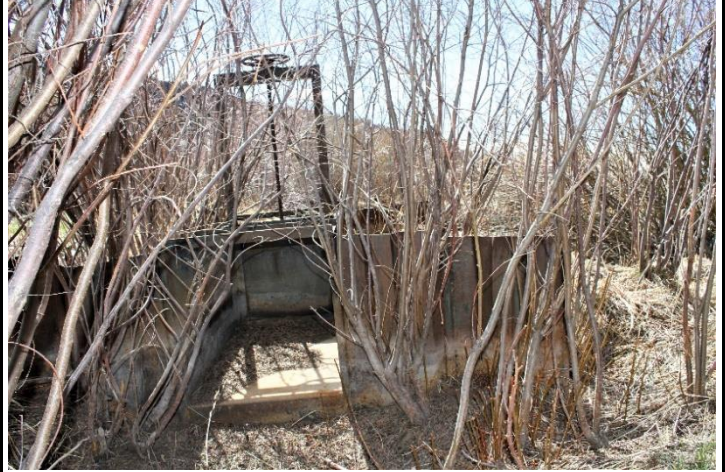
Headgate outlet

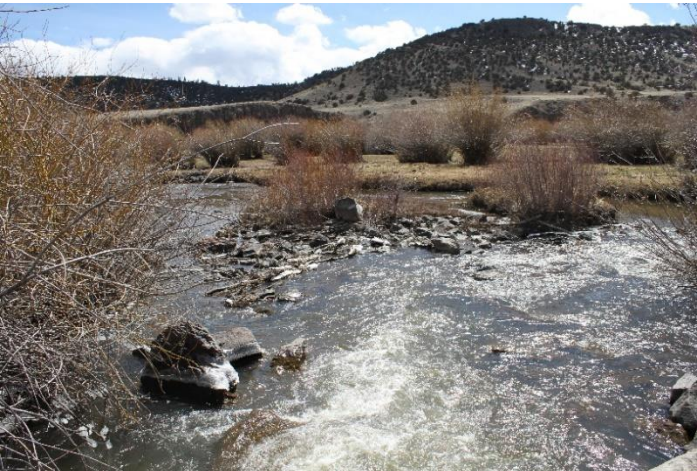
Channel downstream of diversion dam

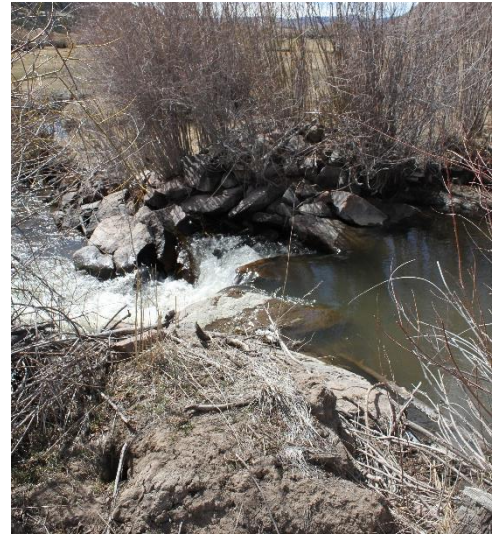
Diversion dam

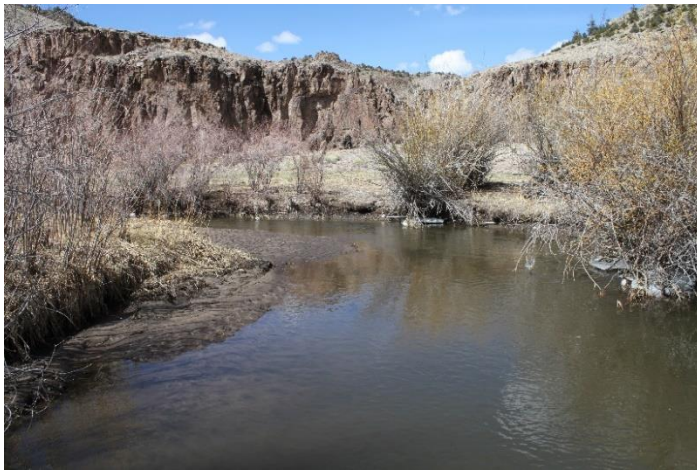
Channel upstream of diversion dam

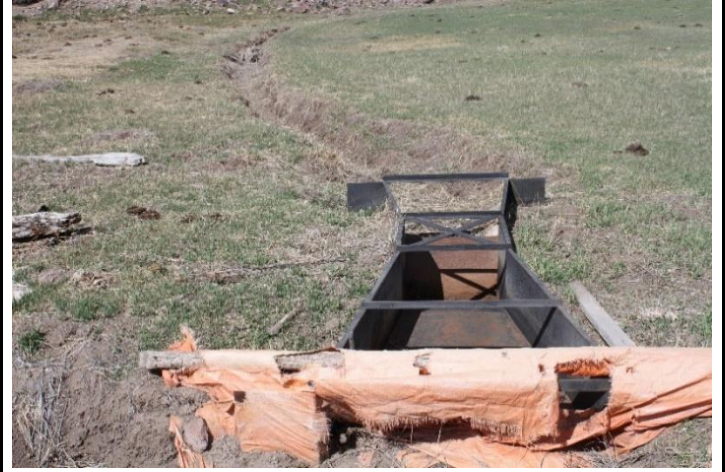
Flume looking downstream

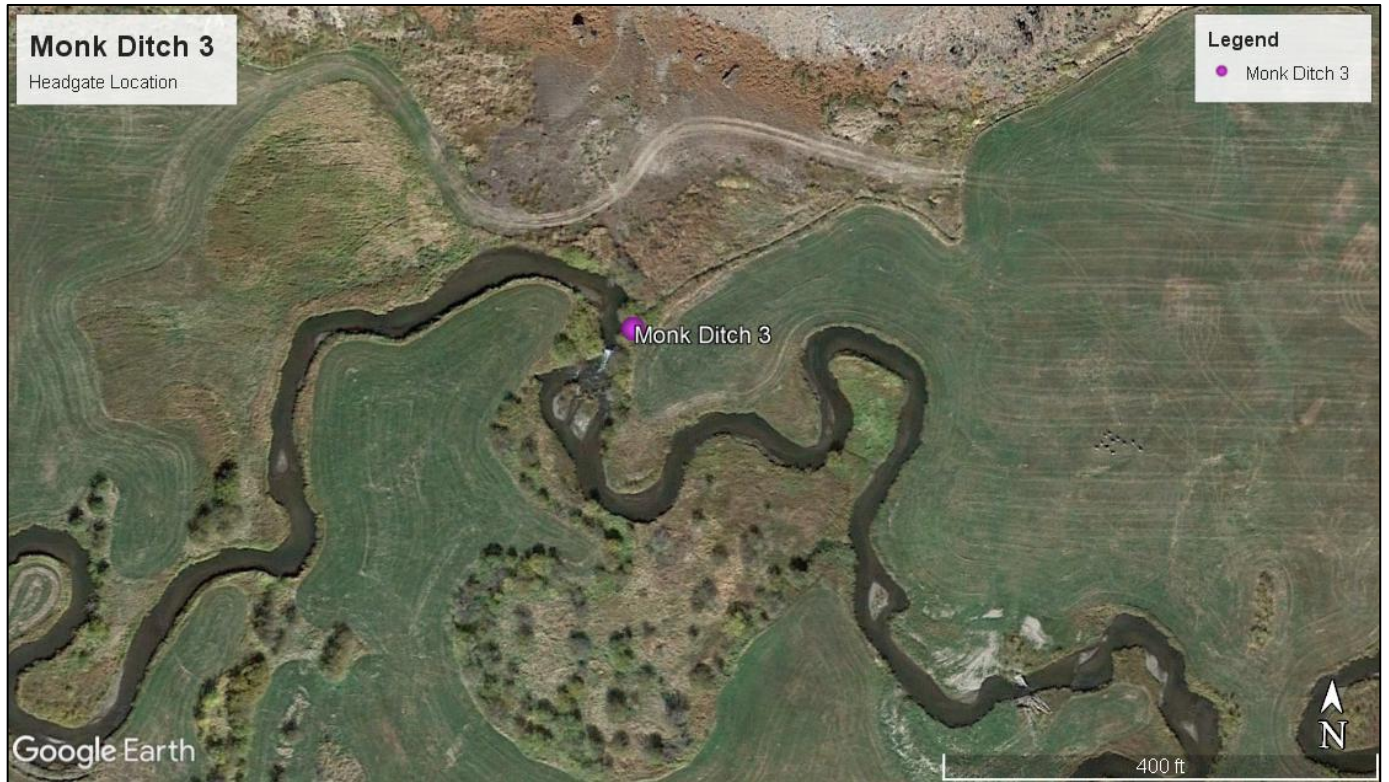
Headgate location and surrounding stream channel

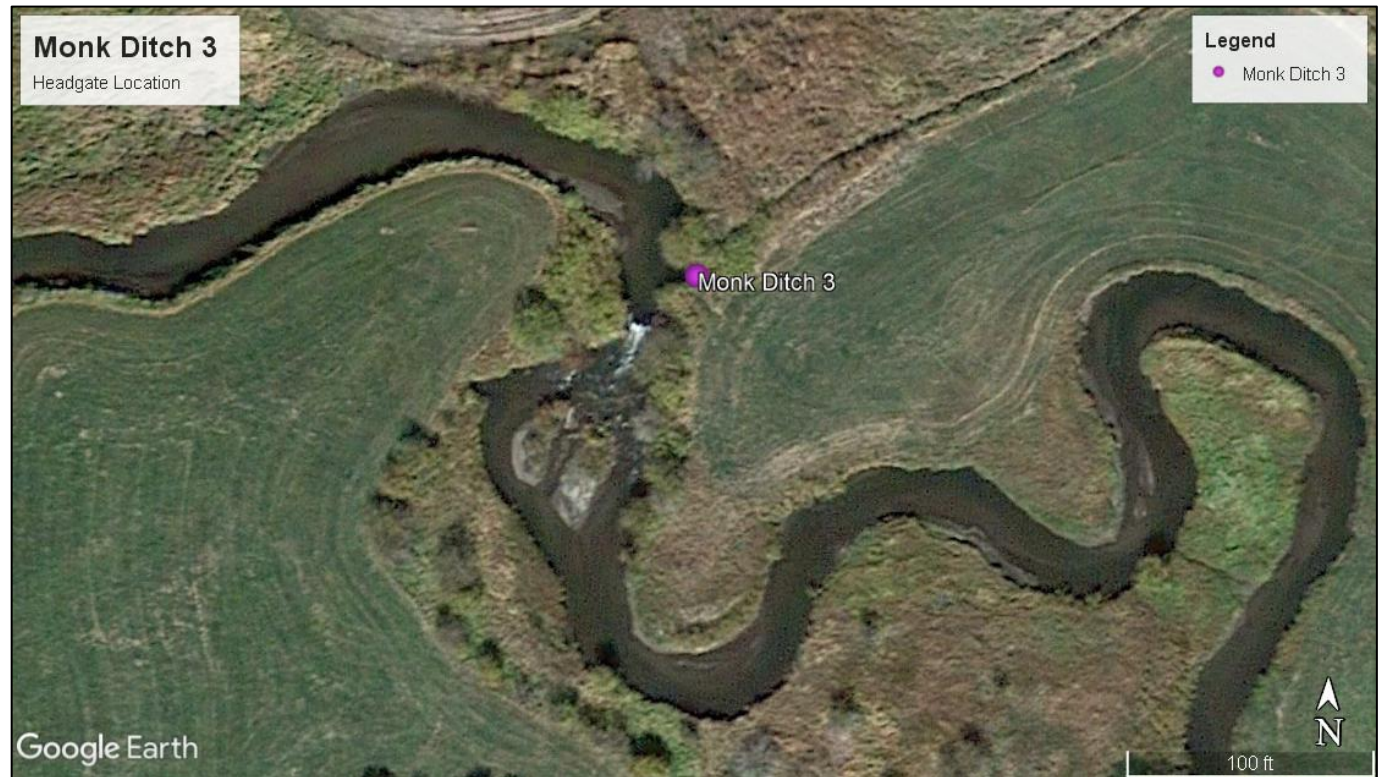
Close-up of headgate and diversion dam. This image illustrates the channel constriction caused by the diversion dam and resulting effects on the stream.
