SAGUACHE CREEK DIVERSION INFRASTRUCTURE INVENTORY

Structure Name: MOSES GOFF D 2

Date: April 11, 2019

Saguache Creek Stream
Management Plan

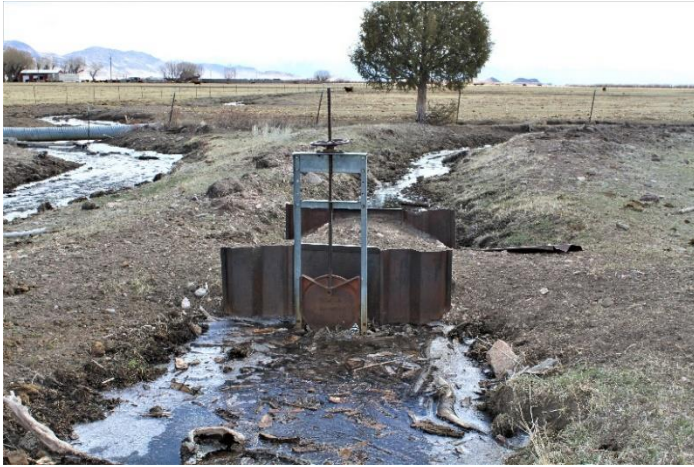
Headgate looking downstream

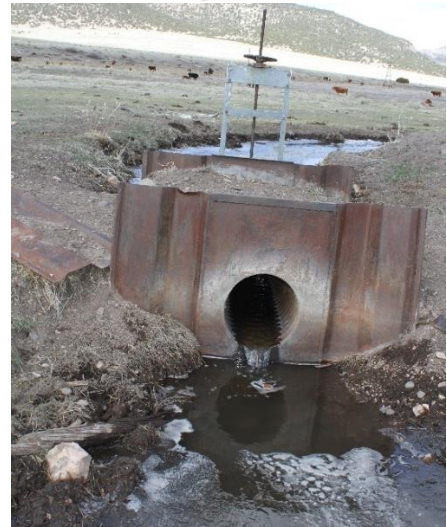
Headgate outlet

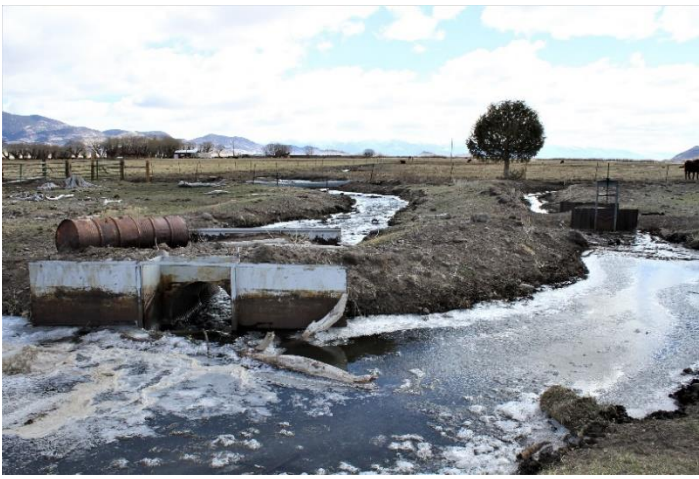
Headgate and diversion dam

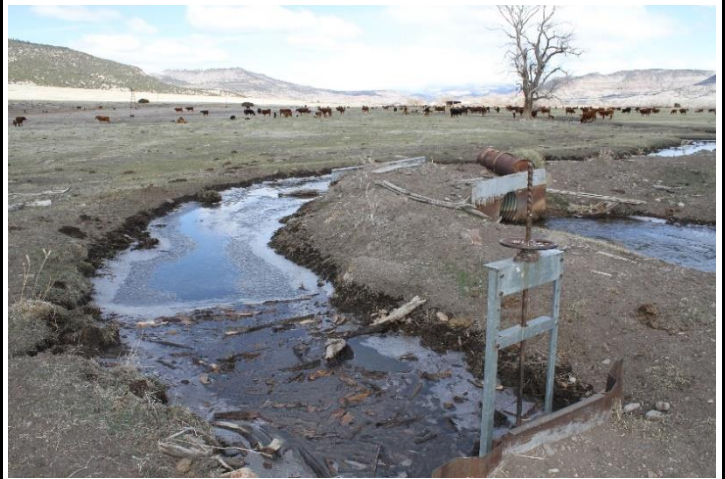
Diversion dam looking upstream

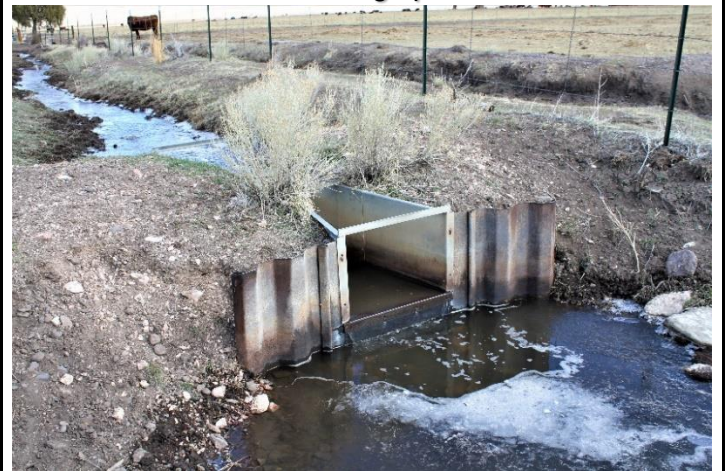
Structure Description: This diversion is located downstream of County Rd Z. Head pressure is adjusted using a 2' wide culvert. Sediment and debris accumulation is a significant issue at this structure. The flume is eroding and may fail in the future.

Flume looking upstream

Repair(s) or Improvement(s) Currently Needed: Although there is no clear long-term solution to the debris accumulation, the SMP Technical Advisory Team (TAT) recommends regular debris clearing. The TAT also recommends stabilization or fill around the flume to prevent further erosion.
