SHALDA CREEK BEAVER DAM STUDY

5/13/2015

Little Traverse Lake Property Owners
Association

Prepared by: Gosling Czubak Engineering Sciences, Inc

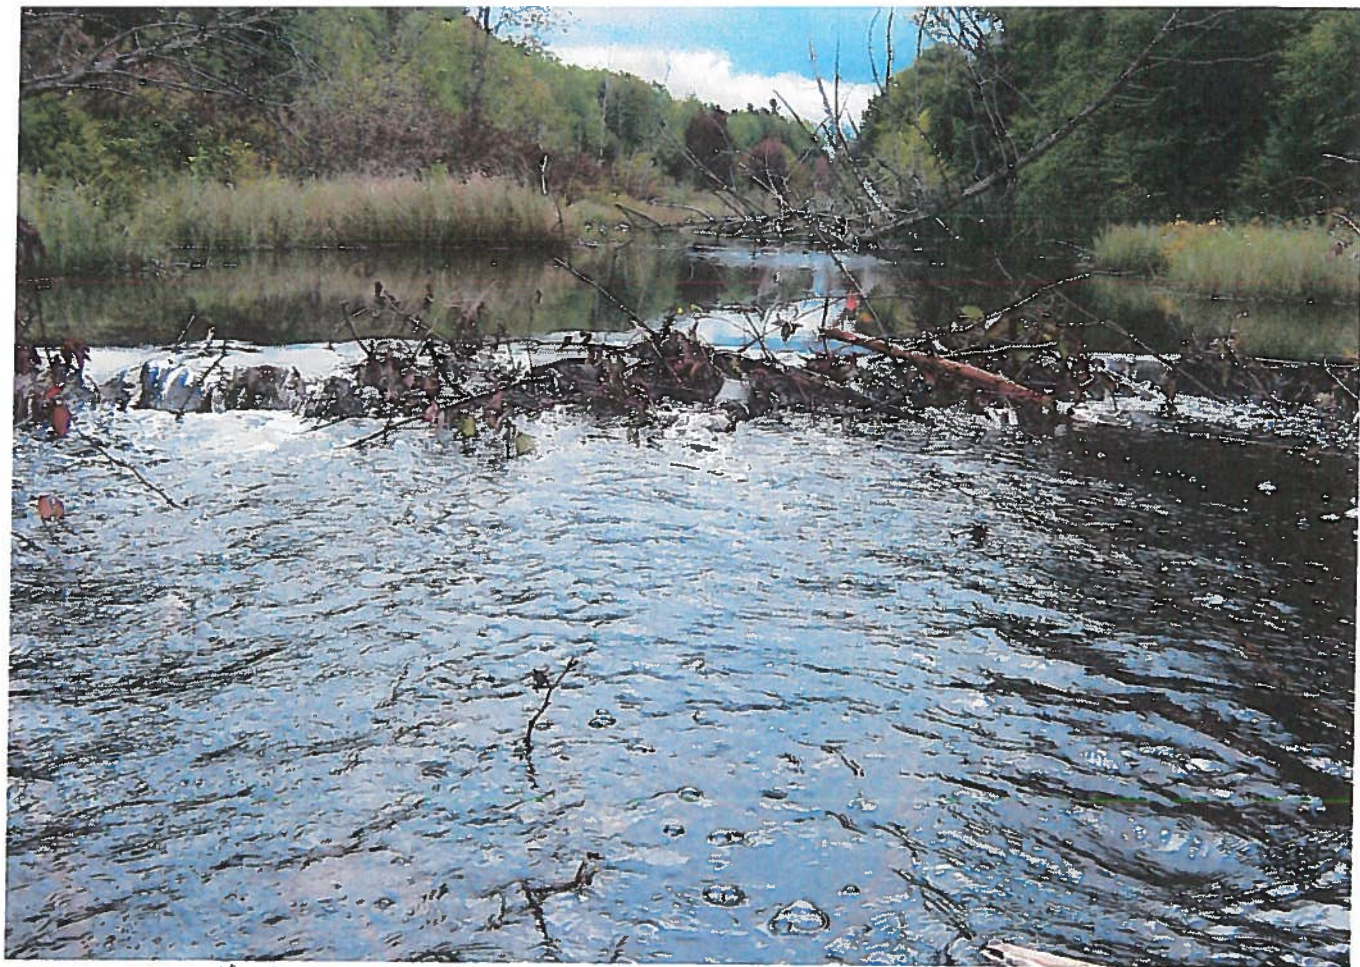
" DAM #1 ~ 6"-8" DROP IN WATER ELEVATION

N 4330 FT DOWNSTREAM OF CR 669

Modifications to the dams were made starting at dam #1 on 9/19/2014. Modifications to dam #2 were completed on 9/26/2014. Modifications to dam #4 were done on 10/9/2014. Dam #3 was relatively minor in comparison to the other dams and modifications to it were completed with dam #2. Dam locations were monitored throughout the study period and modifications were maintained as needed.

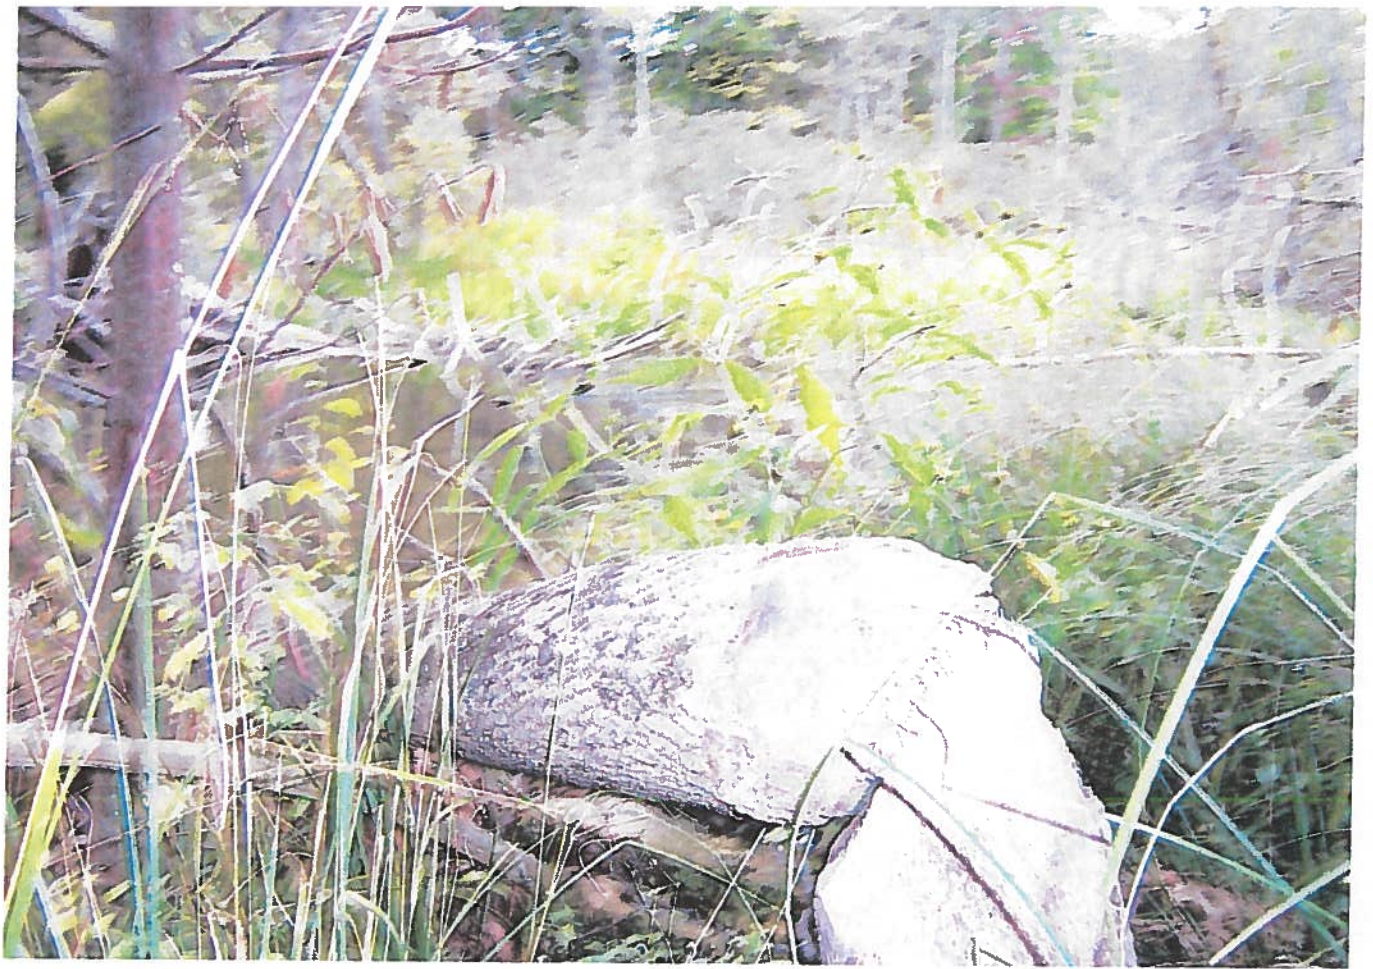
" DAM #3 " ~ 2" DROP IN WATER ELEVATION

N 2150 FT DOWNSTREAM OF # 2

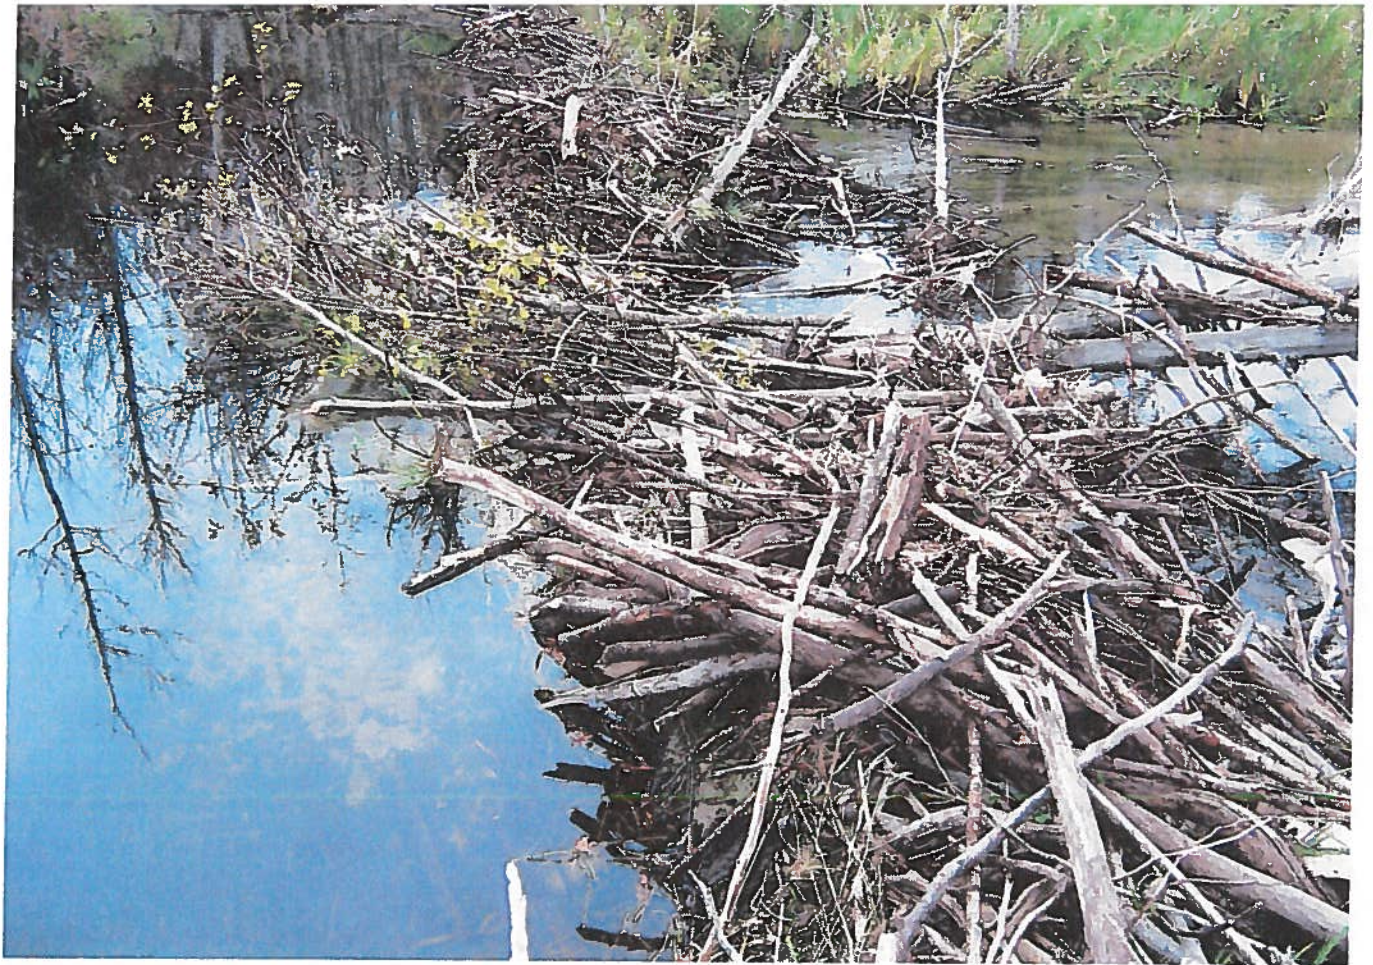
11
DAM # 4 ~ 40" DROP IN WATER ELEVATION
44° 56.463 N 44.94105 = 44° 56' 27.8"
085° 53.543 W 85.89238 = 85° 53' 32.6"

THIS IS THE "LARGE" DAM KNOWN TO
EXIST. THIS ONE IS ~ 2300 FT DOWNSTREAM
OF #3

6. Dam # 4 modified on 10/9/2014. Initial drop of .46' measured on 10/11/2014. Dam #2 dropped .32' when measured on 10/13/2014 after dam #4 modifications.

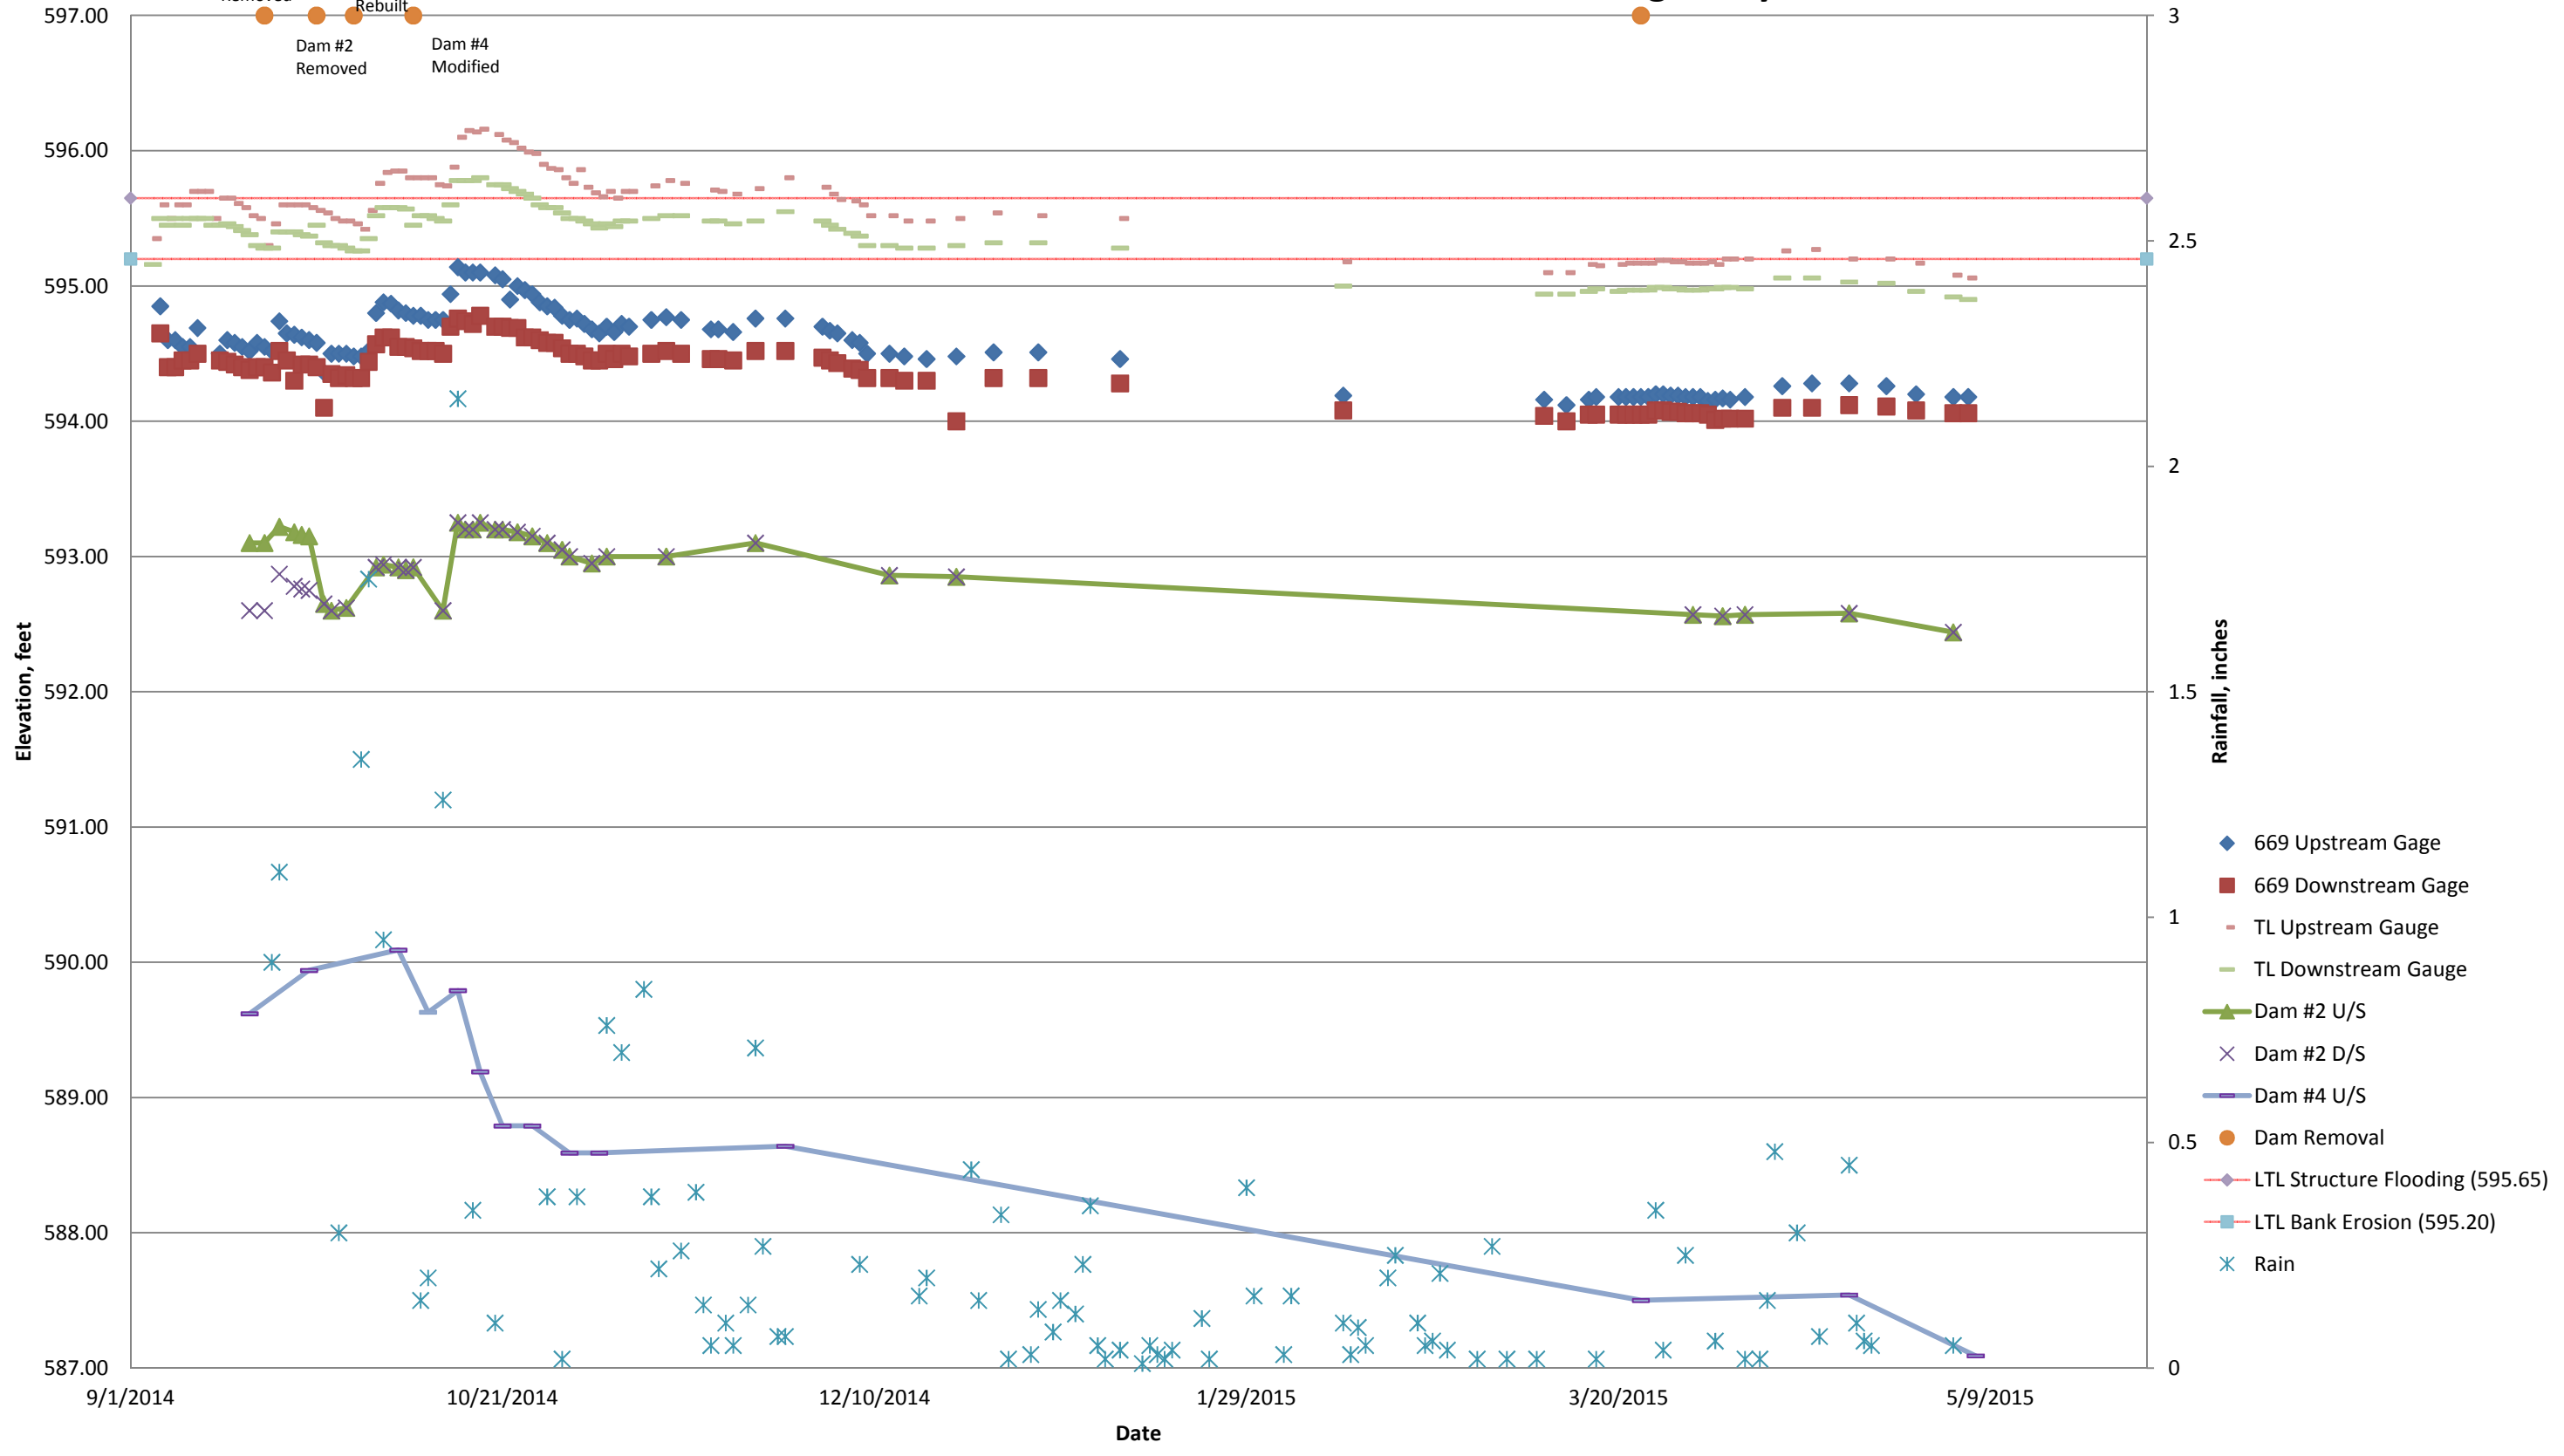
Shalda Creek Water Surface Elevations - Fall 2014 through May 2015

11. The general long term trends reflect that the water level readings upstream of dam #4 at dam #2 follow the readings at dam #4, but not to the same degree. Gauge readings upstream of dam #2 more closely follow the change in readings at the dam #2 gauge. Readings at gauges from several dates are shown below with the corresponding difference from the previous reading in (parenthesis). Elevations noted with an asterisk (*) are interpolated.
