Report of Shalda Creek Water Level Study 2017-2020

Little Traverse Lake Property Owners Association
Cleveland Township, Leelanau County, Michigan

Published: December 15, 2020

Gosling Czubak Engineering Sciences, Inc.

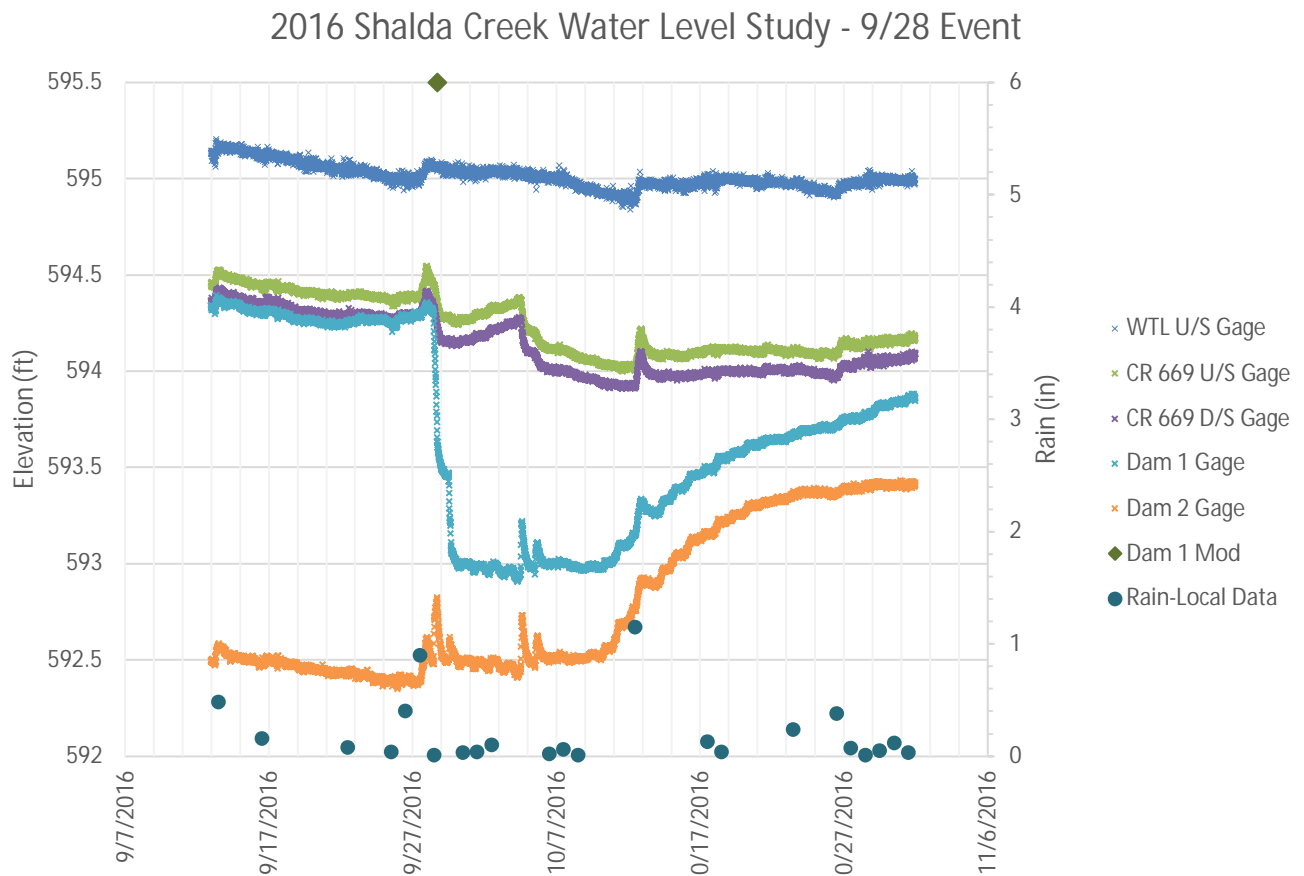
FIGURE 1.

Figure 1 includes the precipitation data that was not included in the original NPS memo figures. The water surface elevation at Little Traverse Lake at the start of this study period is in the high range just above 595 and at the levels where erosion impacts are noticeable (595.2). Precipitation events of about .5 inches or more had the most visible effects in the system. An event of .48 inches on 9/13/2016 manifested in about a .1-inch rise in water surface elevation over 10 hours across the board. Just prior to the dam modification event, precipitation of .9 inches was measured that caused increases in the water surface elevations ranging from .14 to .22 inches over about 11 hours. A second large rain event two weeks later on 10/12/2016 of 1.15 inches was recorded and the water surface elevations responded by rising between .14 and .18 inches over 11 hours.

As noted by the NPS, the removal of Dam 1 showed water levels at the upstream gauge immediately drop 1.3 feet following dam removal and the water levels both up and downstream of County Road 669 gradually declined about 0.2 feet over a period of five days following the removal of the dam. The 1.3 feet of water level difference is indicative of a significant dam at this location. It should be noted that the decline does slow down and slightly rise following those first five days but does continue downward for another week and ends .4 feet lower before a rain event of 1.15 inches was recorded. The decline at Little Traverse Lake is less pronounced, however, it is still noticeable at .2 feet (2.2 inches) over the same two-week time period.

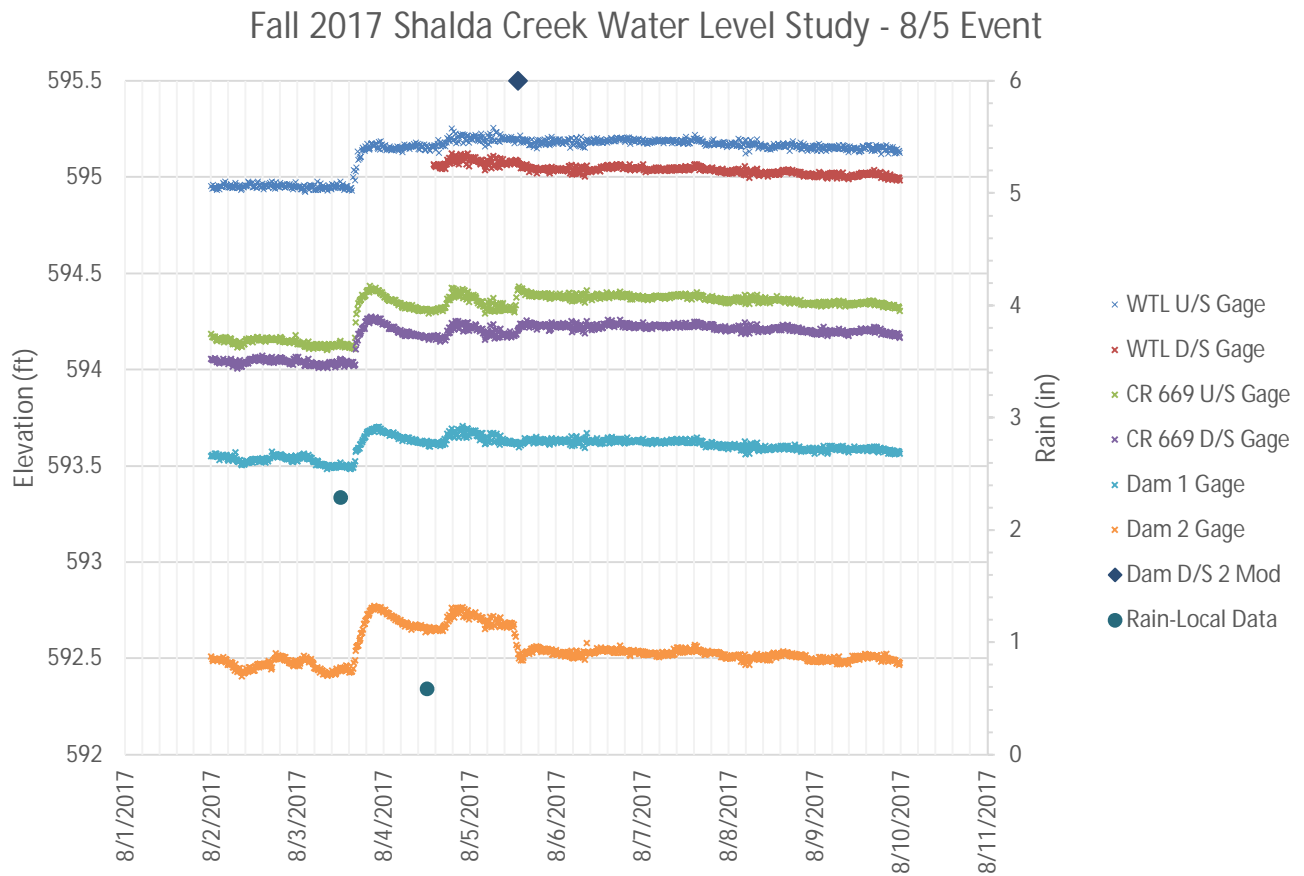
FIGURE 2.

The Fall 2017 study data presented in this report shows an overall graph of the water surface elevations beginning on July 29, 2017 one week before the first dam modification event on August 5, 2017. The overall graph continues through November 3, 2017 and is included as Attachment 5. Figure 2 below is a graph of the period surrounding the first dam modification event on August 5, 2017.

A description of the work conducted at the 8/5 dam modification event was prepared by the NPS and included for reference as Attachment 6. The location of this dam is just downstream approximately 200 feet of dam 2 and is noted as “Dam Mod D/S/ 2” on the Shalda Creek map. Prior to the 8/5/17 dam modification, significant rain events of 2.29 inches on 8/3/2017 and .59 inches on 8/4/2017 were recorded. Observations of the water surface elevations around these events are:

- 1) The 2.29-inch event pushed water levels up at the culvert gauges and dam 1 approximately .25 feet (3 inches) over 6 hours. The water level at dam 2 rose .33 feet (4 inches).
- 2) After the gauges peaked, all of them except the upstream LTL gauged trended down approximately .1 foot (1.2 inches) over 18 hours. The LTL gauge was relatively unchanged over this time period.
- 3) The .59-inch rain event produced a general increase of .1 foot (1.2 inches) over 6 hours.

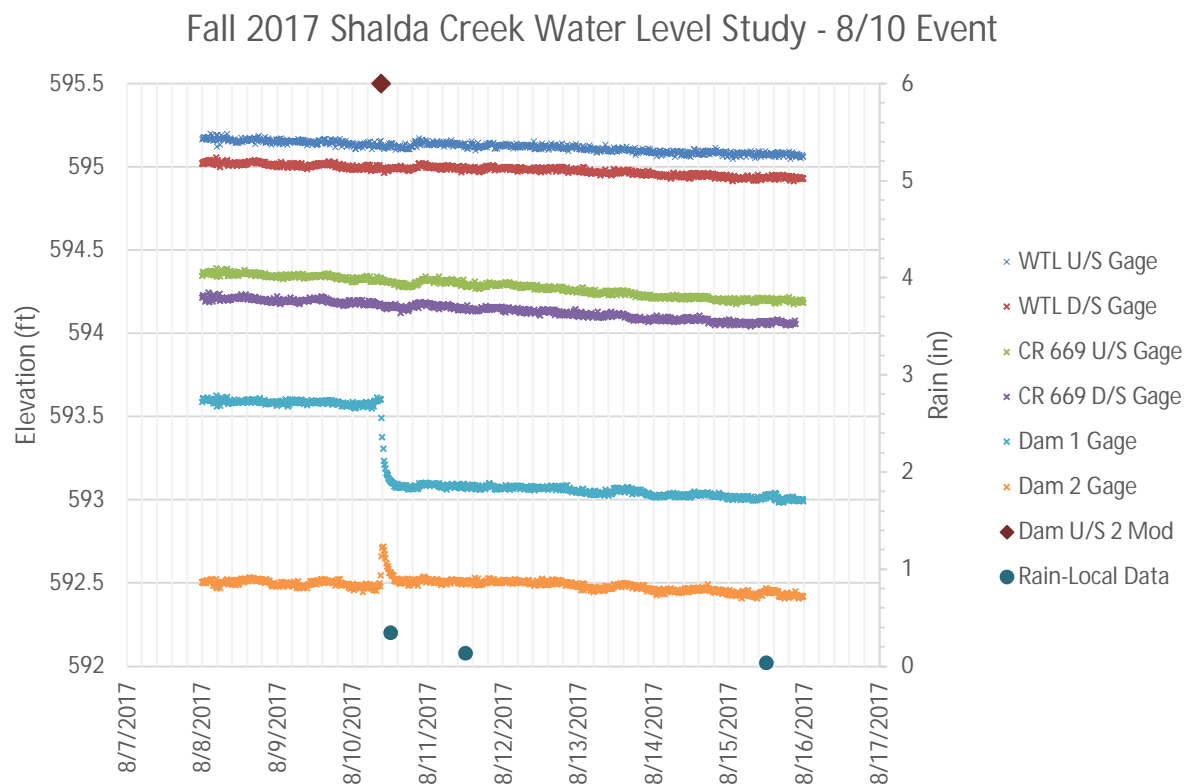
FIGURE 3.

Figure 3, below is a graph of the period surrounding the second dam modification event on 8/10/2017

A description of the work conducted at the 8/10 dam modification event was prepared by the NPS and included for reference as Attachment 7. This event occurred at dam 1, also known as “Fishcamp”, just upstream of dam 2 as shown on the Shalda Creek map. Dam 1 is approximately 4,000 feet downstream of CR 669. Observations of the water surface elevations around this modification event are:

- 1) The removal of dam 1 at this time resulted in a drop in water surface elevation at the dam 1 gauge upstream of .53 feet (6.4 inches) over approximately 6 hours. The 6.4-inch drop at the upstream dam 1 gauge is approximately half of what was observed the previous year.
- 2) The gauge upstream of dam 2 just downstream showed a rise of .25 feet (3 inches) over an hour and then returned to its relative starting point over the next 5 hours.
- 3) Gauges at CR 669 and LTL showed no significant change related to the dam modification event.
- 4) A rain event of .35 inches was recorded the same day of the dam modification. Small blips in the gauges less than .1 foot follow this rain event.
- 5) Smaller rain events (<.15 inch) occurred during this period which showed no noticeable changes in the gauges.

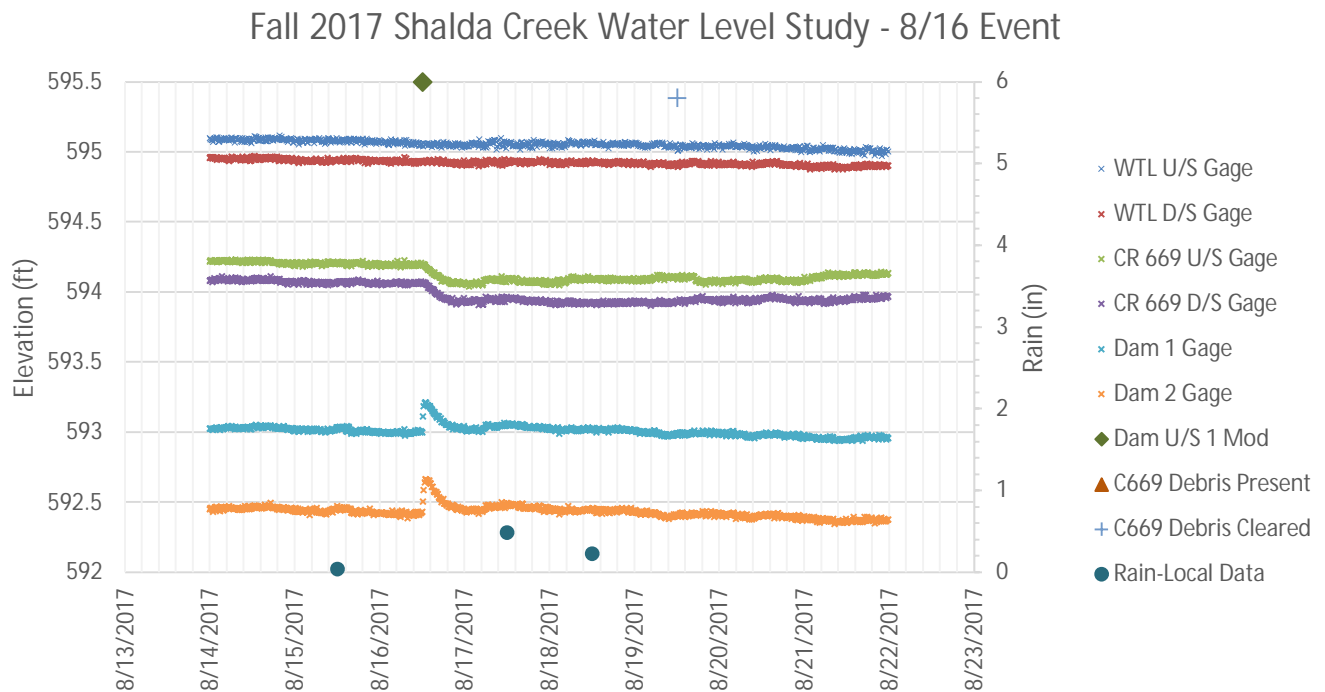
FIGURE 4.

The period surrounding the third dam modification event is shown below in Figure 4. This dam is one that was found upstream of dam 1. Its location is noted on the Shalda Creek map as “Dam Mod U/S 1” and is located approximately 2,500 feet downstream of CR 669.

Observations of the water surface elevations around this modification event are:

- 1) The removal of the dam upstream of dam 1 at this time resulted in rises in both the gauges at dam 1 and dam 2 by about .2 feet (2.4 inches) over 2 hours followed by a return to their relative starting elevation over 12 hours.

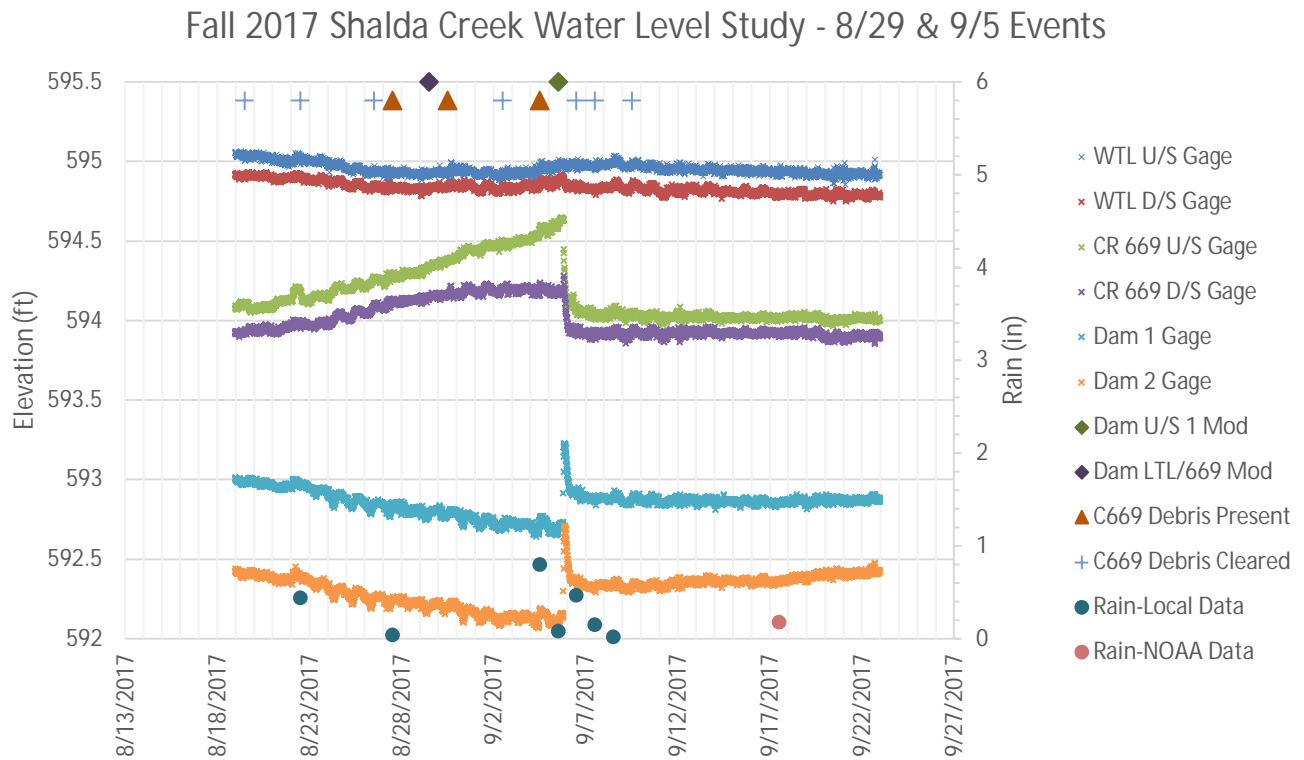
FIGURE 5.

Observations of the water surface elevations around these two modification events are:

- 1) The modification of the dam between LTL and CR 669 showed no significant changes in water surface elevations at the gauges. The elevation at LTL upstream at this time was 594.9.

- 2) A presence of debris at the CR 669 upstream culvert is noted before and after the 8/29 event. A noticeable rise in water level at the upstream CR 669 gauge occurs while the downstream gauge is unchanged.

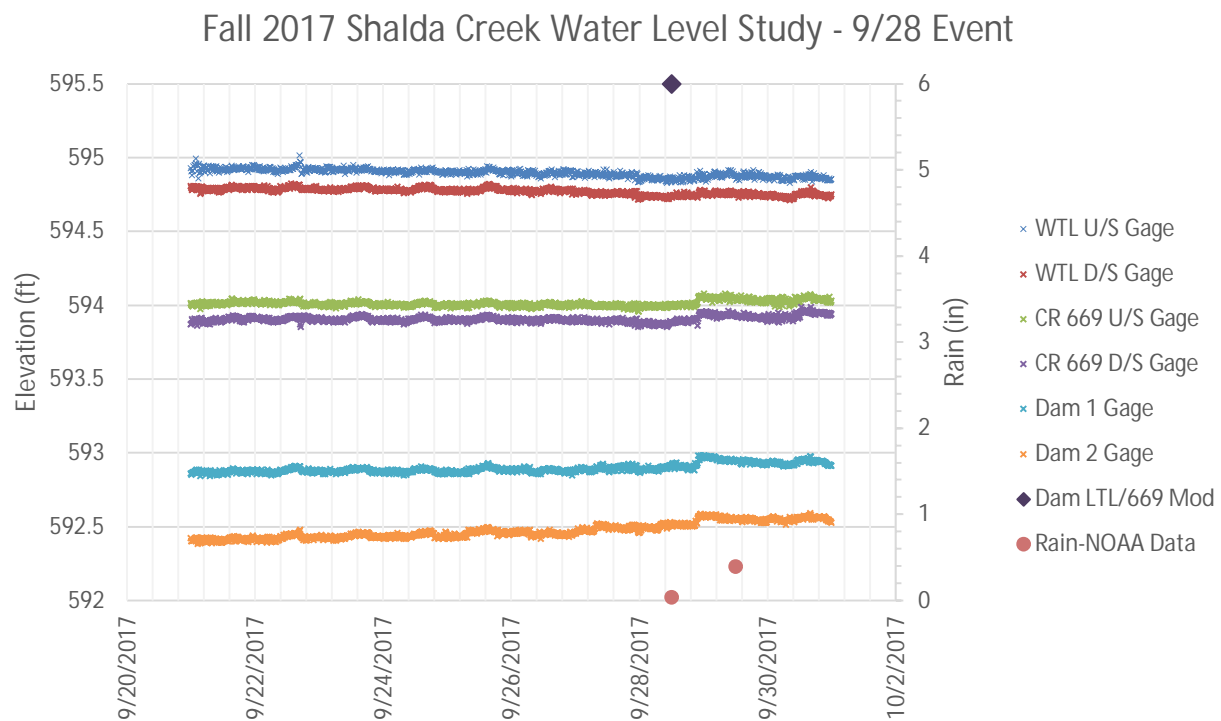
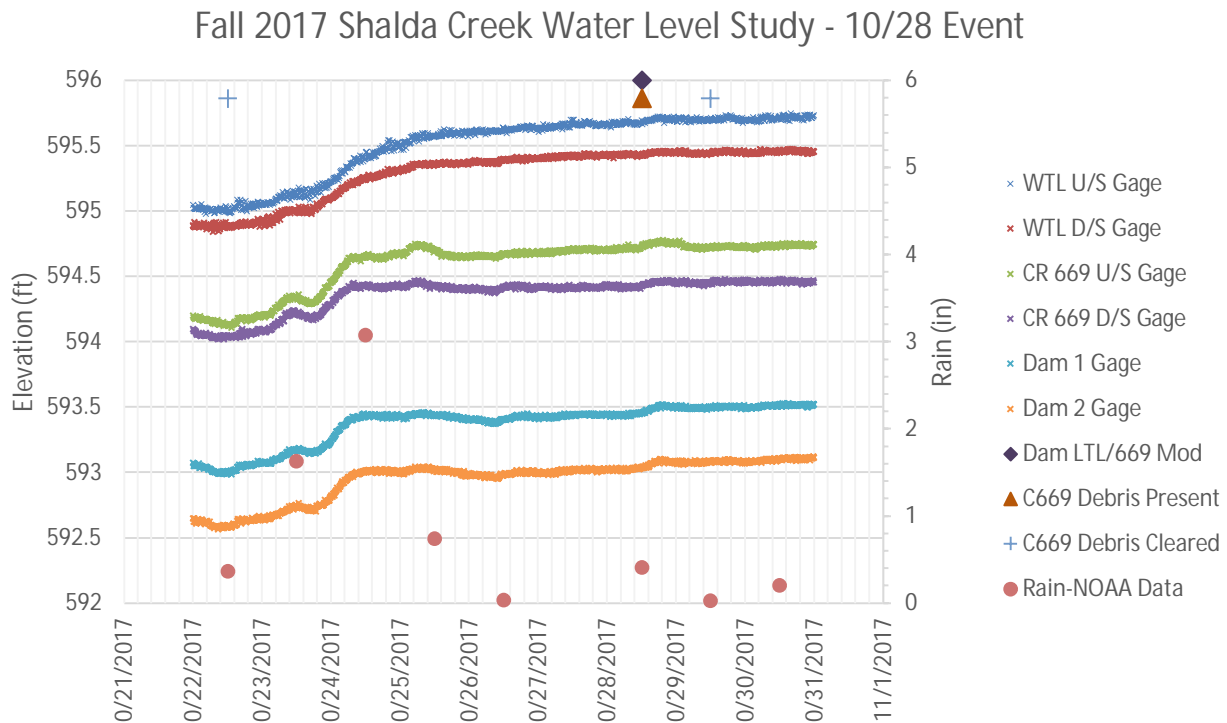
Two final modification events occurred for the Fall 2017 study. They were on 9/28/2017 and 10/28/2017. Figures 6 and 7 below show those events. No significant changes in water surface are noted from either the 9/28 or 10/28 event. Of note were two significant precipitation events on 10/23 and 10/24 of 1.63 and 3.08 inches, respectively. These events pushed the measured elevations up to the highest points measured during the study. During the period from 10/22 to 10/29, the water surface elevation of LTL rose .72 feet (8.64 inches) from 595.0 to 595.72.

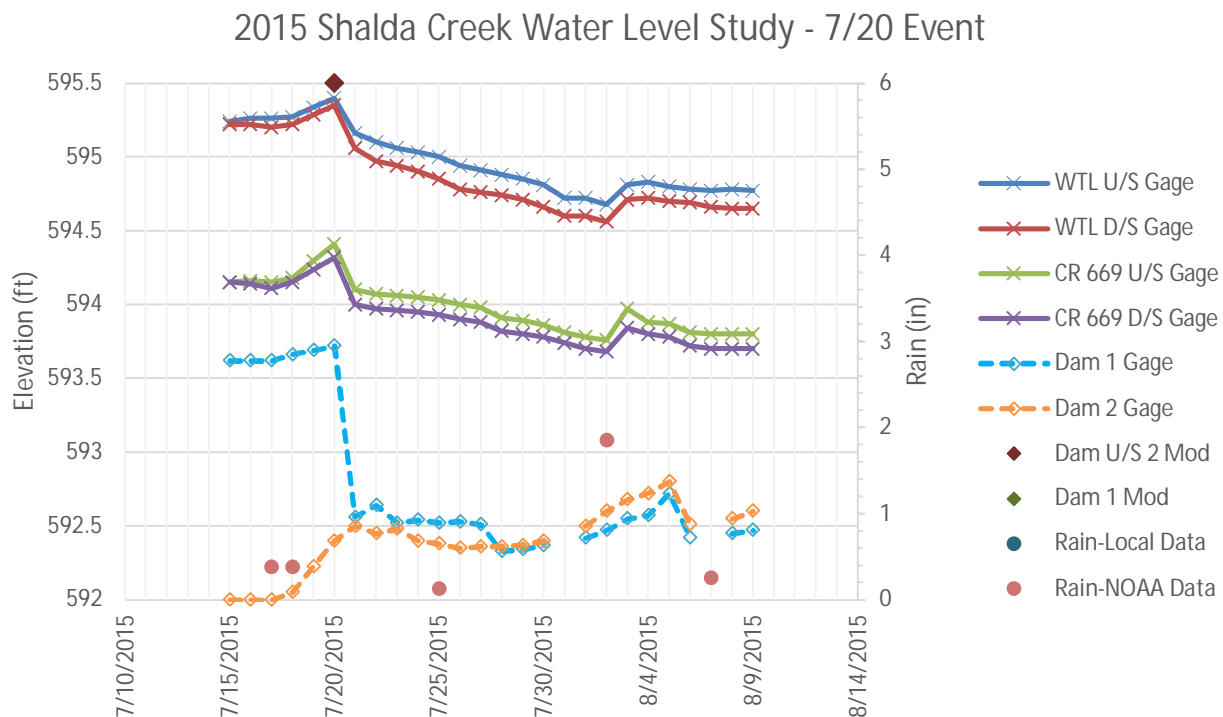
FIGURE 8.

Prior to the Fall 2017 Study, there were previous studies completed as described earlier in this report with several significant data points worth including here again. Table 1 below summarizes the dam modification events referenced throughout this report. The first is the modification of dam 1 on

7/20/2015 shown below in Figure 8. The modification indicated the dam was of significant size impounding at least 1.16 feet of water when it was removed. At that point, the water level of LTL was at a high of 595.4. Following removal of the dam, it dropped .72 feet (8.64 inches) to a relative low of 594.68 over thirteen days when a significant rain event of 1.85 inches pushed levels up about .1 foot where the leveled off. The observed drop in water levels on at 669 were nearly the same magnitude. The downstream water level at CR 669 was 594.32 on 7/20 before the dam was modified and fell .64 feet (7.68 inches).

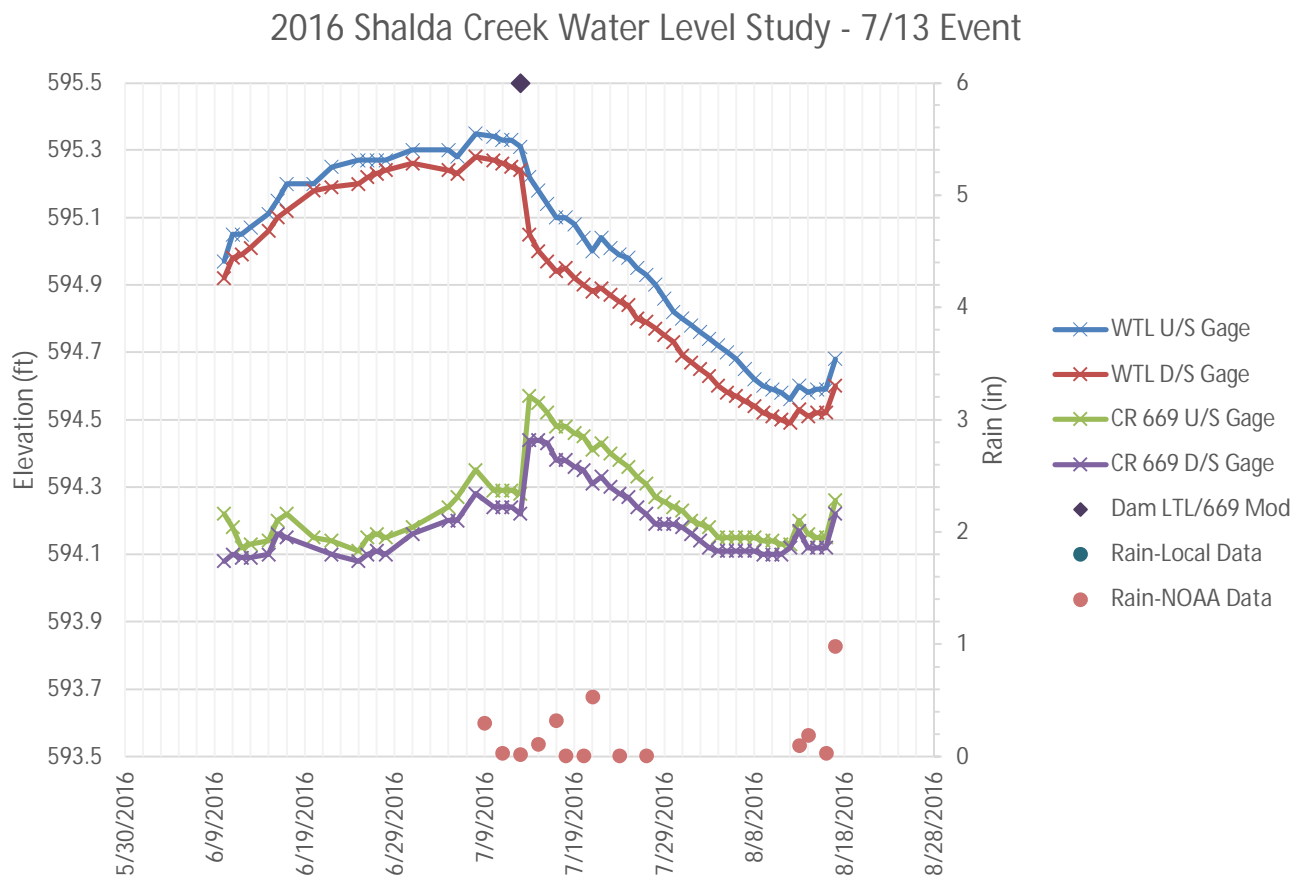
FIGURE 9.

A modification of the dam found between LTL and CR 669 was completed on 7/13/2016. This modification event is shown in Figure 9. At the time of this modification, the water level of LTL was again at a relative high of 595.3. Following the removal of the dam, it steadily dropped .75 feet (9 inches) over 30 days to 594.56.

A comparison of the trend at the two culvert locations shows an important observation. LTL levels increase .36 feet from 6/10/2016 through 7/13/2016 while the U/S 669 levels decrease and ultimately only increase .07 feet over the same period of time. This observation suggests the presence of a beaver dam between the two locations interfering with the ability of water levels to respond normally.

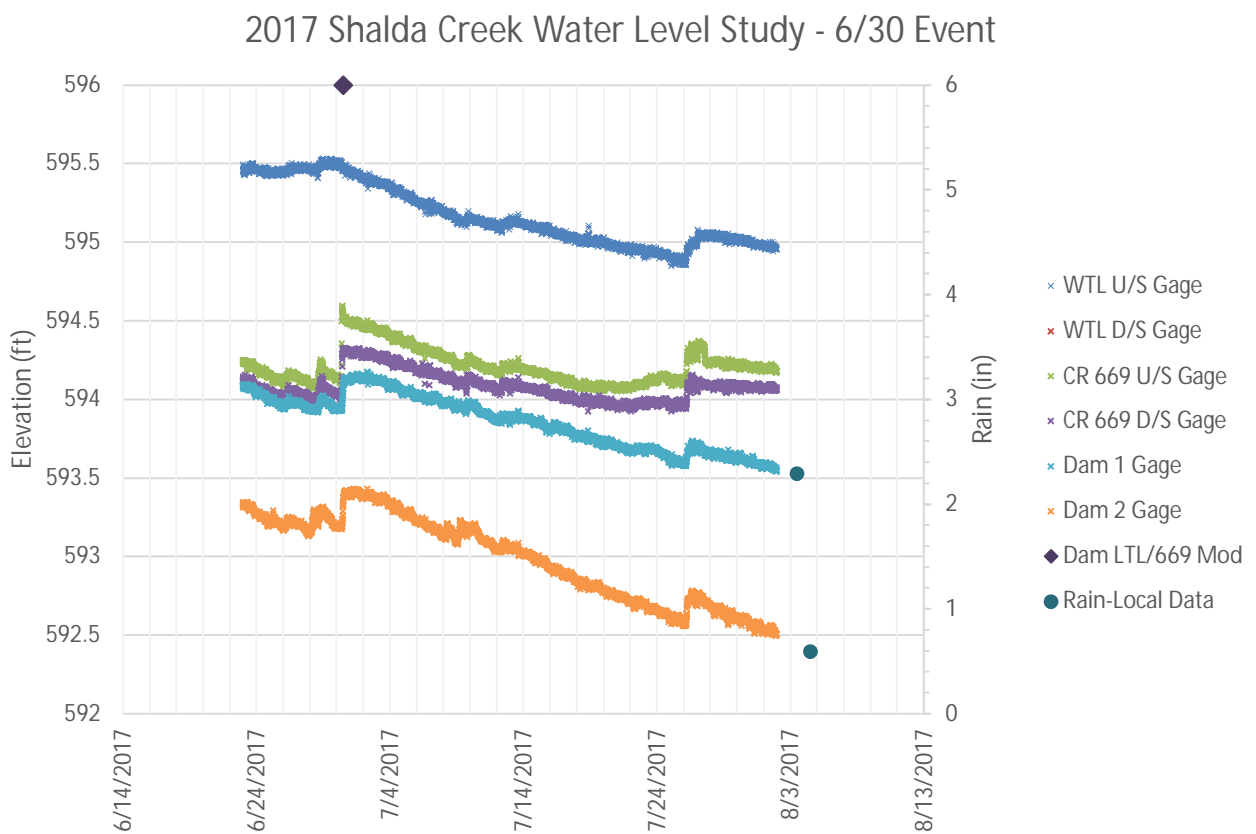
FIGURE 10.

The final data set shown in Figure 10 is from data collected following a modification of the dam between LTL and CR 669 on 6/30/2017. Once again, the water surface elevation at LTL was relatively high at 595.5 when the dam was modified. LTL levels immediately prior to dam removal were steady while water levels at CR 669 were decreasing during this same time. Following its modification, there were quick upticks in elevation at the downstream gauges followed by steady decline of water levels over approximately 1 month. During this period, the LTL level declined .65 feet (7.8 inches).

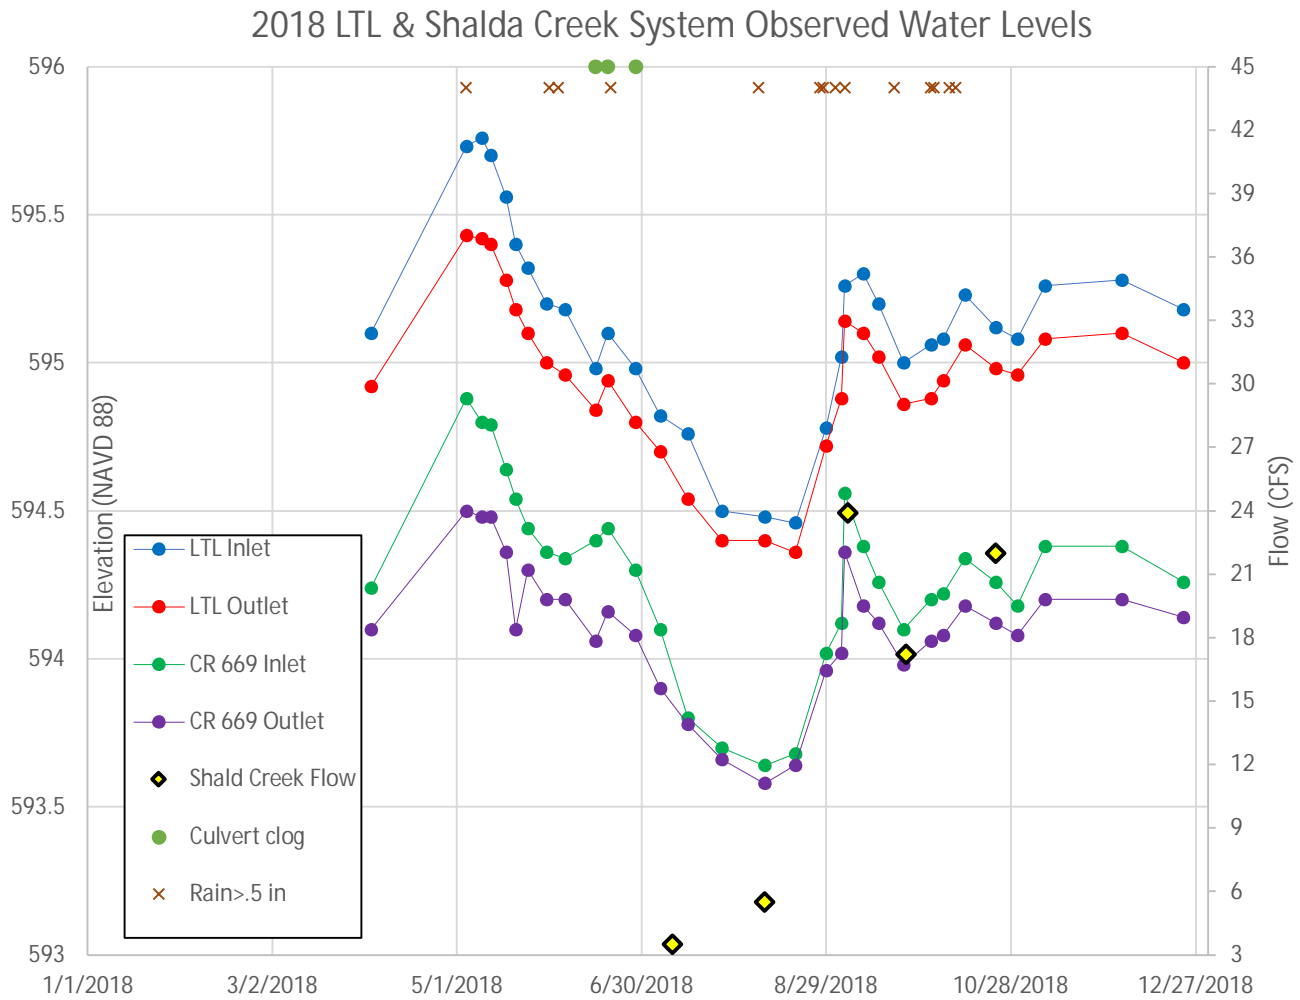
FIGURE 11.

It was noted by LTLPOA that 2018 was an unusually quiet year for beaver activity with no new dams reported within the original study area. Figure 11 below is a graph of the 2018 data recorded by the LTLPOA. The data starts in early April when spring runoff is working its way through the system. The peak water level at Little Traverse Lake for the year was 595.76 and recorded on May 9. This followed 1.58 inches of rain recorded on May 4. That water level is .11 feet above the elevation of 595.65 identified in previous reports that lake residents experience adverse impacts to their property, such as flooded crawl spaces. Without beaver activity and significant rain, the water levels in the system generally drop over the summer season and that is what was observed in 2018. Table 2 below summarizes the monthly precipitation for 2018, 2019, and 2020 along with the normal monthly precipitation. The above normal precipitation through the winter and spring and below normal precipitation through June and July align with the high and low water level observations for the period.

There were three reported instances of the County Road 669 culverts being partially clogged with woody debris on June 15, 19, and 28 2018. A rain event of 1.34 inches was recorded on June 20. The water levels at all locations are up slightly during this period but generally continue downward through mid-August with a low reading of 594.46 at Little Traverse Lake recorded on August 19. After this, several days of significant rain were experienced at the end of August with .52 inches on 8/27 and 2.04 inches on 8/28. A fall high water level of 595.3 was recorded on 9/10. The water level generally fluctuated between this level and 595 through the end of the year. These fall water levels are right at the 595 level where high-water erosion impacts are noticed. With the absence of beaver activity and the slightly below normal precipitation in the summer, the system water levels were able to drop to a level that the higher-than-normal precipitation experienced August through October was able to be passed

through the system without lake levels rising to above the 595.65 level where property damage is experienced.

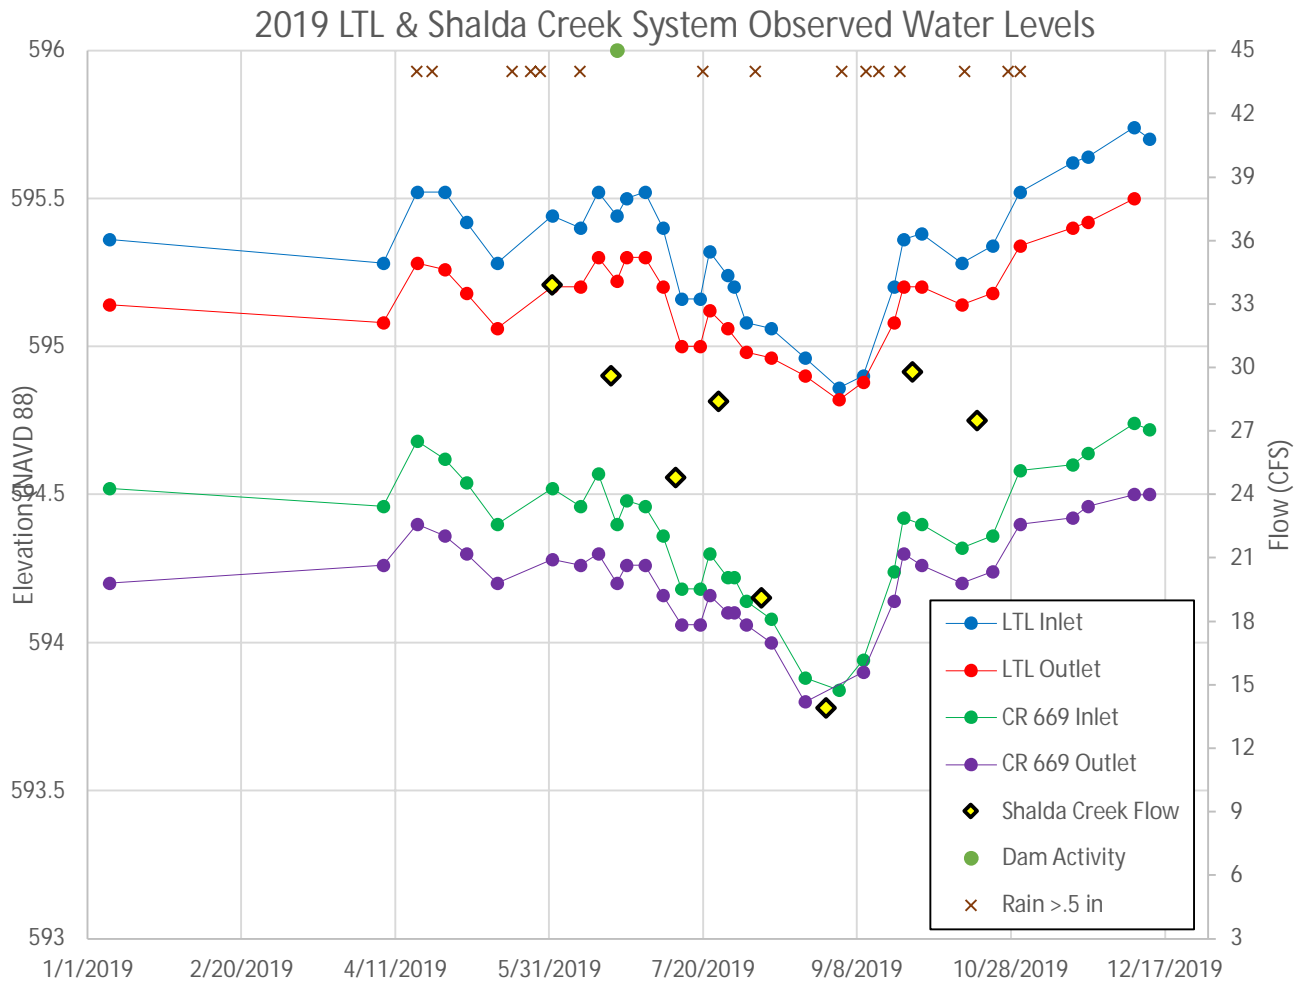
FIGURE 12.

2019 data is shown in Figure 12 below and follows a similar trend as 2018 of water levels decreasing in the summer. However, dam activity at the Fish Camp location is noted in June. The total precipitation for May, June, July, and August is 9.4 inches and 2.91 inches below the normal total of 12.31 inches for this period of 2019. The decrease in water elevation measured at Little Traverse Lake from 595.42 on May 4, 2019 to 594.86 on September 2, 2019 is .56 feet (6.7 inches). If we compare the observations for the same period of 2018, it is noted the total precipitation is 13.09 inches which is .78 inches above normal for the period. The decrease in water elevation at Little Traverse Lake from 595.76 measured May 9, 2018 to 594.46 measured August 19, 2018 is 1.3 feet (15.6 inches). This is significant because the lake level dropped over 2.3 times as much in 2018 when there was no beaver dam activity noted but the total precipitation is above normal for the summer months. It would have been reasonable to expect a water level drop of the same magnitude over the similar time frame in 2019 especially with below normal precipitation. If you only look at June, July, and August, the precipitation is 47% below normal for this period. The meager drop of .58 feet during this time period of low precipitation is indicative of obstructive elements such as beaver dams within the system.

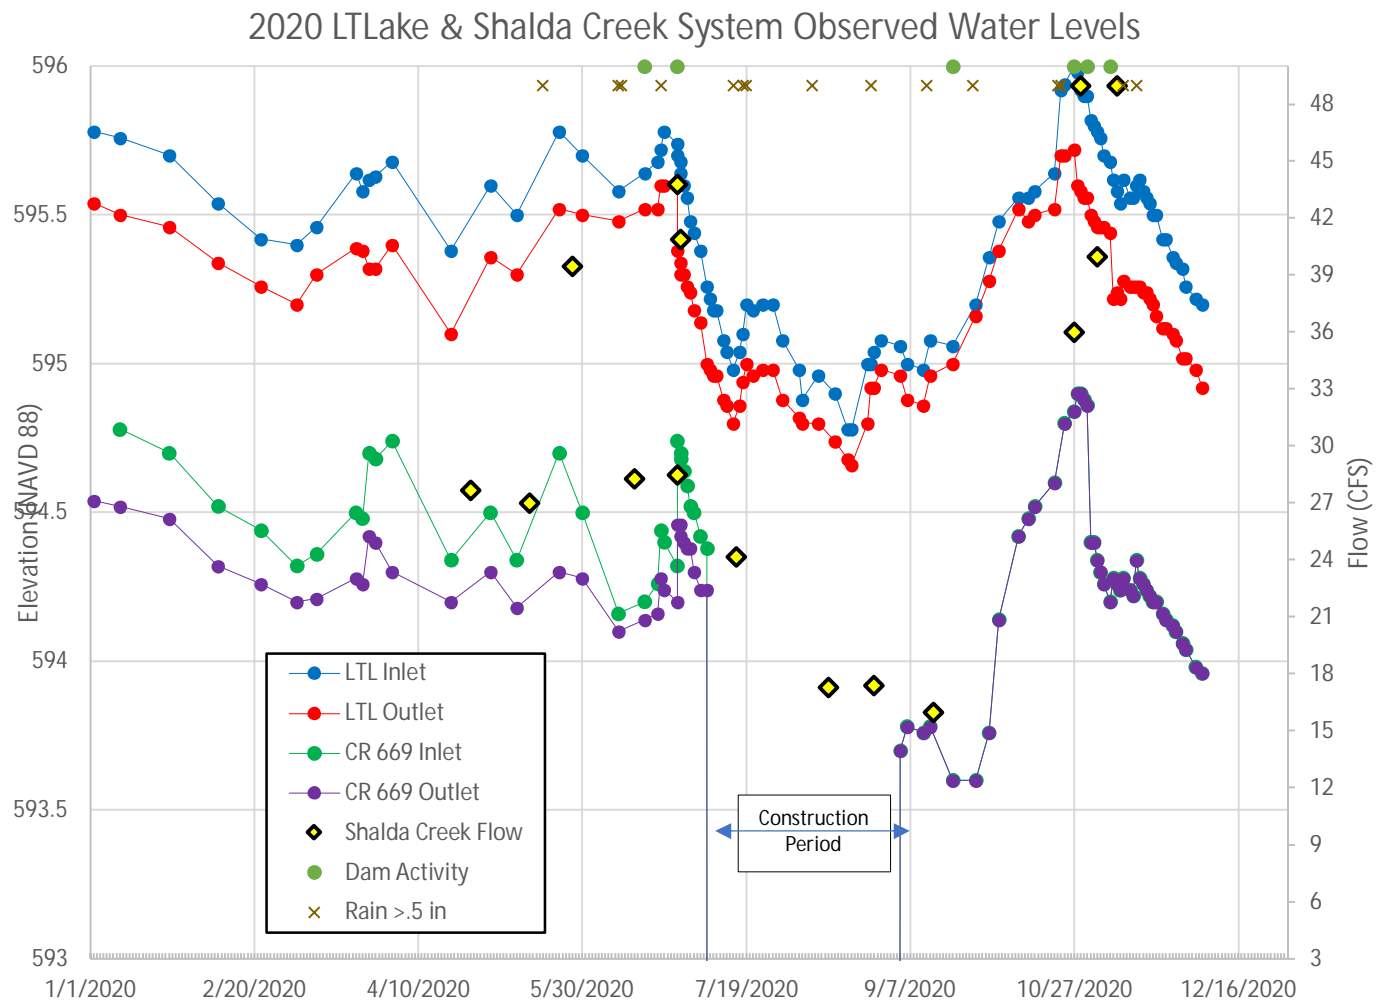
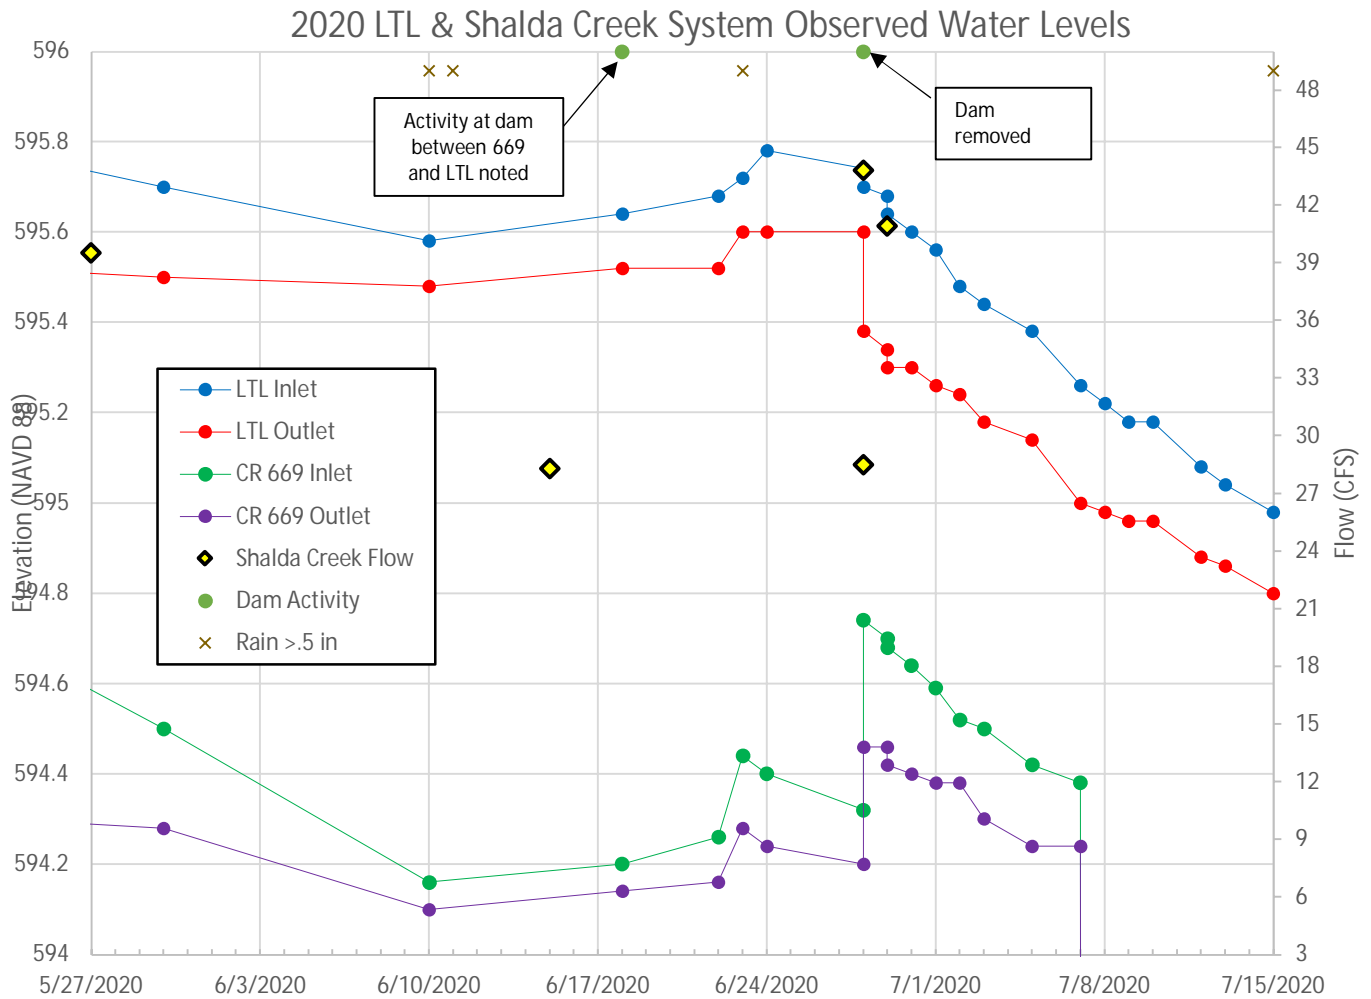
The overall data for 2020 is shown in Figure 13 below and an enlarged graph of the data through mid-July is shown in Figure 14. 2020 data started with LTL water levels at 595.78 just above the 595.65 level where residents are affected. The level fluctuates through the winter and spring and only gets to a low of 595.38 on April 20. Activity at the beaver dam upstream of CR669 was noted on June 18 during a period of increasing Little Traverse Lake water levels and steady flows of 28 cfs at CR669 measured by the Benzie Conservation District. Following the permitted modification of this dam on June 28, 2020 the flow rapidly increases to 44 cfs and declines to 40.9 cfs the following day. This sudden increase in flow can be attributed to the removal of the beaver dam and release of the water. Over the course of two weeks, the water level declines .76 feet. During this period on July 7, 2020 the stream diversion was installed for the removal of the culvert being replaced at CR 669. The staff gages at CR669 were removed at this time. Several days of heavy rains occurred from July 15-19 and caused a brief water

level rise that leveled off from July 19-27. The overall water level trend continued downward after that to a low of 594.78 on 8/20. The measured flow at CR 669 continually declined after the dam modification through September 14 to 16 cfs on that day.

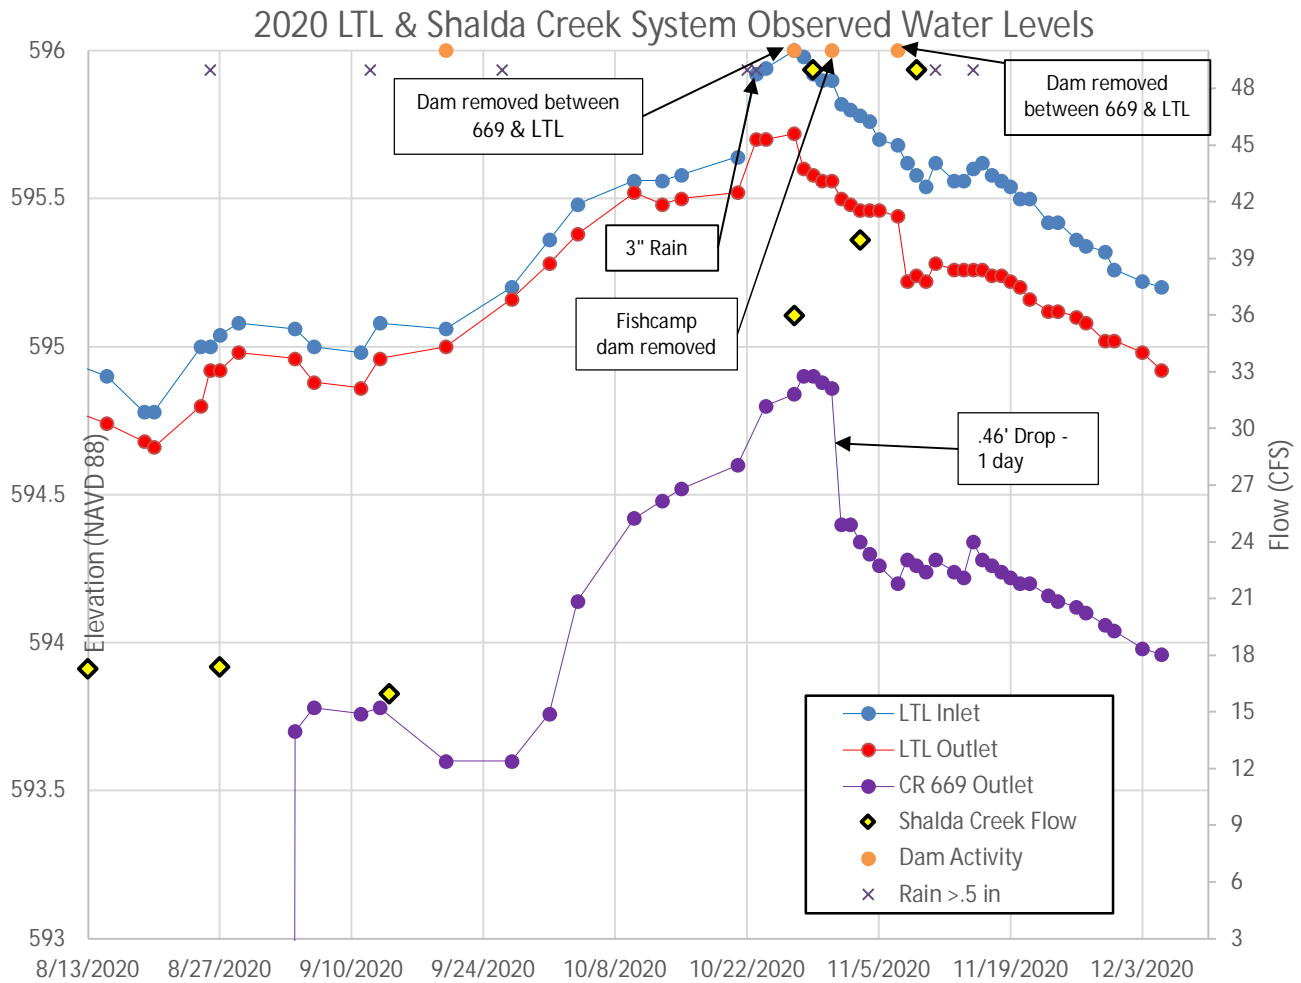
FIGURE 15.

The flow pattern in the system generally shows over the course of the year that higher water levels correspond to periods of higher flow rates and lower water levels correspond to periods of lower flow rates. The water level response from the latest dam modifications is significant with the drops occurring during periods of high flow. The flows at Little Traverse Lake are elevated, yet under the inlet control level, for at least over a week following the Fishcamp dam removal. Additional precipitation input is also observed in the system. The water levels have continued to trend downward during this high flow period further verifying the impacts of beaver dams on water levels.

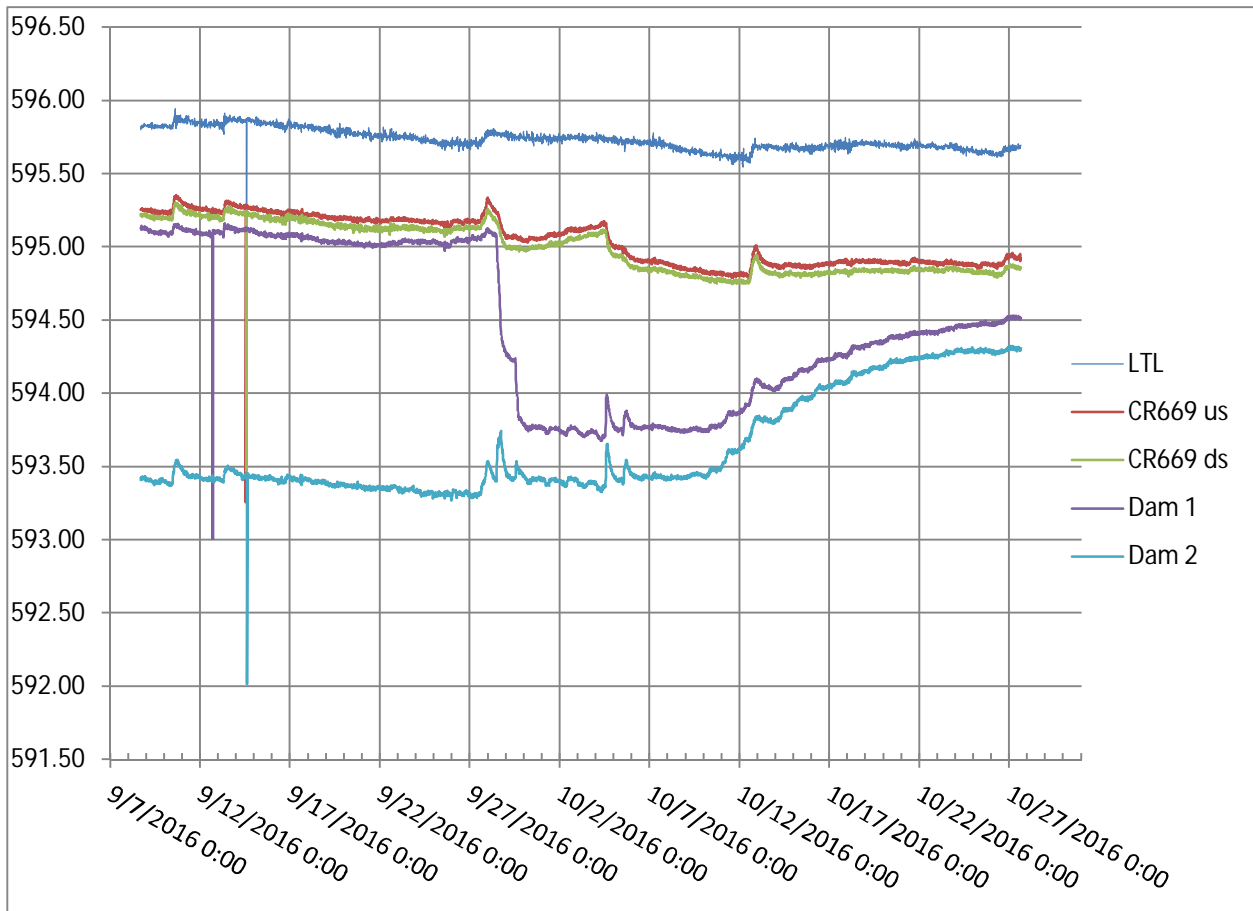
Figure 1. Relative water surface elevations at the five sites through the common data record, 9/8 to 10/27, 2016. The vertical drops near the beginning of the record were equipment checks. Removal of Dam 1 occurred on 9/28/16 and is evidenced by a 1.3 foot drop in the water level immediately above the dam (purple line). Note the lack of an obvious drop in the water level at LTL.
