Report of Shalda Creek Water Level Study 2017-2020

Little Traverse Lake Property Owners Association
Cleveland Township, Leelanau County, Michigan

Published: December 15, 2020

Gosling Czubak Engineering Sciences, Inc.

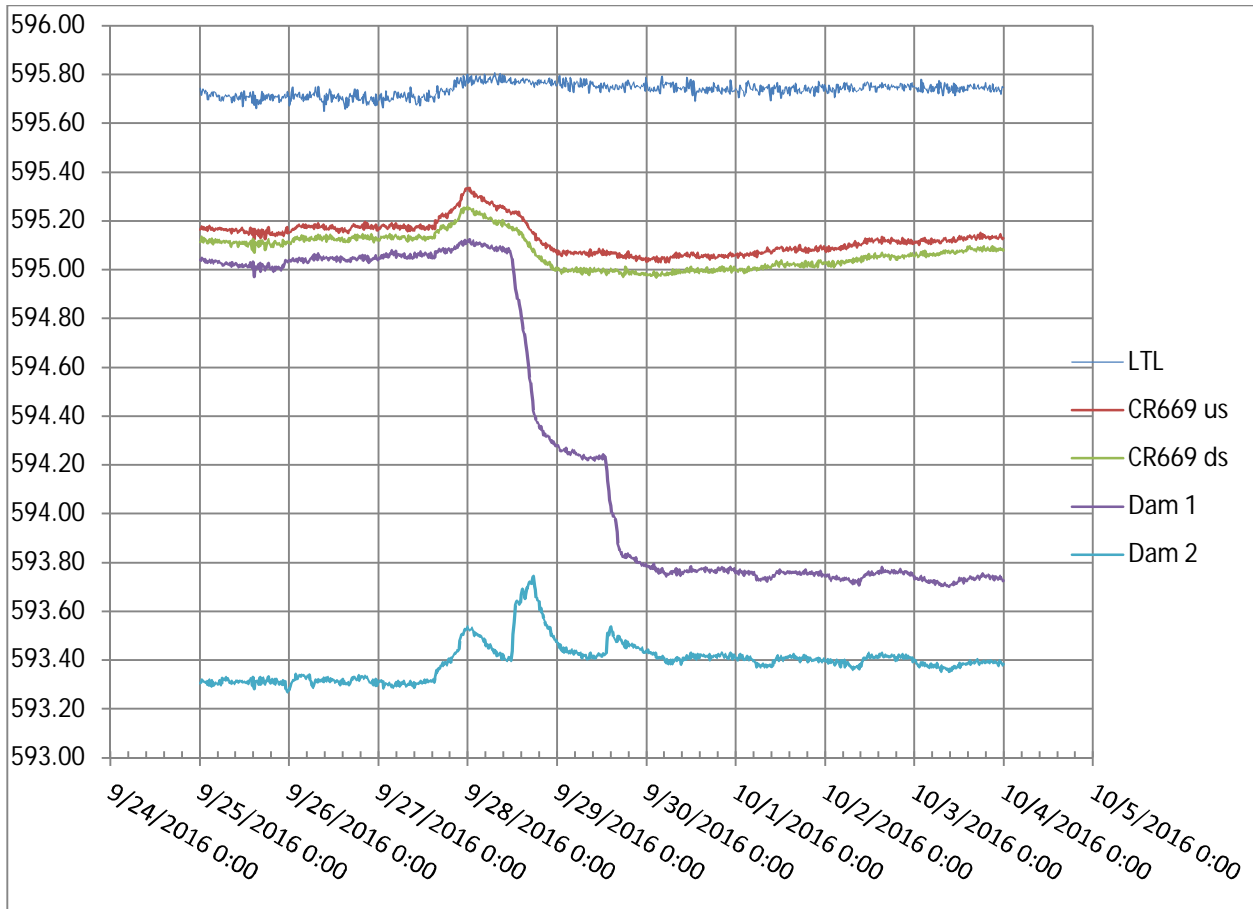
Figure 2. Relative surface water elevations at the five sites over the nine days surrounding the experiment, 9/25 to 10/3, 2016. Removal of Dam 1 occurred on 9/28/16 and is evidenced by a 1.3 foot drop in the water level immediately above the dam (purple line). Note the lack of an associated drop in the water level at LTL. It appears that there may have been a small drop of about 0.2 ft. at County Road 669 from the dam removal, although there may have been other associated watershed processes.

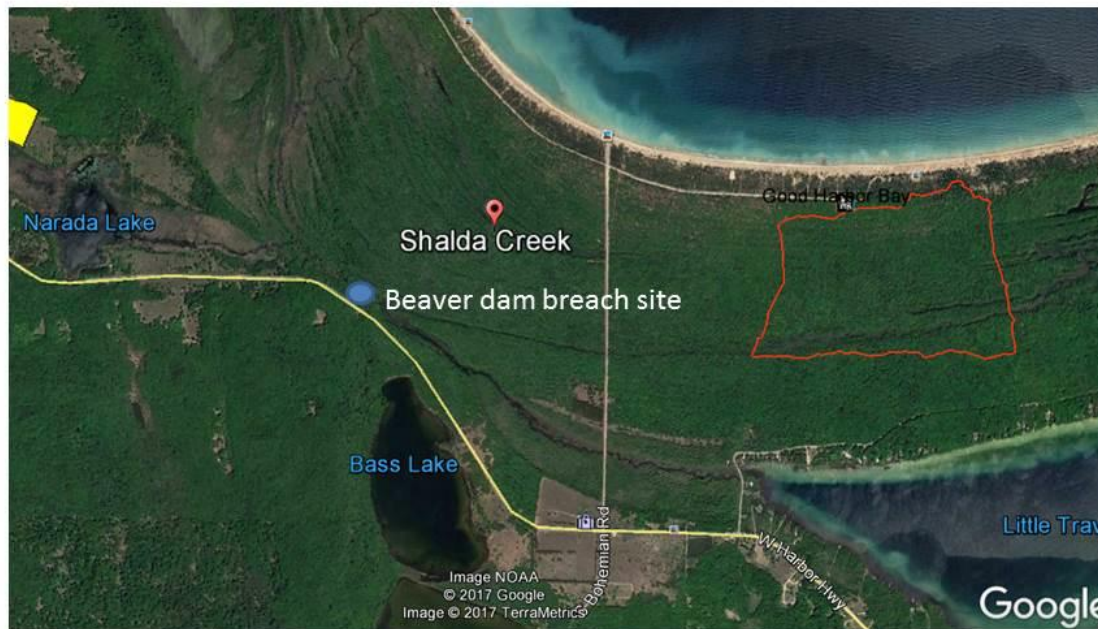
Figure 1. Approximate dam breach site on Shalda Creek, Sleeping Bear Dunes National Lakeshore. Project was conducted on August 5, 2017.

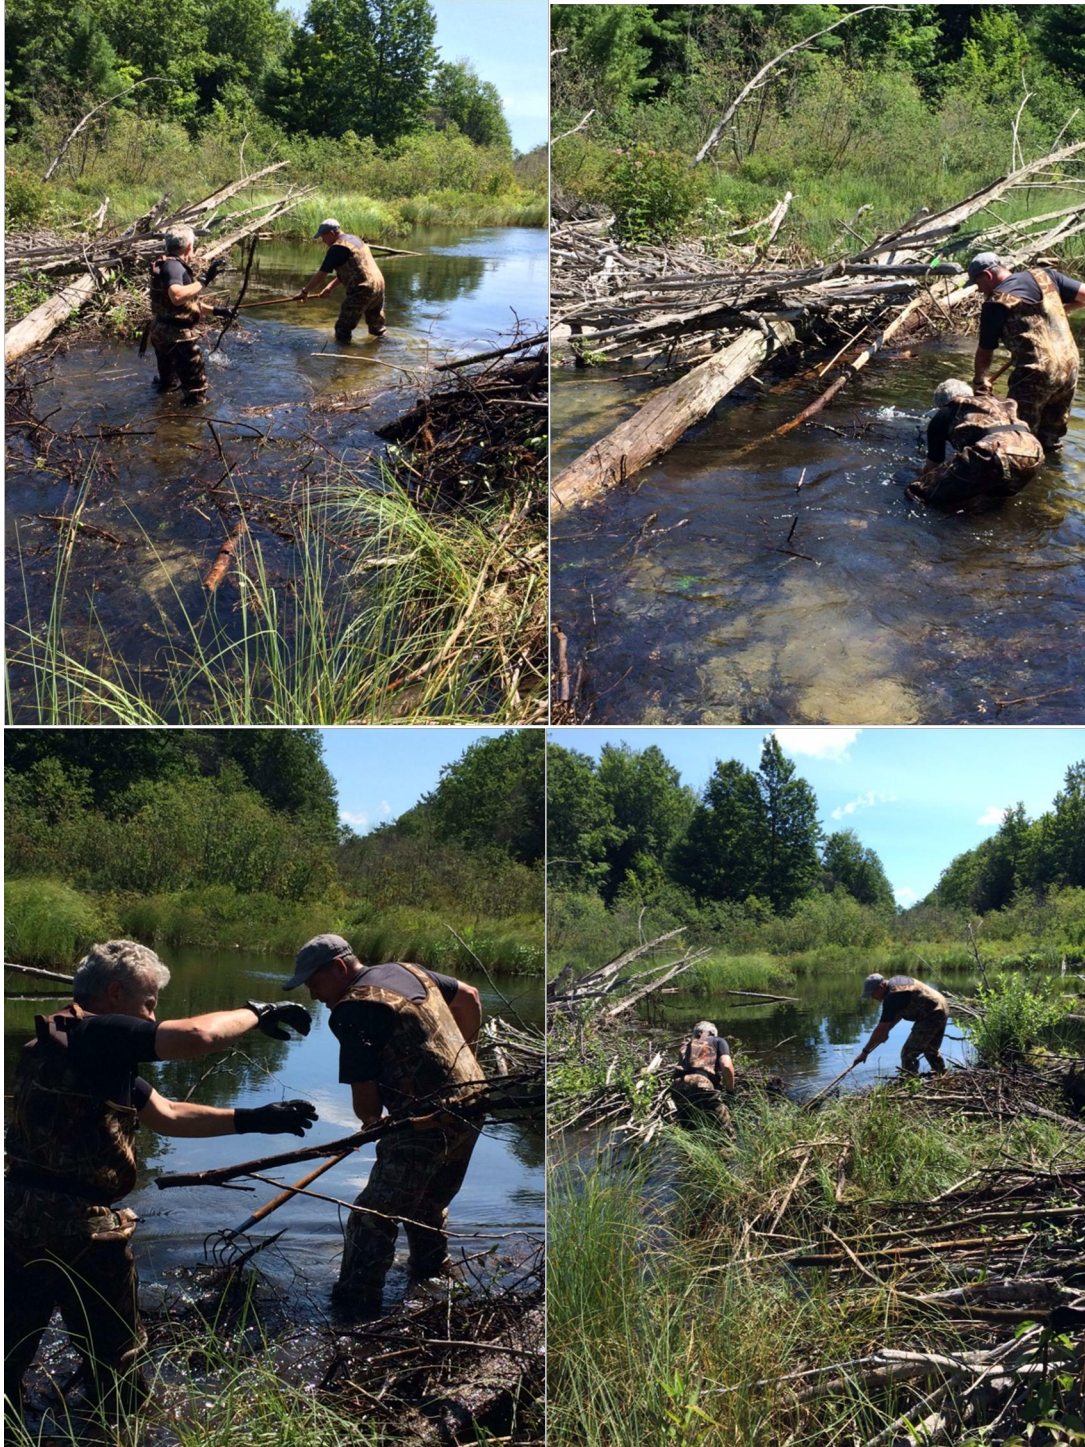
Jeff and Jim worked on the site for approximately 1 hour and 20 minutes. During this time they created an approximately 10 to 12 ft breach in the dam.

Figures 2-5. Breaching beaver dam on August 5, 2017 on Shalda Creek, Sleeping Bear Dunes National Lakeshore.

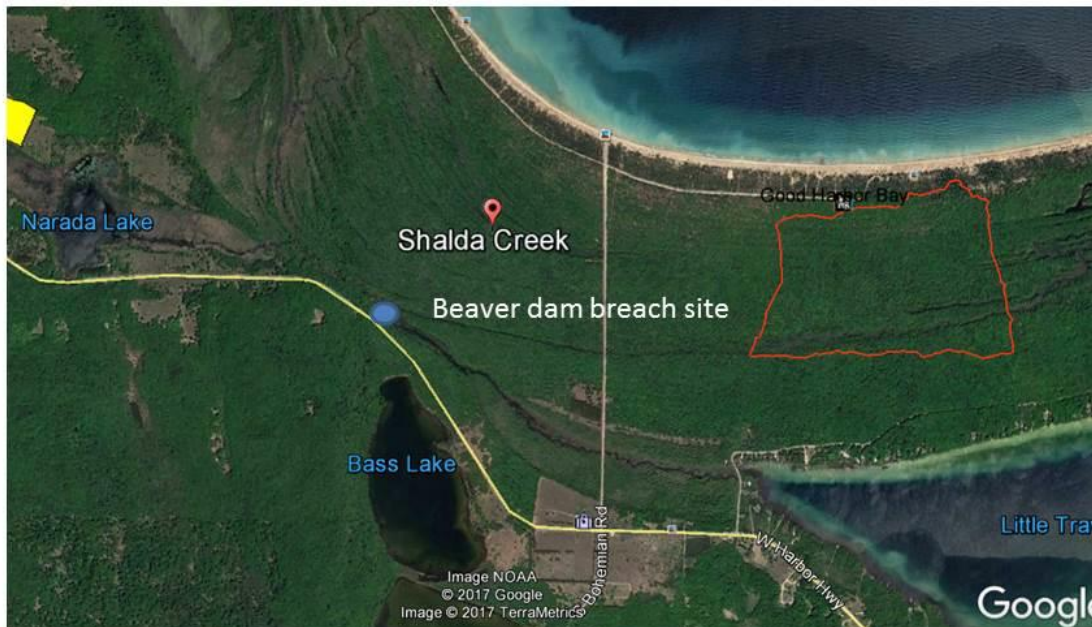
Figure 1. Approximate dam breach site on Shalda Creek, Sleeping Bear Dunes National Lakeshore. Project was conducted on August 10, 2017.

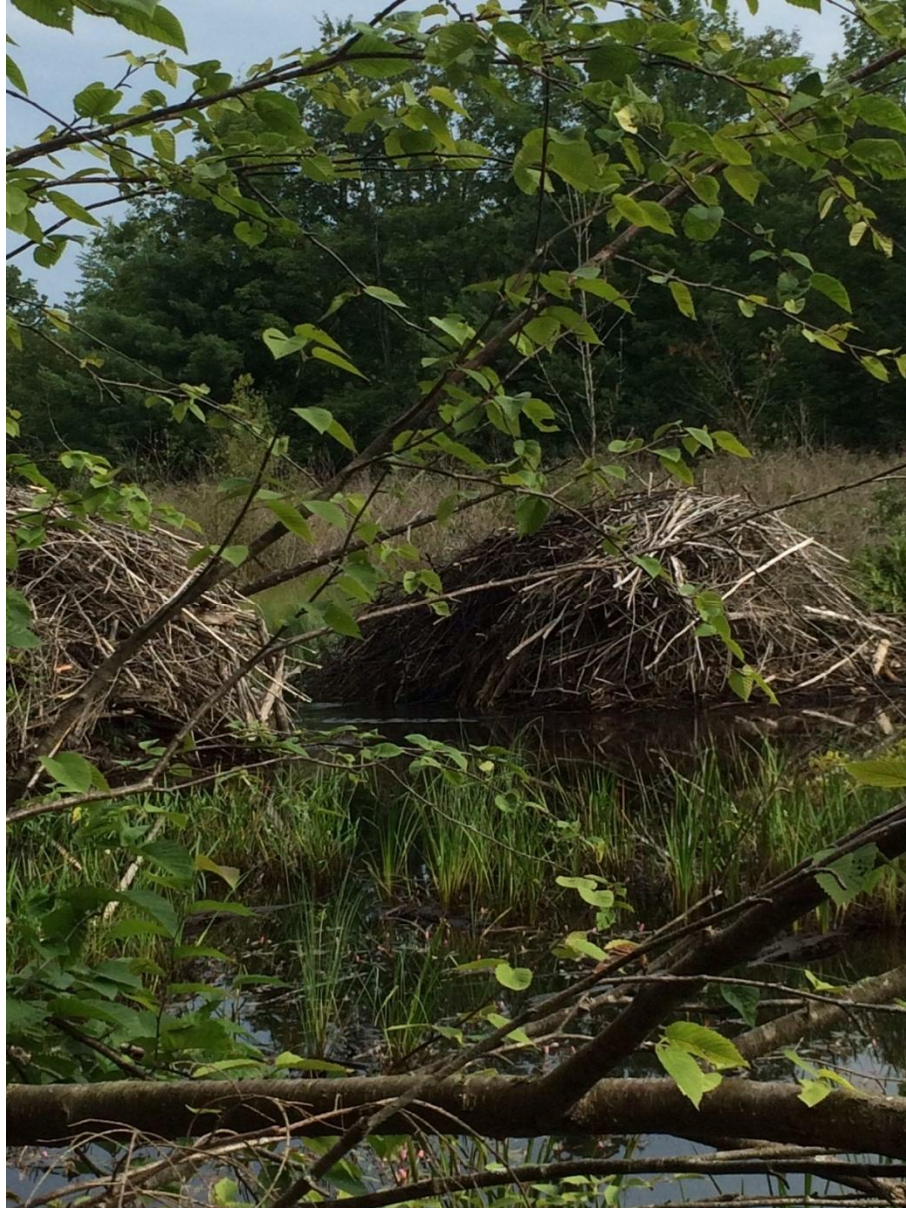
Staff worked on the site for approximately 2 hours from 8:00 am -10:00 am. During this time the team created an approximately 10 ft. breach in the dam. Volume of removed branches and logs was approximately 10 ft (l) x 5 ft (w) x 3 ft (d).

Figure 2. Breaching involved removal of material between two large piles (one left, one center right) of woody debris. These piles presumably do not represent beaver activity, but rather storage areas for material removed from previous dam breaching efforts. Photograph is from a poor vantage point because of the lack of a waterproof camera for taking photos in the immediate vicinity of the dam removal. But the clear passage between mounds can be observed.

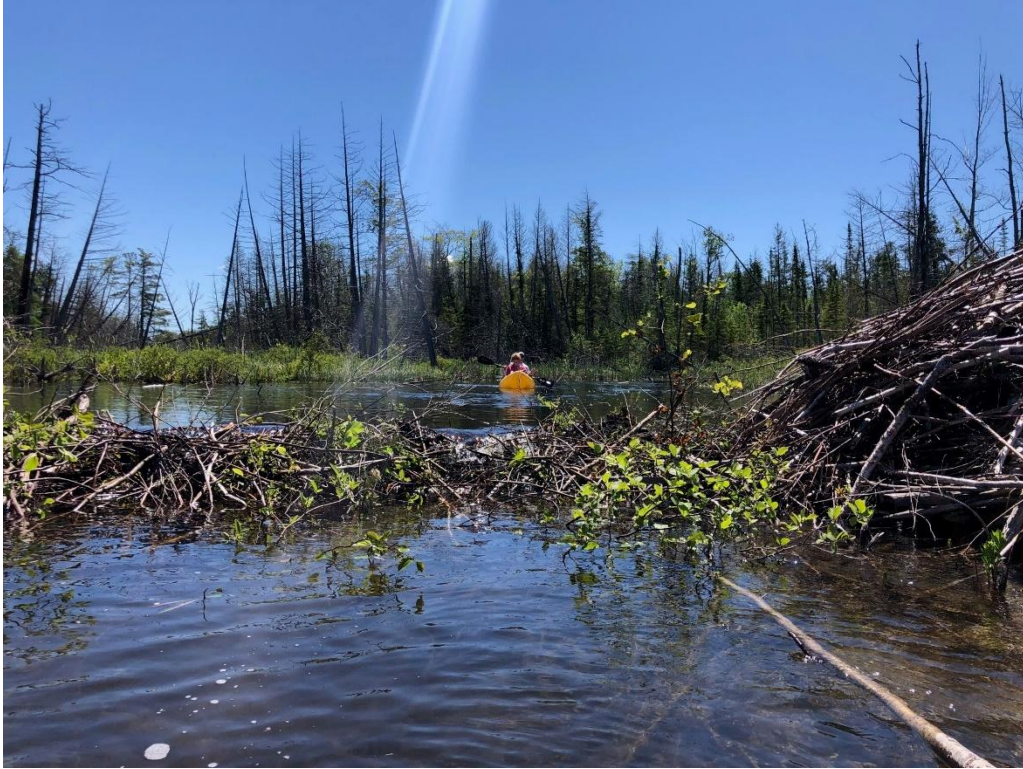
2 - Dam between Little Traverse Lake / CR669 prior to removal June 2020

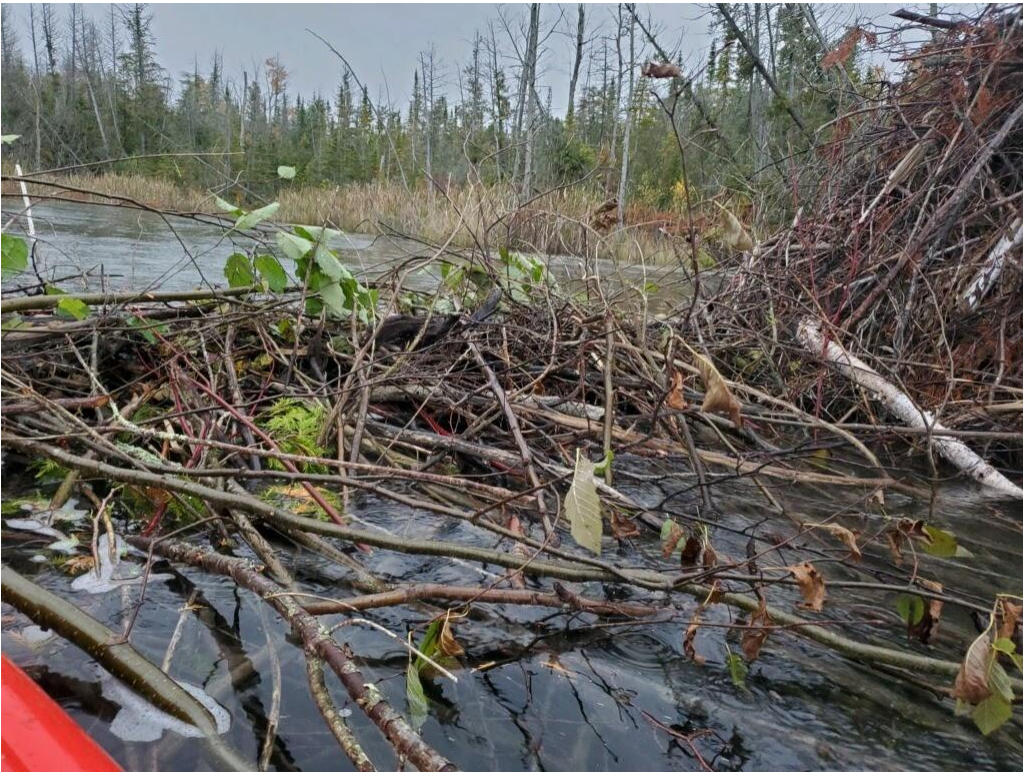
1- Dam between Little Traverse Lake / CR669 prior to removal June 2020

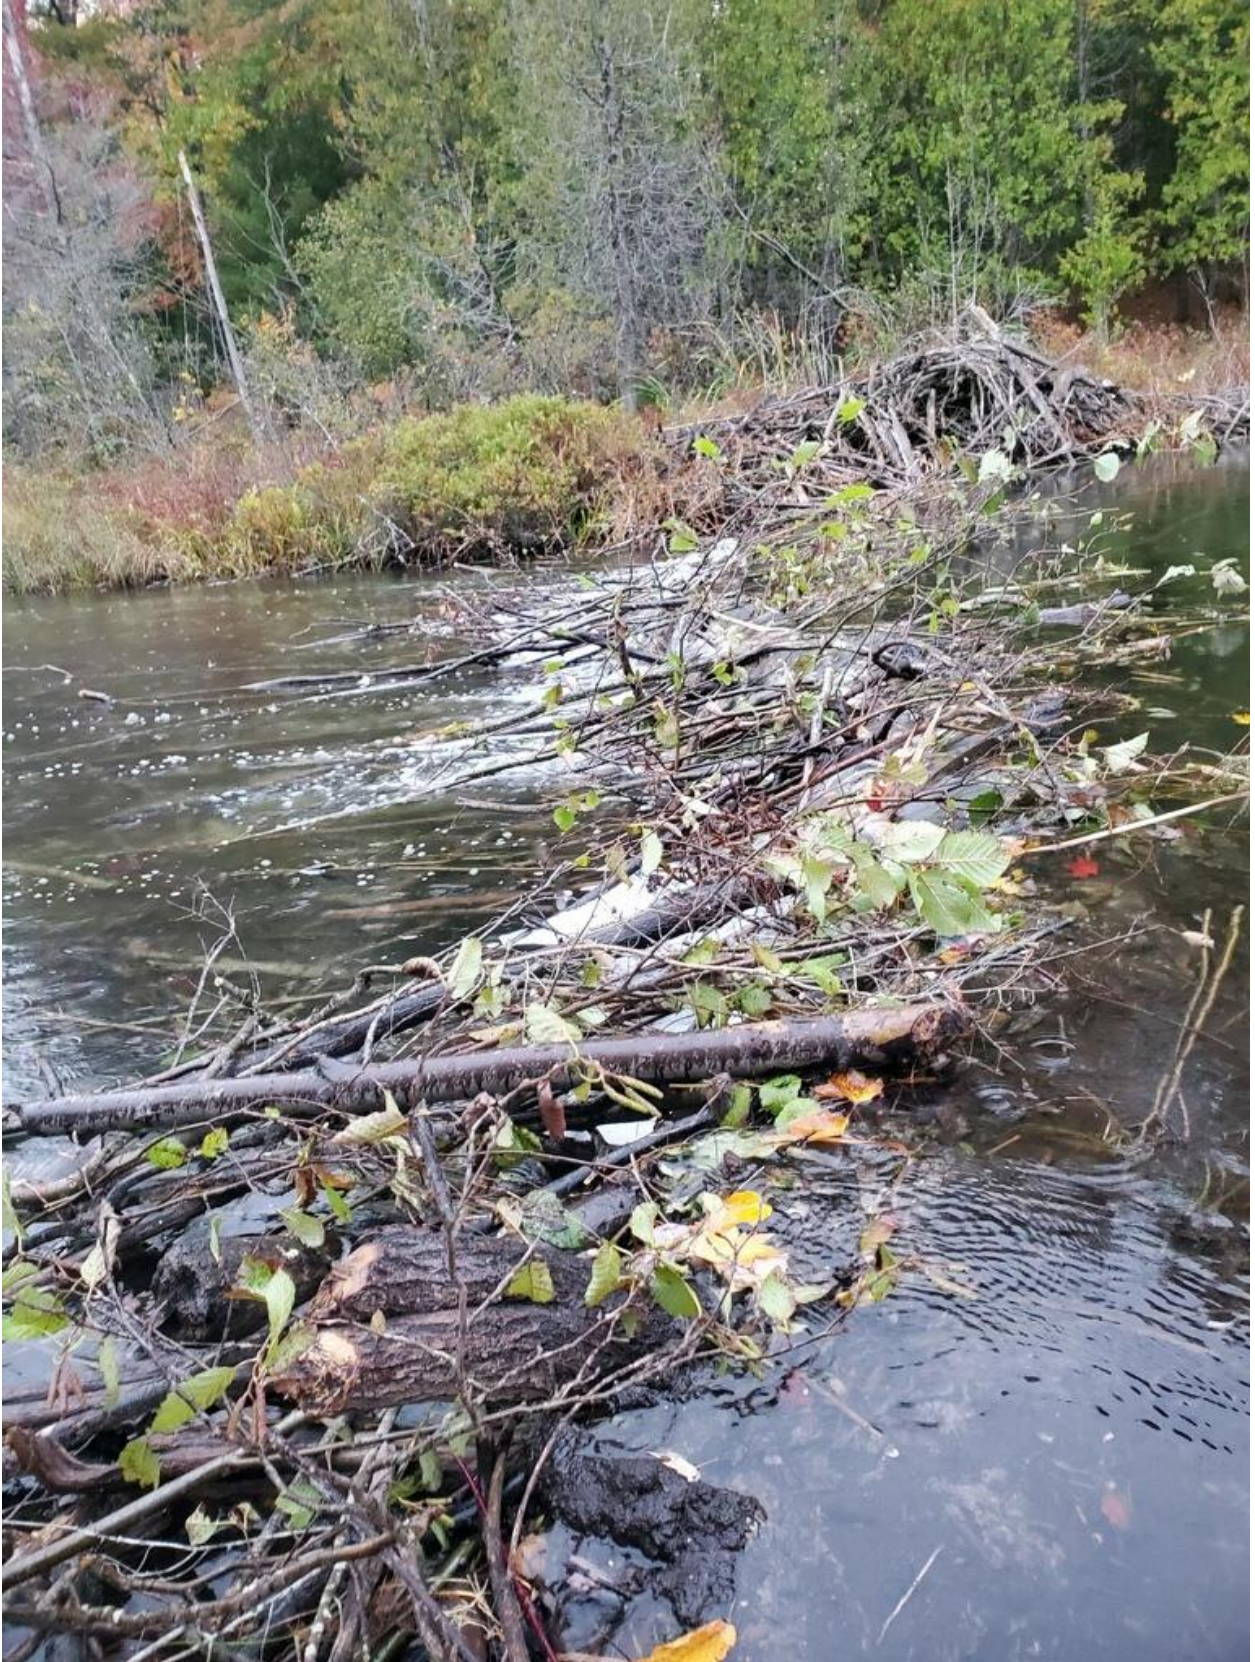
3- Fishcamp dam prior to removal 10-24-2020

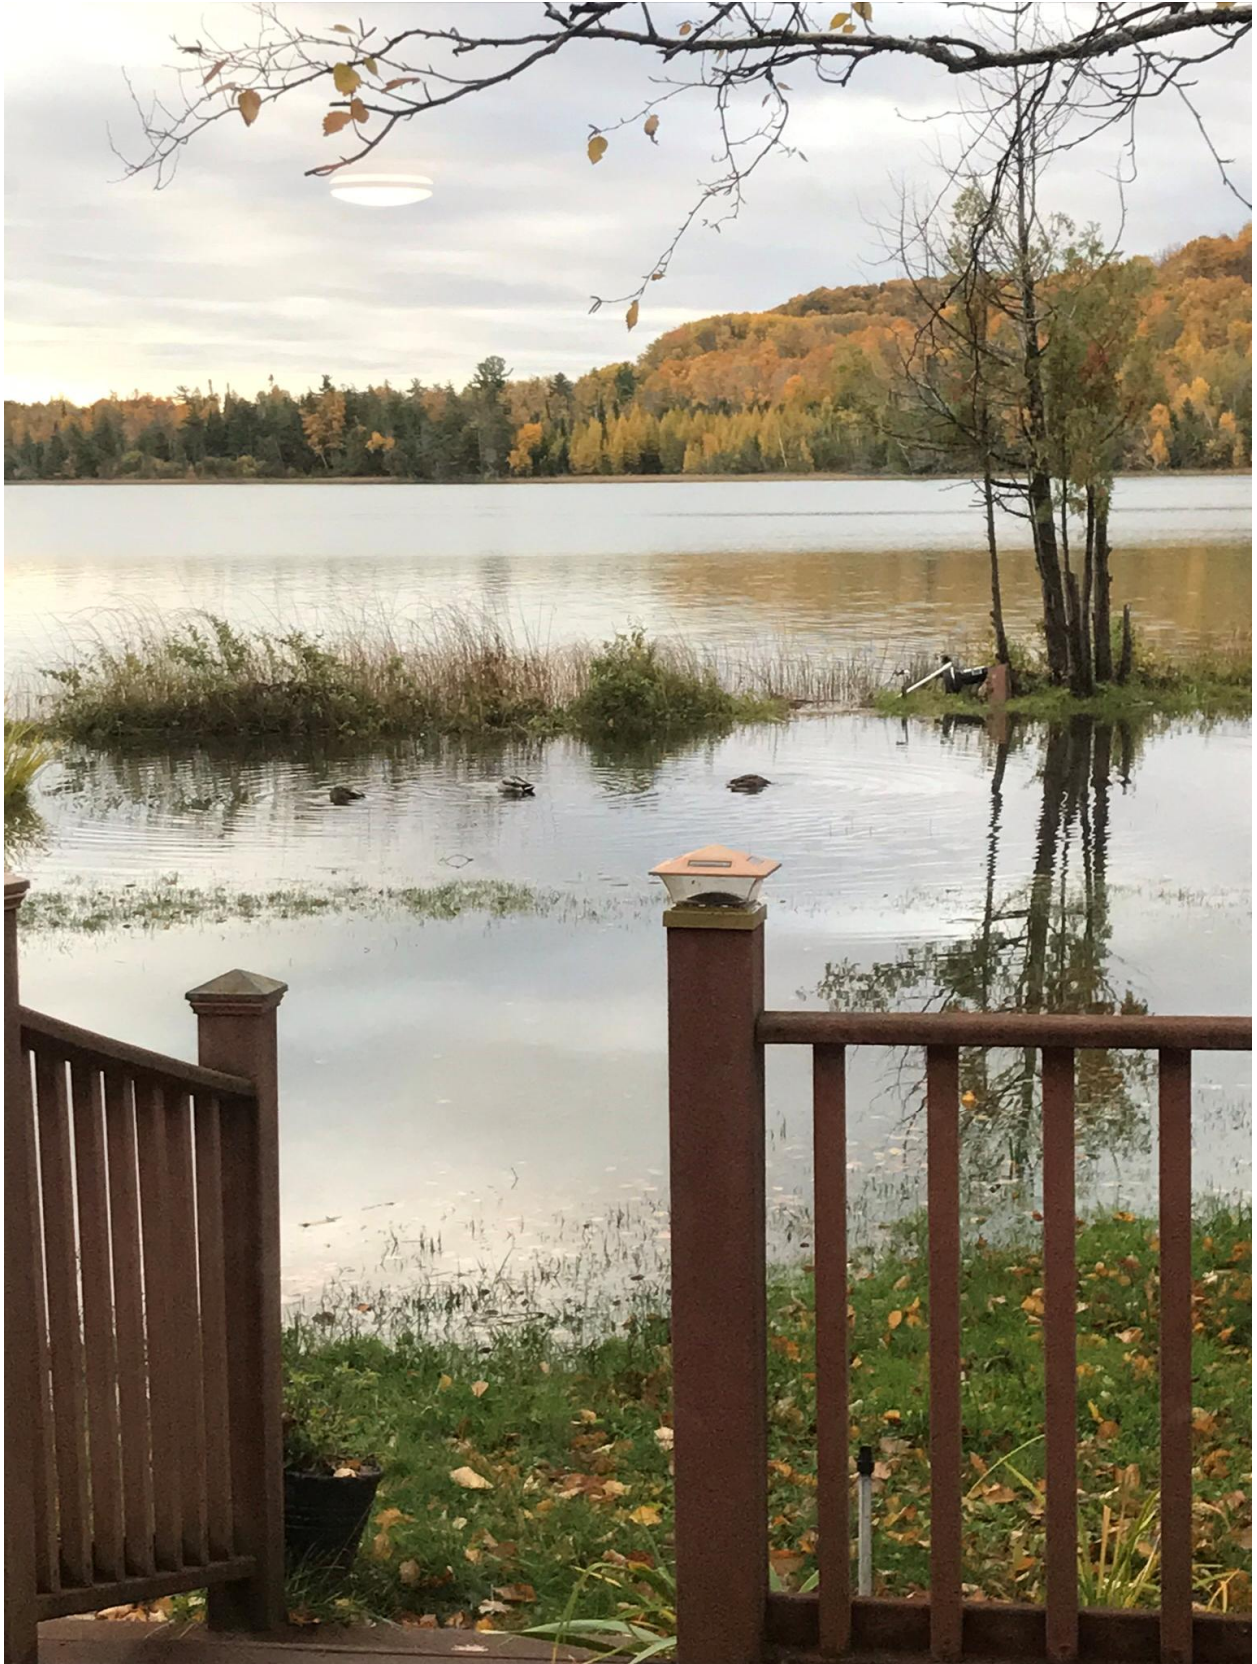
4- Little Traverse Lake property flooding fall 2020

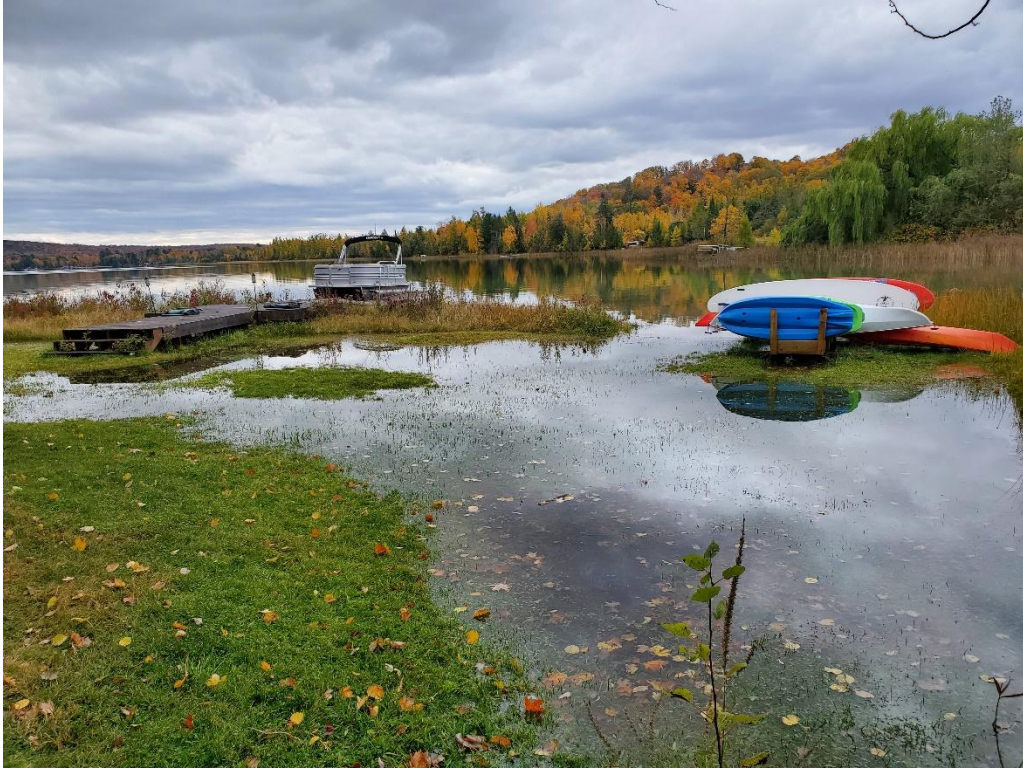
5- Little Traverse Lake property flooding fall 2020

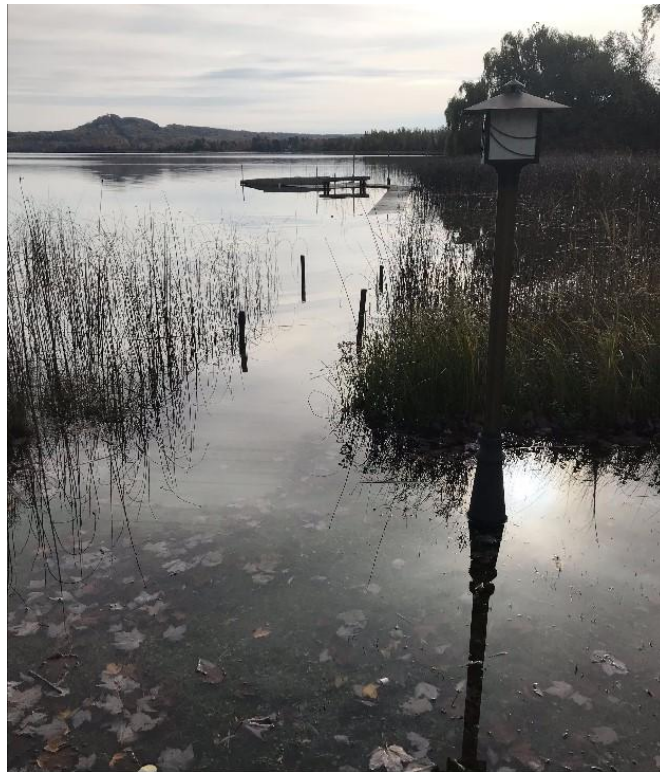
6- Little Traverse Lake property flooding fall 2020

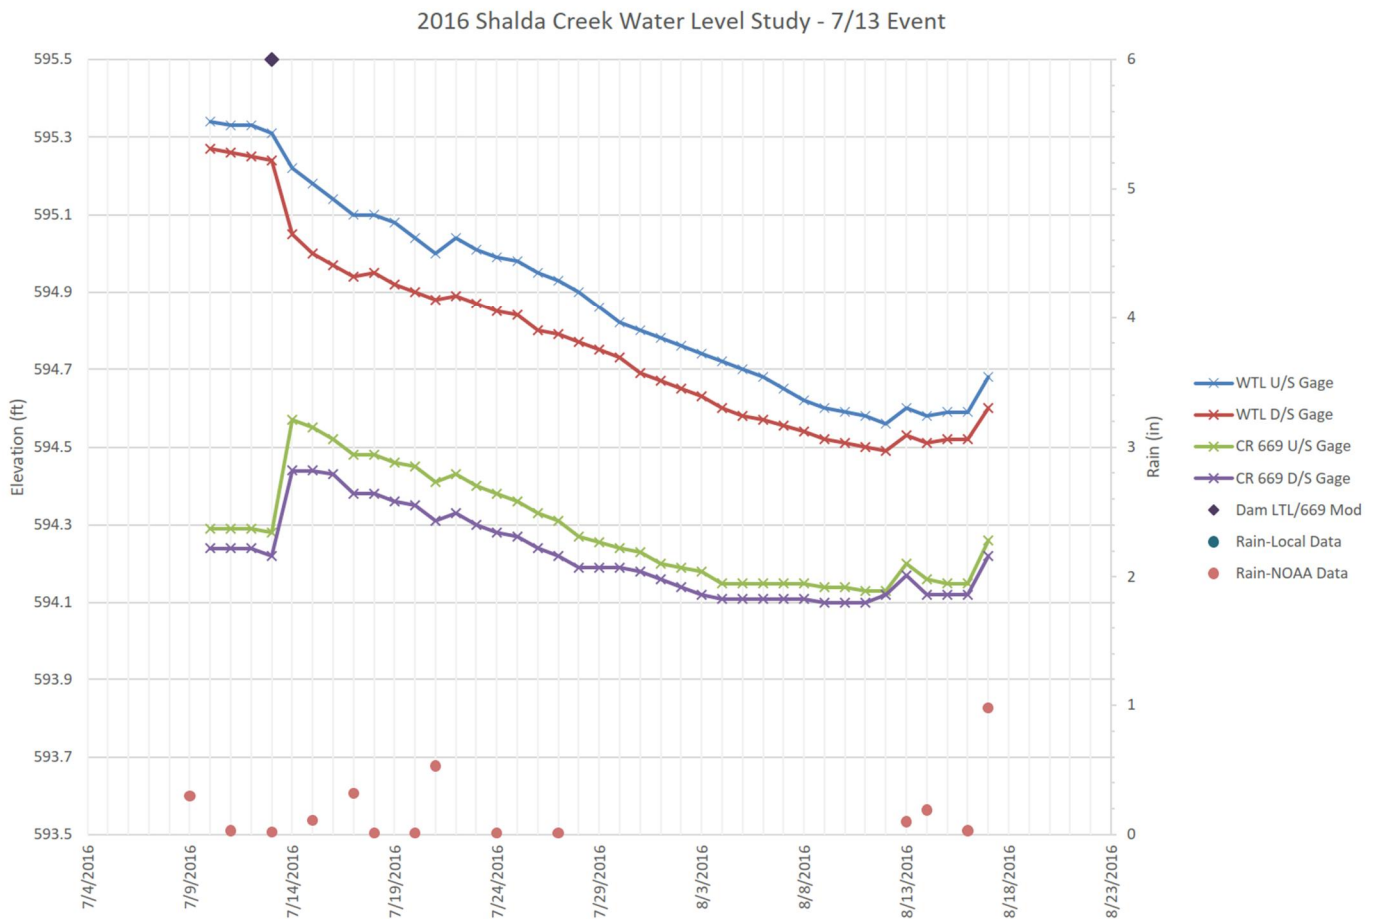
Figure 1

LTL residents are currently experiencing some of the highest recorded water levels similar to the levels surrounding the two separate dam modifications presented in this memorandum. Those modifications occurred just prior and during a yearlong data collection period from fall 2016 to fall 2017 for which a final report is currently being prepared. One of the goals of the larger study was to observe system water levels as beaver dams were modified downstream of the CR 669 culvert. This dam is the farthest upstream observed dam in the system and modification of it was necessary to access effects of the downstream dam modifications during the study. The data presented for the modifications of this beaver dam between CR 669 and West Traverse Lake Road provide a reasonable basis for the NPS to allow additional modifications of the beaver dam located within the Sleeping Bear Dunes National Lakeshore by LTLPOA.

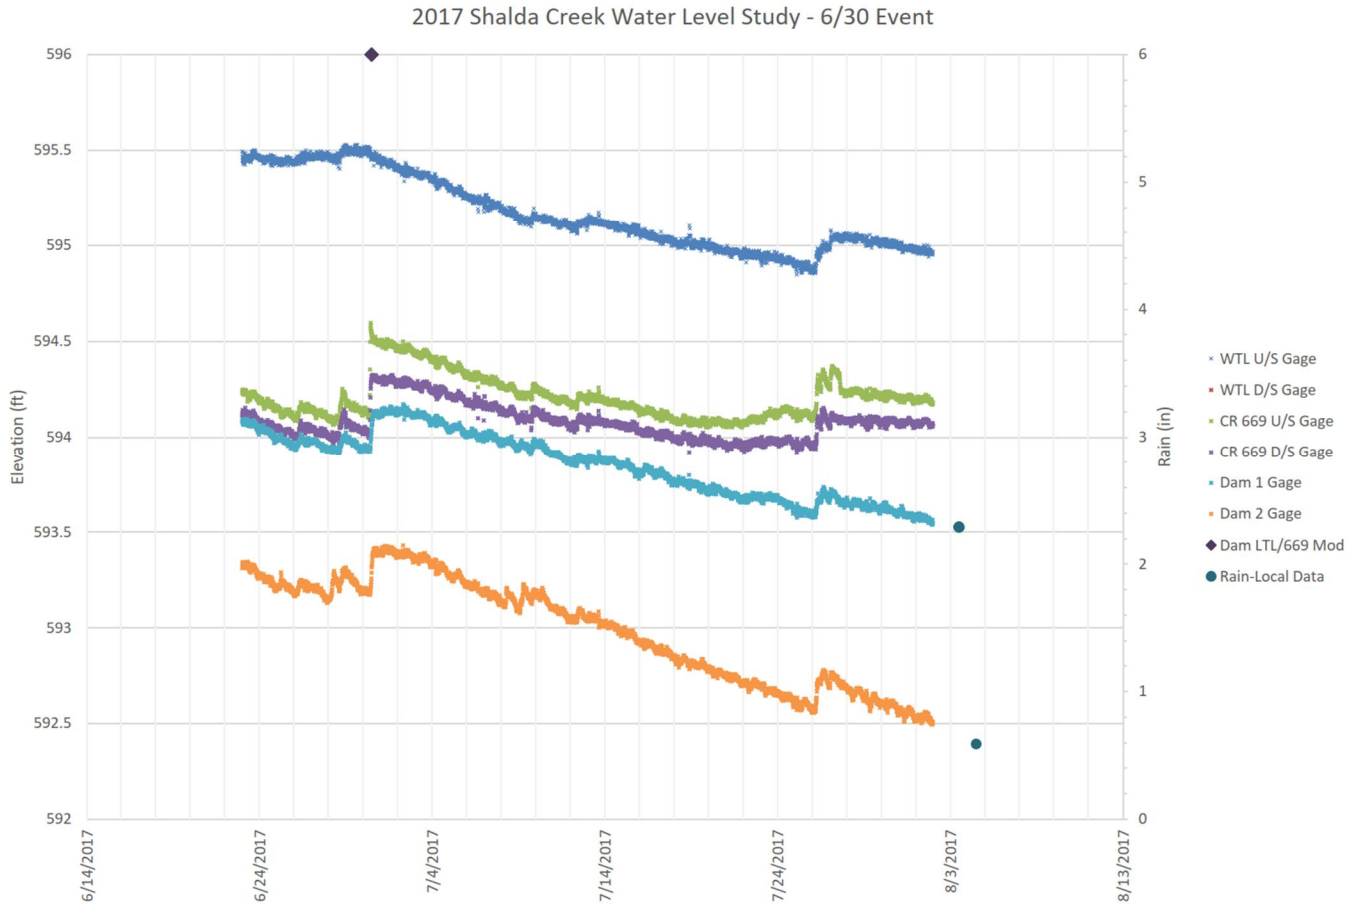
Another data set graph is shown in Figure 2 from data collected following a modification of the dam between LTL and CR 669 nearly a year later on 6/30/2017. This data was recorded by the data loggers that were deployed by NPS in August 2016. Once again, the water surface elevation at LTL was relatively high at 595.5 when the dam was modified. After the dam modification, there were quick upticks in elevation at

the gauges downstream of the dam followed by steady decline of water levels over approximately 1 month. During this period, the LTL level declined .65 feet (7.8 inches).
