Date: February 25, 2015  
Inspector: Tim Menebroeker  
Report example

# Home Inspection Report

**John Doe**  
**Example**  
**Address**

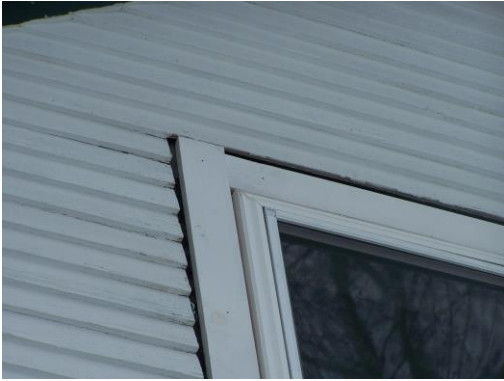
Rain gutter shows signs of leaking at the seam near downspout on south side of house.

Water leaking from seams is not getting to the downspout for proper drainage away from foundation.

Some of the windows mainly on the upper south and east side of house have gaps around the trim and siding. These gaps should be sealed to prevent moisture from getting behind siding.

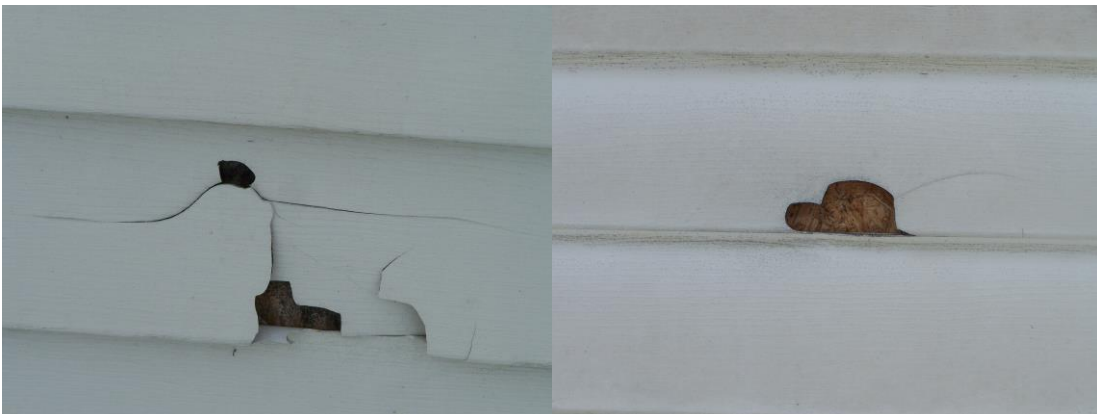
Garage has vinyl siding there are several places where the siding is cracked or has holes in the siding especially on the east and south sides. There doesn't appear to be a vapor barrier behind siding. These two conditions could lead to water penetrating the wood sheathing causing mold or rotting of the underlying wood.

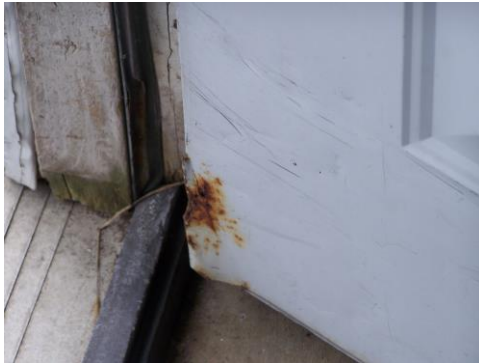
Service door showing signs of rust at bottom and has a few slashes in door which could allow water penetration and cause corrosion inside of door.

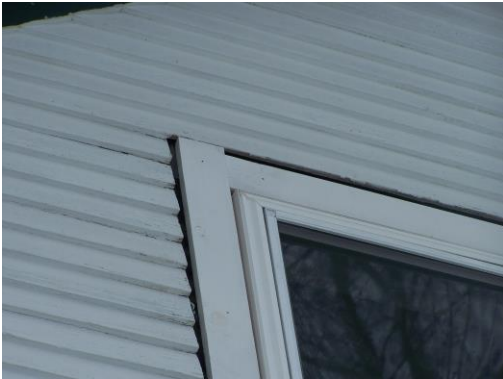
Some of the windows mainly on the upper south and east side of house have gaps around the trim and siding. These gaps should be sealed to prevent moisture from getting behind siding.

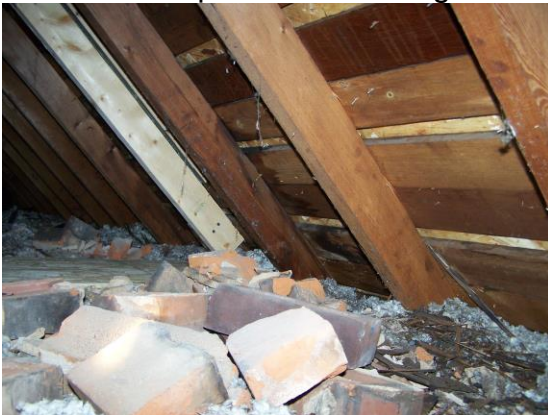
Rafters are of 2X4 construction with cross boards and osb (Orientated Strand Board) sheeting. There are signs of old water stains possibly where a chimney may have been removed. Noted some new 2x4's bricks lying in the area of this repair. No other signs of leaking were observed.

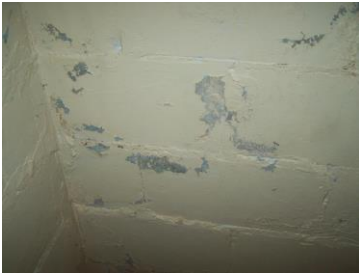
Some walls are finished and covered with dry wall brick wall on west side of basement shows peeling paint could be a result of water penetration.

Peeling paint on west wall could be from water penetration, some signs of past water penetration or water on floor noted on bottom of drywall on north rooms.

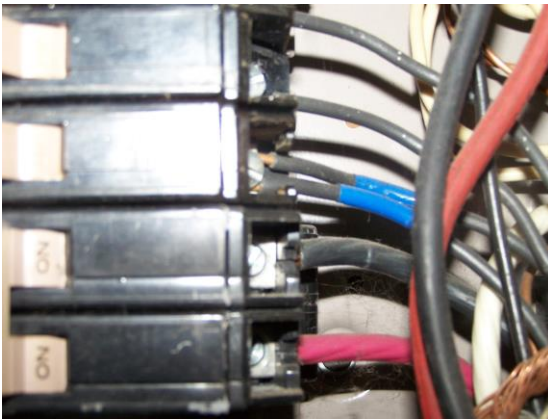
Noted two wires tied into one breaker this should be looked at by licensed electrician breaker switches are not designed to have more than one wire connected to them more could cause arcing and a possible fire hazard.
