### Disabling Temp. Pin on Depth Xducer Wire

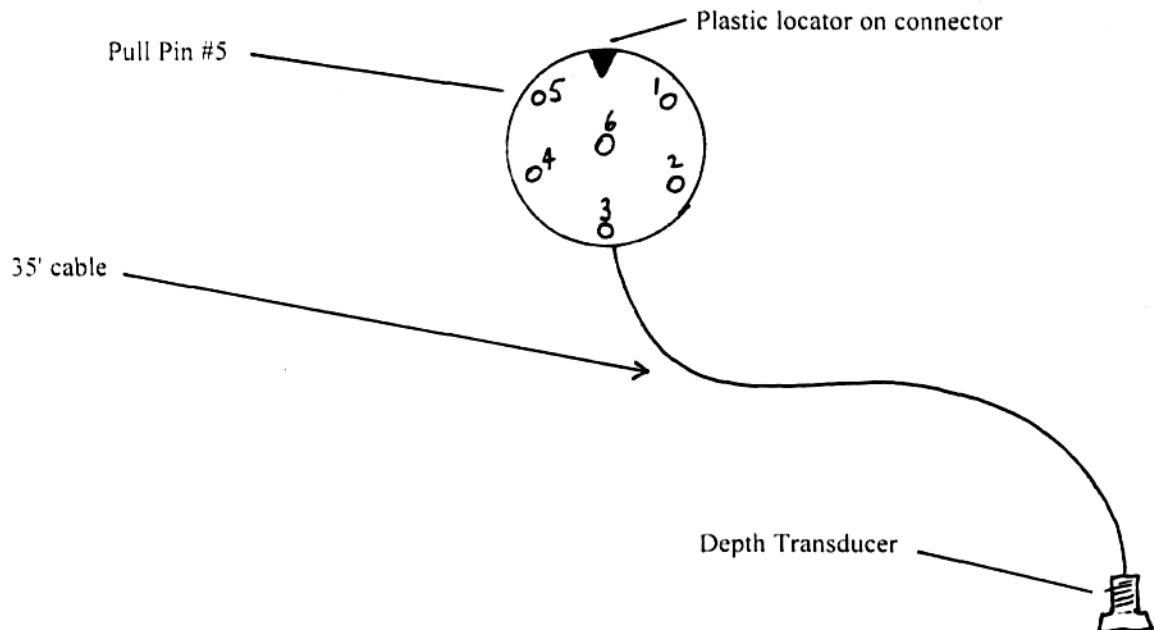
Please note that the damage to your instrument was most likely caused by a shorted-out temperature element in your depth transducer. If you connect the same transducer to the repaired instrument without correcting the cause of the problem, the same damage will occur.

SignetMarine recommends replacing your depth transducer, however there is a stop-gap solution if your boat is in the water. As shown in the diagram below, the temperature element can be disabled by removing **pin #5** from the depth transducer cable connector. Make sure that you are looking at the correct connector before pulling a pin. It is the connector at the end of the 35' cable connected to the depth transducer. It must be a male 6-pin connector (slightly less than 3/4" diameter). Once you have located the correct pin, pull it out with long-nosed pliers or bend it back and forth until it breaks off. This will disable the temp. element and should restore normal functions to your system (excluding the temp. function). We recommend replacing the depth transducer when the boat is next hauled out of the water.
