# Inspection Report

**Property Address:**  
123 Happy Home Lane  
Glastonbury CT 06033

**Allied Home Inspection**

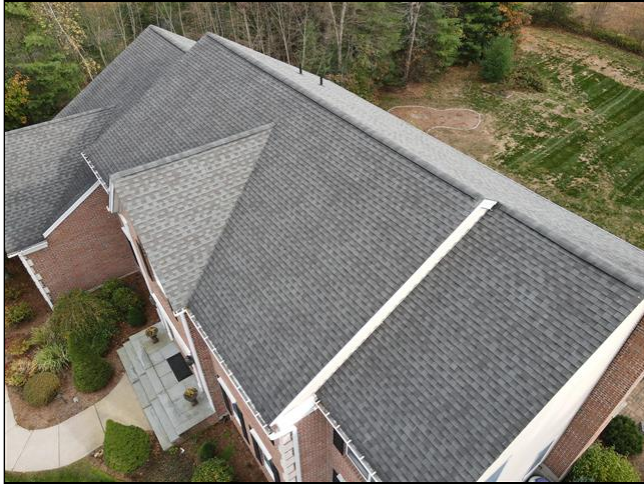
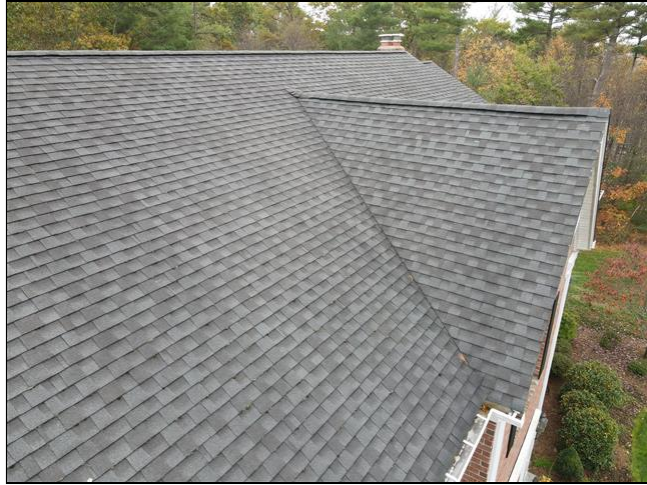
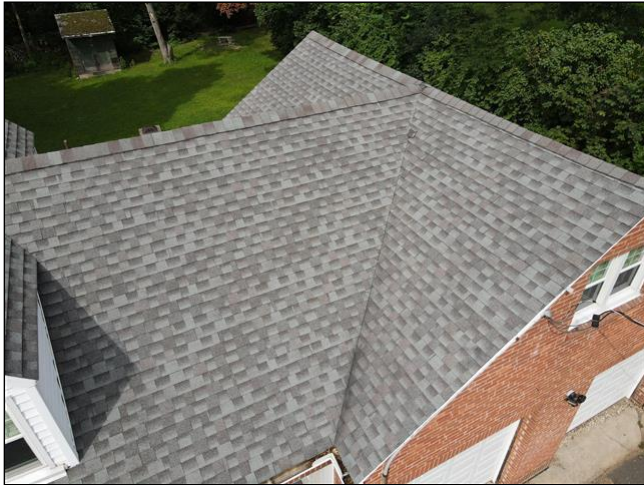
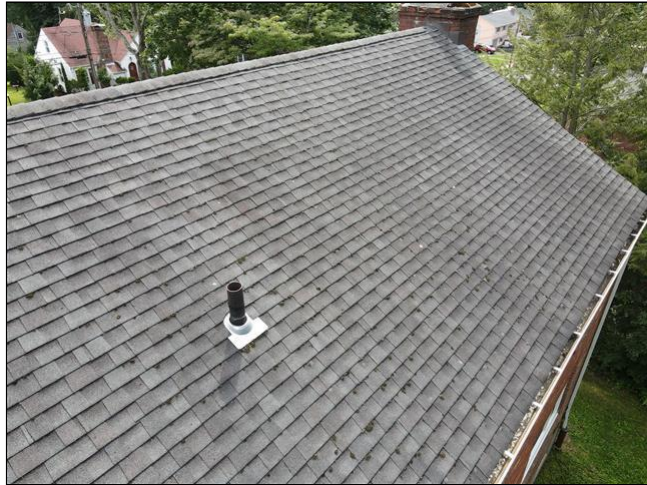
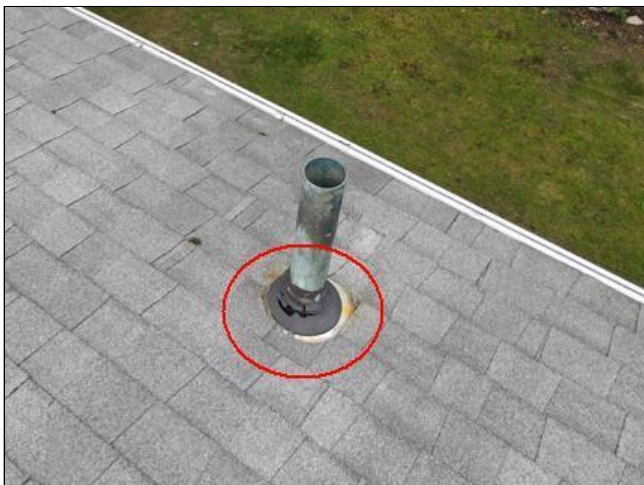
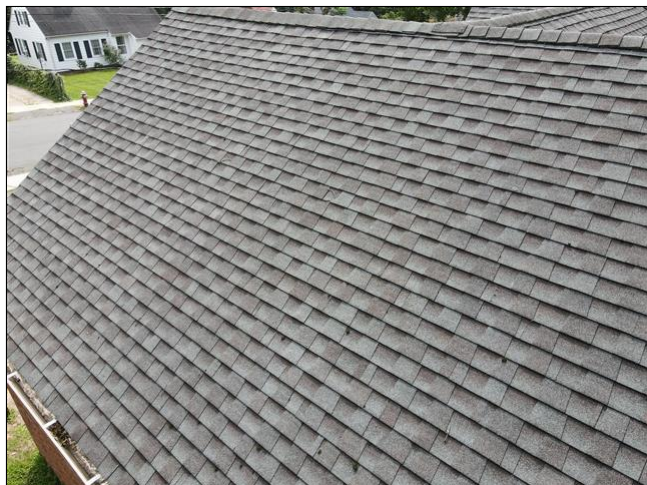
According to information provided to me at the time of the inspection, the roof is approximately 10 years old. The roof has architectural shingles which have a "normal" life of approximately 25-35 years depending on the manufacturer and model shingle. The roof shingles were in good condition; however, there is a large hole in the vent boot to the rear plumbing stack vent which requires replacement to prevent roof leaks. I recommend repair be accomplished by a qualified roofer at this time

1.0 According to information provided to me at the time of the inspection, the roof is approximately 10 years old. The roof has architectural shingles which have a "normal" life of approximately 25-35 years depending on the manufacturer and model shingle. The roof shingles were in good condition; however, there is a large hole in the vent boot to the rear plumbing stack vent which requires replacement to prevent roof leaks. I recommend repair be accomplished by a qualified roofer at this time

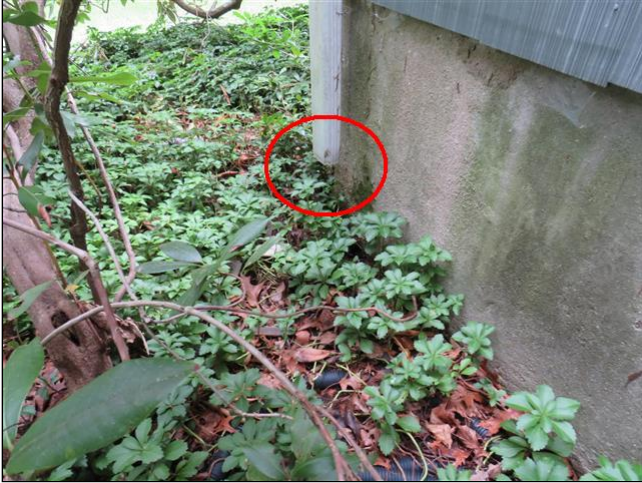
1.1 Item 1(Picture)

The rear right downspout discharges water too close to the foundation which could result in basement water entry. I recommend an elbow and downspout extension be installed to allow for proper drainage away from the foundation. Ideally, downspouts should discharge water at least 6 feet from the foundation.

**1.1** The rear right downspout discharges water too close to the foundation which could result in basement water entry. I recommend an elbow and downspout extension be installed to allow for proper drainage away from the foundation. Ideally, downspouts should discharge water at least 6 feet from the foundation.

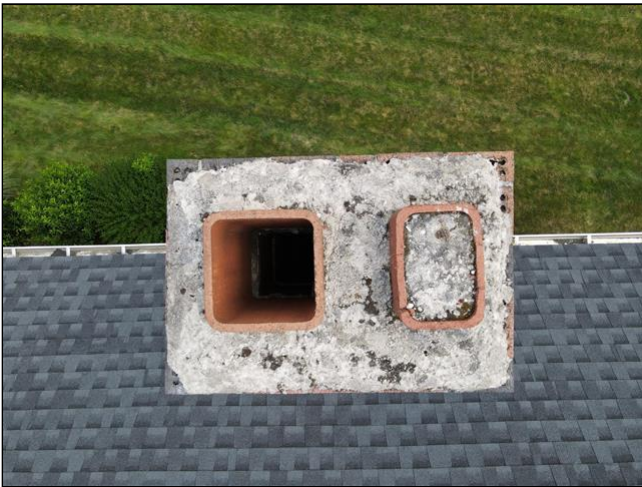
1.2 Item 1(Picture)

The chimney crown is heavily weathered and no longer adequately covers the top of the chimney. This could allow water to enter through openings in the crown and freeze and expand during the winter

months causing further damage to the chimney. I recommend a mason or qualified chimney service contractor replace the crown at this time.

**1.2** The chimney crown is heavily weathered and no longer adequately covers the top of the chimney. This could allow water to enter through openings in the crown and freeze and expand during the winter months causing further damage to the chimney. I recommend a mason or qualified chimney service contractor replace the crown at this time.

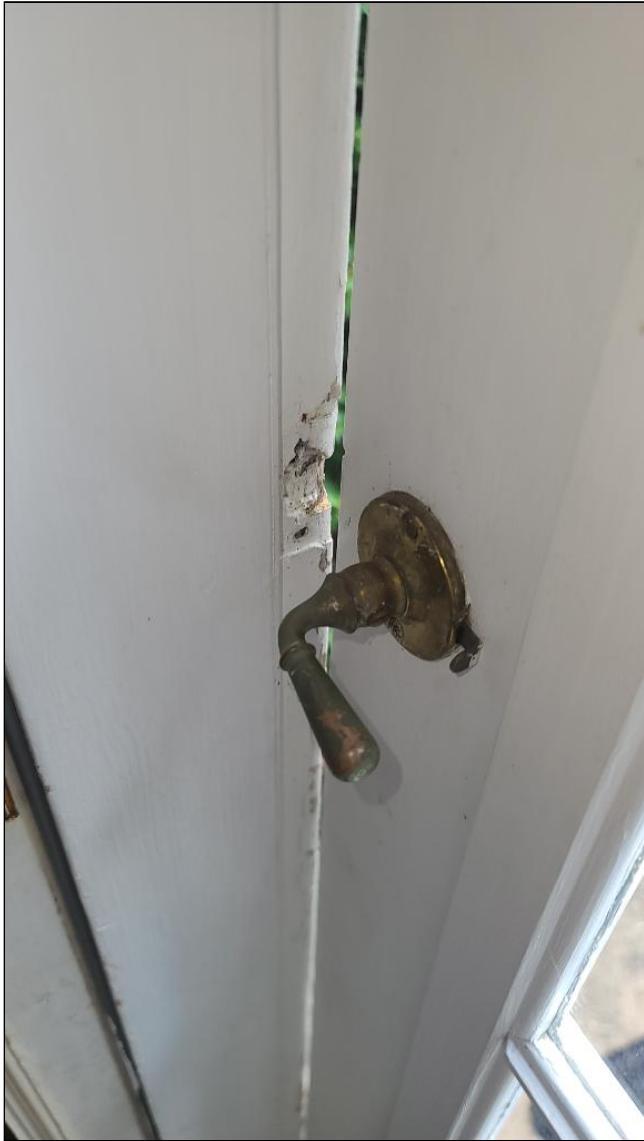
1.4 Item 1(Picture)

The front glass storm door hits on the door frame and the strike plate is missing. The door should be adjusted to allow for it to close properly and a strike plate should be installed to prevent damage to the door jamb.

**1.4** The front glass storm door hits on the door frame and the strike plate is missing. The door should be adjusted to allow for it to close properly and a strike plate should be installed to prevent damage to the door jamb.

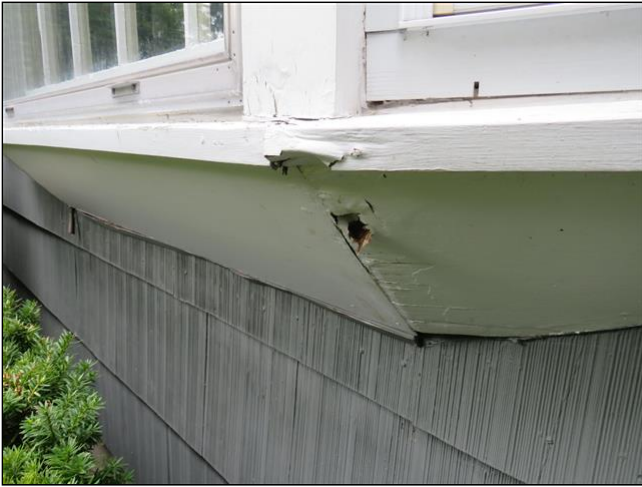
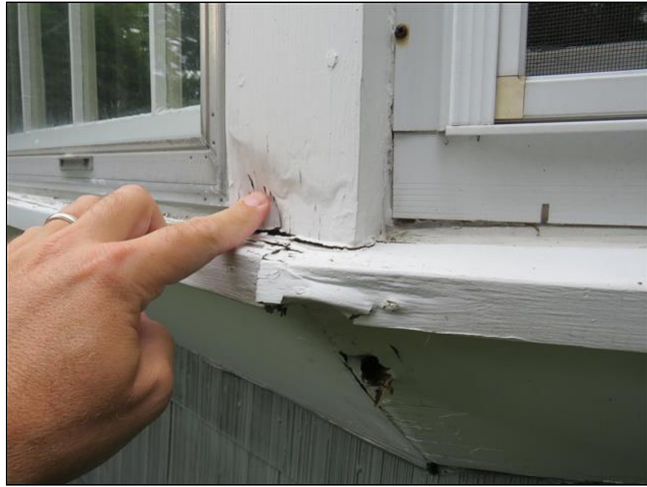
(1) There is significant rot to the bottom of the bay window frame and the right double hung window of the unit is racked and will not open. This window is the original and at over 40 years old is considered to be beyond its useful life. Based on its age and overall condition I recommend the bay window be replaced by a qualified contractor.

1.5 (1) There is significant rot to the bottom of the bay window frame and the right double hung window of the unit is racked and will not open. This window is the original and at over 40 years old is considered to be beyond its useful life. Based on its age and overall condition I recommend the bay window be replaced by a qualified contractor.

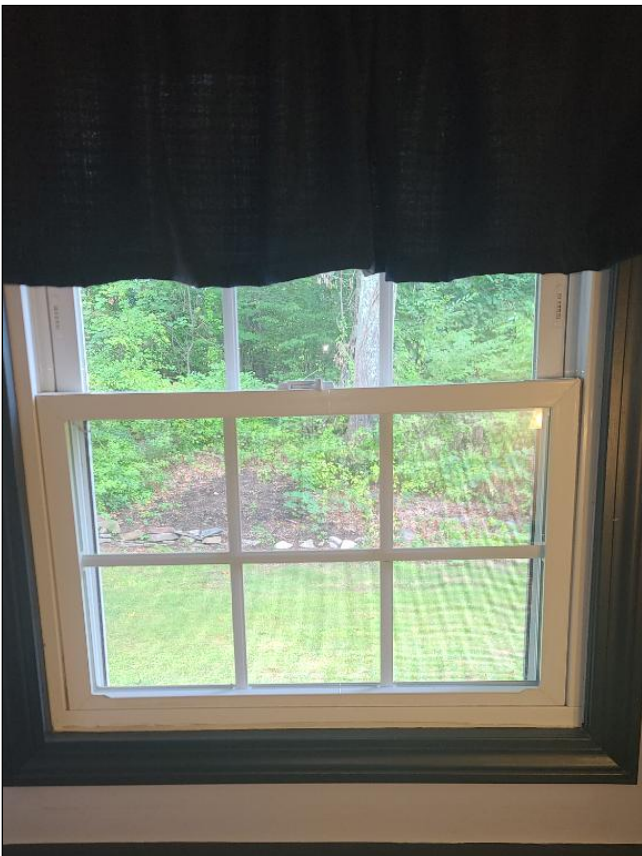
1.5 Item 3(Picture)

(2) The first floor bathroom window does not stay up when opened (sash balance springs broken) and requires repair by a qualified window contractor.

1.5 (2) The first floor bathroom window does not stay up when opened (sash balance springs broken) and requires repair by a qualified window contractor.

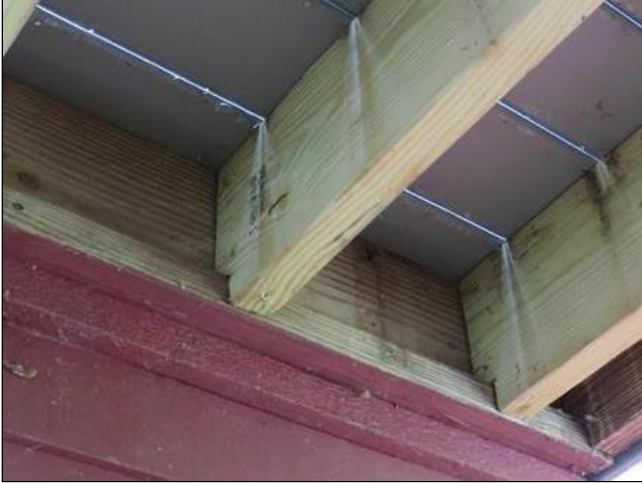
1.7 Item 1(Picture)

The deck ledger board was not secured to the house with lag bolts or lag screws which provide a better connection between the ledger board and house framing members. To prevent possible separation between the deck and house, I recommend this hardware be installed by a carpenter at this time.

**1.7** The deck ledger board was not secured to the house with lag bolts or lag screws which provide a better connection between the ledger board and house framing members. To prevent possible separation between the deck and house, I recommend this hardware be installed by a carpenter at this time.

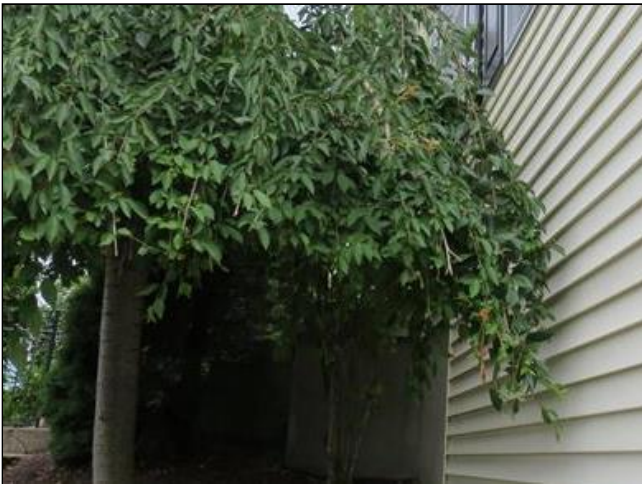
1.10 Item 1(Picture)

There is vegetation in contact with the house which could cause damage to the siding. I recommend that the vegetation be trimmed back so that it is no longer in contact with the house. This is considered a part of normal homeowner maintenance. Ideally, a 12" gap should be maintained between any vegetation and the siding.

**1.10** There is vegetation in contact with the house which could cause damage to the siding. I recommend that the vegetation be trimmed back so that it is no longer in contact with the house. This is considered a part of normal homeowner maintenance. Ideally, a 12" gap should be maintained between any vegetation and the siding.

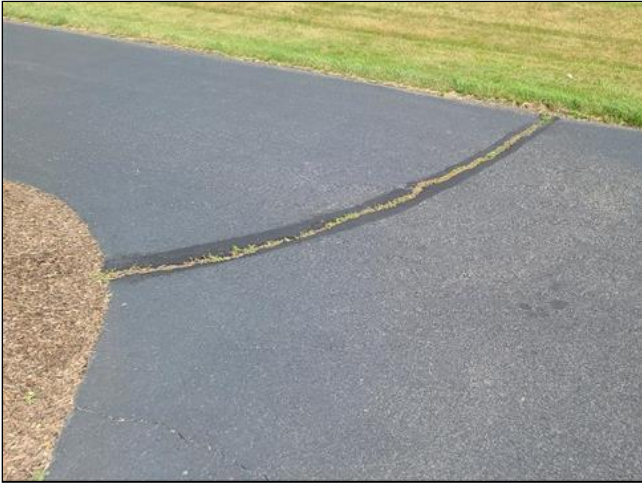
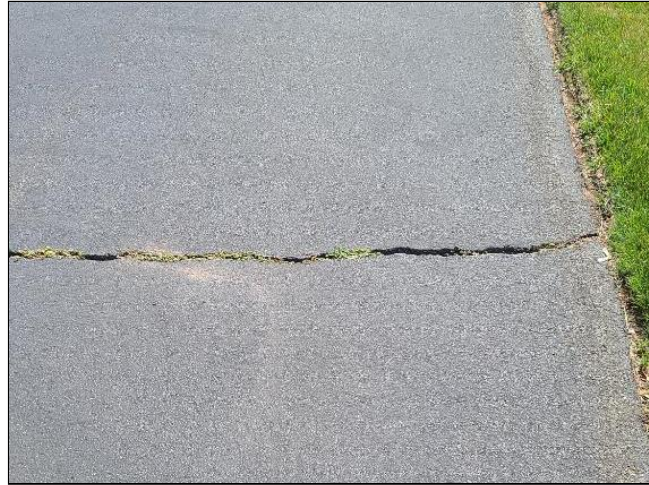
There are a few cracks which run the width of the driveway and should be repaired with an asphalt filler to prevent further deterioration.

1.11 There are a few cracks which run the width of the driveway and should be repaired with an asphalt filler to prevent further deterioration.

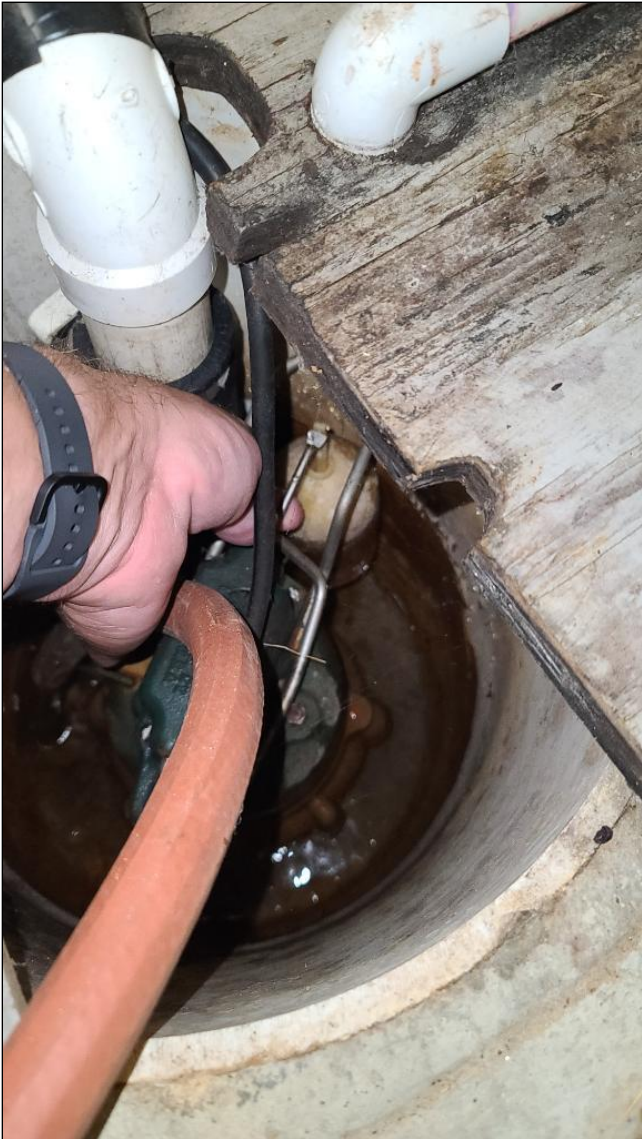
2.0 Item 1(Picture)

**2.0** The basement was dry at the time of the inspection. To prevent excessive moisture and possible mold growth I recommend operating a dehumidifier as a part of good homeowner maintenance. The sump pump was tested and did operate properly at the time of inspection. This should be periodically tested by lifting the float switch to turn on the pump.

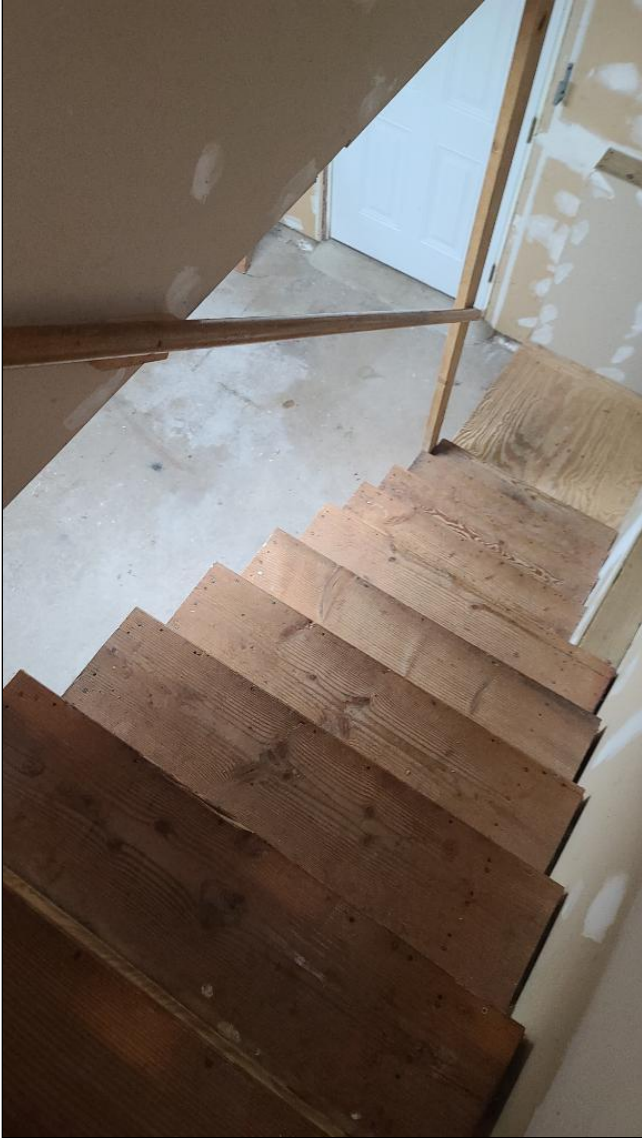
2.6 Item 1(Picture)

The railing on the basement stairs is an "open" type which is considered a safety hazard, especially for small children. I recommend installing a "closed" type railing for safety reasons (railing in which a 4" diameter ball cannot pass through).

2.6 The railing on the basement stairs is an "open" type which is considered a safety hazard, especially for small children. I recommend installing a "closed" type railing for safety reasons (railing in which a 4" diameter ball cannot pass through).

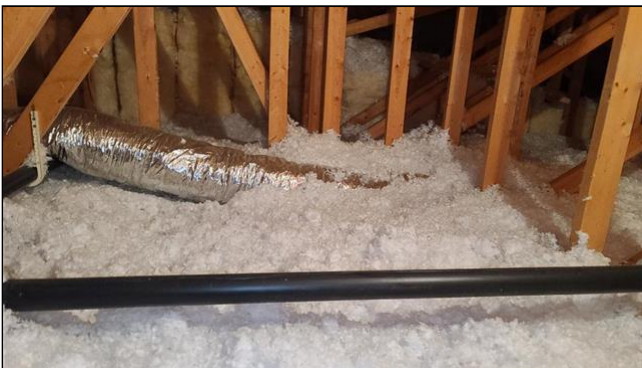
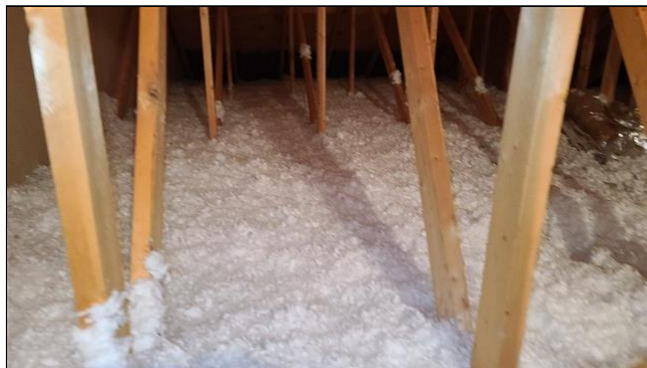
2.9 There is approximately 9" of fiberglass insulation (R-30) in the attic. Today, considering the many years of increases in energy cost, the recommendation is for approximately 16" of fiberglass insulation (R-49) or its equivalent. If you wish to have a more energy efficient home, you may want to consider adding additional insulation over the existing insulation.

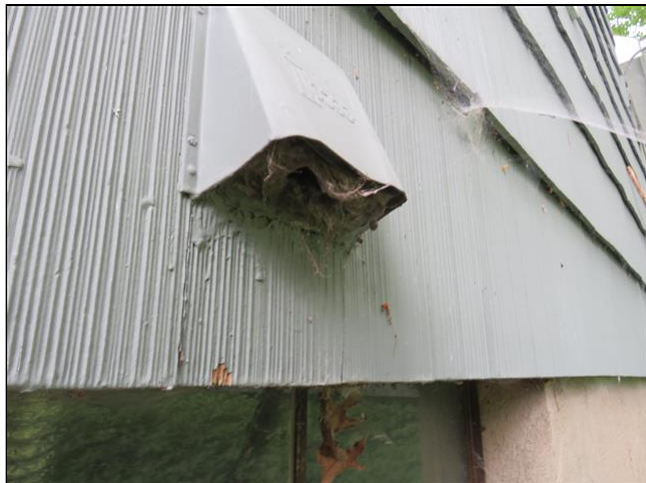
2.11 Item 1(Picture)

The flap to the dryer vent cap is damaged and stuck in an open position. This could allow for pests to nest inside the duct and create an obstruction. I recommend the dryer vent cap be replaced. Additionally, a significant amount of lint was obstructing the vent cap and lint could be felt inside the duct. The dryer duct should be cleaned to remove any accumulation of lint and ensure safe operation. As a part of normal homeowner maintenance, the dryer duct should be cleaned annually.

**2.11** The flap to the dryer vent cap is damaged and stuck in an open position. This could allow for pests to nest inside the duct and create an obstruction. I recommend the dryer vent cap be replaced. Additionally, a significant amount of lint was obstructing the vent cap and lint could be felt inside the duct. The dryer duct should be cleaned to remove any accumulation of lint and ensure safe operation. As a part of normal homeowner maintenance, the dryer duct should be cleaned annually.

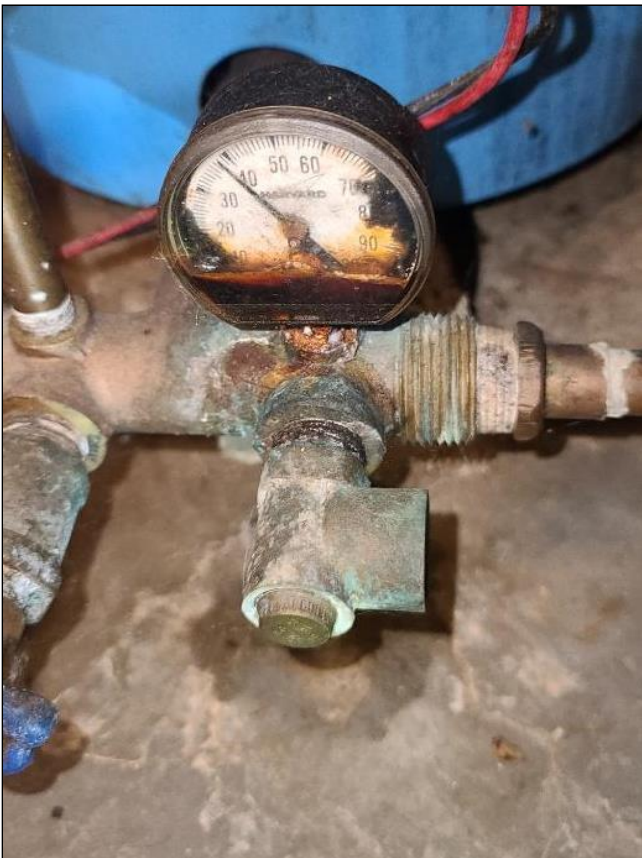
3.1 Item 1(Picture)

The well pump gauge needle does not move and the gauge is full of water and is leaking. I recommend that the gauge be replaced at this time by a licensed plumber.

**3.1** The well pump gauge needle does not move and the gauge is full of water and is leaking. I recommend that the gauge be replaced at this time by a licensed plumber.

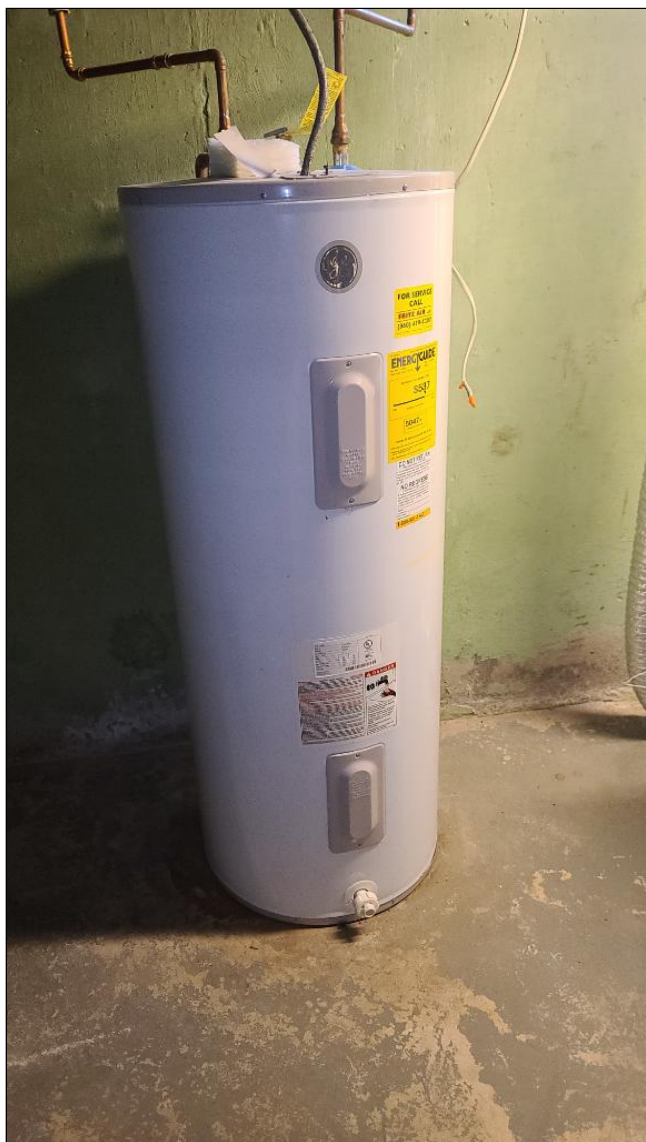
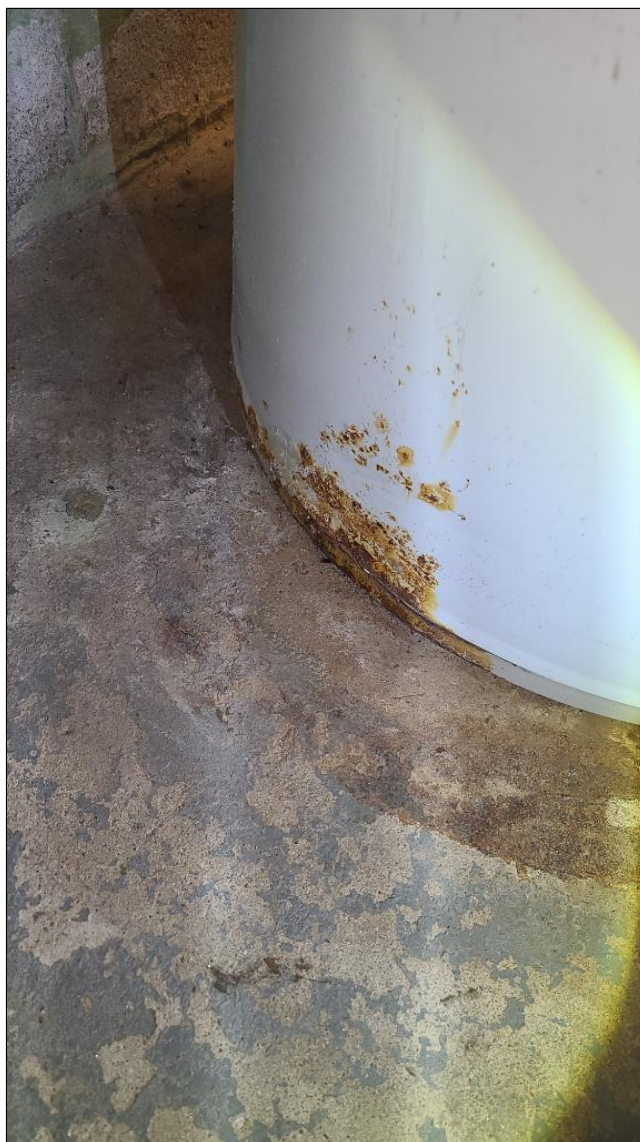
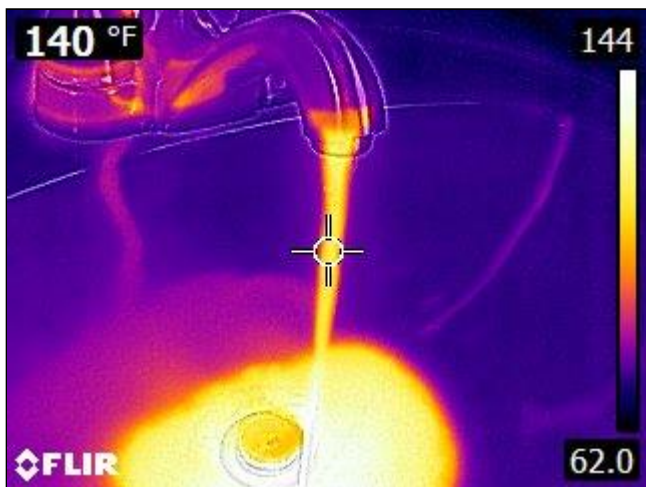
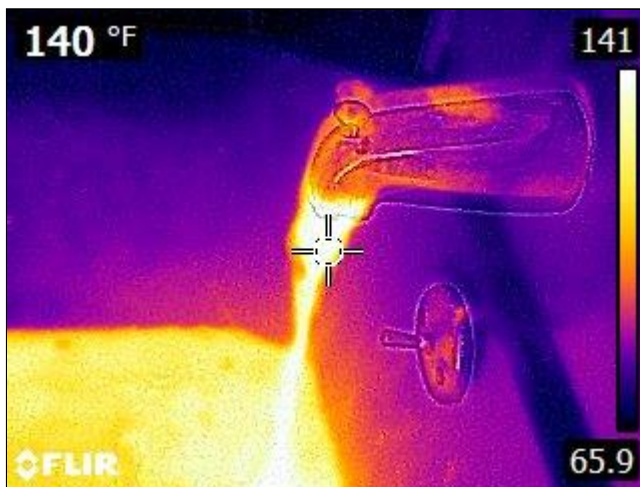
Heavy rust was noted along the bottom of the water heater tank which is evidence of advanced aging and an indication the inner liner of the tank may be failing. The water heater is approximately 16 years old and considered to be beyond its useful life. Based on the age and condition of the water heater I recommend it be replaced at this time. Additionally, the temperature of the domestic hot water was tested and found to be over 140(F) which is considered too hot and a potential burn hazard. I recommend the temperature be adjusted to a lower and safer temperature, ideally 120(F).

**3.6** Heavy rust was noted along the bottom of the water heater tank which is evidence of advanced aging and an indication the inner liner of the tank may be failing. The water heater is approximately 16 years old and considered to be beyond its useful life. Based on the age and condition of the water heater I recommend it be replaced at this time. Additionally, the temperature of the domestic hot water was tested and found to be over

140(F) which is considered too hot and a potential burn hazard. I recommend the temperature be adjusted to a lower and safer temperature, ideally 120(F).

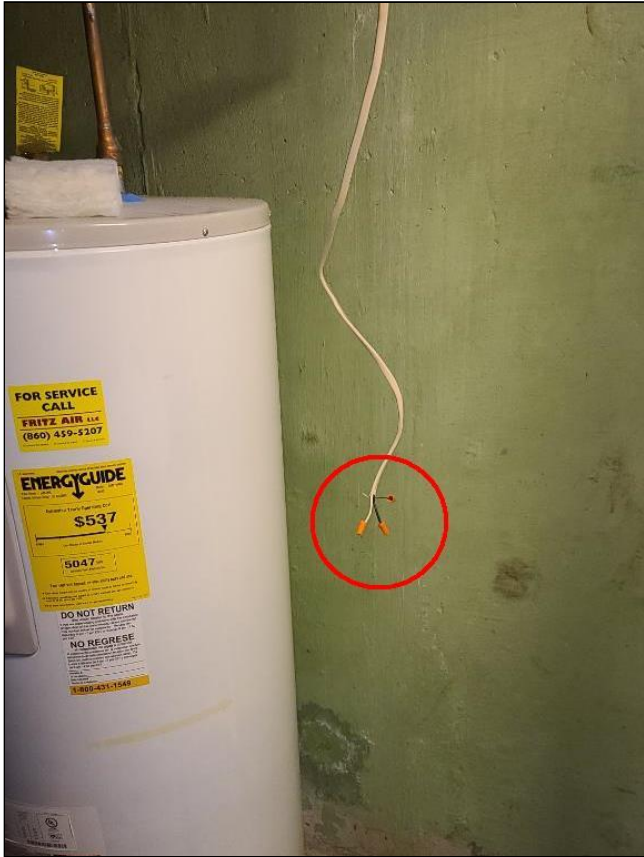
4.3 Item 1(Picture)

There is an improperly terminated wire hanging down from the ceiling next to the water heater. This is a possible safety/shock hazard and I recommend it be properly terminated inside of a junction box for safety reasons.

4.3 There is an improperly terminated wire hanging down from the ceiling next to the water heater. This is a possible safety/shock hazard and I recommend it be properly terminated inside of a junction box for safety reasons.

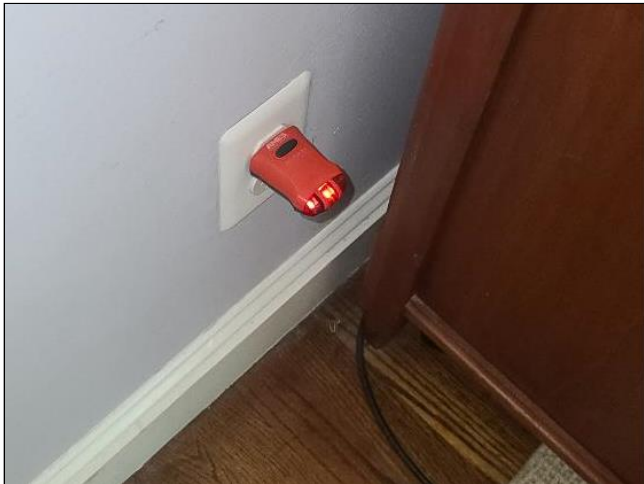
4.4 Item 1(Picture)

The outlets in the master bedroom were tested with a circuit tester and found to have reversed wiring (hot/neutral reverse). Outlets with reversed wiring are considered to be a greater shock hazard. I recommend these receptacles be repaired by a licensed electrician at this time.

4.4 The outlets in the master bedroom were tested with a circuit tester and found to have reversed wiring (hot/neutral reverse). Outlets with reversed wiring are considered to be a greater shock hazard. I recommend these receptacles be repaired by a licensed electrician at this time

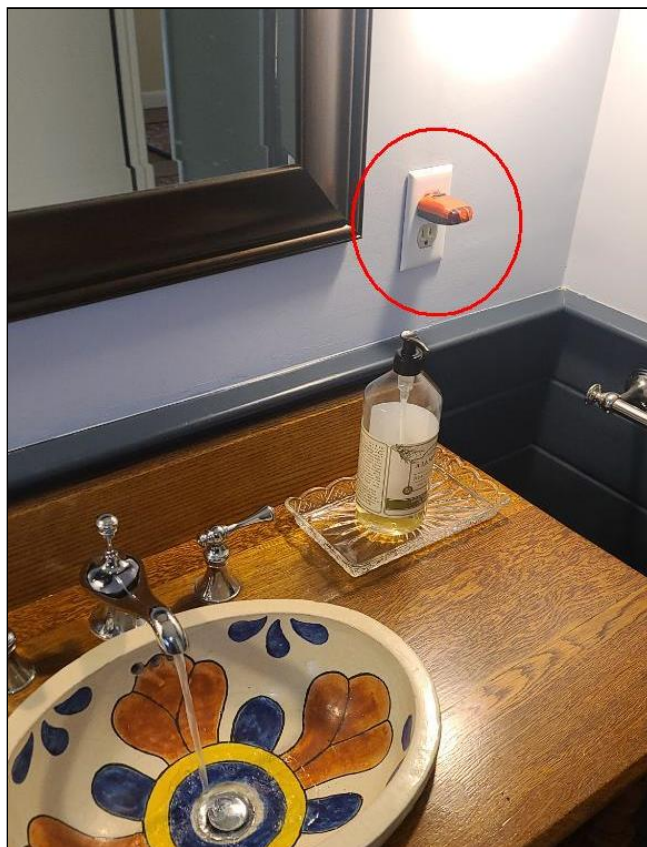
4.5 Item 1(Picture)

The first floor bathroom outlet is not protected by a ground fault circuit interrupter (GFCI). For safety reasons, all outlets within 6 feet of a plumbing fixture should be protected by a GFCI. I recommend this receptacle be replaced with a GFCI outlet at this time.

4.5 The first floor bathroom outlet is not protected by a ground fault circuit interrupter (GFCI). For safety reasons, all outlets within 6 feet of a plumbing fixture should be protected by a GFCI. I recommend this receptacle be replaced with a GFCI outlet at this time.

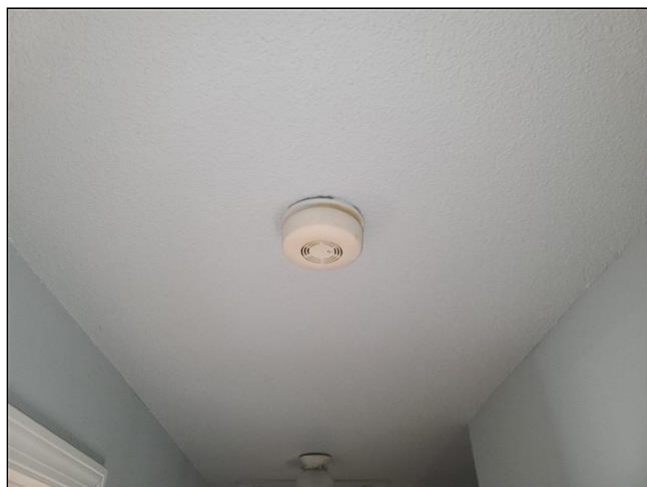
4.7 Item 1(Picture)

The second floor hall smoke detector is 18 years old and is beyond its useful life. There are also no smoke detectors in the bedrooms and I did not observe any carbon monoxide detectors in the home. The National Fire Protection Association ([www.nfpa.org](http://www.nfpa.org)) recommends that detectors be replaced every ten years. The NFPA also recommends installing smoke alarms in every bedroom, outside each sleeping area and on every level of your home. CO alarms should be installed in a central location outside each sleeping area and on every level of the home and in other locations where required by applicable laws, codes or standards. I recommend new smoke and carbon monoxide detectors be installed where required on all levels of the home.

4.7 The second floor hall smoke detector is 18 years old and is beyond its useful life. There are also no smoke detectors in the bedrooms and I did not observe any carbon monoxide detectors in the home. The National Fire Protection Association ([www.nfpa.org](http://www.nfpa.org)) recommends that detectors be replaced every ten years. The NFPA also recommends installing smoke alarms in every bedroom, outside each sleeping area and on every level of your home. CO alarms should be installed in a central location outside each sleeping area and on every level of the home and in other locations where required by applicable laws, codes or standards. I recommend new smoke and carbon monoxide detectors be installed where required on all levels of the home.

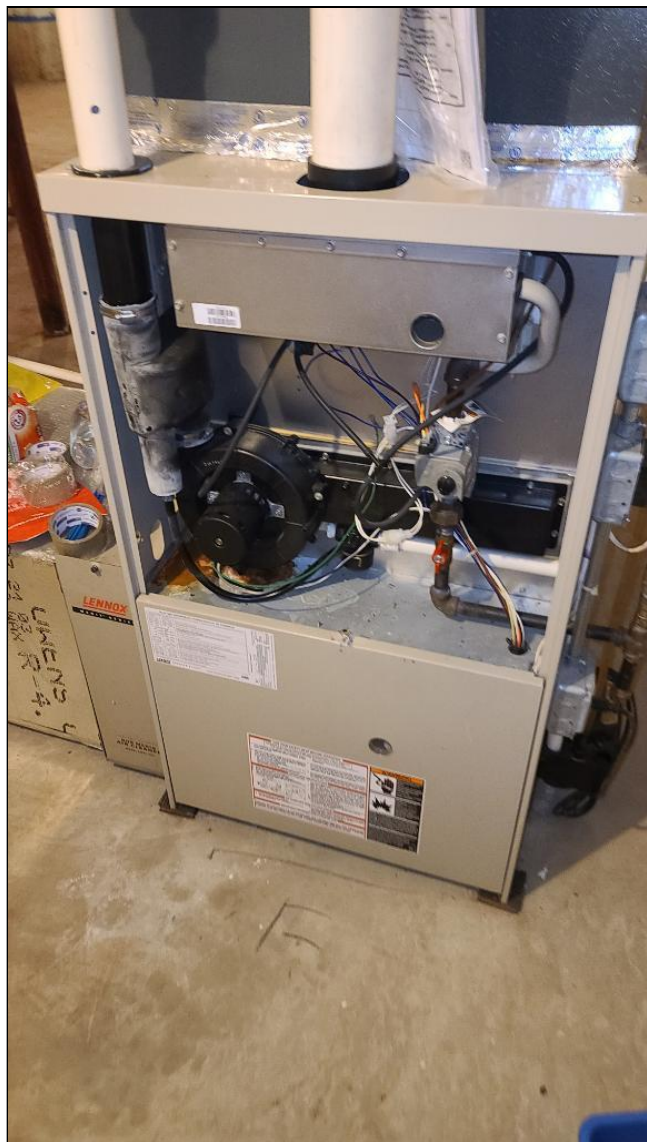
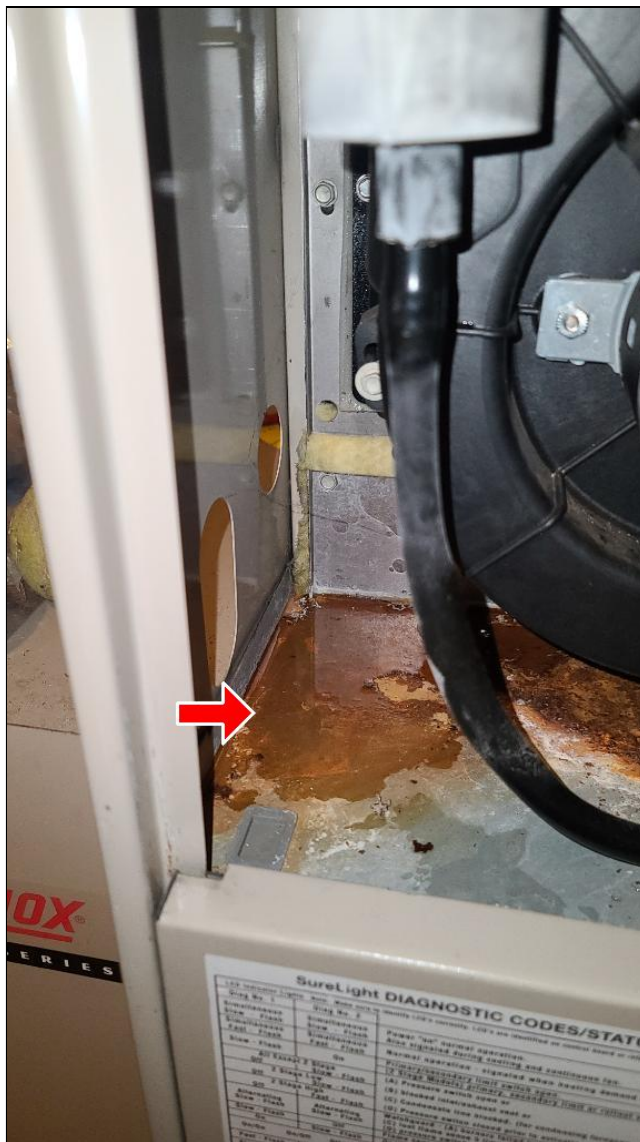
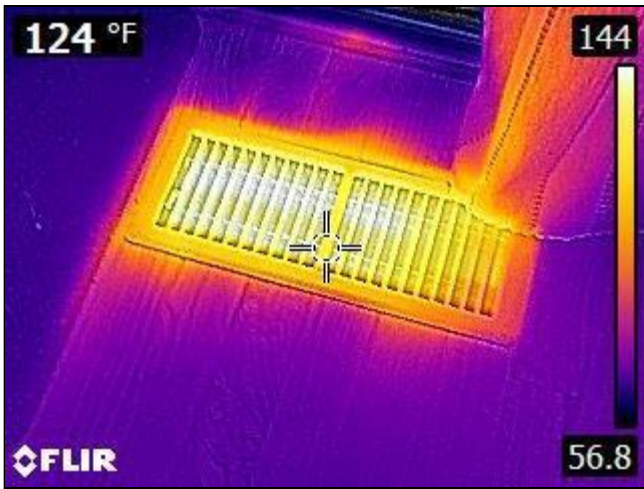
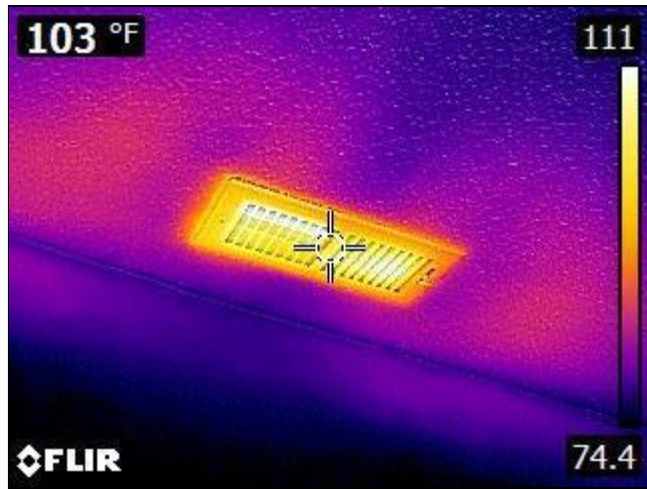
Heat is provided by a gas fired furnace which did operate when tested. There is rust and water on the middle shelf of the furnace which is evidence of a condensate leak that requires repair at this time. Additionally, no maintenance sticker was observed at the heating system. Ideally, heating systems should be serviced on an annual basis to ensure proper operation. I recommend repair and service be accomplished by a licensed HVAC service technician to ensure proper operation and maximum efficiency.

5.1 Heat is provided by a gas fired furnace which did operate when tested. There is rust and water on the middle shelf of the furnace which is evidence of a condensate leak that requires repair at this time. Additionally, no maintenance sticker was observed at the heating system. Ideally, heating systems should be serviced on an annual basis to ensure proper operation. I recommend repair and service be accomplished by a licensed HVAC service technician to ensure proper operation and maximum efficiency.

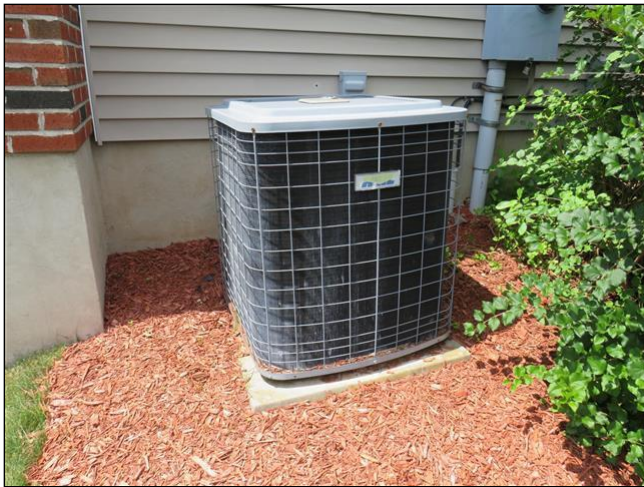
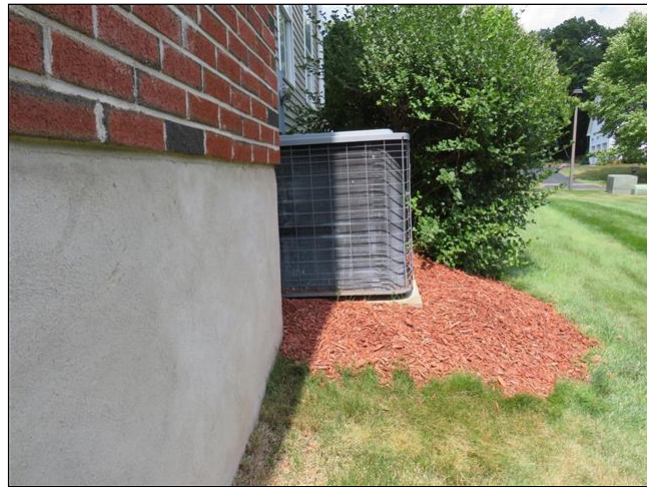
While operating the central air conditioning system, I found that the temperature differential between the supply and return air was only several degrees and although the cooling system ran for almost two hours during the inspection the house never felt cool. An adequate temperature differential is between 16-22 degrees. With a temperature differential of only several degrees this is an indication that the cooling system is in need of service. I recommend a licensed HVAC service technician further inspect the central air conditioning system and accomplish whatever service or repairs necessary at this time. Additionally, the outdoor condenser is not level which can damage the bearings to the compressor due to inadequate lubrication and I recommend the condenser be made level.

5.6 While operating the central air conditioning system, I found that the temperature differential between the supply and return air was only several degrees and although the cooling system ran for almost two hours during the inspection the house never felt cool. An adequate temperature differential is between 16-22 degrees. With a temperature differential of only several degrees this is an indication that the cooling system is in need of service. I recommend a licensed HVAC service technician further inspect the central air conditioning system and accomplish whatever service or repairs necessary at this time. Additionally, the outdoor condenser is not level which can damage the bearings to the compressor due to inadequate lubrication and I recommend the condenser be made level.

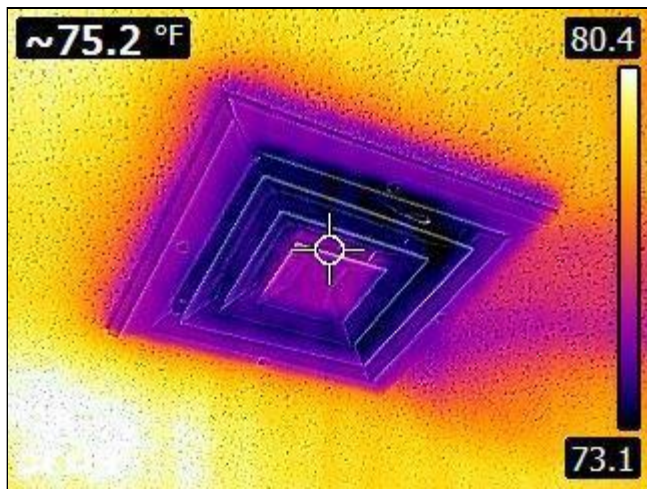
5.6 Item 3(Picture) Supply Air

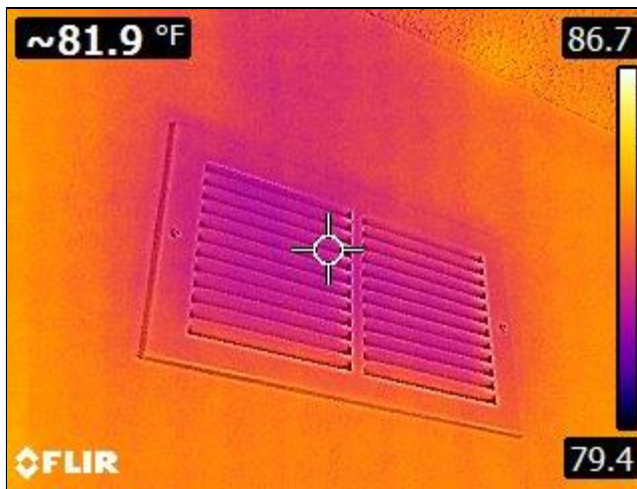
5.6 Item 4(Picture) Return Air

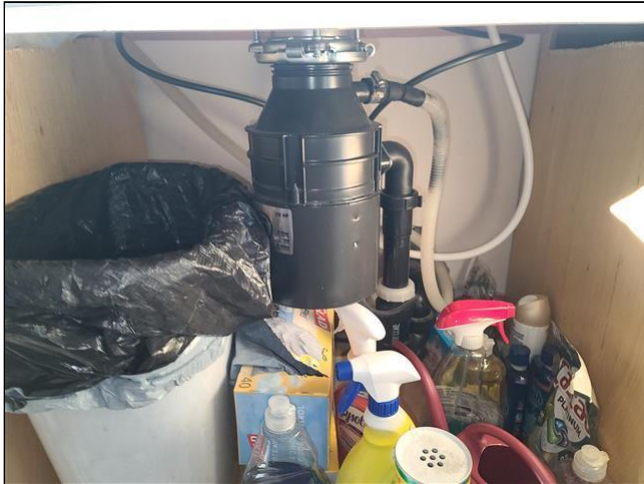
6.2 Item 1(Picture)

The garbage disposer made a humming noise when tested and then the internal breaker tripped. This is an indication that the disposer is bound up and not operating properly. I recommend the garbage disposer be replaced at this time.

6.2 The garbage disposer made a humming noise when tested and then the internal breaker tripped. This is an indication that the disposer is bound up and not operating properly. I recommend the garbage disposer be replaced at this time.
