# Inspection Report

Produced on behalf of – CITY

Site location – Broadway Hill

Adirondack Septic Tank, Inc.

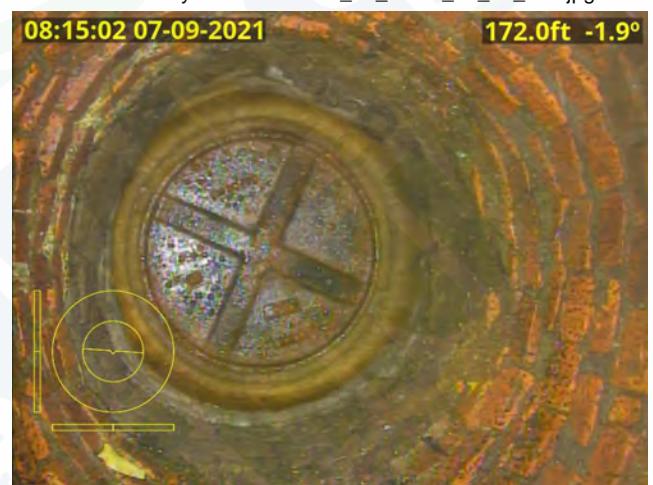
MH survey0000079/2021\_07\_09-08\_15\_02\_488.jpg

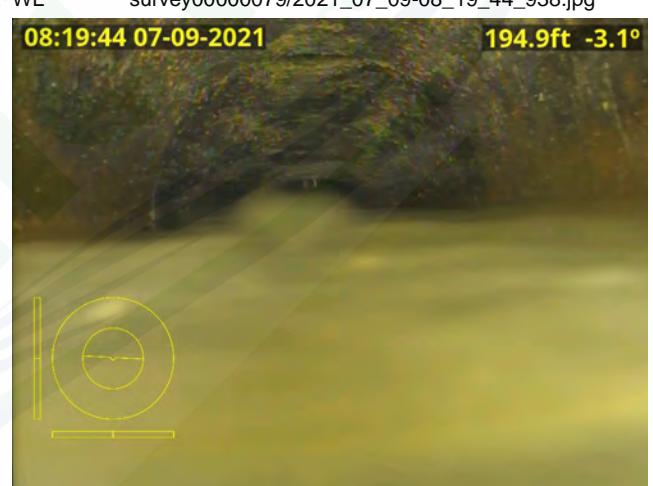
WL survey0000079/2021\_07\_09-08\_19\_44\_938.jpg

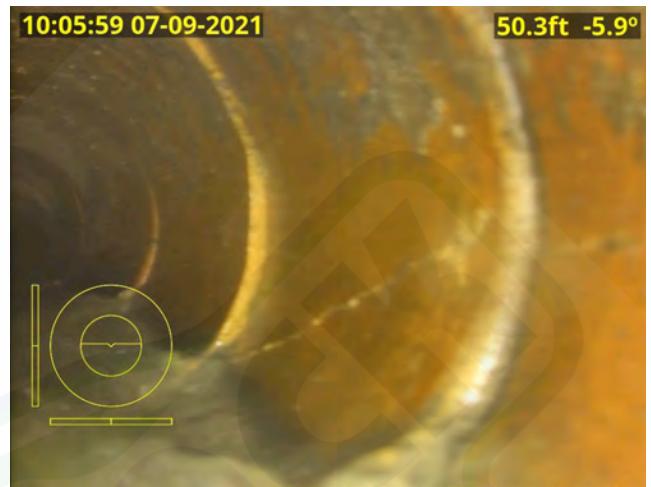
CL survey0000088/2021\_07\_09-10\_05\_59\_206.jpg

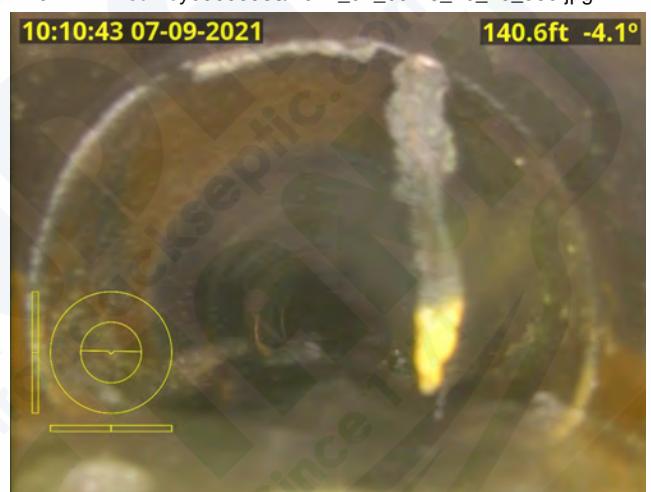
RFJ survey0000088/2021\_07\_09-10\_10\_43\_383.jpg

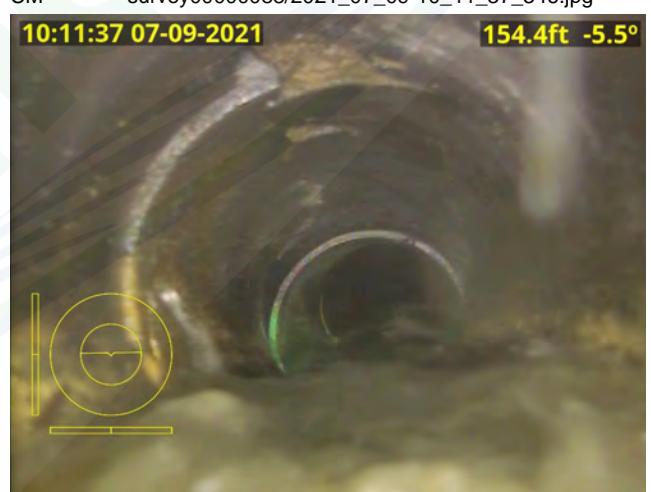
CM survey0000088/2021\_07\_09-10\_11\_37\_346.jpg

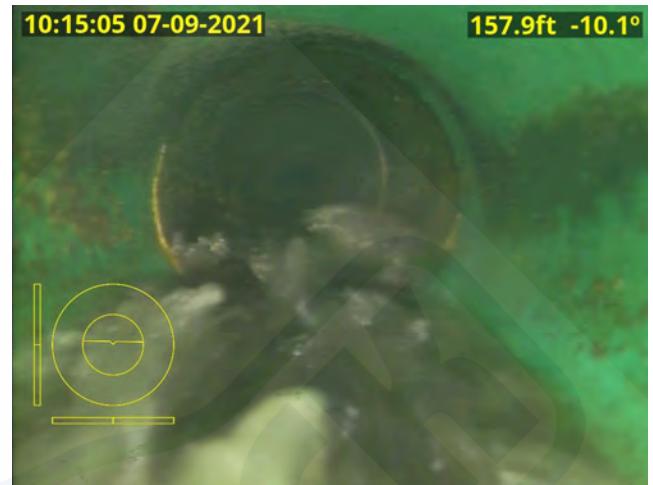
GO survey0000088/2021\_07\_09-10\_15\_05\_612.jpg

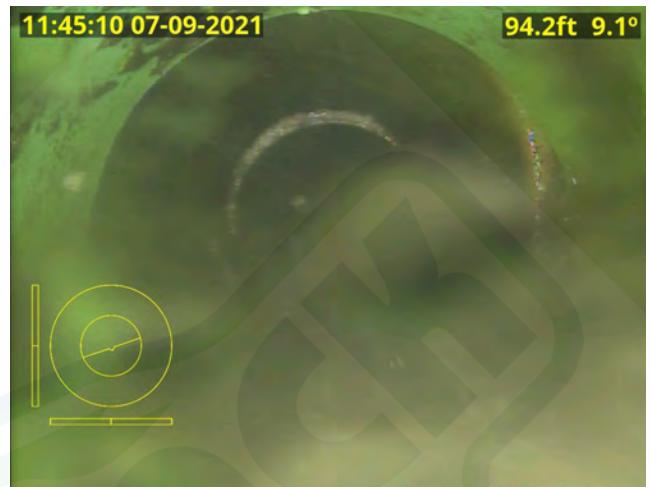
MC survey00000090/2021\_07\_09-11\_45\_10\_413.jpg

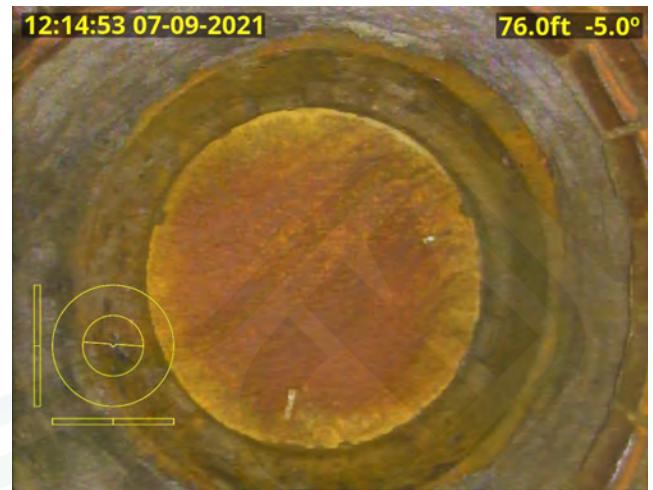
MH survey00000091/2021\_07\_09-12\_14\_53\_314.jpg

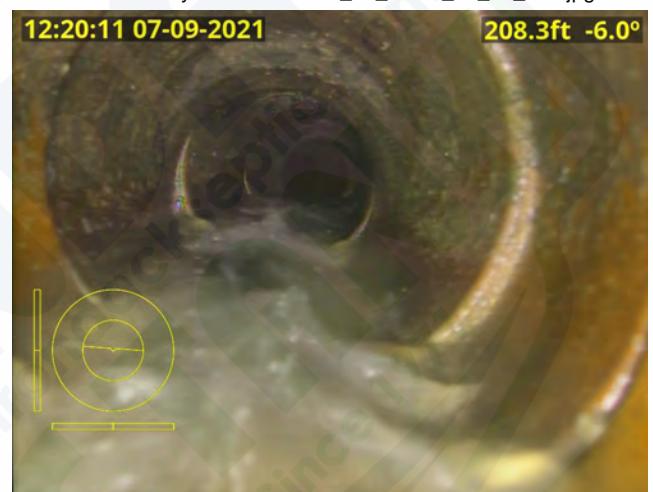
JDL survey00000091/2021\_07\_09-12\_20\_11\_140.jpg

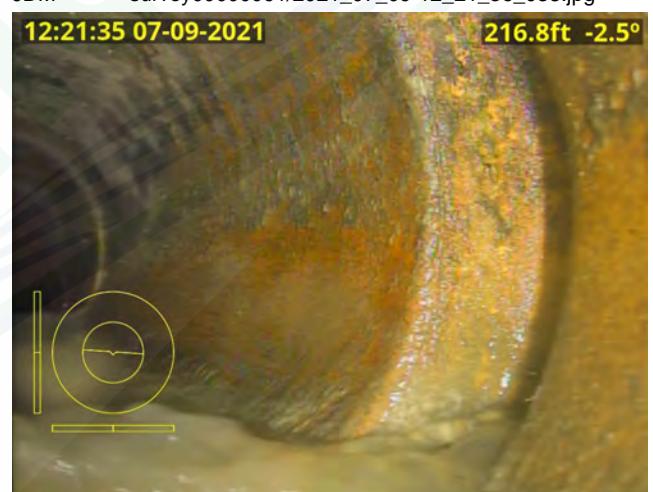
JDM survey00000091/2021\_07\_09-12\_21\_36\_038.jpg
