PROPERTY

Property Located At:
[Insert Inspection Address]

Inspection Date: 18/03/2019

Report #: 180319

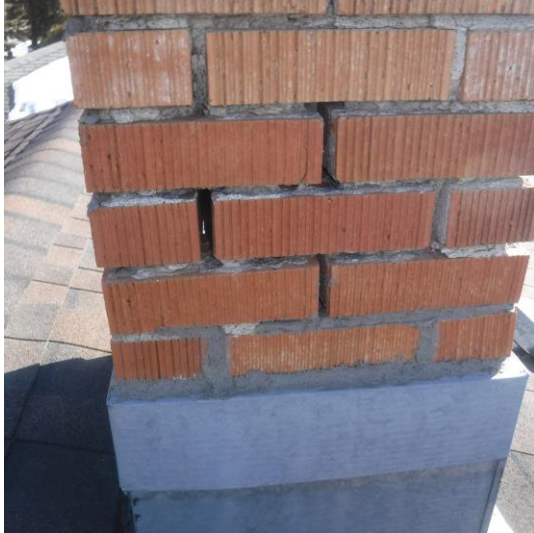
#107- deterioration to chimney mortar joints and unsealed concrete cap, recommend contractor to address to prevent further damage.

Mortar deterioration to chimney

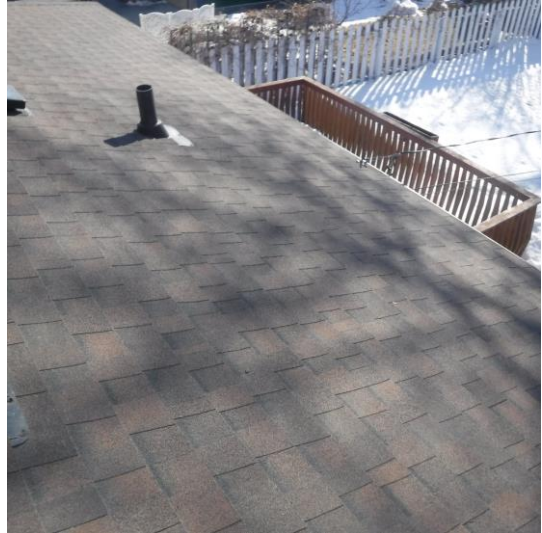
Shingles at back

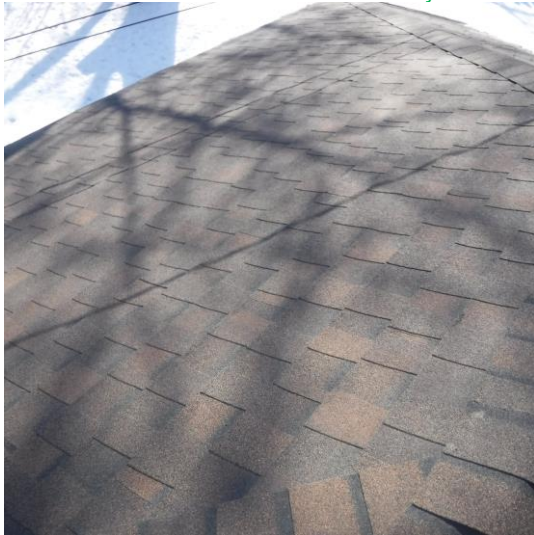
Garge shingles

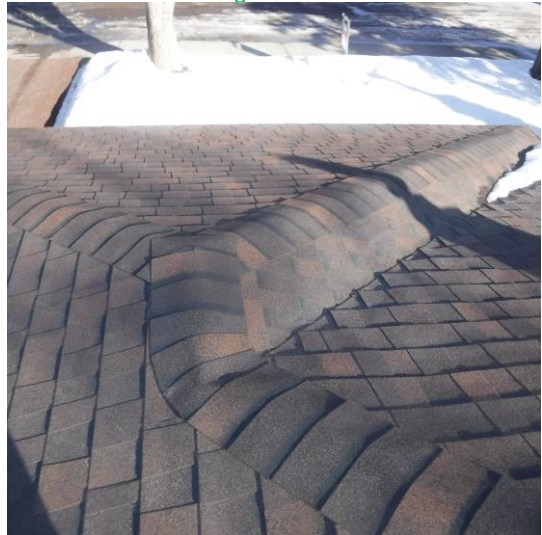
House shingles at front

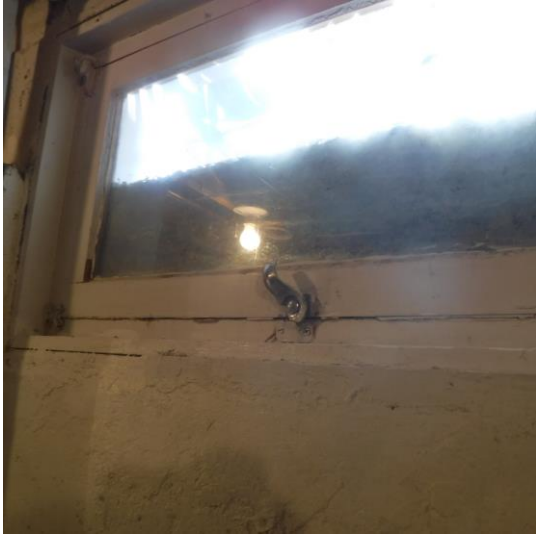
Basement window below grade-no wells

- #206- no window wells installed at basement windows and driveway material covering had of window making the unusable and causing pressure. Recommend contractor to address for adequate installation.

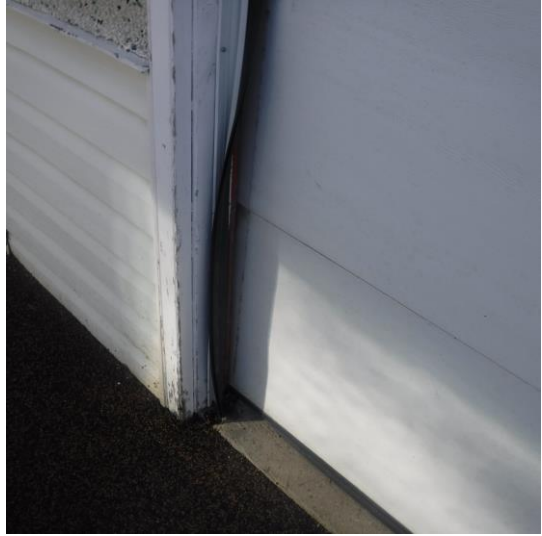
Damaged garge door seal

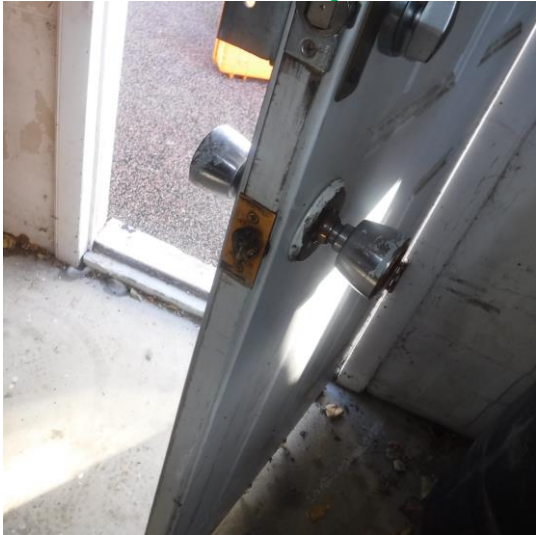
#204- poor operation on bottom lock set on man door to garage and doesn't latch shut, recommend repair for intended operation.
 #206- no window wells installed at basement windows and driveway material covering had of window making the unusable and causing pressure. Recommend contractor to address for adequate installation.

Man door not latching shut

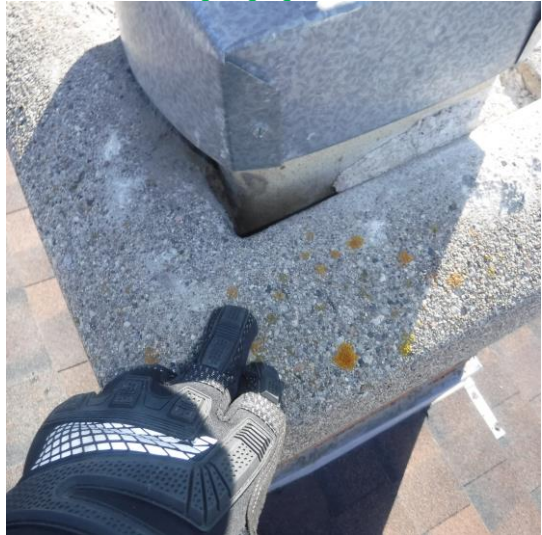
Unsealed chimney cap

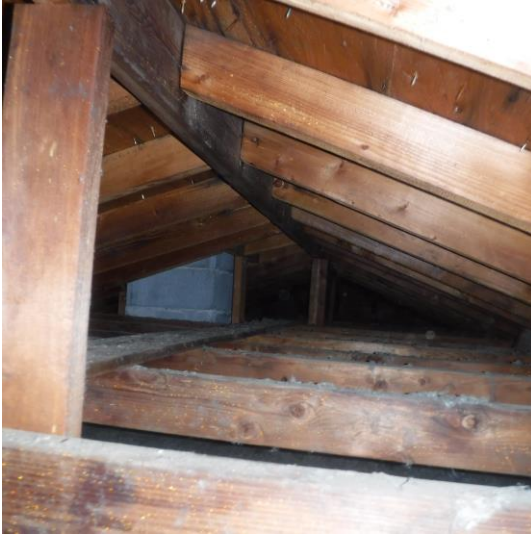
Roof structure in attic

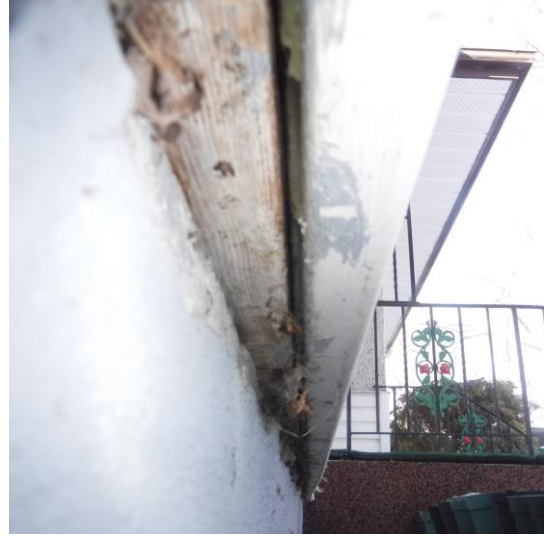
#307- inward movement in front foundation wall at sill plate seen from exterior, large cracking seen in front wall on west side, inward movement in west wall seen from interior and cracking visible from interior, steel bracing has been installed only on west portion of back wall and poor installation of grout behind bracing to prevent further movement.. Recommend contractor to address bracing on front wall, west wall, east portion of back wall and possibly west foundation wall to prevent further movement.

Inward movement in front foundation wall

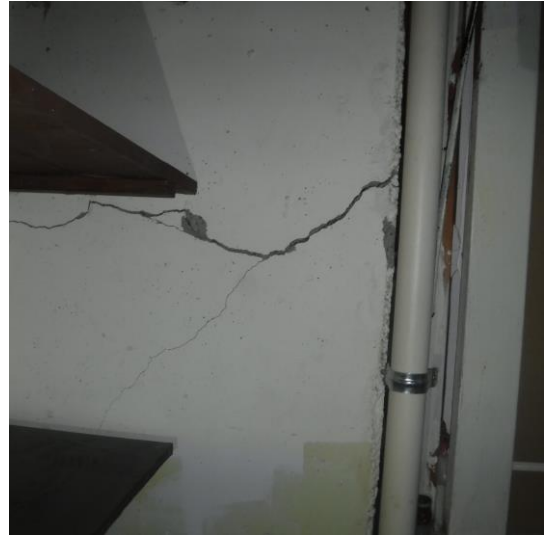
Cracking in front foundation wall

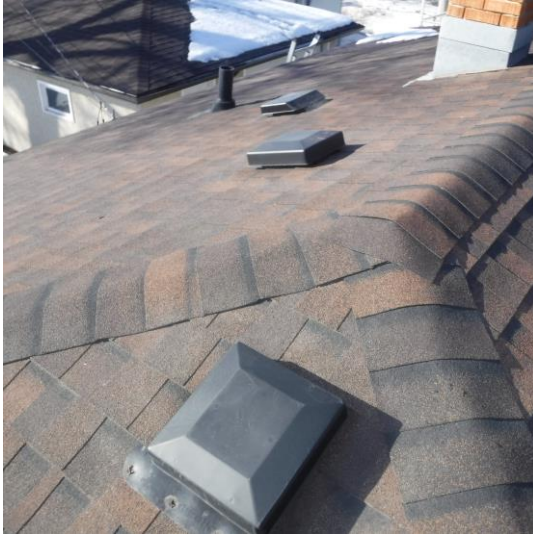
Roof top ventilation

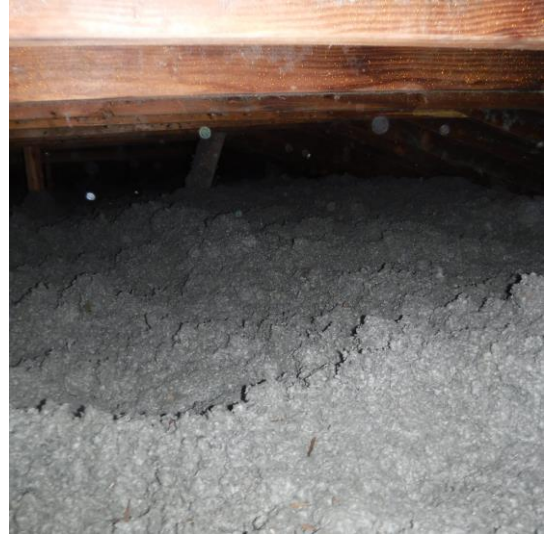
Attic insulation

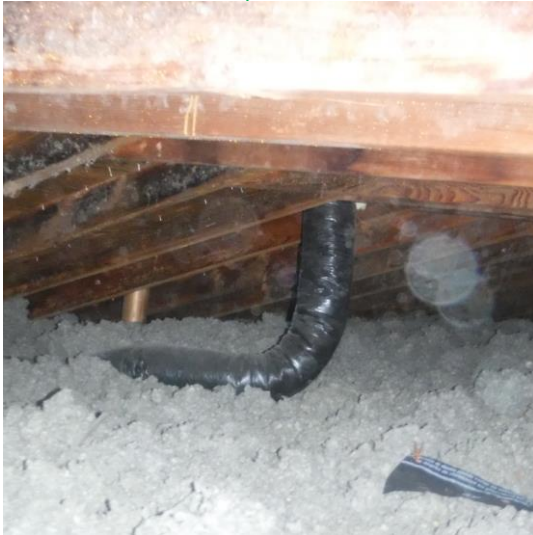
Bathroom exhaust fan termination point

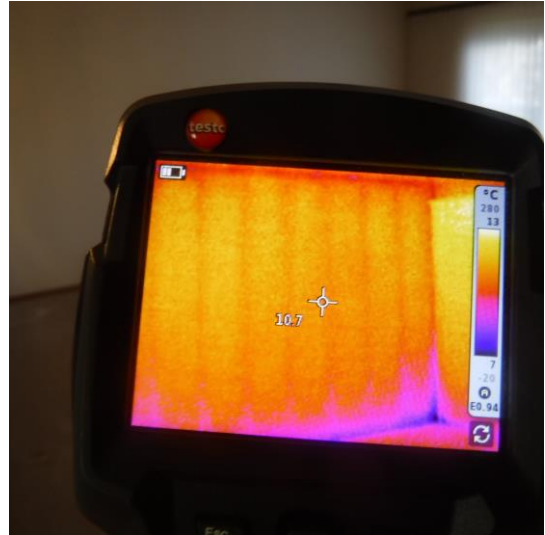
Thermal image of west wall in main floor living room

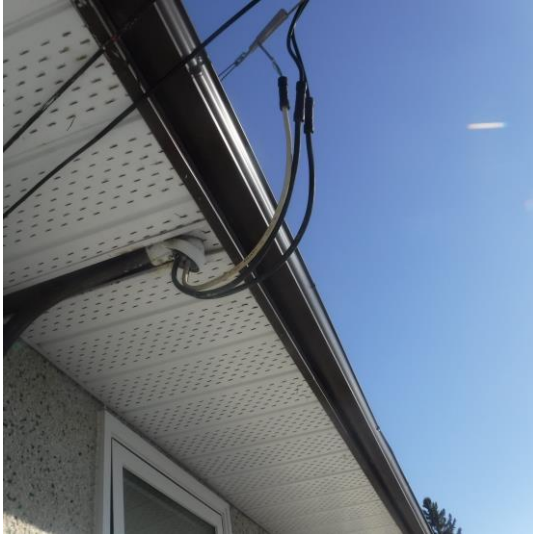
Service entrance-mast head

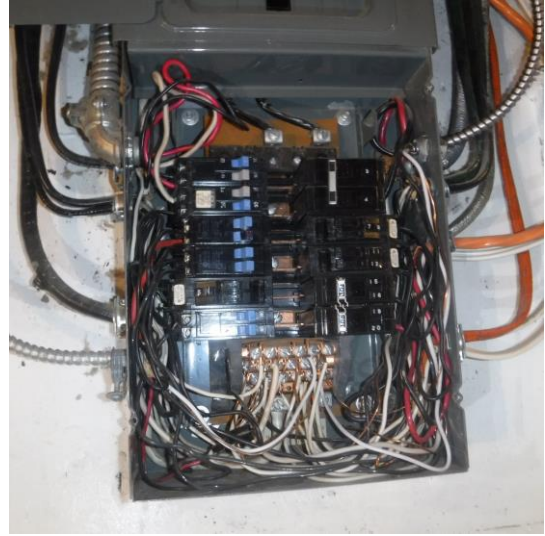
Electrical panel

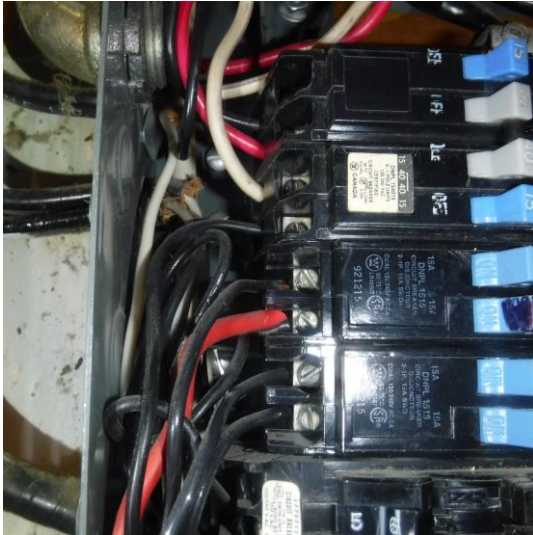
#503- panel is at max capacity with one double tapped breaker, most main floor plugs are not grounded. Recommend electrician to address double tap for adequate installation and operation.

Double tapped breaker in panel

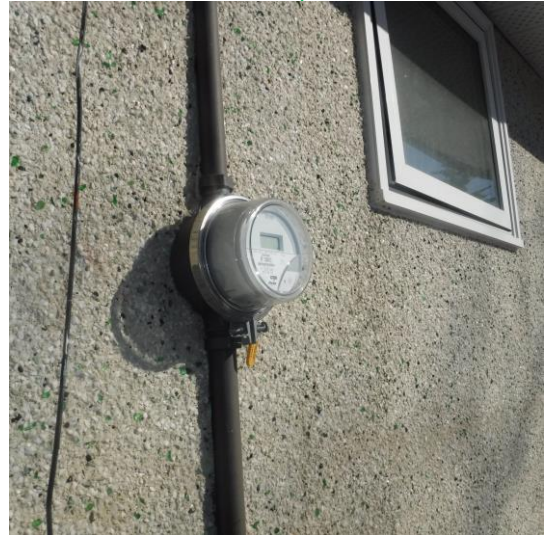
Meter box

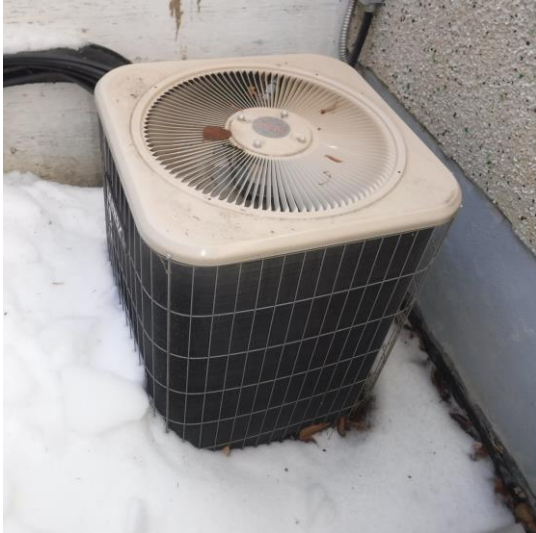
AC unit-not tested

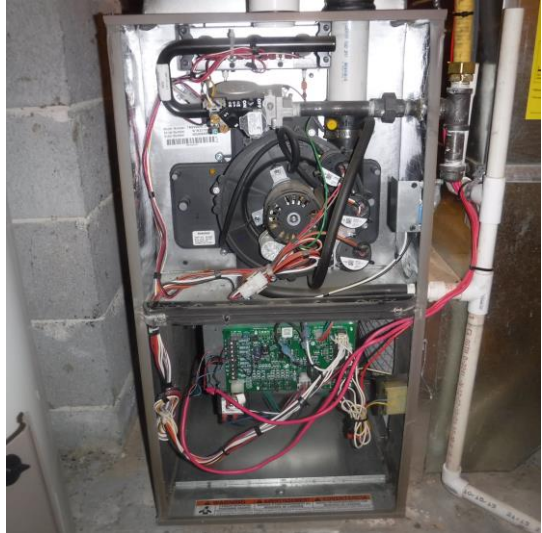
Furnace

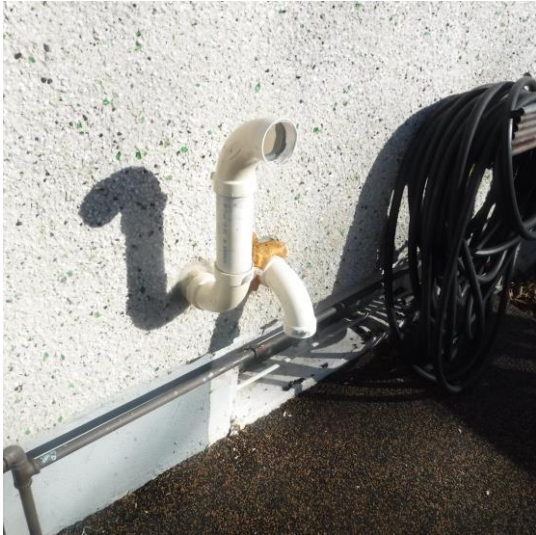
Furnace venting

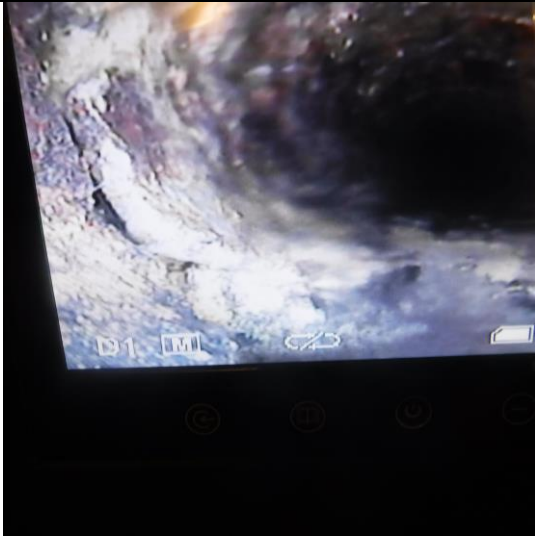
#705- camera sewer line inspection done from main stack, roots in cast iron line in 2 spots in basement floor (no connection visible but no large cracking or offsets noted). Broken cast iron line at approx.. 2 feet past the front cleanout and the camera got stopped at an obstruction (or possibly damaged line) at 4 feet. Recommend sewer line be replaced due to broken line.

Broken cast iron line at 2 feet past front cleanout

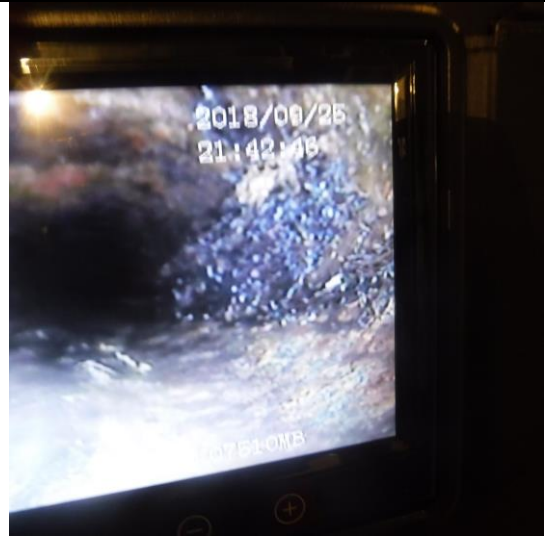
Roost in cats iron line in basement slab

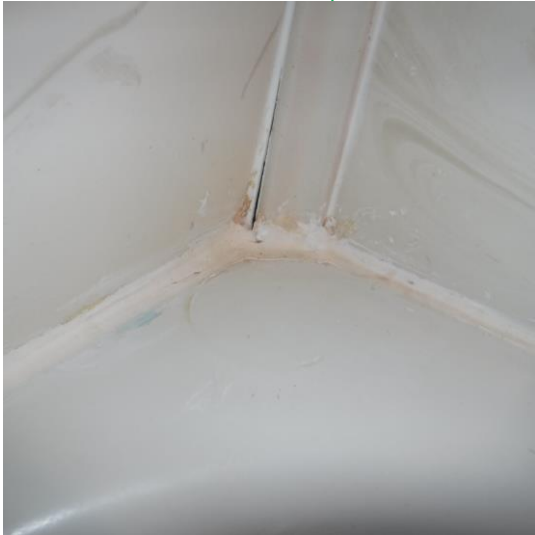
#701- missing main shut off handle before the meter, leaking kitchen sink drain and unsealed tub surround in some areas. Recommend plumber to address for operation and to prevent damage.

Unsealed tub surround

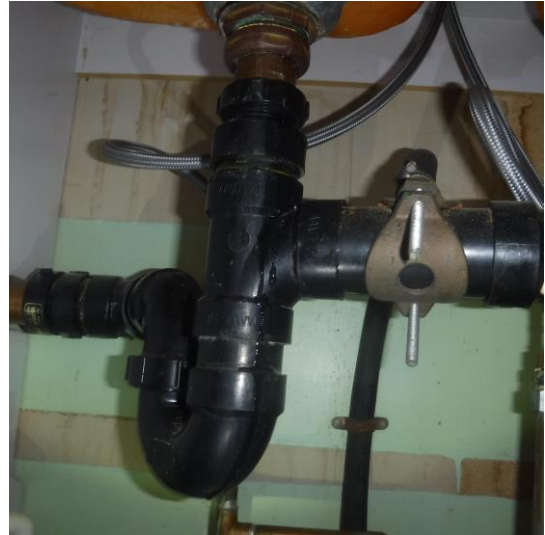
Leaking kitchen sink drain

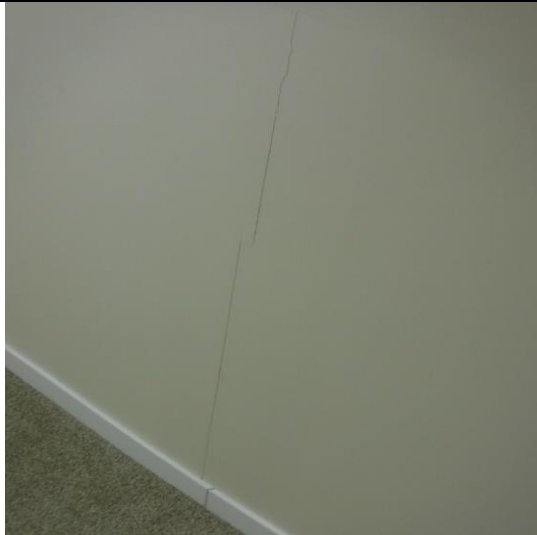
#801- flooring under main floor carpet may contain asbestos (recommend undisturbed), cracking in walls and ceilings on main floor and basement from movement, doors not latching shut due to movement.

Cracking in front wall in basement drywall

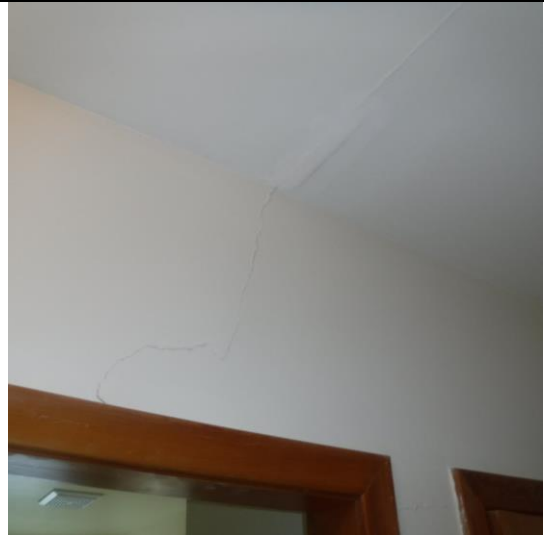
Cracking in main floor walls/ceilings

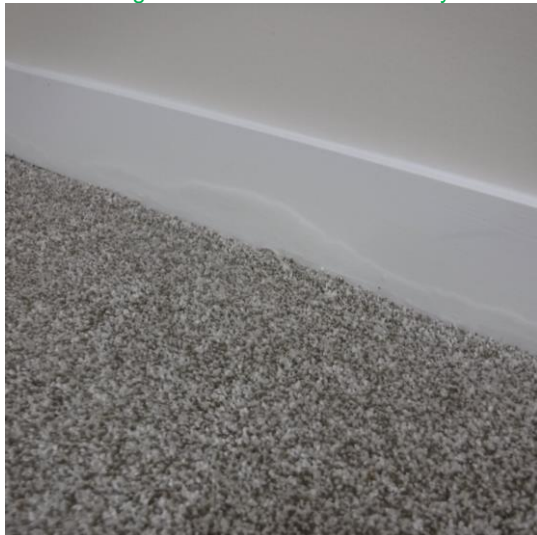
#316- moisture staining on base trim on west wall and back wall in basement, moisture meter readings are all 0% at time of inspection but recommend contractor to address as necessary.

Moisture staining on ack wall in basement

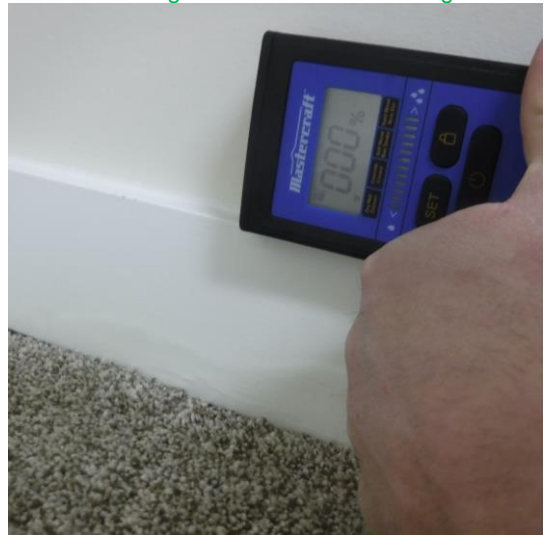
Moisture meter readings 0%

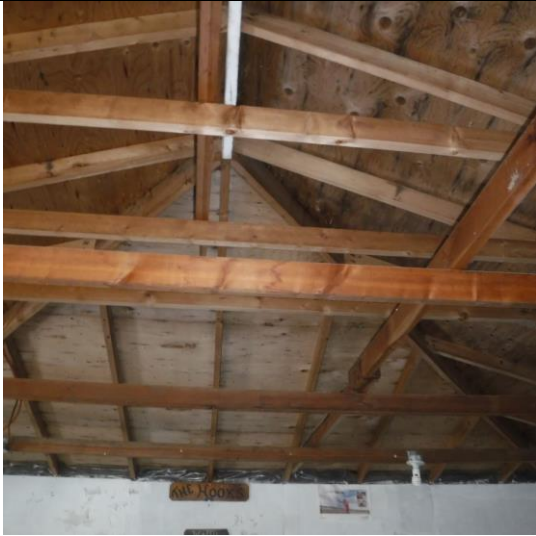
Garage roof structure

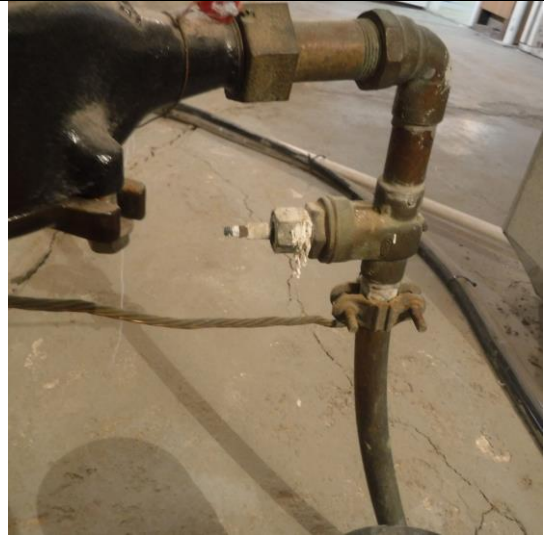
Missing shut off handle on main water line

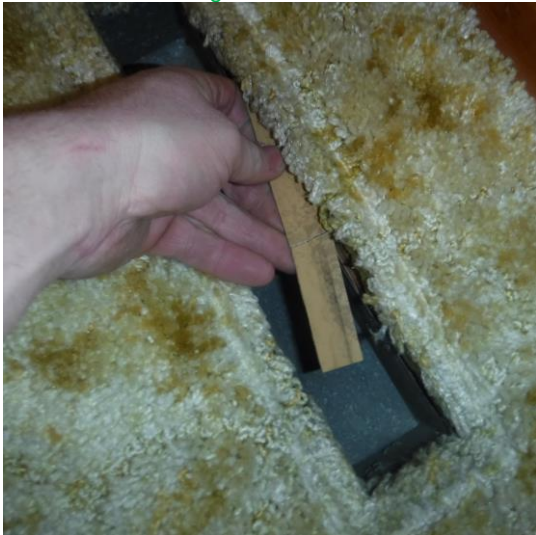
Possible asbestos flooring

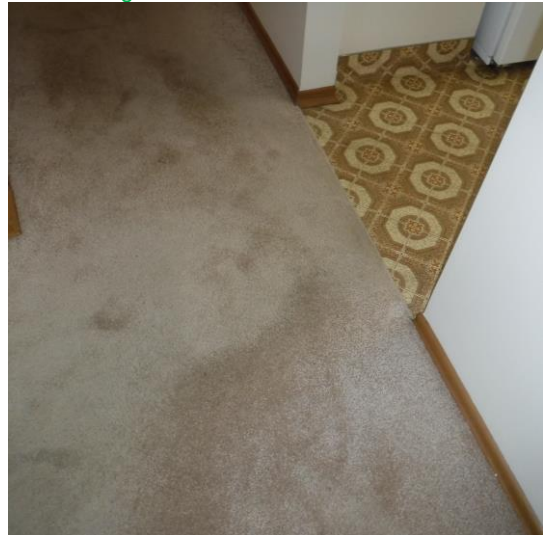
#303-304- significant high spots in main floor above main beam/support columns and some basement wood framed walls are not floated. Recommend contractor to address support column adjustments and all basement walls are adequately floated to prevent pressure on above structures and so main bema adjustments are possible.

High spot sin main floor above main beam

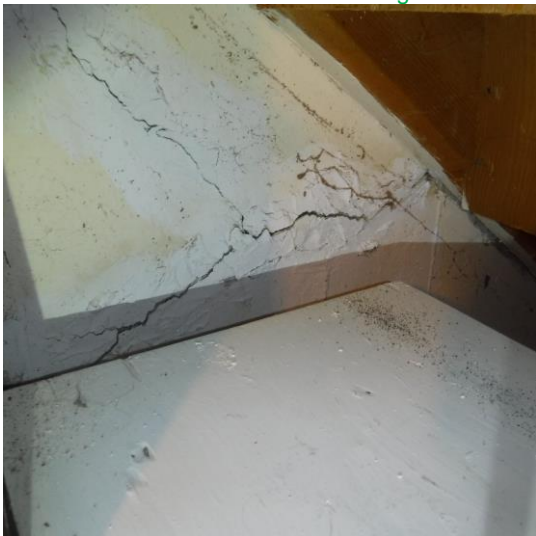
Cracking/inward movement in west foundation wall

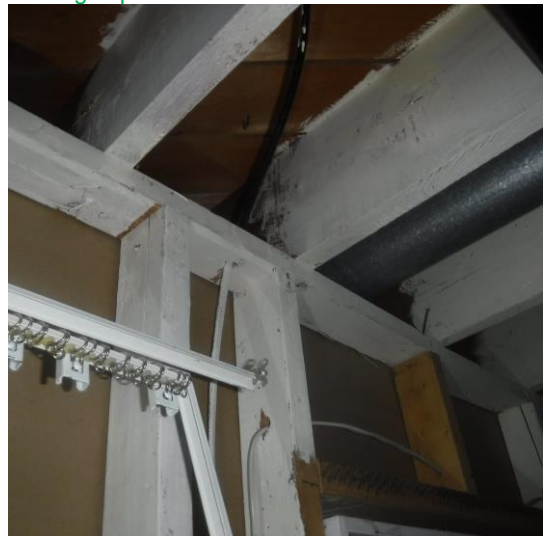
Un-floated basement walls
