Inspection Report

Interior Exterior Home Inspection, Inc.

> Property Address Sample Report

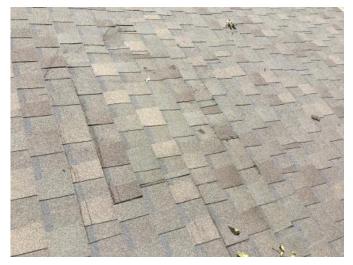
• Tree damage was observed on the roof. This is minor damage and isn't causing a leak. Recommend monitoring this area.

Minor tree damage to shingles

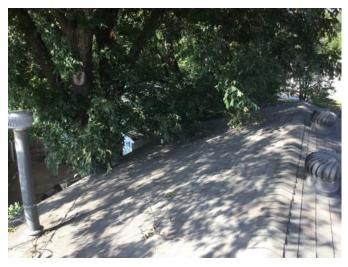
• Tree branches/leaves were in contact with the roof surface. Recommend trimming branches back to prevent potential roof damage.

Trees contacting roof

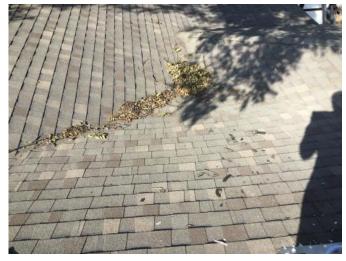
• Debris was in the valley of the roof. Normal cleaning in the area is recommended to prevent organic growth from occurring.

Debris in valley

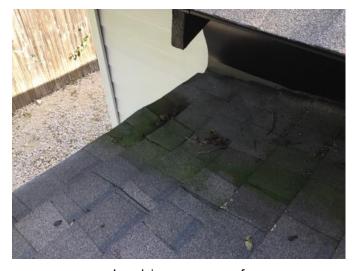
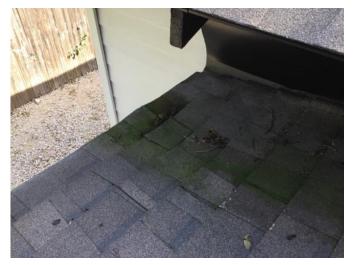
• Moss covering was observed on the roof. While mostly cosmetic and not immediately harmful, this condition can indicate a moisture-related condition. This is a low lying area. Recommend correction to the area for proper water mitigation.

Low lying area on roof

Low lying area on the roof

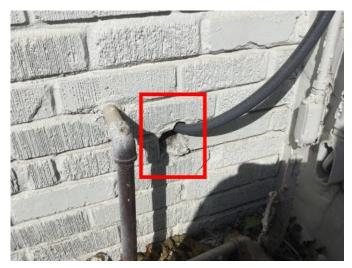
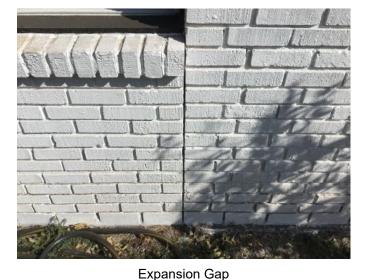
• An open hole on the exterior siding was observed. Recommend sealing the hole to prevent water and bugs from entering the home.

Open hole

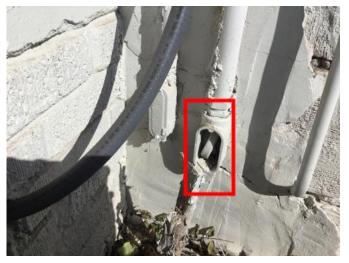
- The exterior outlets appeared to be in serviceable condition at the time of the inspection.
- An exposed electrical wire was observed. Recommend adding a cover to the area.

Missing Cover

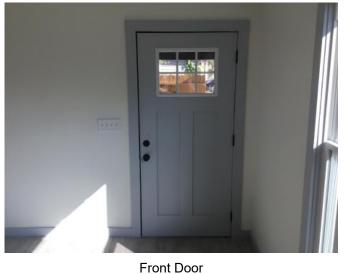
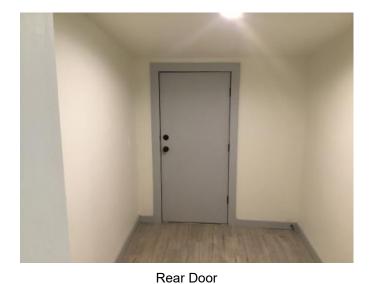
Front and rear exterior door contacts the floor when closing. This will cause the floor to wear out in these areas. Recommend adjusting the doors.

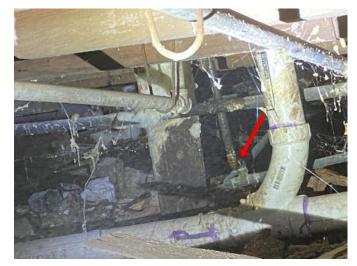
The area under the hallway bathroom had moisture and organic growth. A leaking pipe was observed in this area. It is suggested that a "Licensed Plumbing Contractor" be contacted for further evaluation and repair.

Leaking Pipe

Active leaks were observed in the crawlspace under the hallway bathroom. Recommend further evaluation and repair by a licensed plumber. See section 4.1

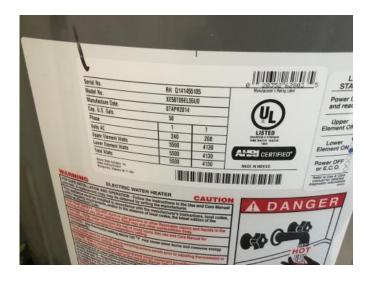
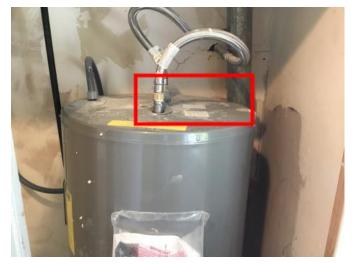
• T P R (temperature pressure relief) valve overflow pipe was missing at the time of the inspection. Recommend the installation of an extension pipe for increased safety.

No TPR overflow pipe

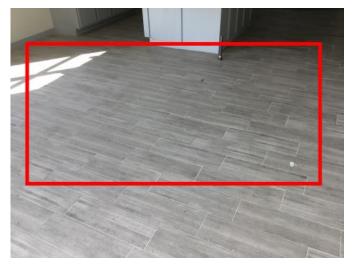
Uneven floors were observed. From the visible and accessible areas, no immediate concern was observed. This may not however, be an indication of future conditions.

Uneven floor

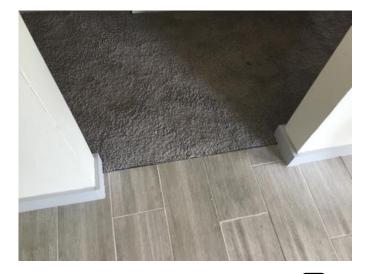
No transition installed between the carpet and tile floors. This could allow for the tile to chip prematurely. Recommend installing a transition to this area.

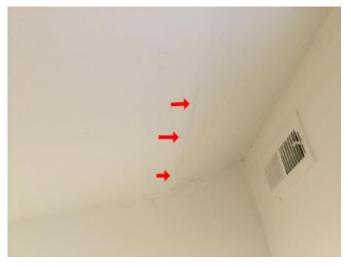
There was a common crack on the ceiling. Although these conditions are common in most homes, client is advised to monitor cracks for future movement.

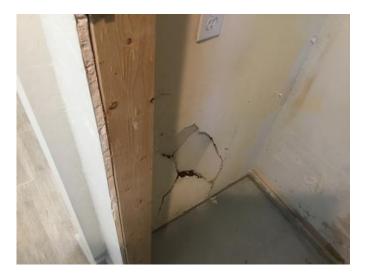
The interior walls were damaged. Recommend repairs as needed.

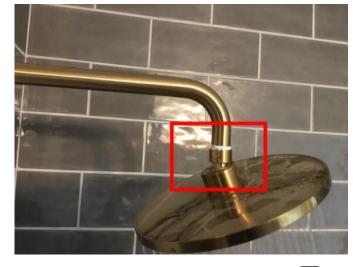
Shower head was leaking during the inspection. Recommend correction.

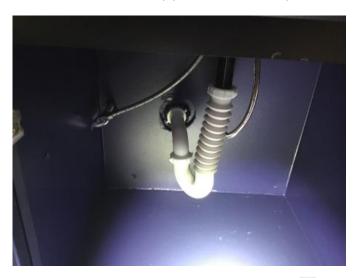
Accordion drain under the sink. An accordion pipe is no longer permitted due to the fact that mildew and debris can catch in the folds of the pipe. Recommend replacement of pipe with smooth UL listed plumbing parts.

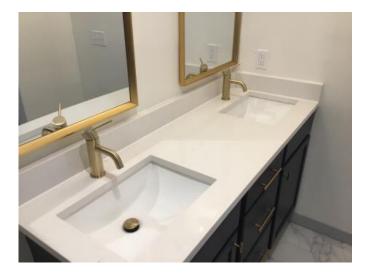
There was no cold water supply in bathroom. Inspector was unable to test or inspect. It is suggested that a "Licensed Plumbing Contractor" be contacted for further evaluation and repair.

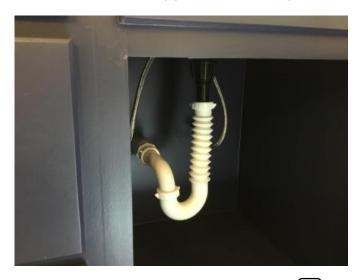
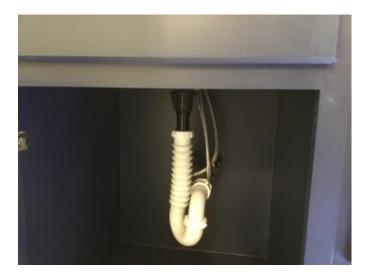
Accordion drain under the sink. An accordion pipe is no longer permitted due to the fact that mildew and debris can catch in the folds of the pipe. Recommend replacement of pipe with smooth UL listed plumbing parts.

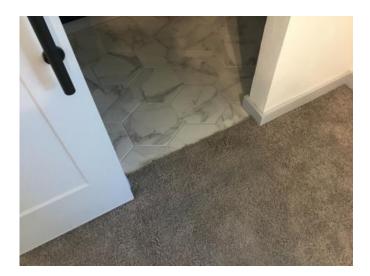
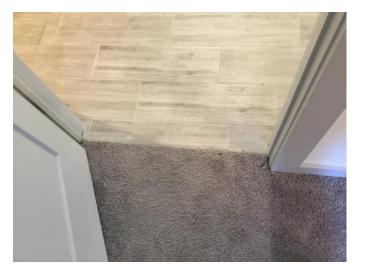
No transition installed between the carpet and tile floors. This could allow for the tile to chip prematurely. Recommend installing a transition to this area.

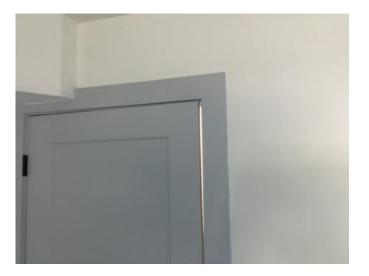
The door sticks at the doorframe in the master bedroom. Repairs and/or adjustments are recommended.
