BPG Inspection, LLC

Inspection Date: 11/29/2023

SECTION I. KEY FINDINGS

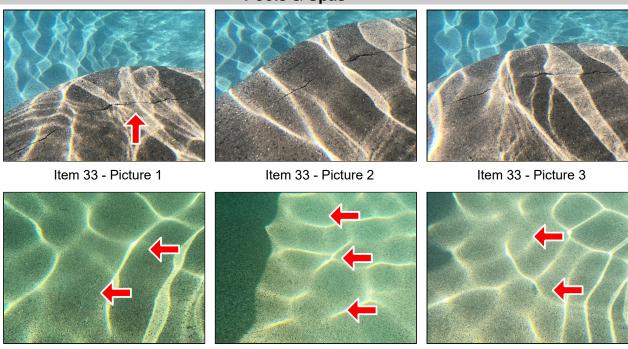
33. The pool and or spa vessel surface material shows signs of cracking and will have a limited remaining useful life. The pool may be leaking underneath. Consult a qualified pool professional to determine remaining useful life and future replacement costs.
